CRJ700/705/900-SL-32-039

SUBJECT: Body Fairing Seal Inspection Common to MLG Inboard Door

MODEL: CL-600-2C10 (CRJ700) and CL-600-2D24 (CRJ900) CL600-2D15 (CRJ705)

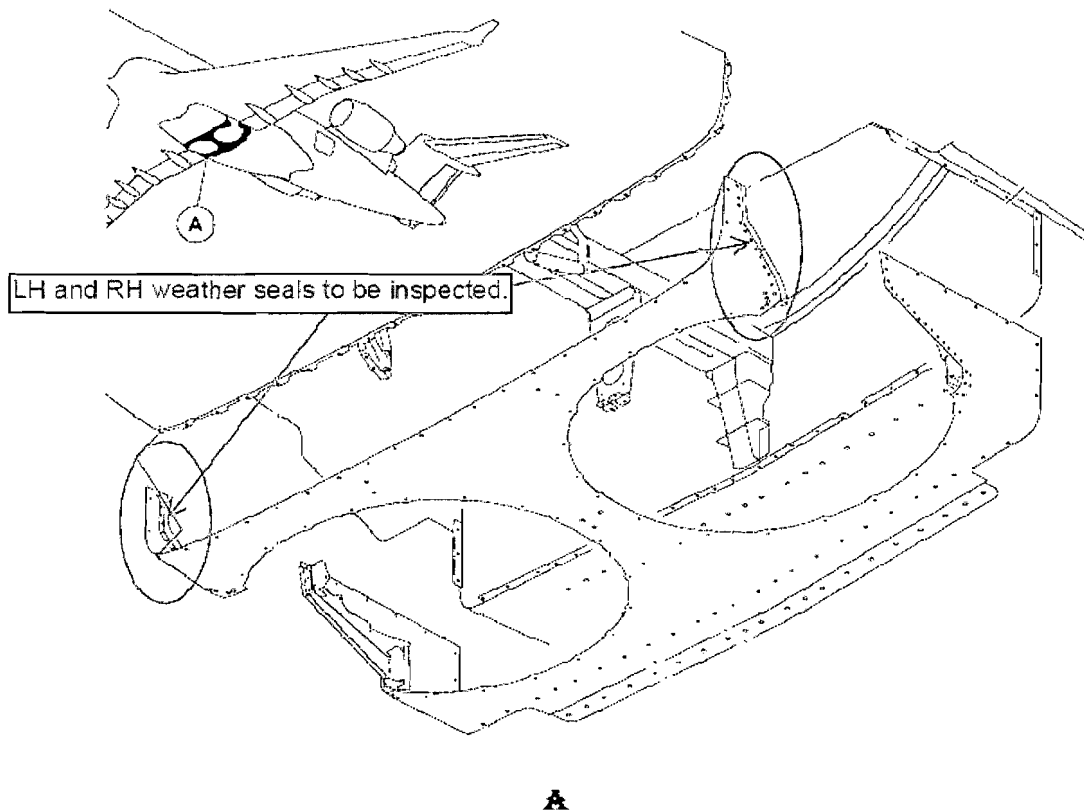
AOM-494 introduced that an operator recently experienced a left MLG up landing. Following preliminary findings of the event, it was observed that the MLG inboard door edge was in contact with its mating body fairing rubber seal / internal metallic stiffener (ref; CC670-39244).

Improper positioning of the door (possibly due to rigging) could result in extra pressure on the seal / premature wear of the rubber covering the metallic stiffener thus causing the metal stiffener to be exposed. This condition could potentially result contact with the MLG Door and in restricted movement of the main landing gear during extension.

Bombardier recommends that operators perform the following general visual inspection at next convenient maintenance opportunity (ex 72 hrs or 100 FH) as follows:

- Inspect the body fairing seal common to the area highlighted above for damage
- If the seals are worn to the point where the inner metallic stiffener is clearly visible; Bombardier recommends the following actions:

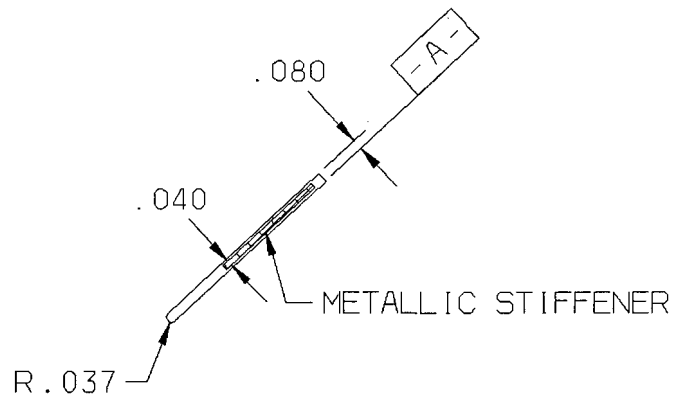
SECTION : A-A

Silicone rubber seal with metallic stiffener within, ref. CC670-39244

1. Replace the damaged seal and do the following steps:
 - Rig the affected MLG inboard door per AMM TASK 32-12-01-220-801 (Configuration A01 or A02)
 - Ensure clearance check (step & gap) of the MLG doors (aircraft jacked & gears retracted) is performed
 - Ensure there is no contact between inboard door and body fairing edge during extension of the gear

2. Remove the MLG Inboard door per Configuration Deviation List (CDL) (as a temporary measure if parts & manpower is not available)
 - AFM section 8, 32--12 Main landing gear door – Inboard door, P/N CC670--10520
