**NATIONAL TRANSPORTATION SAFETY BOARD  
Office of Aviation Safety  
Washington, DC 20594**

**ATC GROUP CHAIRMAN FACTUAL REPORT**

**CEN09FA019**

**Location:** Aurora, Illinois  
**Date:** October 15, 2008 / October 16, 2008 Coordinated Universal Time<sup>1</sup>  
**Time:** 2358 Central Daylight Time / 0458 UTC  
**Aircraft:** N992AA, Bell 222 helicopter

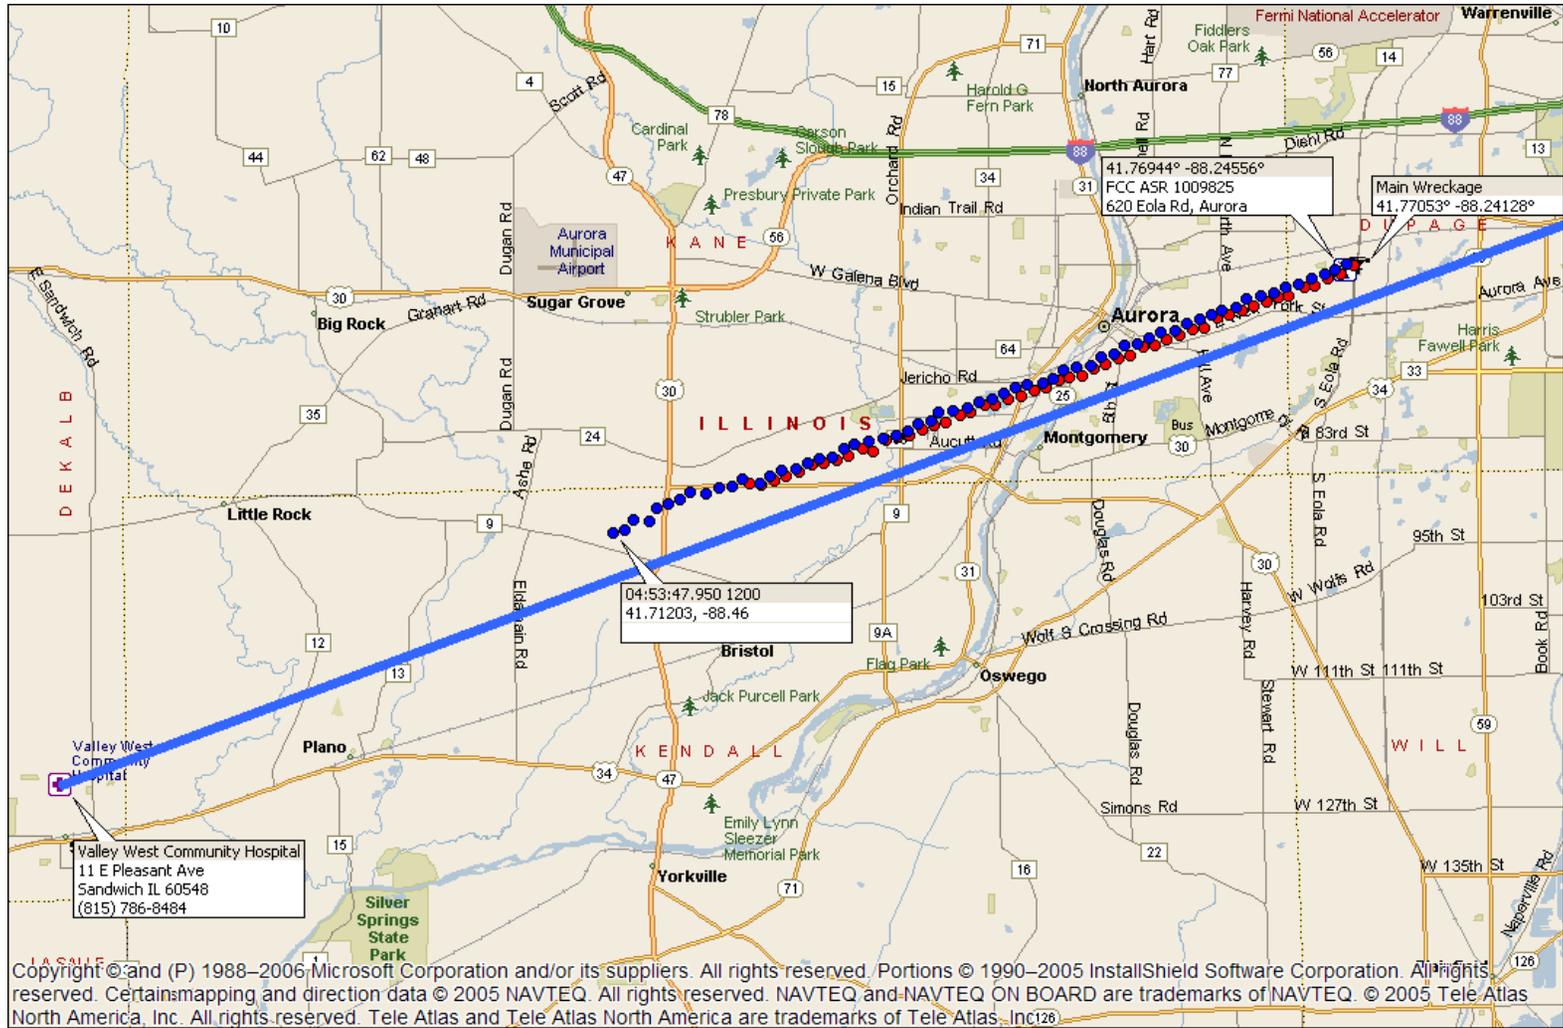
Figure 1 – N92AA direct route and radar targets from the Chicago(blue) and Midway(red) radars.

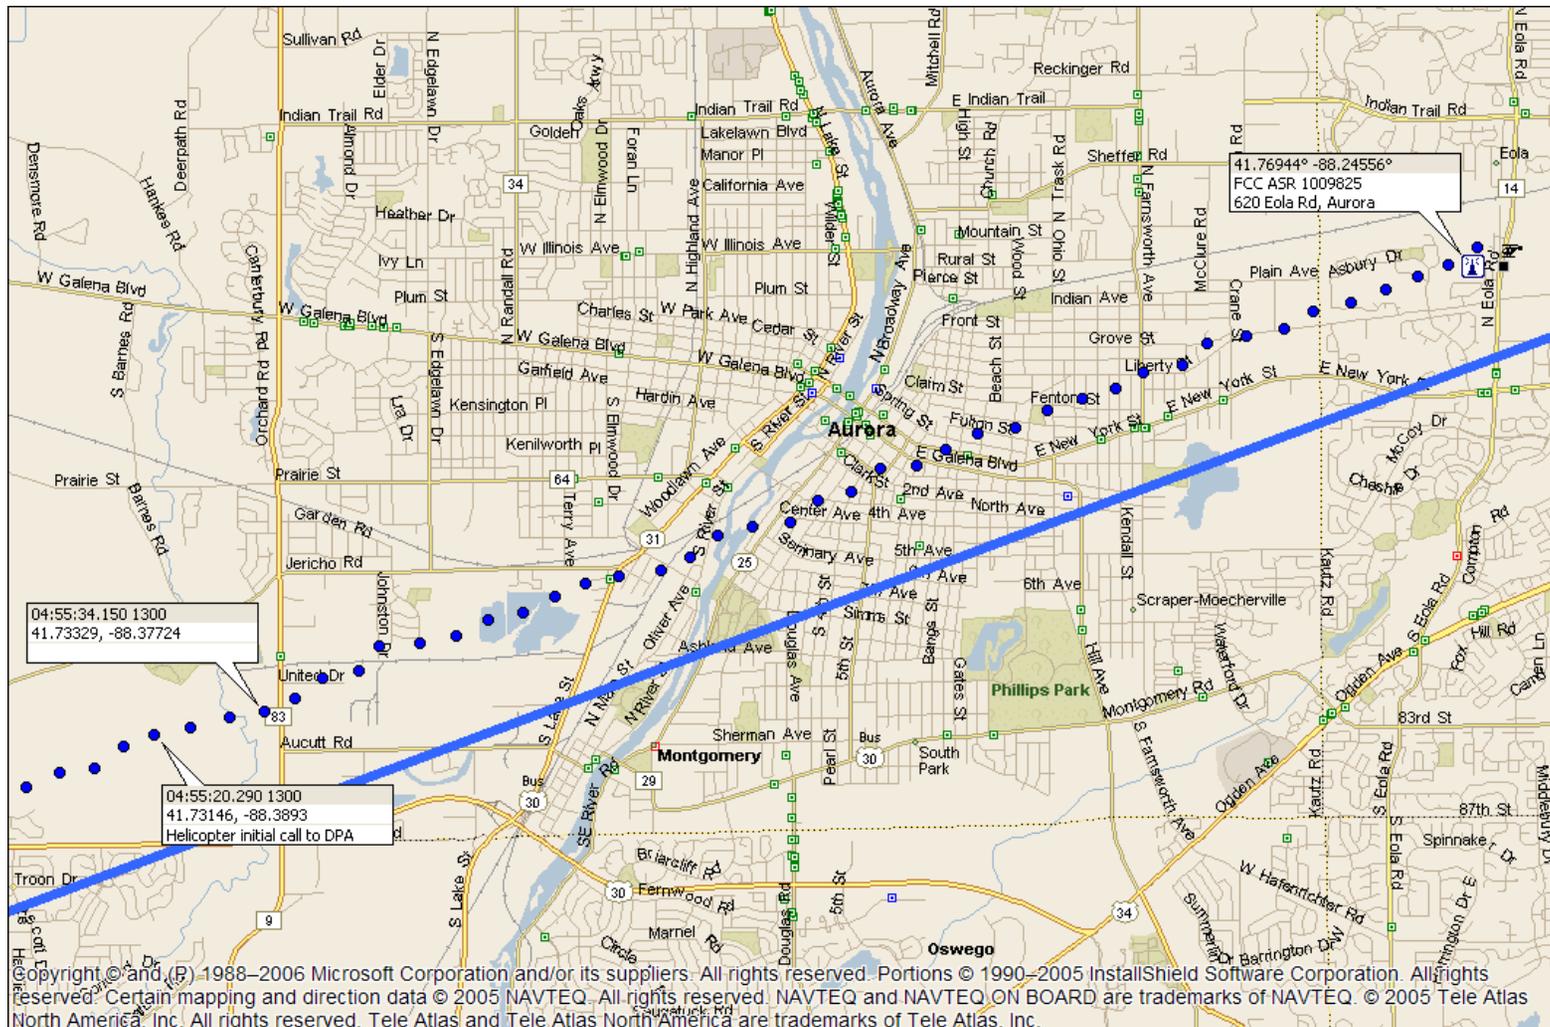
Figure 2 – Section of flight while N992AA was in contact with DPA ATCT.

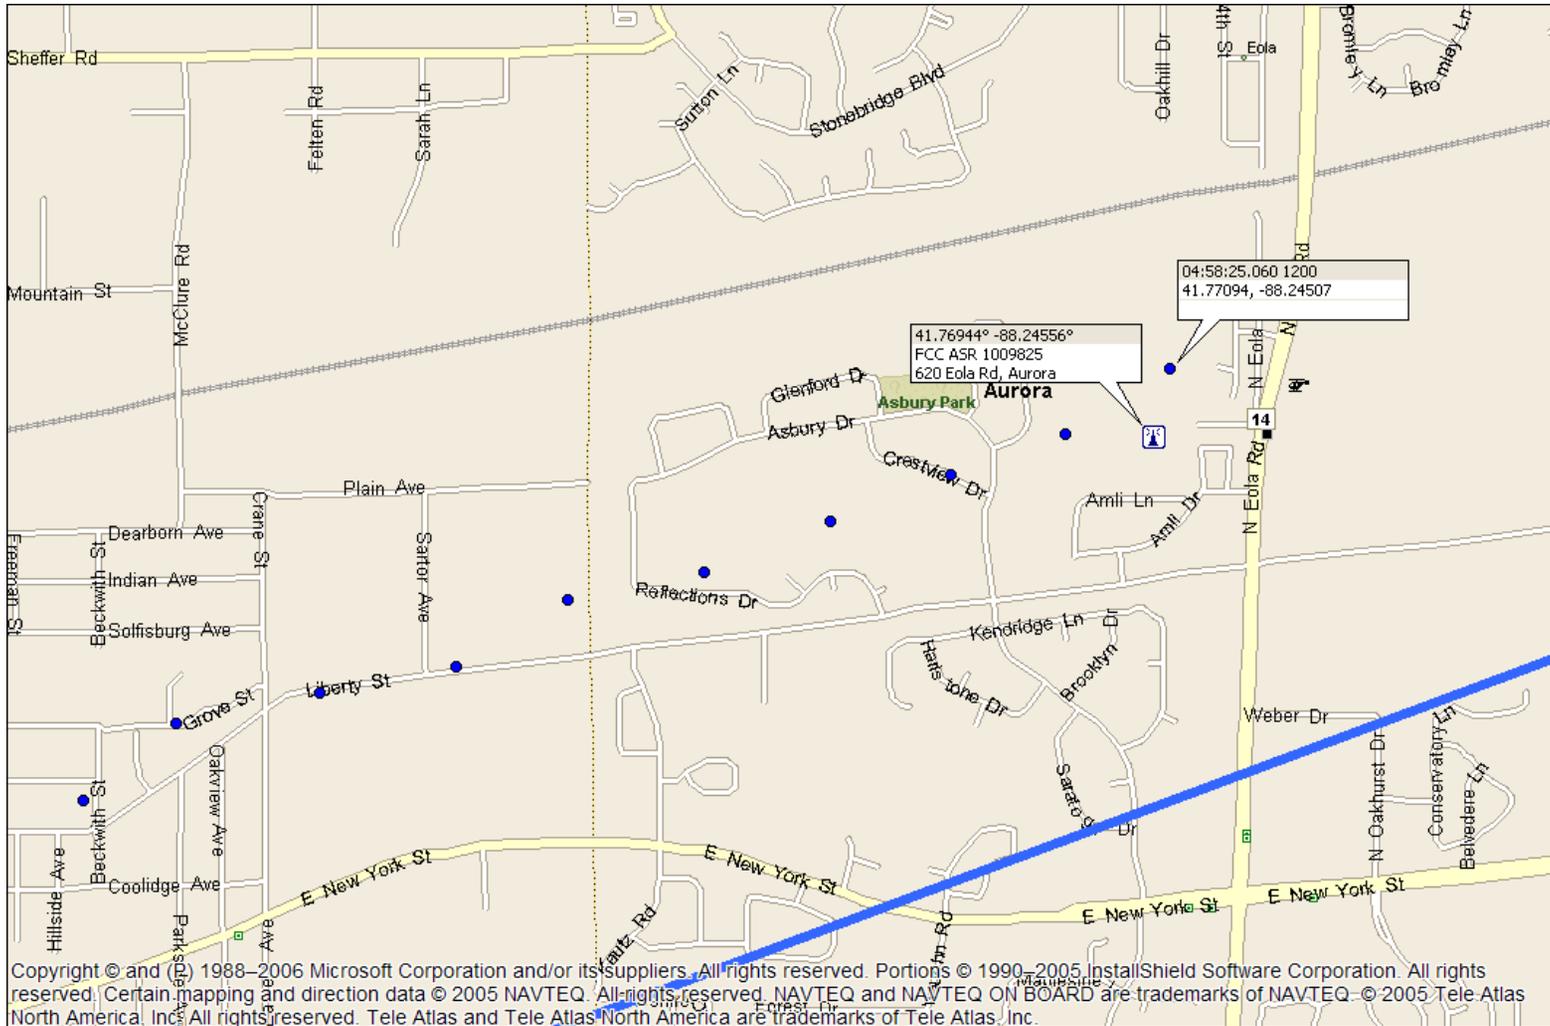
Figure 3 – End of flight.
