**NATIONAL TRANSPORTATION SAFETY BOARD**

**STRUCTURES GROUP FACTUAL REPORT**

**A. ACCIDENT      DCA09MA027**

Location:            Clarence Center, New York  
Date:                February 12, 2009  
Time:                2217 Eastern Standard Time (EST)  
Aircraft:            Colgan Air Inc. (d.b.a. Continental Connection) Flight 3407, Bombardier  
                          DHC-8-400, N200WQ

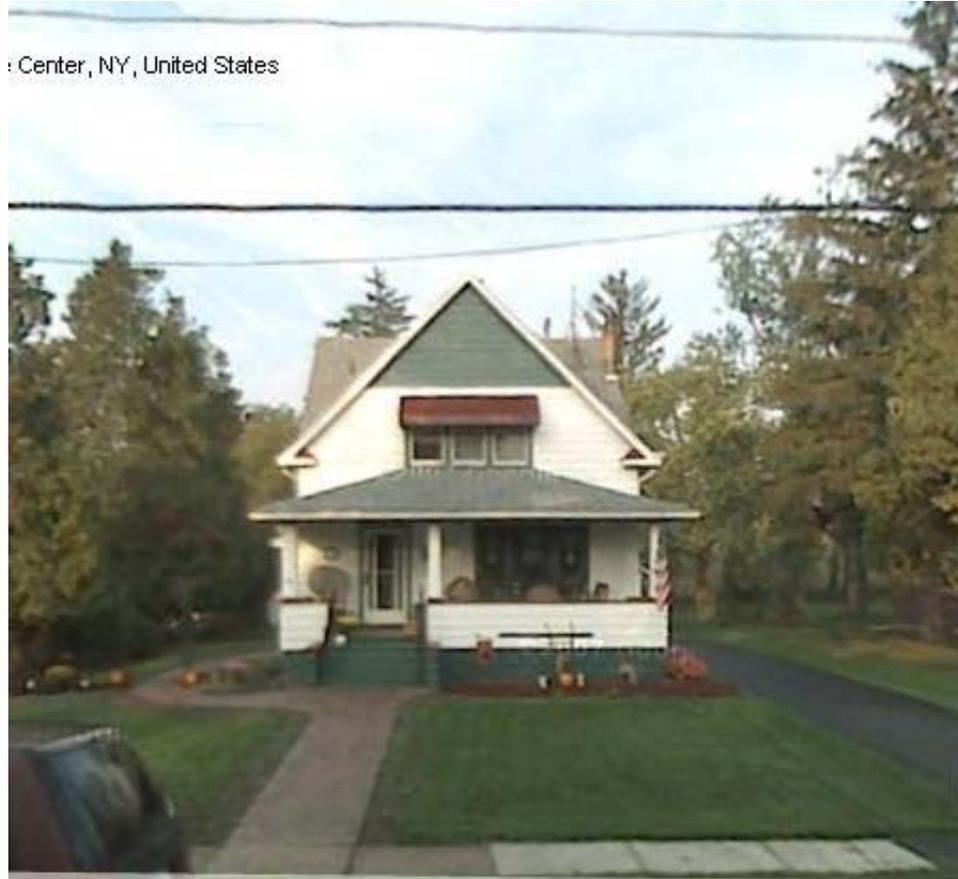
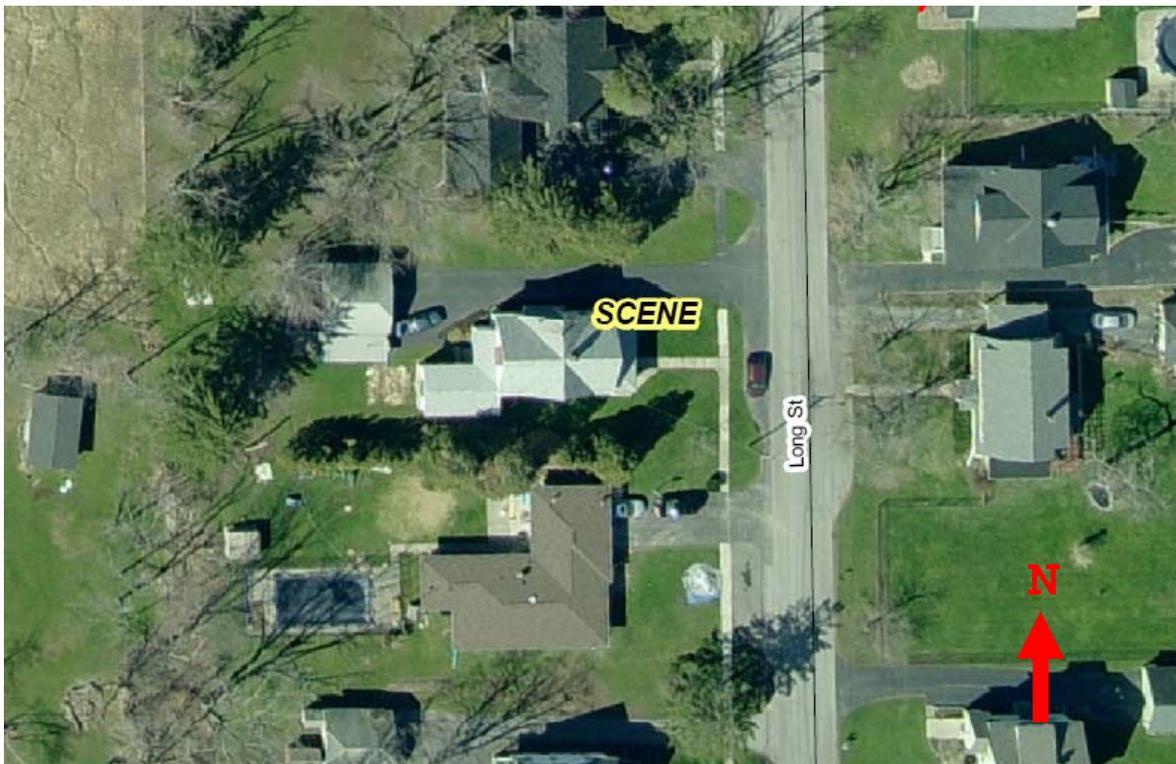
Figure 2 – 6038 Long Street, Clarence Center, New York

The airplane impacted a house located at 6038 Long Street, Clarence Center, New York. The house was a two story old style farmhouse with a basement, covered front porch, and detached two-car garage (Figure 2). The house and two cars located on the driveway in front of the garage were destroyed by the impact and post crash fire but the garage remained intact. The garage of an adjacent house to the south was also impacted by the airplane. The airplane impacted the south side of the house near ground level and pieces of the airplane traveled through the house and ended up beyond the northeast corner of the house foundation. The south basement wall was fragmented by the impact and most of the wall debris was pushed towards the northeast corner of the basement. The top of the north basement wall exhibited impact damage adjacent to the location of the left engine. There was a distinct ground scar on the south side of the house about 10 feet south of the south foundation wall. The ground scar was about 15 feet long, 5 feet wide, and 3 feet deep. Two trees along the southern property boundary were impacted and the tops were sheared off. The west tree was cut about 20 feet above ground level and the east tree was cut about 25 feet above ground level. There was some tree debris between the property boundary and the

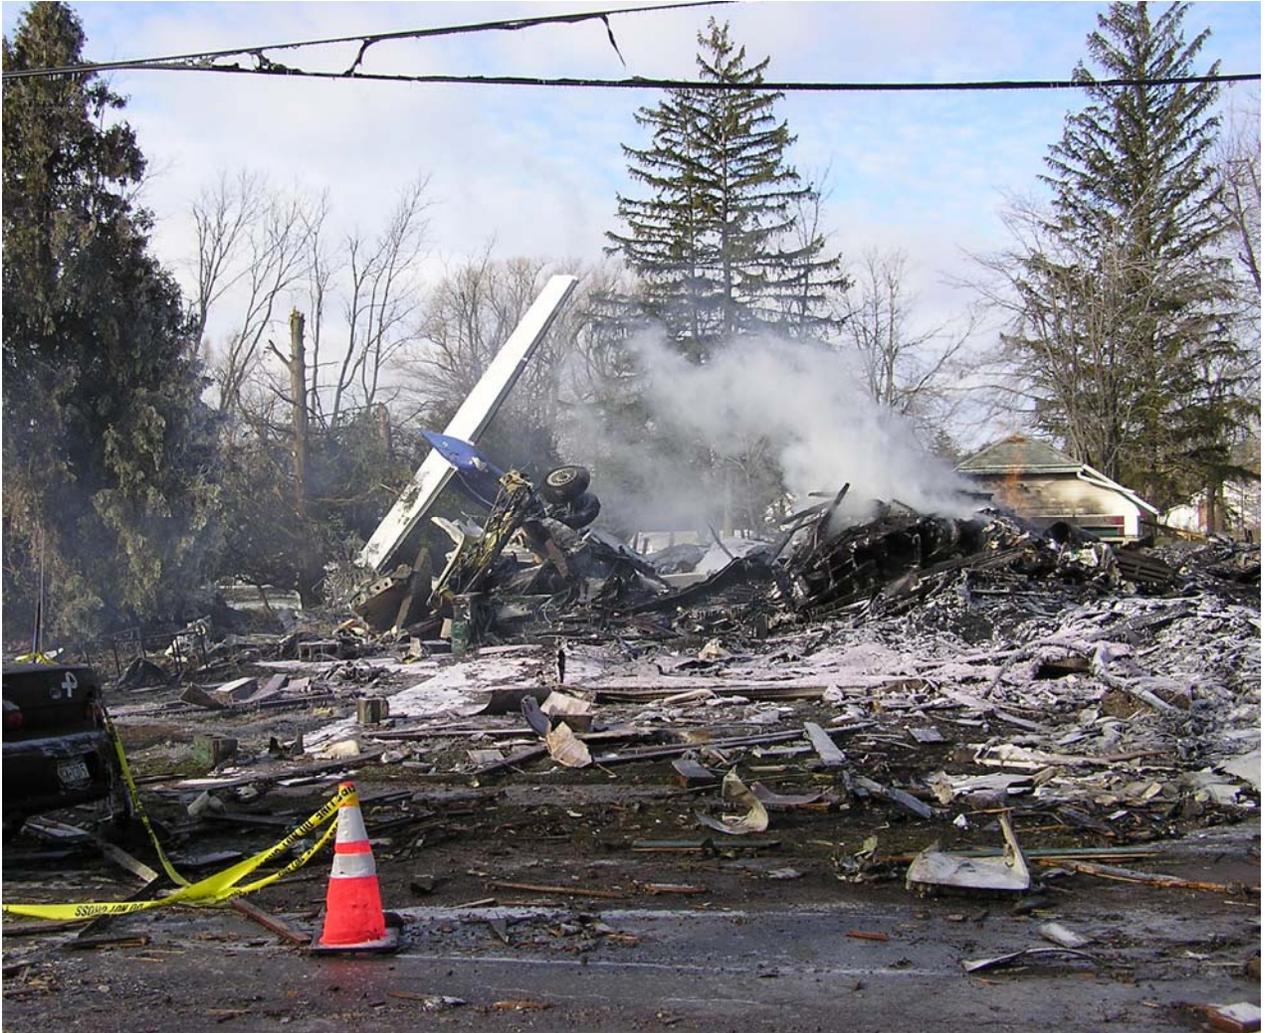
Figure 3 – Main Wreckage Site (Same view as Figure 2)

The airplane was severely fragmented and a significant post crash fire destroyed most of the airplane and house (Figure 3). About 60% of the main structural components of the airplane were conclusively identified. Numerous small pieces of airplane structure and globs of molten and re-solidified metal were recovered but not conclusively identified. Structure from the radome and both wingtips was identified in the wreckage. The empennage was intact in the wreckage. The airplane wreckage was on a heading of about 070° magnetic. See Figures 4 and 5 for schematics depicting the conclusively identified wreckage.
