Attachment 9
Ice Detector Probe Reliability

SERVICE LETTER

DH8-400-SL-30-011

SUBJECT: Ice Detector Probe Test Procedures**MODEL:** Dash 8 Q400**APPLICABILITY:** All**REFERENCE:** Aerazur Abbreviated Component Maintenance Manual
For Ice Detector Probe 30-80-00 Rev. 4

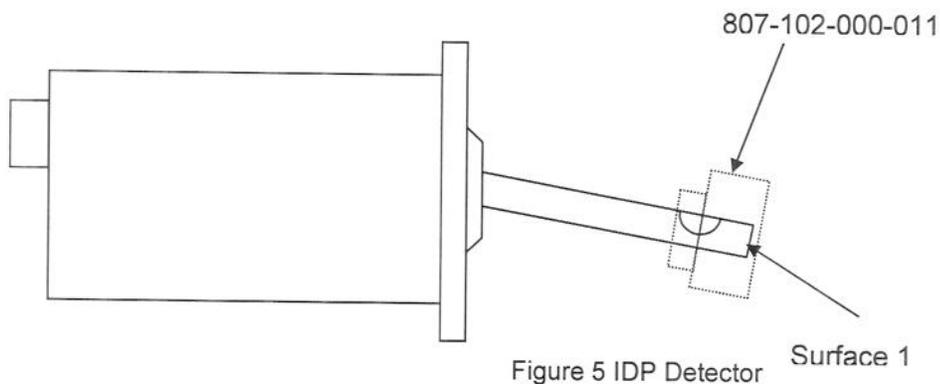
1. Change Amperemeter calibration to 3A AC
2. Apply cooling spray for a 2 second duration on the probe sensor (surface 1) at a distance of 2 centimeters (Refer Figure 5)

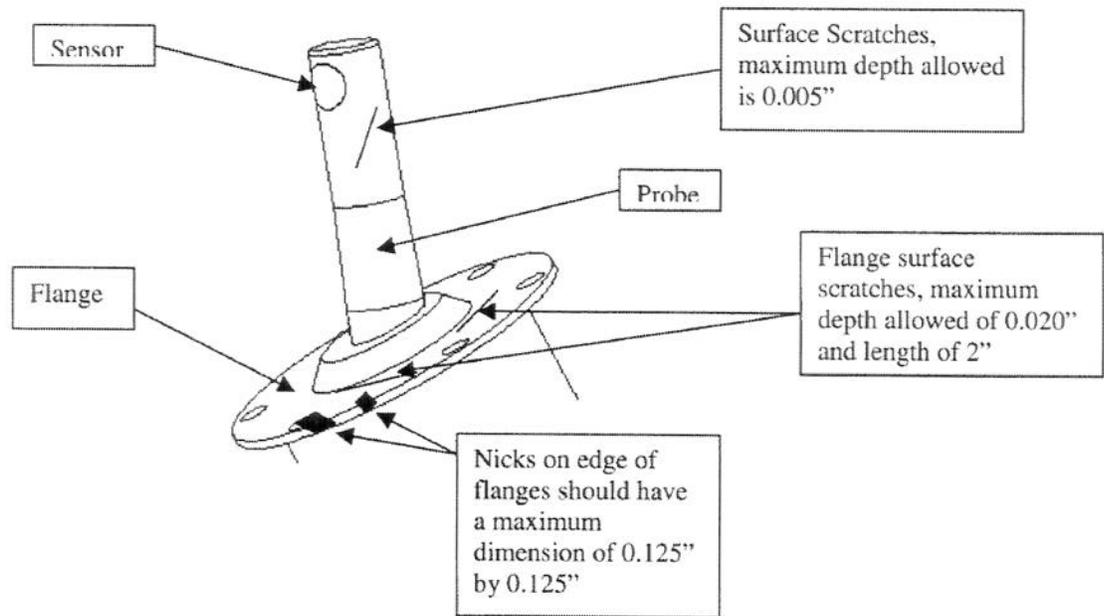
Figure 6

- (1) Make sure that the IDP agrees with the general view given in figure 3 DESCRIPTION And OPERATION section of this manual.
- (2) Make sure that the eight mounting screws used to secure the housing are tightly installed.
- (3) Make sure that the connector is not damaged. Make sure that the surface of the connector is clean and that there is no unwanted material. Make sure that the connector nut is tightly installed. Make sure that there are no loose or bent pins. Make sure the pins are clean and untarnished.
- (4) Visually examine the sensing element. No cracks or damage are permitted.
- (5) Visually examine the flange surface: See figure 6

NOTE: Any damage to flange surface may be blended to remove sharp edges. Damage to the surface of the flange or its edge that does not impact fir or function of the IDP is acceptable. In addition, the painted surface may be left as in "received condition". Slight scratches on the probe that do not touch the sensor are acceptable up to a maximum depth of 0.005".
