National Transportation Safety Board
Washington, D.C. 20594

Airline Accident - Clarence, New York
Pipeline Group's Factual Report

Accident Identification

Location: 6038 Long Street, Clarence, New York 14031
Date: February 12, 2009.
Time: Approximately 10:15 p.m. Eastern Standard Time.
Product: Airline Crash ruptured a natural gas pipeline
Accident No.: DCA 09 MA027
Group Chair: K. M. Gunther

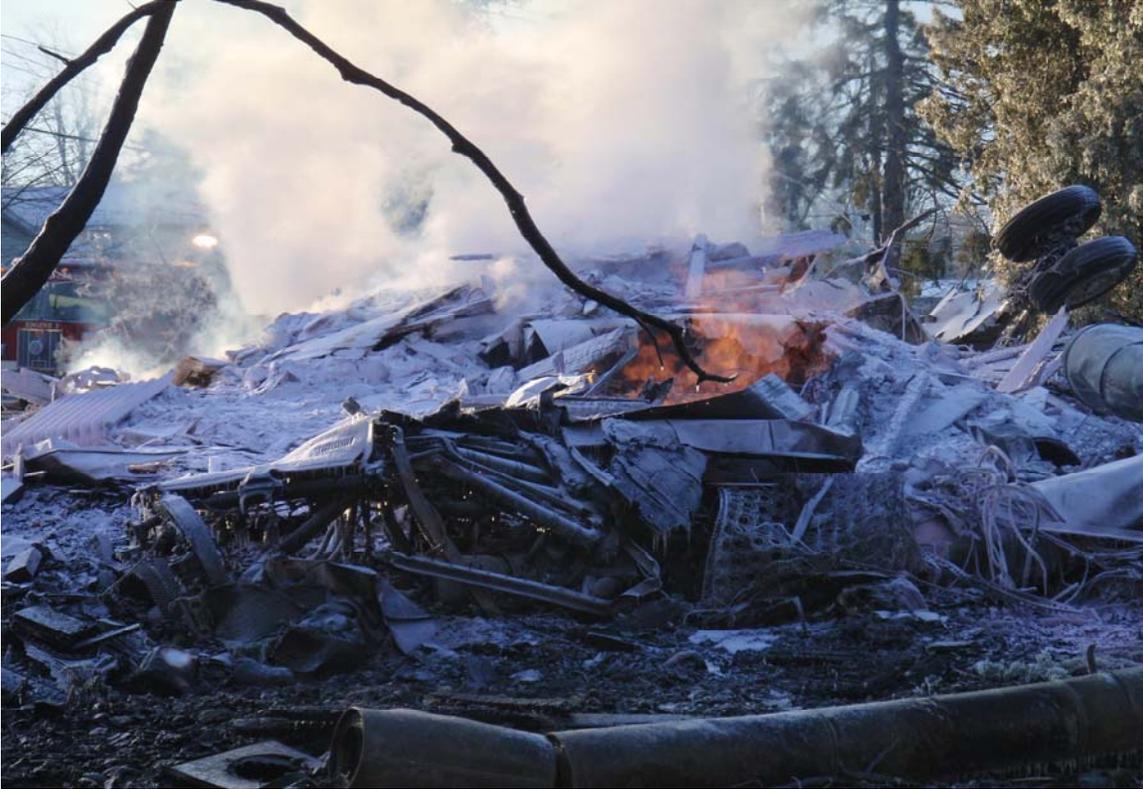
Figure 1: Fire from the broken gas service pipeline

Once the fires were extinguished at 10:45 a.m. on February 13, 2009, National Fuel's initial investigation of the scene revealed that the fire was fed entirely by the service pipe; excavation revealed that the natural gas main was undamaged and could be returned to service. Examination of the accident site remnants revealed that the shut off valve at the meter had been broken in half and the natural gas had been free to flow in a full open position to feed the fire.

National Fuel stood by until 8:55 a.m., at which point the Incident Commander allowed the crew to enter the front yard of 6038 Long Street to secure the flow of gas to the house and thus put out the natural gas fire. The flow of gas was stopped at 10:45 a.m. when the natural gas distribution pipeline was squeezed off at the south side of Long Street and Maple Street. National Fuel was subsequently able to disconnect the natural gas service pipeline from the main. (Appendix 2 and 3)
