Honeywell

September 25, 2008

Re: NTSB ID: DEN08MA116F, N407MJ & N407GA, Bell 407's
Equipment examination at Honeywell

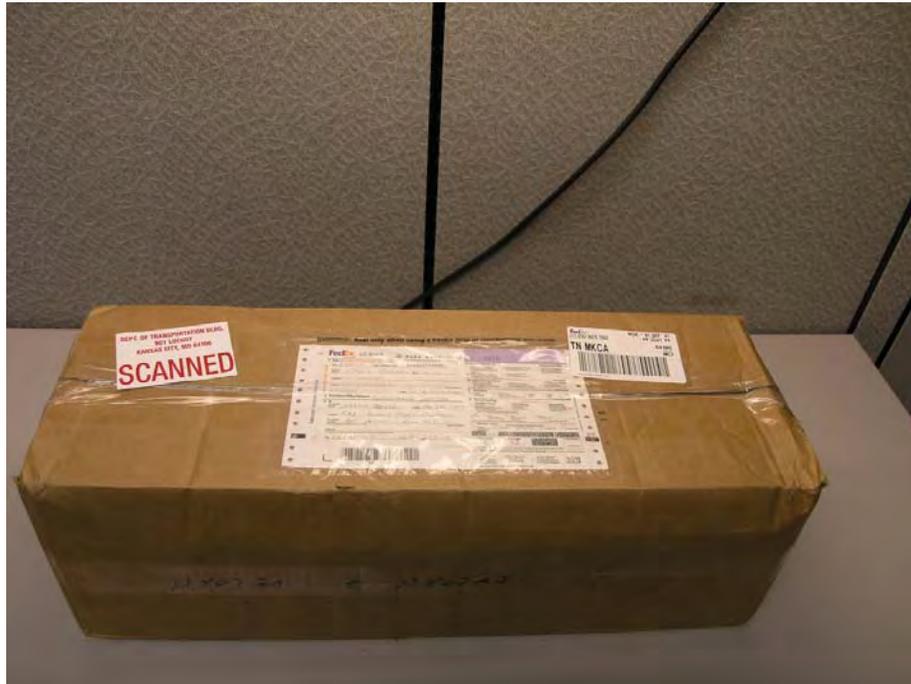
N407MJ & N407GA equipment as-received at Honeywell, September 16, 2008

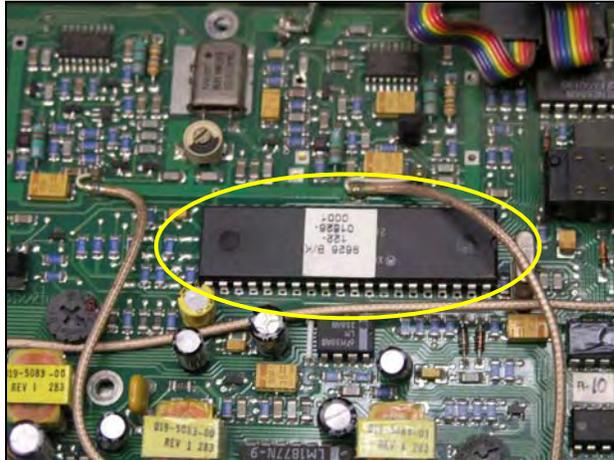
uprocessor after de-soldering (accident unit, S/N 58421)

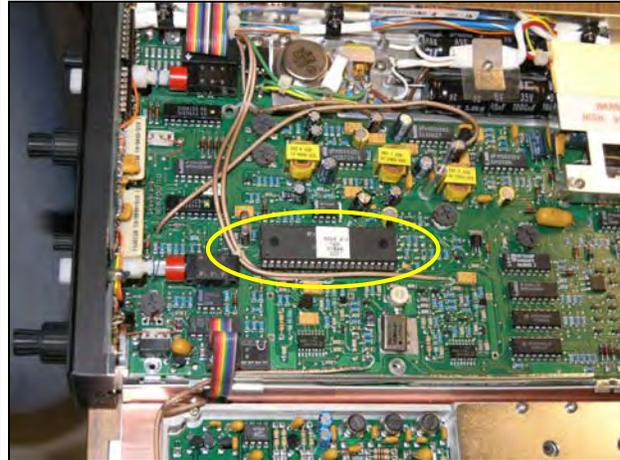
uprocessor from accident unit installed into a host unit

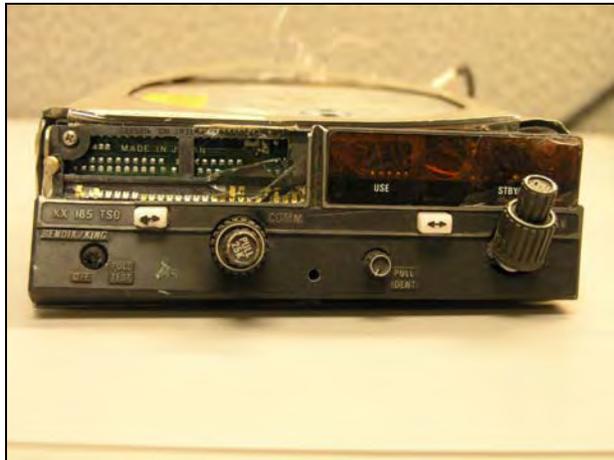
The bezel and display assembly were severely damaged which precluded powering the unit. The micro-processor containing the non-volatile memory was removed from the accident unit and installed into a host unit. The following frequencies were displayed when the host unit was powered:

KX 165, S/N 58421: bezel and display damage

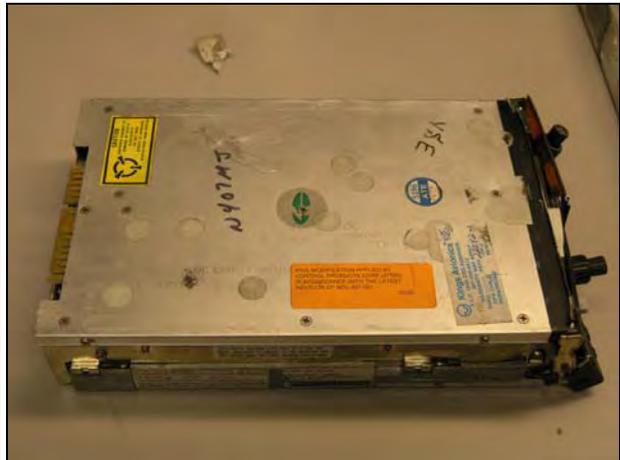
KX 165, S/N 58421: top view

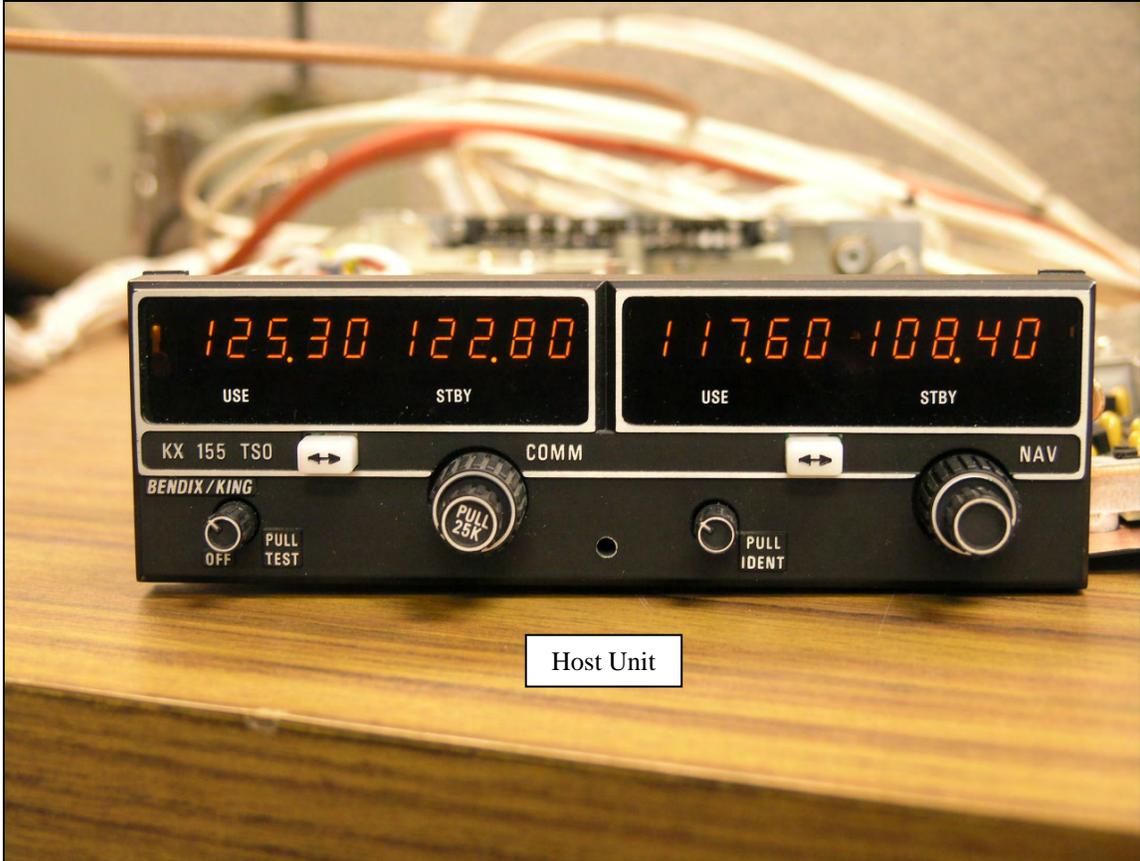
Host Unit

Comm:		Nav:	
Use	Stby	Use	Stby
125.30	122.80	117.60	108.40

Host unit: frequencies displayed are those stored in the non-volatile memory from the accident unit, S/N 58421 (N407MJ)

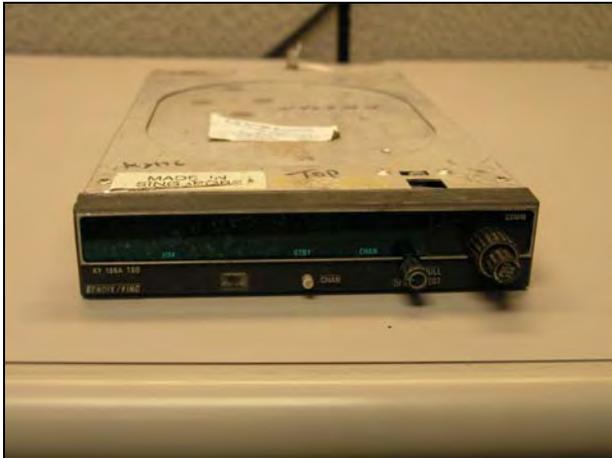
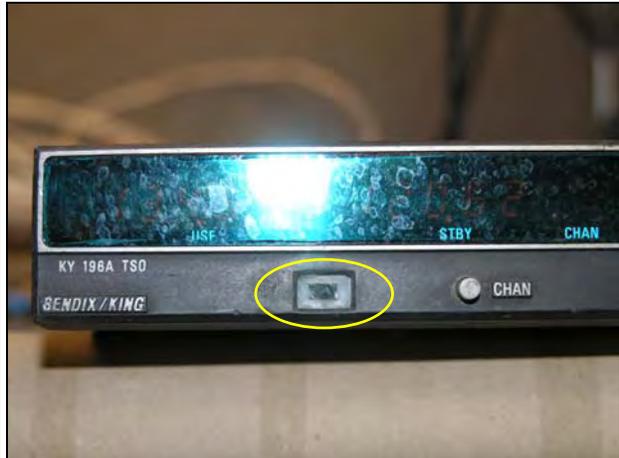
The unit contained minor damage, including a damaged frequency flip-flop switch button – the switch functioned normally). The unit was connected to a harness and powered-up in the “as-received” condition. After unit power was applied, the following frequencies were displayed:

KY 196A, S/N 8345: front & top view. Damaged frequency flip-flop button circled.

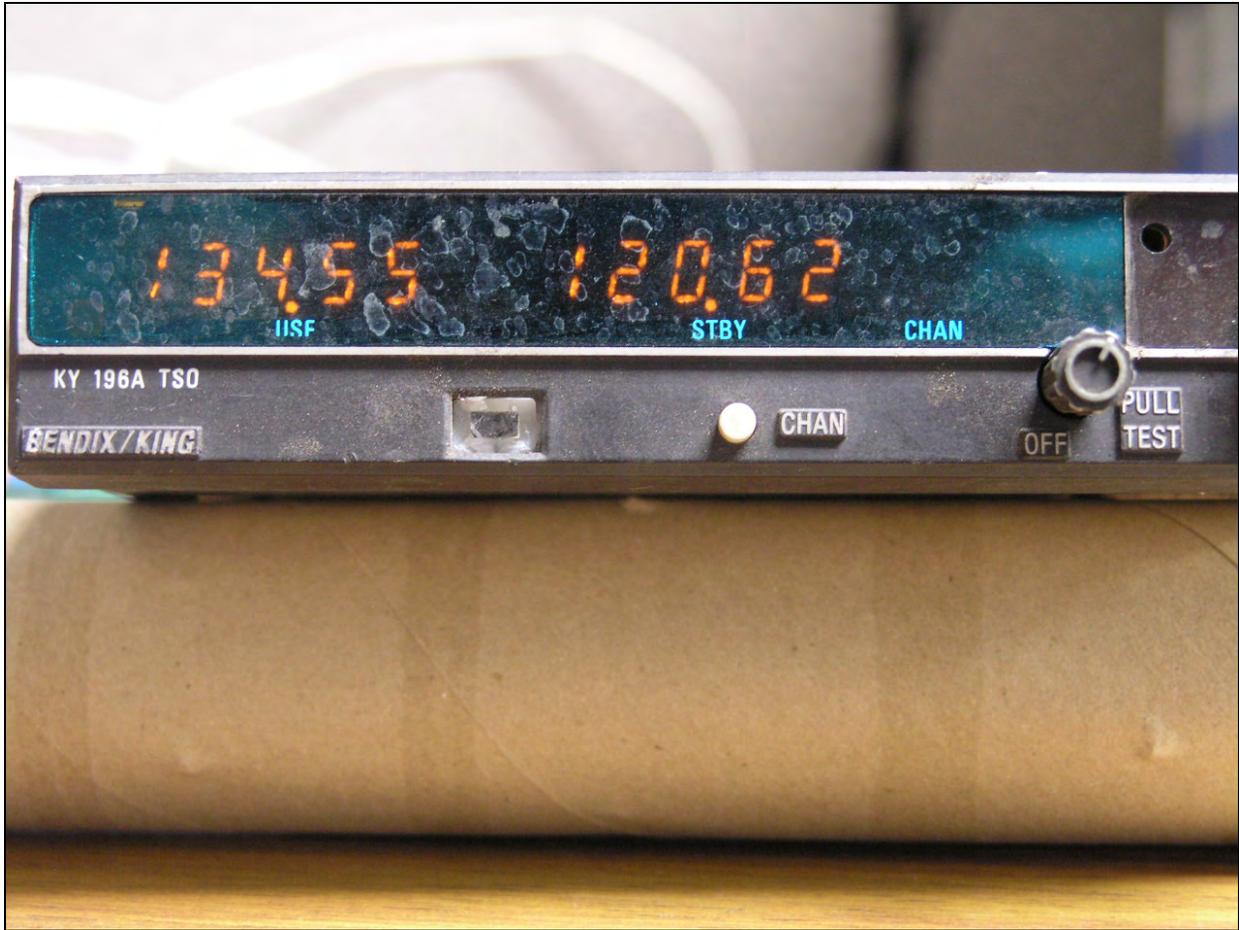
Use	Stby
134.55	120.62

KY 196A, S/N 8345: frequencies displayed when unit power was applied (N407MJ)

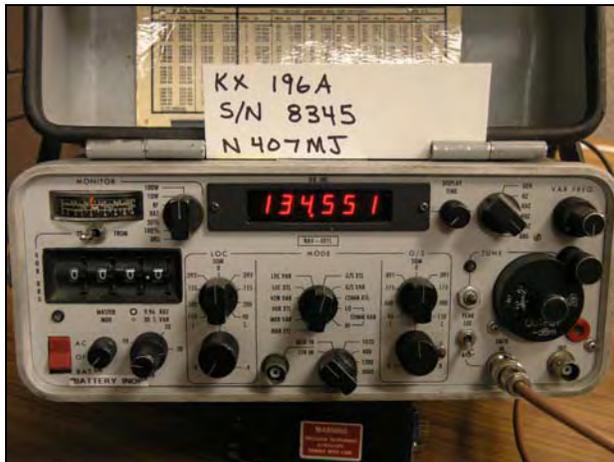
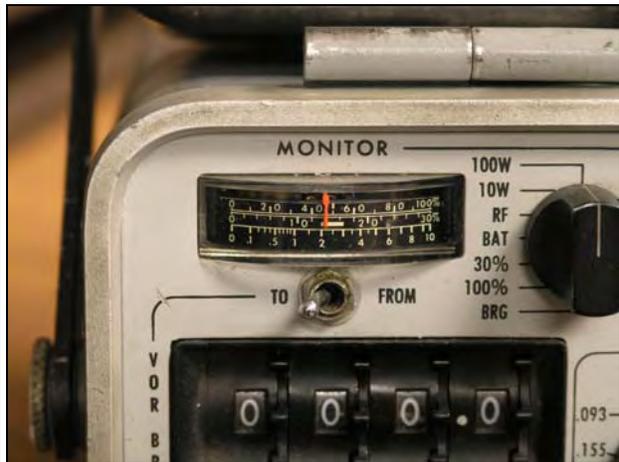
The unit was connected to an IFR 401 test set to examine receive and transmit functions. The receiver was tested satisfactory on 134.55 MHz using a 1.0 kilohertz signal. The transmitter output was acceptable at approximately 20 watts on 134.55 MHz (specification is 10 watts minimum).

KY 196A, S/N 8345: frequency received shown at left from unit transmitting on 134.55 MHz. The meter indication at right displays the transmitted power of slightly more than 20 watts (specification is 10 watts minimum).

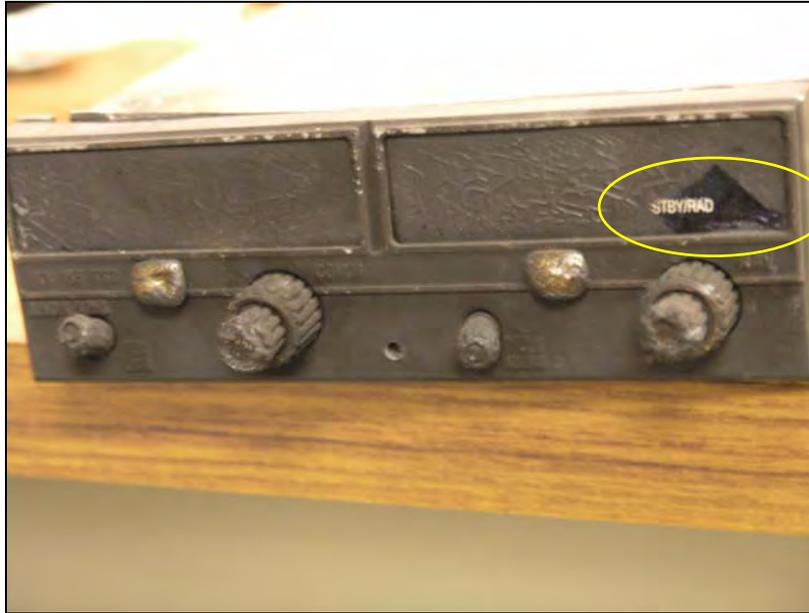
3. **KX 165 navcom, P/N 069-1025-25, S/N 60021, Mods 15, 16, 18, 19, 20 (N407GA -- top navcom in stack)**
Unit bezel/knobs were fire damaged and the display was broken; minor impact damage present on unit chassis. The frequency flip-flop buttons were cut off and the volume switch knobs were removed to facilitate bezel removal. The bezel and damaged display were removed. A new display was installed. After unit power was applied, the following frequencies were displayed:

KX 165, S/N 60021: Bezel & knobs fire damaged; top navcom in the stack;

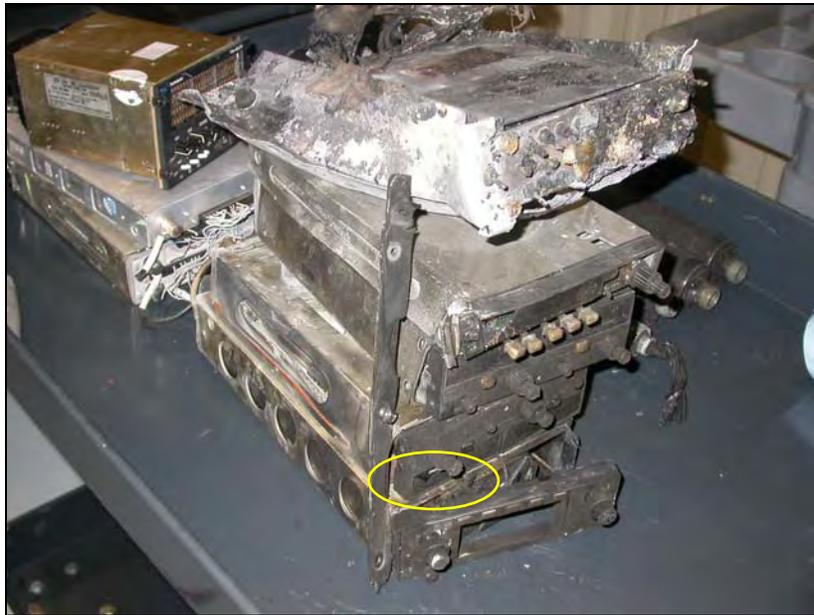
NTSB photo: The radio stack in the center of the photo is shown upside down. Notice that the clear area circled on the bezel matches the bezel of the top photo on this page (top navcom).

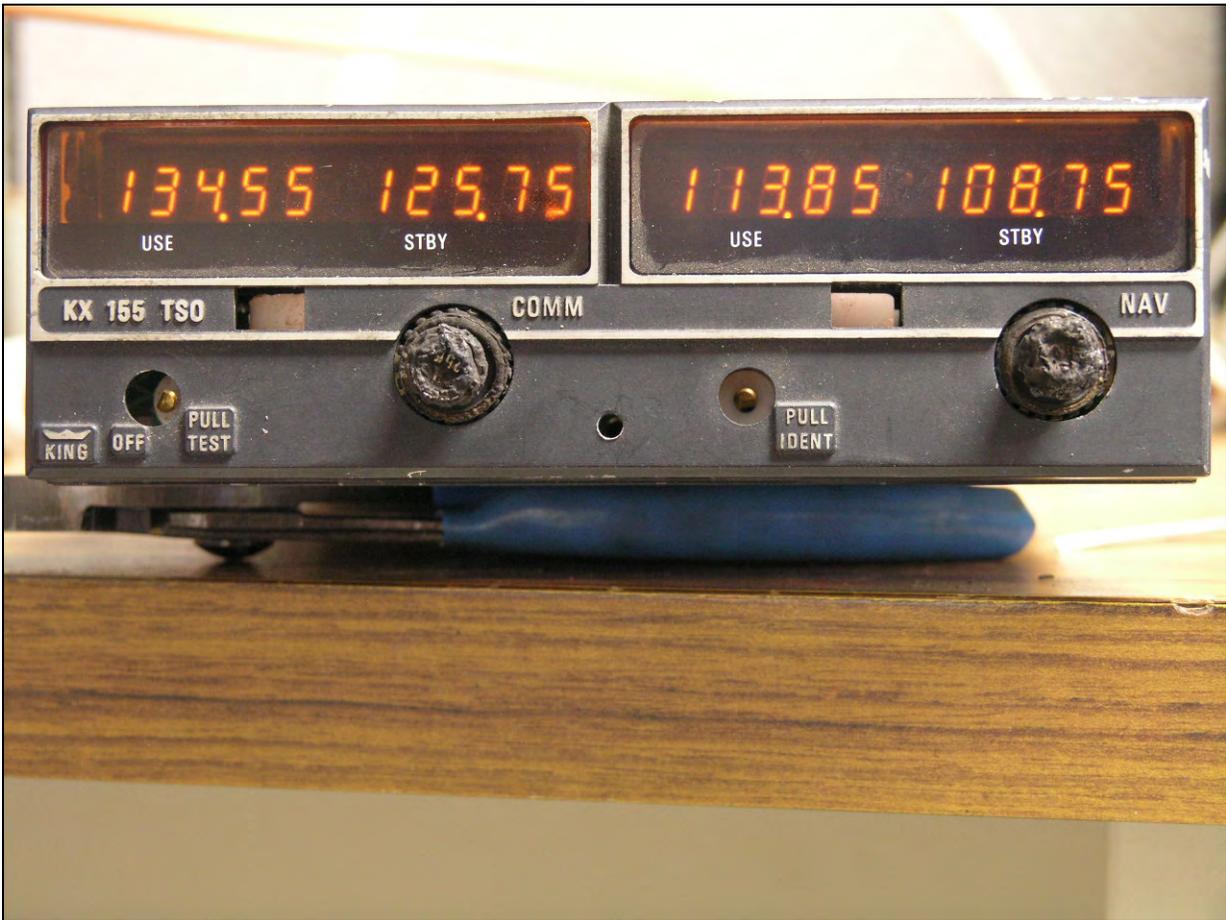
Comm:		Nav:	
Use	Stby	Use	Stby
134.55	122.75	113.85	108.75

KX 165, S/N 60021: Frequencies displayed after power-up; unit was the top navcom in the radio stack (N407GA)

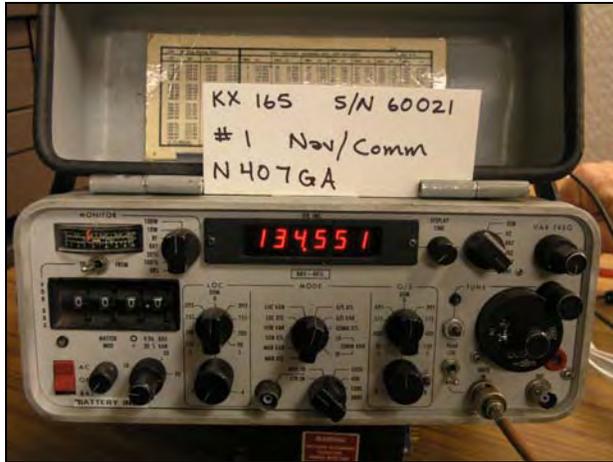
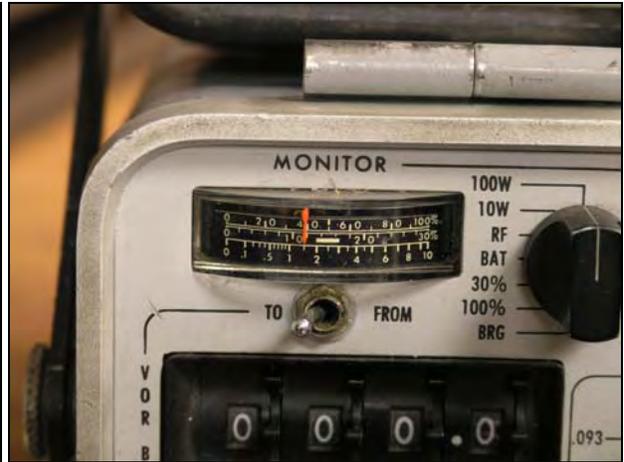
The unit was connected to an IFR 401 test set to examine receive and transmit functions. The receiver was tested satisfactory on 134.55 MHz using a 1.0 kilohertz signal. The transmitter output was acceptable at approximately 15 watts on 134.55 MHz (specification is 10 watts minimum).

KX 165, S/N 60021: frequency received shown at left from unit transmitting on 134.55 MHz. The meter indication at right displays the transmitted power of 15 watts (specification is 10 watts minimum).

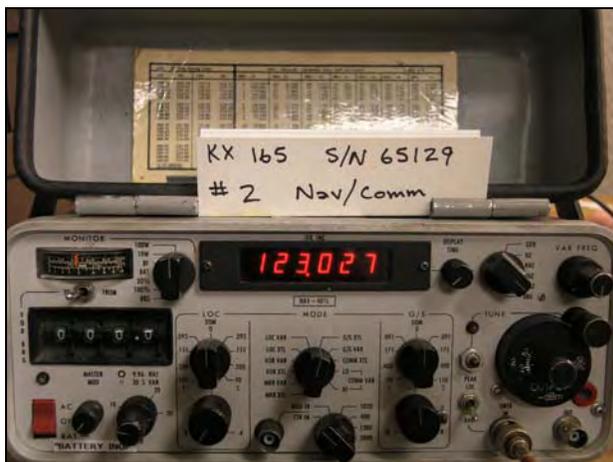
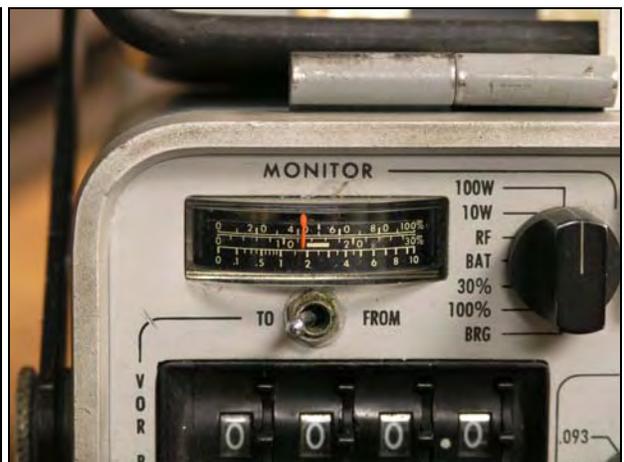
The unit was connected to an IFR 401 test set to examine receiver and transmitter operation. The receiver was tested satisfactory on 123.02 MHz using a 1.0 kilohertz signal. The transmitter output was acceptable at approximately 15 watts on 123.02 MHz (specification is 10 watts minimum).

KX 165, S/N 65129: frequency received shown at left from unit transmitting on 123.02 MHz. The meter indication at right displays the transmitted power of approximately 19 watts (specification is 10 watts minimum).
