**INVESTIGATION REPORT**  
**TMUSA-2008-19124**

**C O N C L U S I O N**

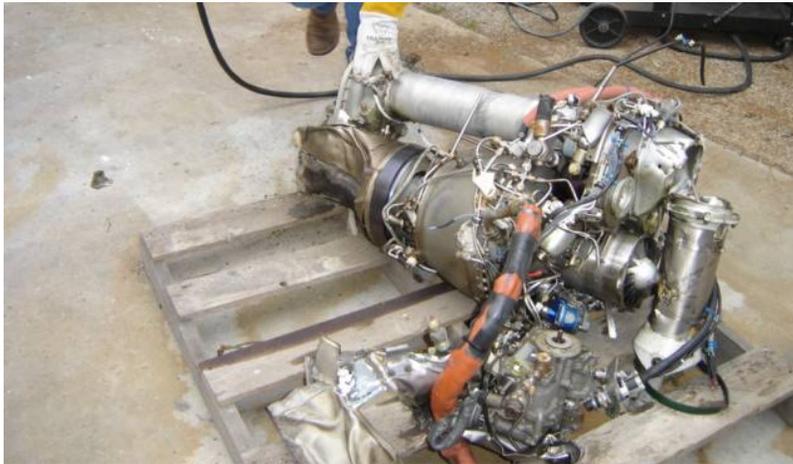
**Figure 1. Arriel 1D1 SN 19124**

The upper left side of the engine was crushed. The upper left side of the exhaust pipe was crushed and flattened. The fuel control unit (FCU) was crushed and enveloped by a metal structure. The air inlet cone exhibited rotational scarring and the blades of the axial wheel exhibited minor foreign object damage (FOD). The axial diffuser stator vanes did not appear to exhibit FOD. The axial compressor was unable to be rotated by hand. There were rub marks on the inside of the compressor casing around the axial rotor at two locations: between 6 and 7 o'clock and 12 and 1 o'clock. The bleed valve was in the open position; the oil filter by-pass indicator was popped; the magnetic plugs that were present and could be removed were clean. The containment shield was intact and the power turbine blades appeared undamaged. The power turbine was unable to be rotated by hand. The ears of the triangular flanges at the attach point of the tail rotor short shaft to the free wheel shaft were bent, and the tail rotor short shaft was lying about 45 degrees to the vertical axis of the engine. The ears of the flange on the opposite end of the tail rotor short shaft were missing. The front engine support was ruptured near the coupling tube attach point, and the coupling tube was lying inline with the vertical axis of the engine. The top of the slotted nut on the splined end of the free wheel shaft assembly appeared to have come in contact with a hard surface. The splined shaft was unremarkable. The bolt holes in the cover of the free wheel assembly were elongated or torn. Rotational scarring was noted on the interior and exterior circumferences of the forward-facing surface of the cover. The free wheel shaft was fractured; the fracture surface appeared to have a 45 degree lip.

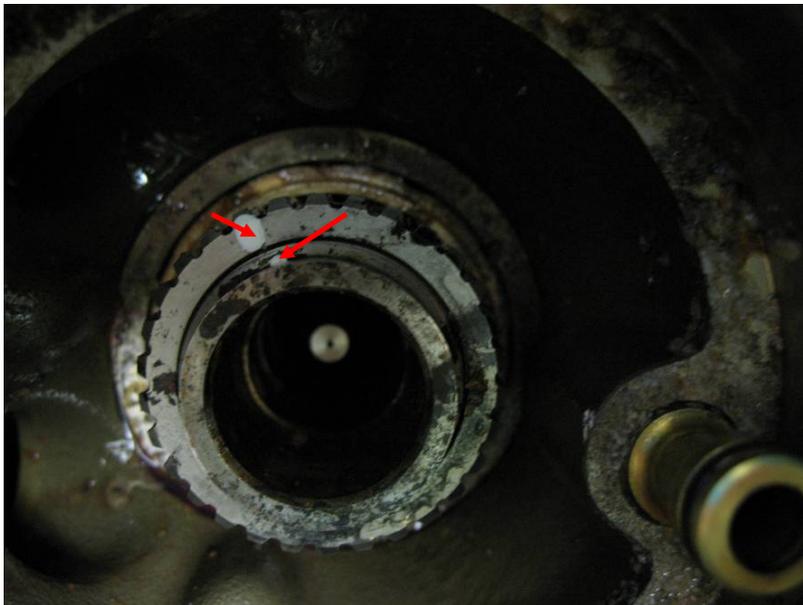
**Figure 2. MO5 Alignment Marks**

The engine experienced an over torque event due to the sudden stoppage of the main rotor system. This indicated the engine was delivering power to the main rotor system at the time of impact.

Examination of the marks engraved on the module 5 between the driving pinion and the splined nut were found misaligned by about 2mm, indicating an over torque event had occurred.
