AIRWORTHINESS GROUP CHAIRMAN'S FACTUAL REPORT

MIA-08-MA-203

Turbomecca Engine Run Data

INVESTIGATION REPORT
TMUSA - 2008-5102

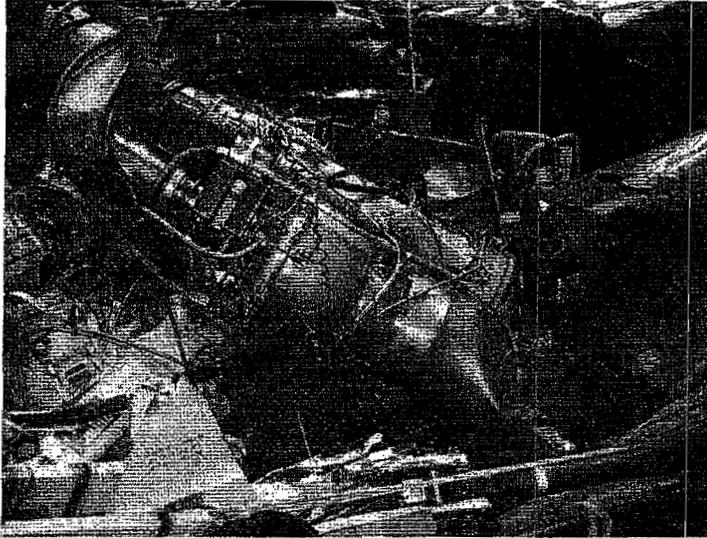
The exhaust was crushed and dented. The linking tube was dented. The front support was undamaged.

The borescopic inspection revealed rub marks on the second stage nozzle.

Figure 1. No. 2 Engine S/N 5060 – At Accident Site

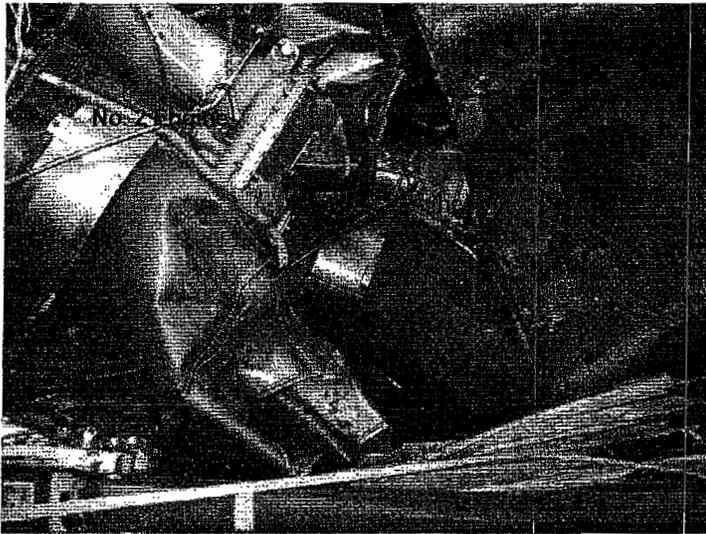
The exhaust was crushed and dented. The linking tube was dented. The front support was undamaged.

The borescopic inspection revealed rub marks on the second stage nozzle.

Figure 2. No. 1 Engine S/N 5102 – At Accident Site

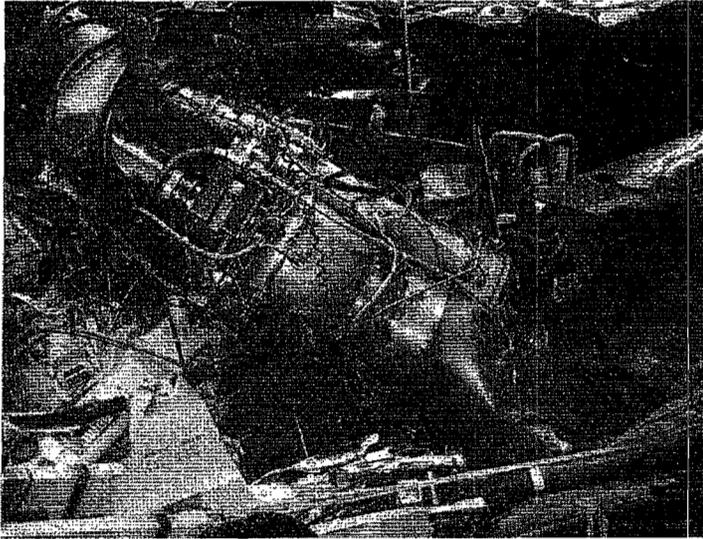
The exhaust was crushed and dented. The linking tube was dented. The front support was undamaged.

The borescopic inspection revealed rub marks on the second stage nozzle.

Figure 1. No. 2 Engine S/N 5060 – At Accident Site

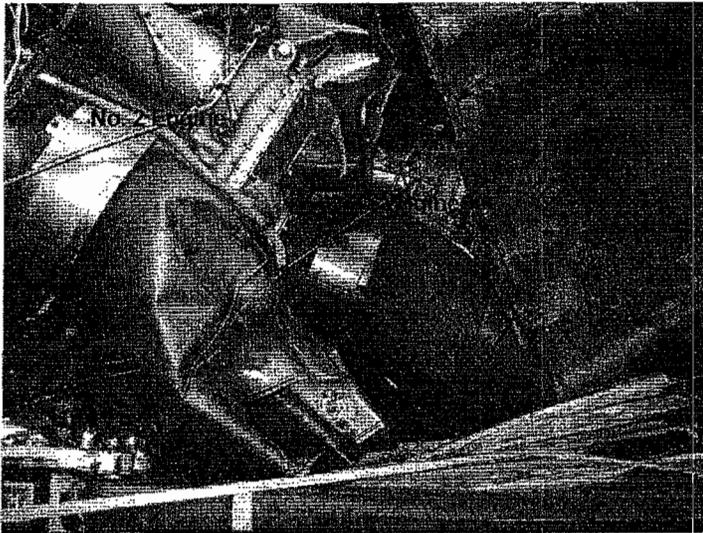
The exhaust was crushed and dented. The linking tube was dented. The front support was undamaged.

The borescopic inspection revealed rub marks on the second stage nozzle.

Figure 2. No. 1 Engine S/N 5102 – At Accident Site
