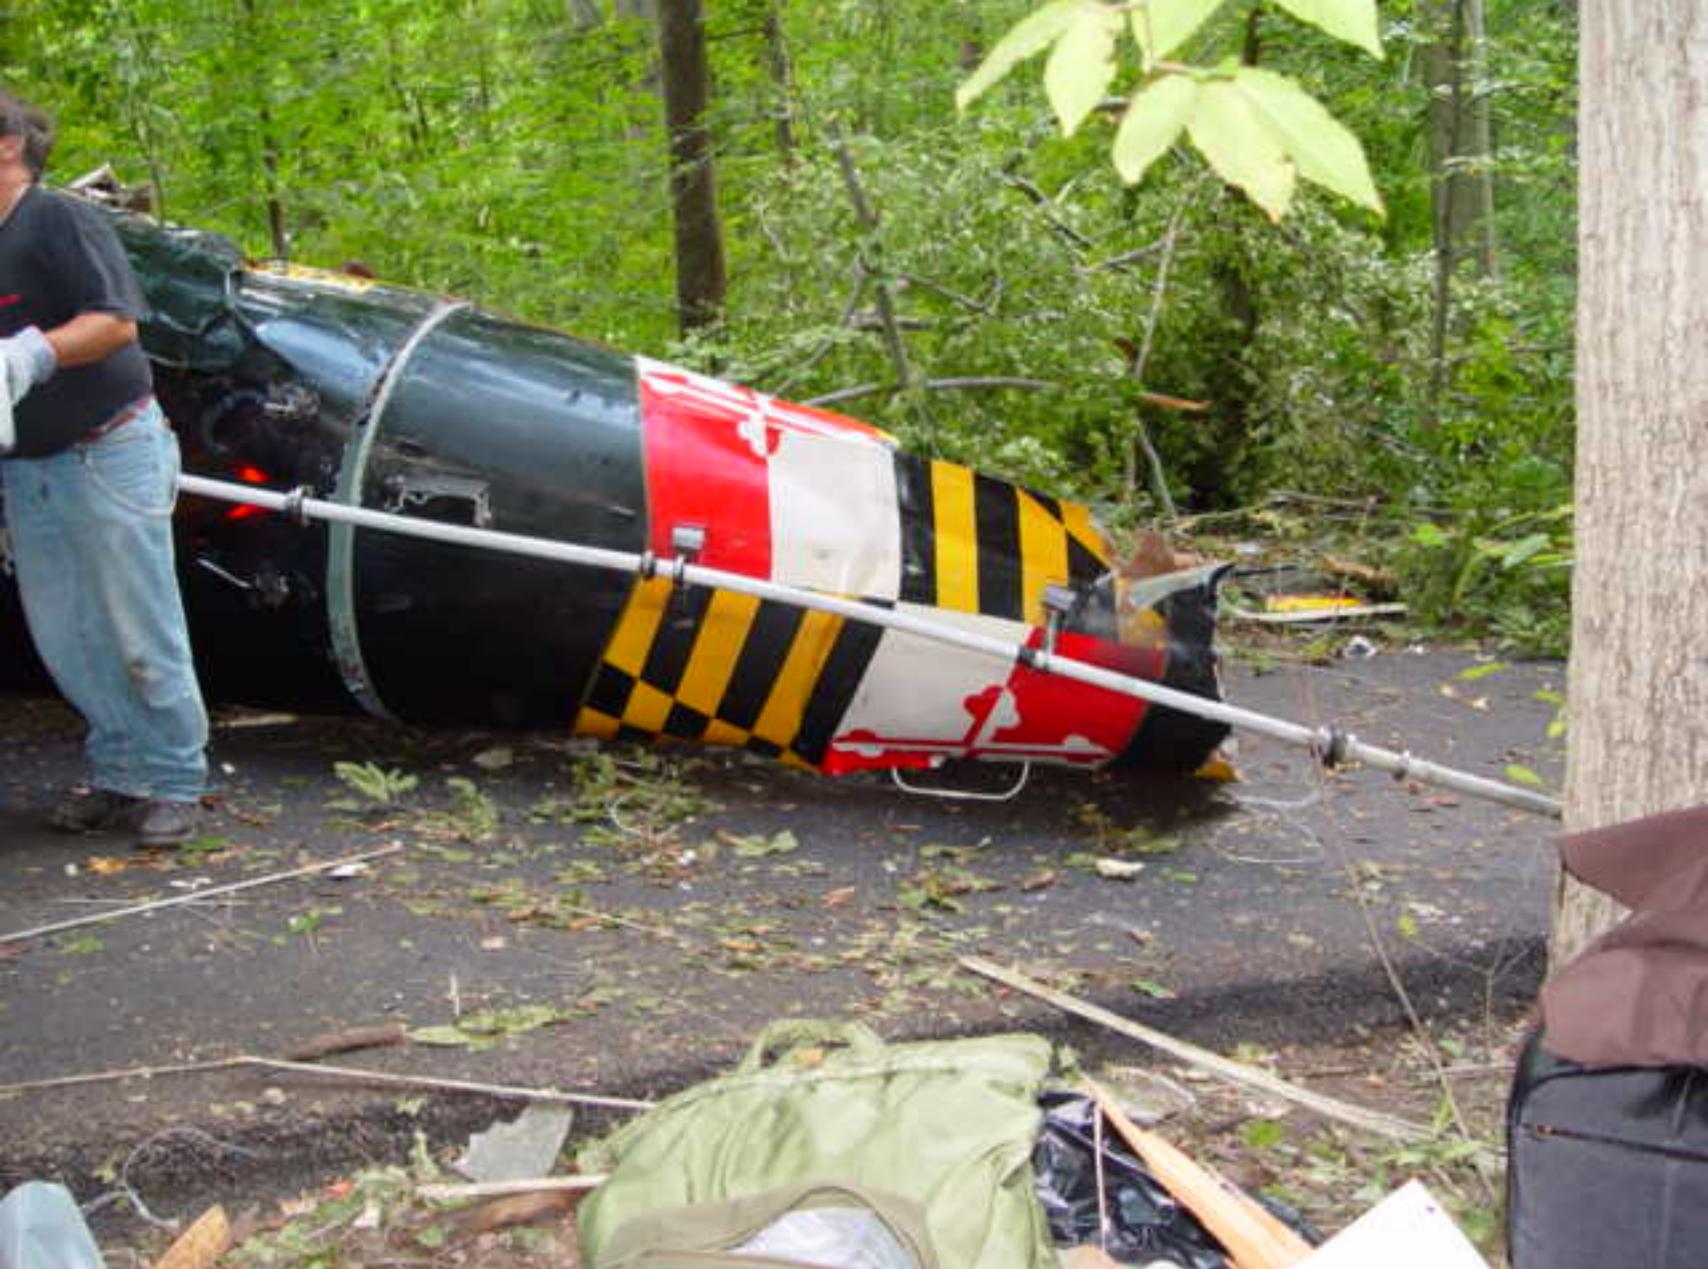
Photo 6 - Tailboom with fenestron drive shaft. Photo NTSB.JPGDSC01062
