PARTY SUBMISSION OF NASCAR, INC.  
To the National Transportation Safety Board

Regarding the Accident Involving  
Cessna 310R, N501N

Sanford, Florida

NTSB# NYC07MA162

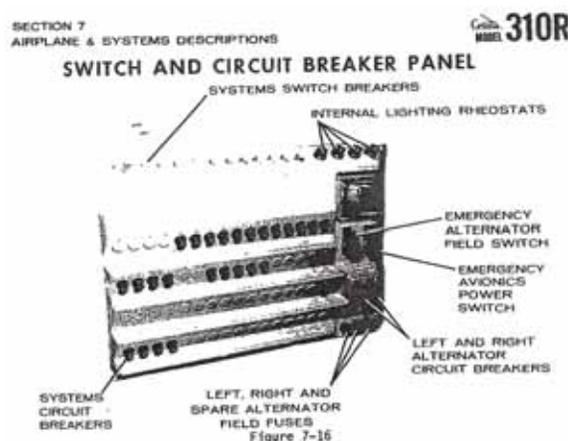
**Figure 3.**  
Diagram of switch and  
circuit breaker panel from  
Manufacturer's POH

This advice is contrary to industry best practice. Heat from excessive current causes the breaker to physically "pop out," which mechanically removes electrical power from the failed circuit. Manually pushing the breaker back in after it cools reenergizes the

damaged circuit, serves as a source of further ignition for an electrical fire, and can potentially cause the circuit breaker to fuse closed, overriding its circuit protection.<sup>6</sup>

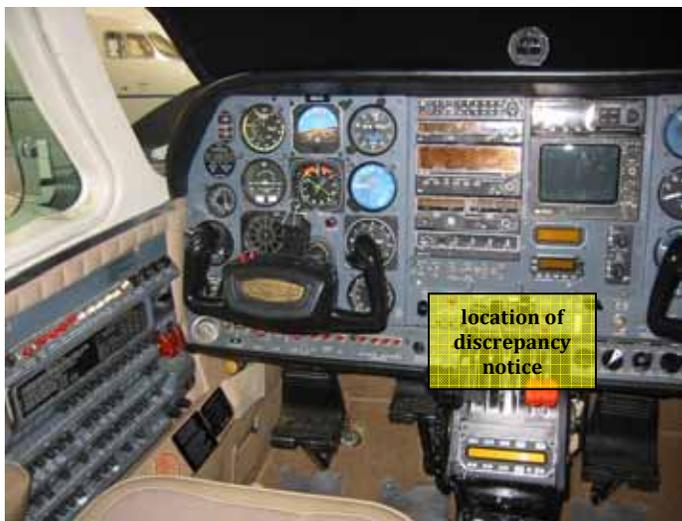
**Figure 6.**  
Showing position of  
discrepancy notice on  
throttle quadrant

The throttle quadrant (see Figures 4. and 5.) contains the levers for the pilots to operate the aircraft engines, containing controls for the throttles, the fuel mixture, and the propeller pitch for each of those engines. The pilot logging the discrepancy physically placed the discrepancy notice on top of these levers, and it would have been impossible for the pilots on the accident flight to have started the aircraft or, indeed, to have flown it at all, unless they physically moved this discrepancy note. (See Figure 6. below)

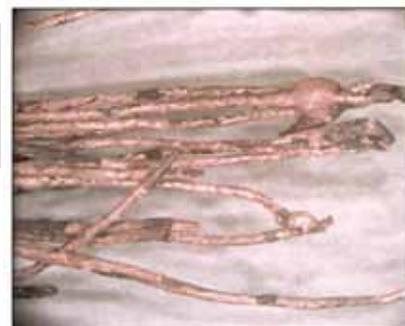
**Figure 9.**  
Showing  
beading and  
strand fusing

Figure 8. is a photograph of the burned wiring harness. Figure 9. is a photograph showing the beading and strand fusing on the wire ends of that harness.<sup>15</sup>

Beading of wire ends is considered to be consistent with the wire end being close to the ignition point of the electrical fire, as beading typically only occurs close to the source of the fire, in conditions of low oxygen. Strand fusing means that the individual strands, which are typically braided together to make a wire, are fused together by heat.<sup>16</sup>

The manufacturer’s representative confirmed that this connector plug and wiring was of a type that would have been installed as part of the original wiring of the aircraft.<sup>17</sup> According to the manufacturer, the connector was a Winchester or Amp connector, part number 200-512-2 and in an original installation, would connect to the back of the nav/com (navigation/communication) radio rack. This rack is not where the radar display unit was mounted.

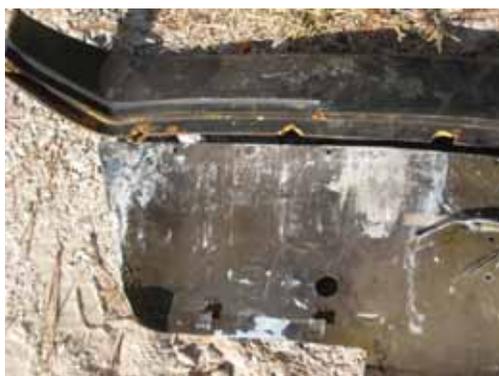
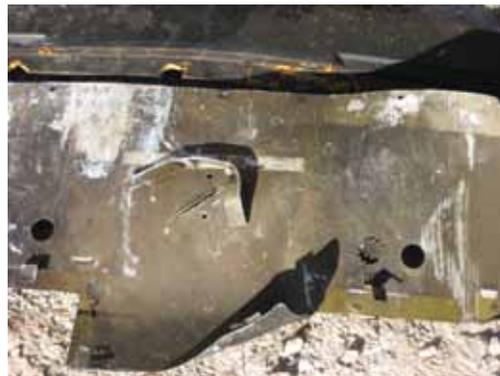
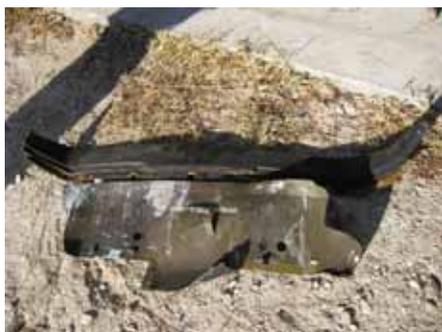
While most of the aircraft wreckage was consumed in the post-crash fire, portions of the aircraft interior fell free of that fire, were unaffected by that fire, and were available for examination. The most significant of these was a sheet metal panel which served as the airplane's glareshield, being mounted just under the windshield and just over the radios, serving as the top of the instrument panel.<sup>18</sup> Figures 10 and 11 are photographs of that glareshield panel. A photograph of the instrument panel is also included as Figure 13. for convenient comparison. The sheet metal panel shown in Figures 10., 11. and 12. would have wrapped around the top of the instrument panel shown in Figure 13, just behind the vinyl glareshield eyebrow apparent in that photograph. The vinyl glareshield eyebrow was also essentially undamaged by fire.

It will be noted from a comparison of Figures 10., 11. and 12. with Figure 13 that the radar display unit is mounted just below the center of this glareshield panel; therefore, any burning or malfunction in the area of that radar display unit would have deposited sooting on the glareshield panel, just above that unit. There is no such

sooting. The panel does contain soot deposits, but these are primarily on the left of the glareshield panel, and are consistent with burning other than from the radar display unit. It is consistent with burning near where the engine instruments are installed.<sup>19</sup> The cabin door, which would have been located at the right-hand (co-pilot's) seat, was also undamaged by fire. See Figure 14 below. Investigators noted black clumped residue at the midpoint of the door and below, indicating deposits from the cabin electrical fire. (Figure 15.) Although these deposits have not yet been analyzed by the Board, they visually appear to be a similar material to the sooting deposits on the glareshield panel shown in Figures 10., 11. and 12. No such deposits were found near the radar display either on the metal glareshield panel or on the vinyl glareshield eyebrow.

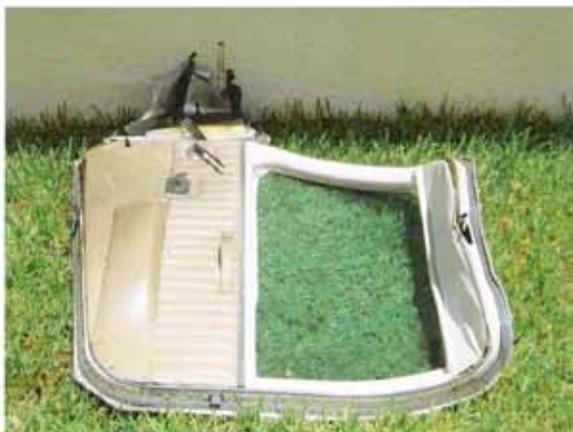
**Figure 14.**  
Cabin door

The aircraft cabin door was found separated from the main aircraft wreckage and was undamaged by fire. (See Figure 14 and Section IV.C. above) When closed, the door is latched in place by pins which insert into the aircraft door frame. These pins are latched and unlatched by handles on both the interior and exterior of the door. These latching pins appear undamaged, and the door appears to have been torn from the

The cabin door is located on the right (co-pilot's) side of the airplane. Opening this door in flight would create drag on the right side of the airplane, which, if uncorrected, would cause a tendency for the aircraft to turn and bank to the right. The crew could, and did, override this right-turning tendency by use of the flight controls, primarily by use of the rudder and ailerons. However, once the crew was incapacitated by the smoke and fumes, they were no longer able to override the airplane's right-turning tendency, and the aircraft rolled and turned to the right, as seen by the ground witnesses, and as exhibited by the analysis of the radar data.

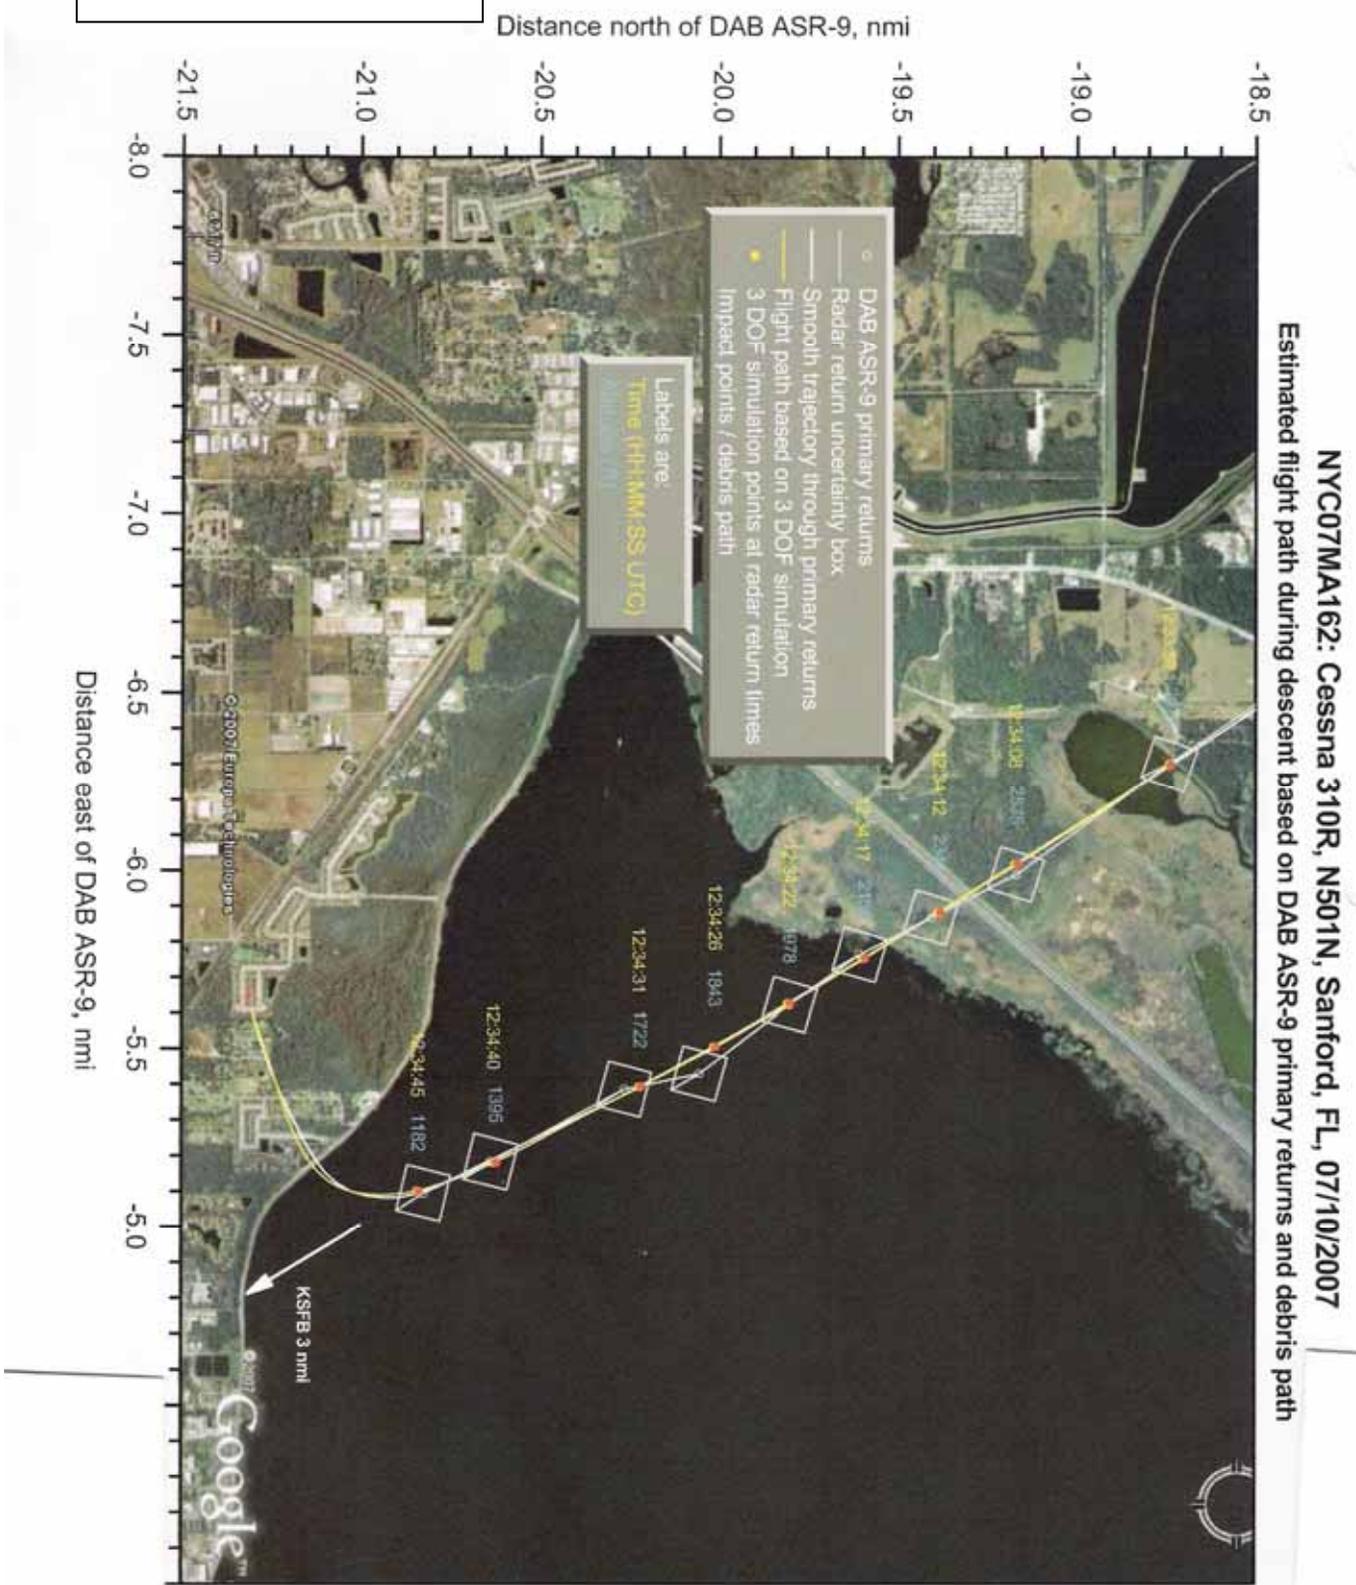
**Figure 16.**  
(Figure 3b. of Board's aircraft performance radar study)

<sup>29</sup> The conclusion of the Aircraft Performance Radar Study was that the aircraft would have had to have banked approximately 68 degrees to make its final right turn. Eyewitness Kunzer, who observed this turn, described it as a "hard bank, about 70 degrees." See July 11, 2007 summary of Kunzer statement.

facts showed that an electrical fire occurred behind the electrical equipment in the forward cockpit area. This suggests that the crew was impaired by smoke or fumes in the cockpit. This incapacitation from burning electrical insulation (polyvinyl chloride) is caused by the release of hydrogen chloride and other smoke products that are strong sensory and pulmonary irritants that will force the pilot(s) to keep their eyes closed and/or prevent respiration.
