**ATTACHMENT 18 – Mn/DOT MEMORANDUMS DOCUMENTING CRACKS IN
THE NORTH APPROACH SPAN GIRDER NEAR PIER 9 FROM OCTOBER 1998
THROUGH NOVEMBER 2000**

Subject: Bridge No. 9340
Cracks in North Approach Span Girder Near Pier 9

Subject: BR 9340 - Cracks in Approach Span Girders, North End of Bridge Near Pier 9

Re: Bridge No. 9340 - Load Test Results

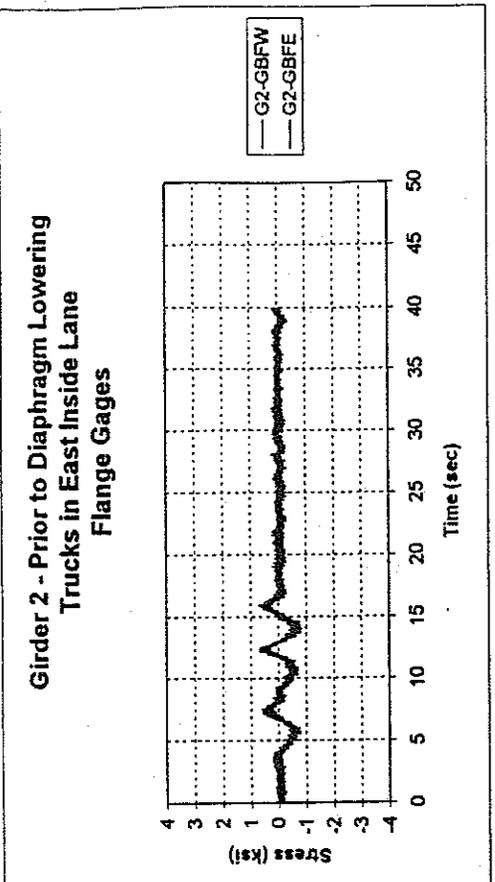
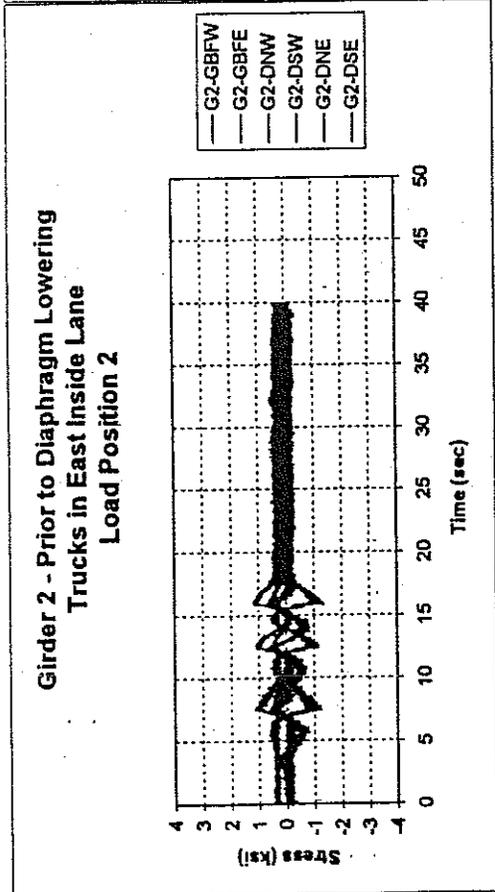
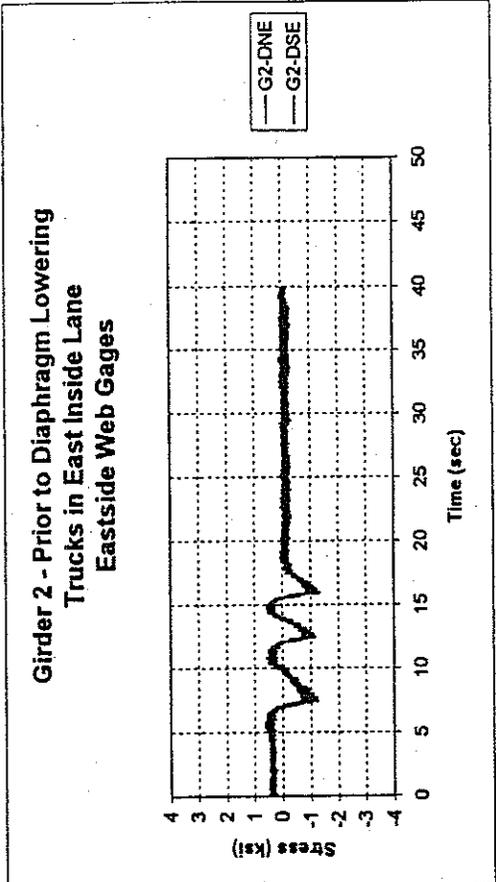
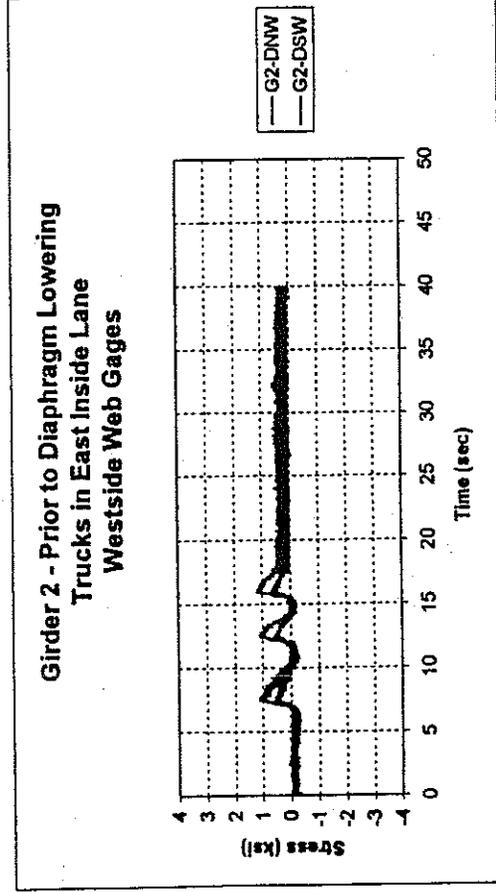
Figure 1
Girder 2 - Prior to Diaphragm Lowering

No data from Load Position 1, Load Position 3, and Load Position 4 are shown for Girder 2, because the maximum stresses developed in the web of Girder 2 as a result of the load tests occurred during Load Position 2 (trucks in east inside lane). Figure 1 contains four charts which show stress (ksi) versus time (seconds) in the girder web and compression flange prior to

lowering the diaphragms for Load Position 2. The upper left chart is a comparison of all six strain gages. The upper right chart contains the flange strain data, the lower left chart contains web strain data for the web on the west side, and the lower right chart contains web strain data on the east side of the web. In a like manner, Figure 2 contains the results for Load Position 2 after the diaphragms were released and lowered. Stress values were calculated from the strain gage data collected during the load tests.

Prior to releasing and lowering the diaphragms, the web of Girder 2 near the diaphragm connection plate is bending around the flange, as one would expect. The west side of the web is in tension with a peak value about 1 ksi and the east side of the web is in compression with a peak value about 1 ksi. After the diaphragms were lowered, the stress in the web was almost completely eliminated, with a peak value less than 0.2 ksi. The flange stress and response in both load tests are almost the same, indicating that lowering the diaphragms has not changed the distribution of load among girders or the torsion.

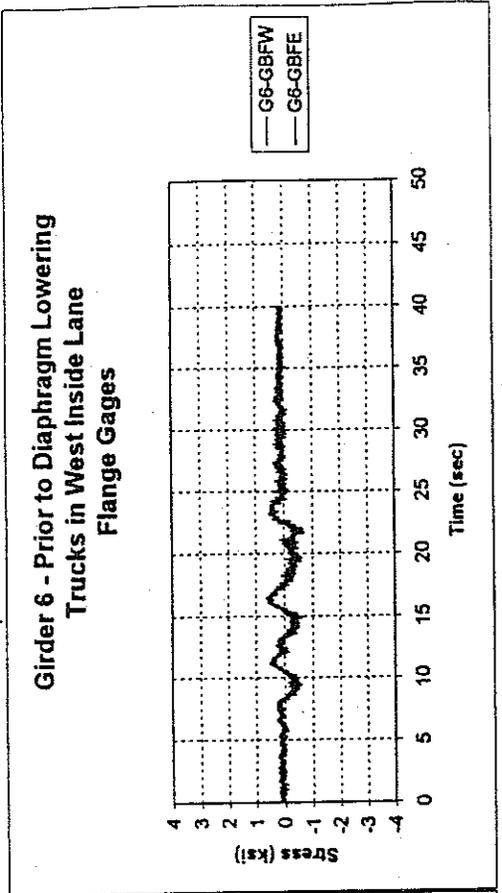
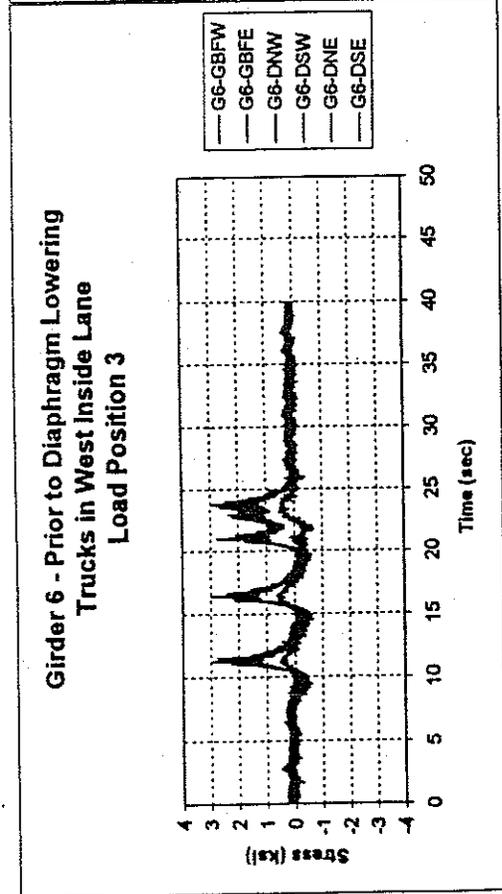
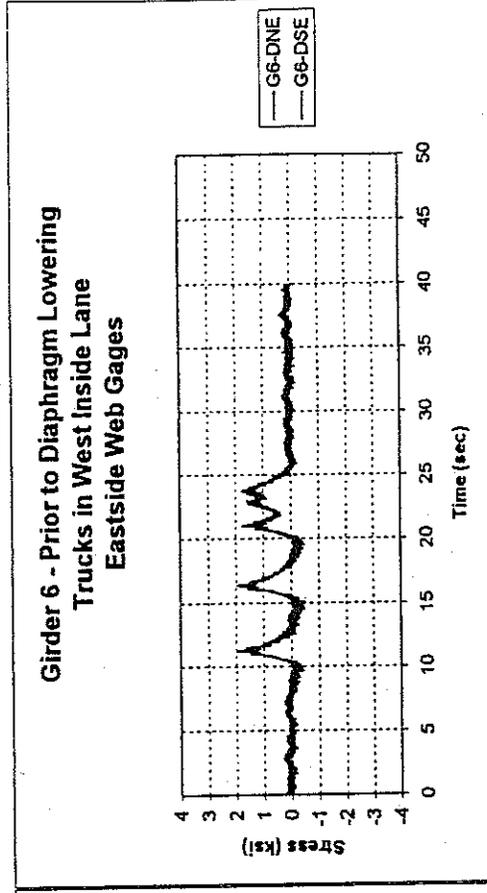
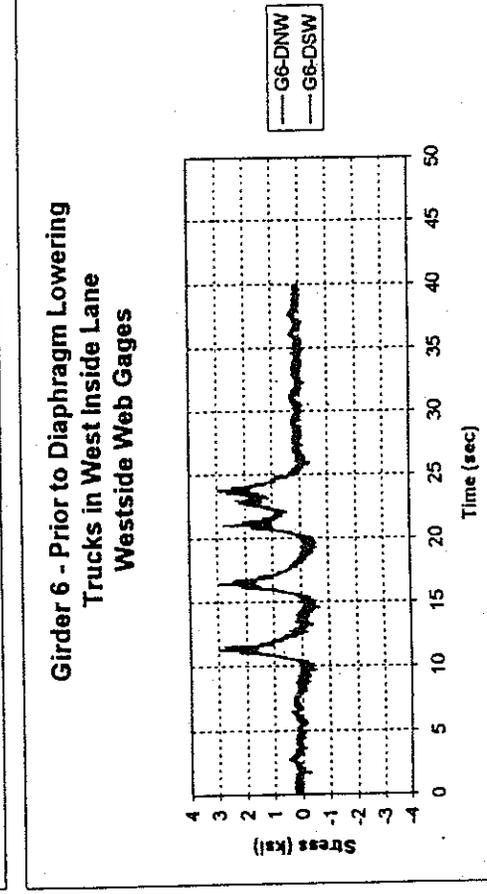
Figure 3
Girder 6 - Prior to Diaphragm Lowering

The maximum stresses developed in the web of Girder 6 during the load tests occurred while the trucks were in Load Position 3 (trucks in the west inside lane). As a result, no data from Load Position 1, Load Position 2, and Load Position 4 are shown for Girder 6. Using the same chart layout as explained above, Figure 3 contains the results prior to lowering the diaphragms for Load Position 3 and Figure 4 contains the results for Load Position 3 after the diaphragms were released and lowered.

This section did not behave as expected. Prior to lowering the diaphragms the west side of the web shows a tensile stress of approximately 3 ksi the east side of the web shows a tensile stress of about 2 ksi. One can conclude that the web has a net tensile stress of about 2.5 ksi along with a bending stress of approximately 0.5 ksi. After the diaphragms were released and lowered, the stress on the west side was tensile with a magnitude of approximately 1.2 ksi and on the east side the stress was compressive with a magnitude of about 0.6 ksi. Again this section has a net tensile stress along with a bending component, although the magnitudes are reduced substantially. Similar to Girder 2, the flange stress and response in both load tests are almost the same, indicating that lowering the diaphragms has not changed the distribution of load among girders or the torsion.

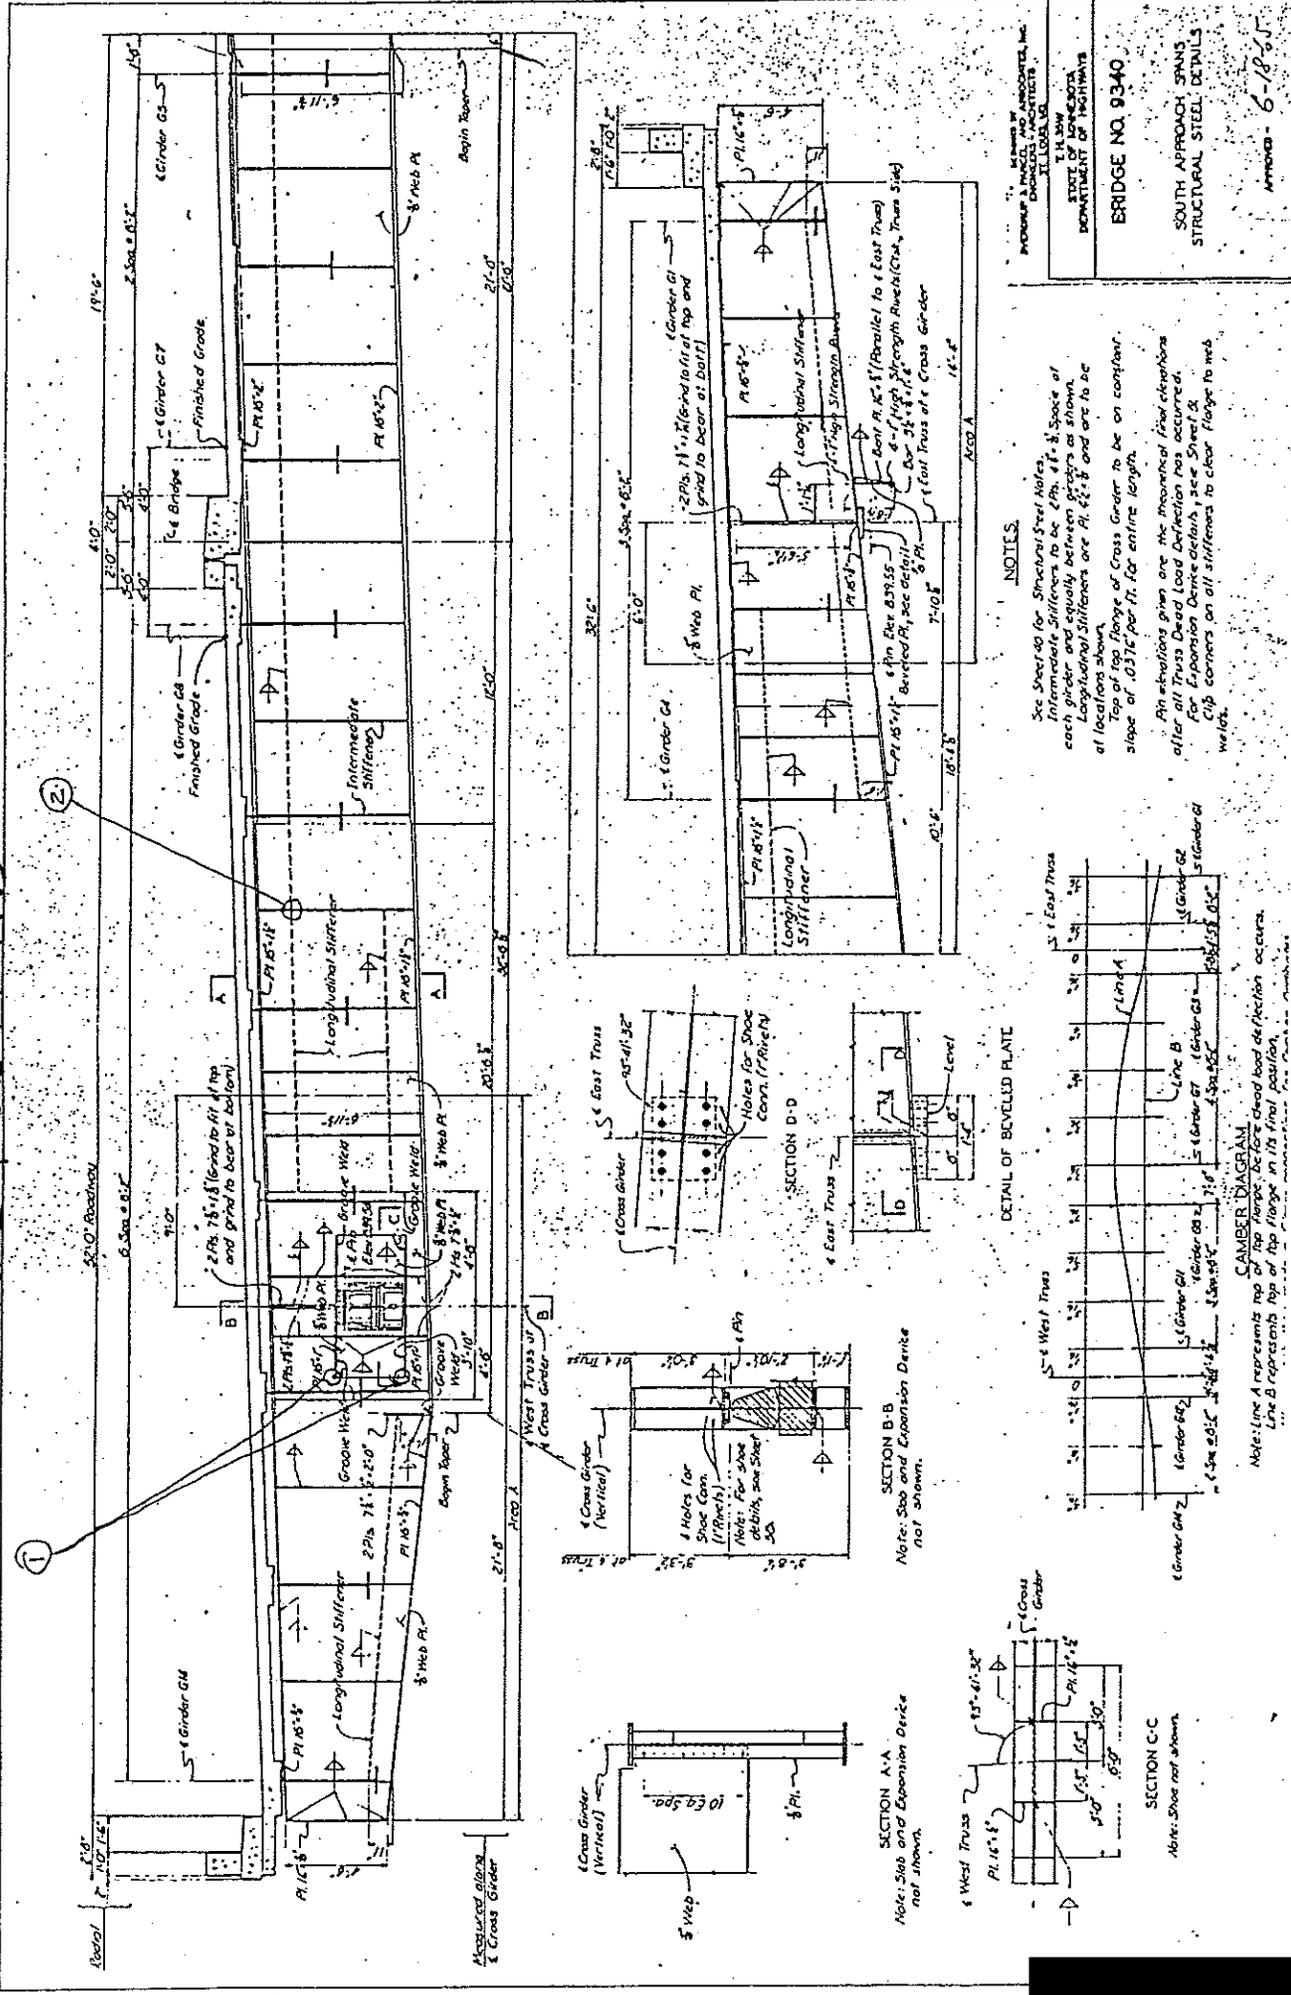
BRIDGE NO. 9340
SOUTH APPROACH SPANS
STRUCTURAL STEEL DETAILS
APPROX - 6-18-97

Floor Beam
Cracks Found in 1998
Also Some found in 1997
Some found in 1993

21 Crack Locations
