**ATTACHMENT 16 – URS CORPORATION FATIGUE EVALUATION BRIDGE
9340 35W OVER MISSISSIPPI RIVER INITIAL INSPECTION REPORT DATED
JUNE 9, 2003
(100 pages)**

**Fatigue Evaluation
Bridge 9340
35W Over Mississippi River**

Mn/DOT

June 9th - June 13, 2003

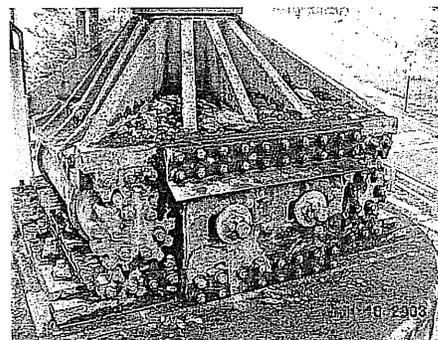
- The roller bearings appeared to not be functioning as intended. There was significant corrosion of the bearing surfaces, debris and dirt packed into various areas of the bearing and very thick coatings of paint. The roller bearings appear to be "frozen" in place.
- The access to observe the rocker bearings was very difficult due to the construction details. The bearings are built into "pockets" in the floor beam with little clearance to the sides of the bearing. Some debris was noted in the pocket and it was impossible to visually determine if the bearings are functioning. The bearings were marked so that potential movements could be determined in the future under different temperature conditions. The bearing marking will be discussed in greater detail later in the report.

Typical Condition of Expansion Bearing at Pier 6 (West Truss)

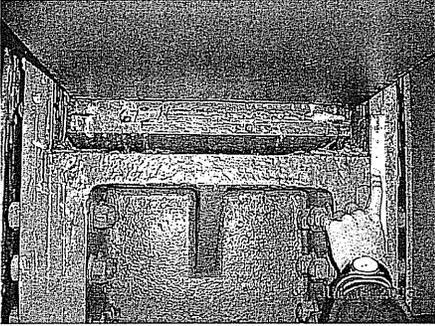
Typical Marking of Rocker Bearings

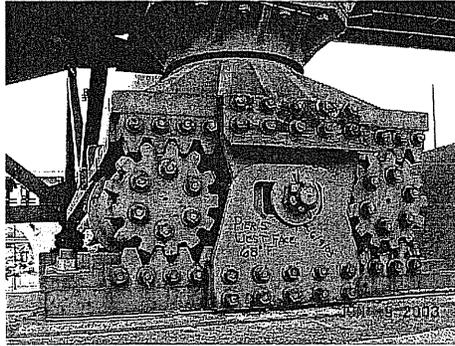
Typical Field Marking of Roller Bearings

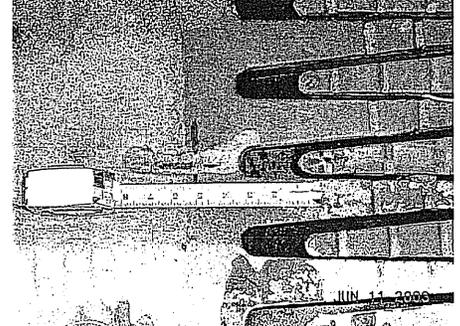
Typical Marking of Finger Joints

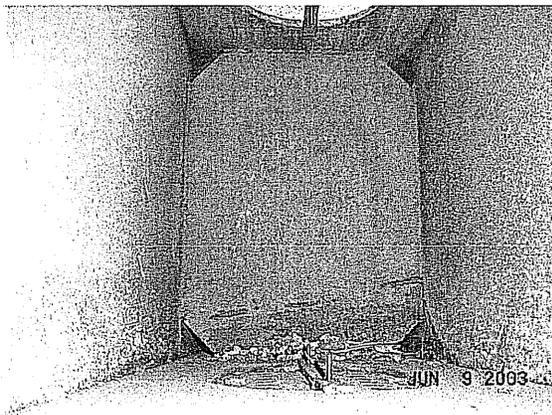
It was difficult to determine if the diaphragm was welded to the truss chord or only to the tabs within the member. Access holes are not located directly adjacent to the diaphragm locations and the diaphragms were visually observed from a distance. There was also an accumulation of debris/dirt around the perimeter of the diaphragms inspected. It appeared that the tabs were attached to the interior of the truss by welding with fillet welds in the longitudinal direction.

Back Side of Internal Diaphragm (Appears Welded)

Further visual inspection of the tab connections and diaphragms could be made by removal of more of the cover plates. Probing scopes could also be utilized to provide up close inspection of the tab connections and diaphragms. Scopes with photographic capabilities would prove to be extremely valuable for documenting and determining the condition at these internal tabs.

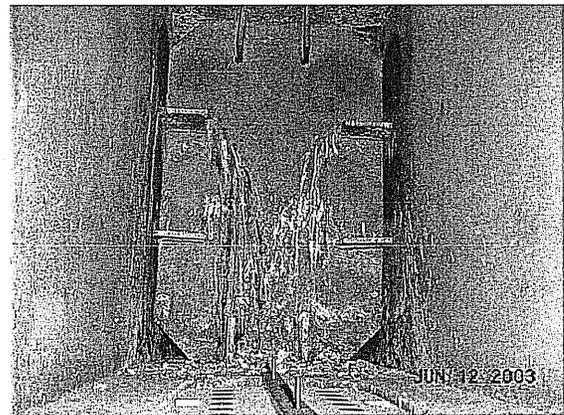
Front Side of Internal Diaphragm (Weld Tabs)

Removing the cover plates at each of the diaphragm locations to inspect the truss interior at the tab connections is of critical importance. This is one of the primary locations that one would expect a critical fatigue crack to develop in a truss chord member.

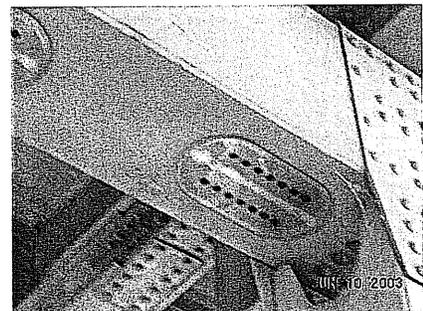
<u>PHOTO</u>	<u>LOCATION</u>	<u>DESCRIPTION</u>
3-4	U22 west truss East face Looking southwest	Good condition
3-5	U22 west truss East face looking southwest	Good condition Floor beam also
3-6	L21 to U22 member mid-point	Flaking rust
3-7	U22 west truss East face looking west	Good condition
3-8	U22 west truss East face looking west	Good condition
3-9	West truss U21 connection east face looking southwest	Good condition
3-10	West truss U21 connection east face looking southwest	Good condition
3-11	West truss U21 Floor beam connection at U21 East face looking west	
3-12	U21 to U22 2' north U21	Tack crack inside box

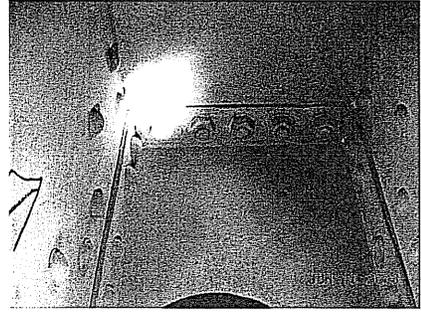
<u>PHOTO</u>	<u>LOCATION</u>	<u>DESCRIPTION</u>
3-13	U21 to U22 north U21 2'	Inside box Top chord flaking beam connection Weld crack upper left corner looking south
3-14	U21 to U22 north U21 2'	Inside box Top chord flaking beam connection Weld crack upper left corner looking south
3-15	U21 to U22 north U21 2'	Inside box Looking north
3-16	U21 connection West truss East face looking northwest	Good condition
3-17	U21 connection West truss East face looking northwest	Good condition
3-18	Walkway at U21	Interior bay
3-19	U20 connection East face looking west	Good condition
3-20	U20 connection East face looking west	Good condition

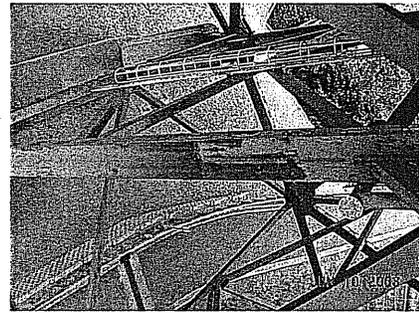
<u>PHOTO</u>	<u>LOCATION</u>	<u>DESCRIPTION</u>
5-11	U8 East face Looking southwest	Good condition
5-12	U8 West face Looking southeast	Slight flaking rust Drain pipe (plugged) cause rust
5-13	U8 to L8	Rust due to plug drain
5-14	U8 to L8	Rust due to plug drain
5-15	U8 West face Looking east	Flaking rust
5-16	Drain connection at U8	
5-17	Expansion bearing Pier 6 West face Looking east	Major flaking rust and debris
5-18	Pier 6 North roller West face	Close up marks
5-19	Pier 6 South roller West face	Flaking rust
