HIGHWAY CONSTRUCTION FACTORS FACTUAL REPORT
HWY-07-MH-024
Minneapolis, MN

C. ACCIDENT SUMMARY

INTRODUCTION

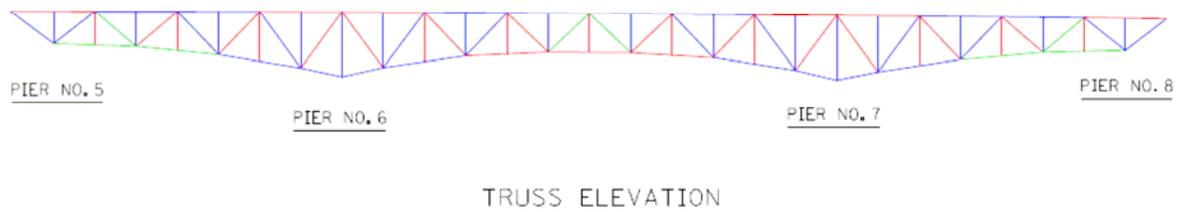
Figure 2 – Tension and compression members of the continuous steel deck truss

Figure 2 shows the tension and compression members of the continuous steel deck truss. Tension members are shown in red, compression members are shown in blue, and reversal members are shown in green. Four piers supported the truss (5, 6, 7, and 8).

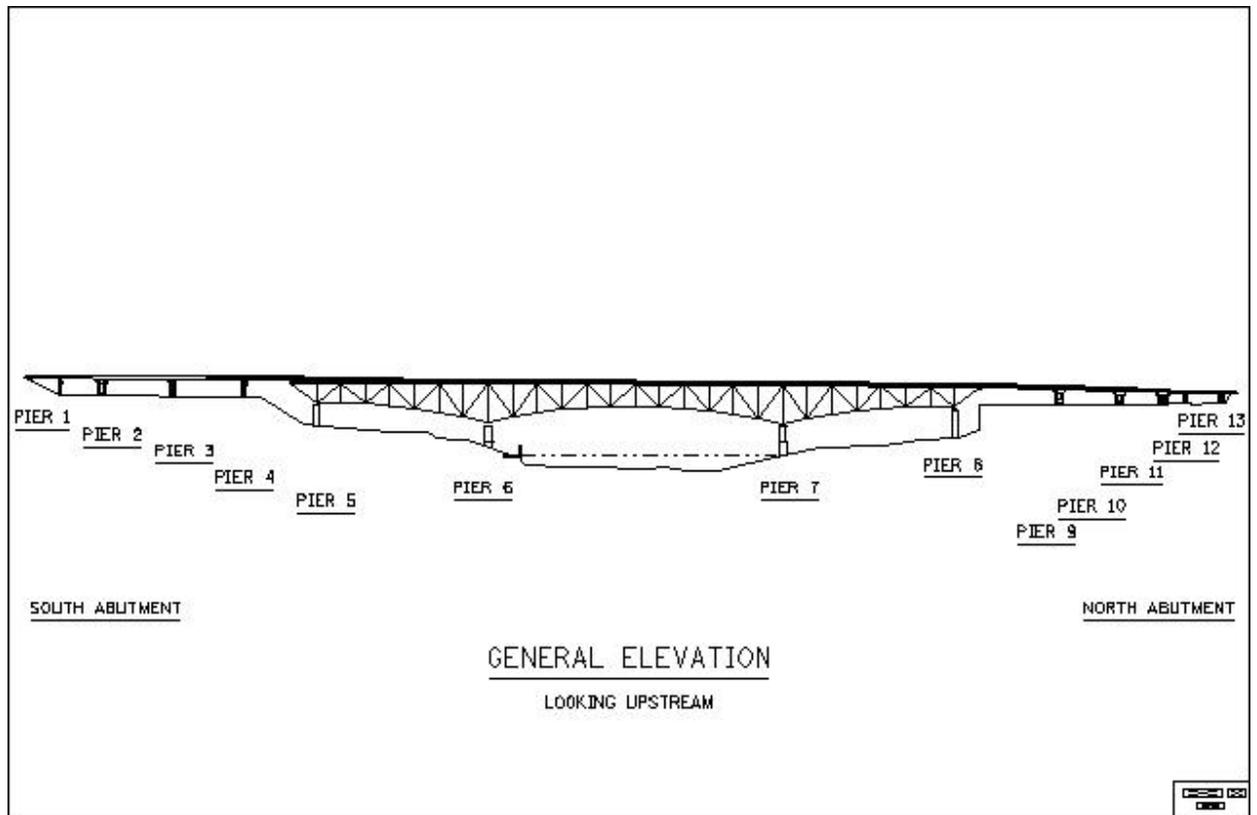
Figure 3 – Elevation of entire length of bridge from south abutment to north abutment

Figure 3 shows the entire length of the bridge from the south abutment to the north abutment. Figure 3 shows the approach slabs on either side of the continuous steel deck truss. Four piers supported the south approach spans (1, 2, 3, and 4) and five piers supported the north approach spans (9, 10, 11, 12, and 13).

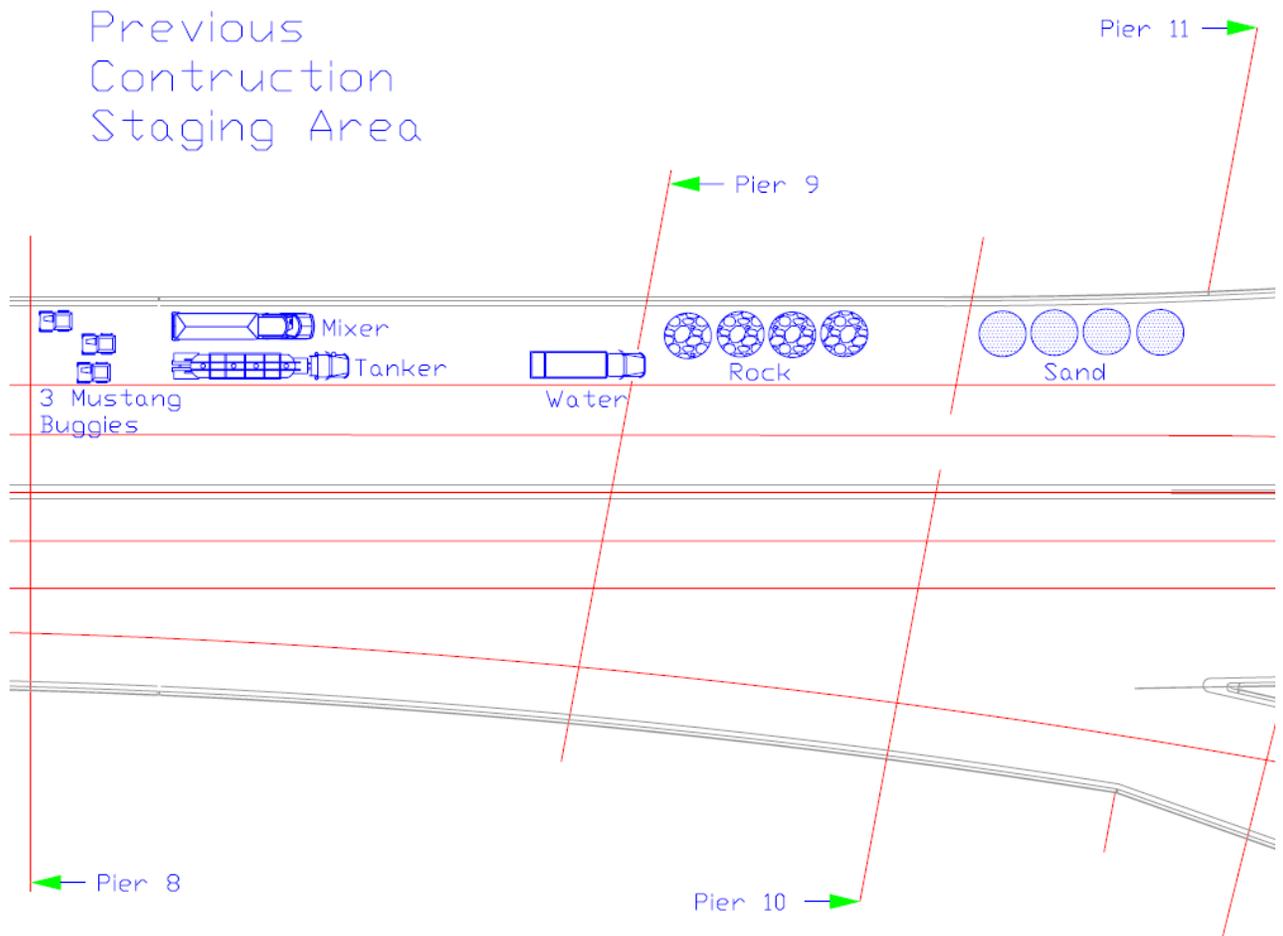
On the night of July 6th, 2007 two crews paved the outside southbound lanes from pier# 8 south to the end of the south bridge deck. Materials for the southbound lanes staging area and projected 720-foot overlay from pier# 6 to the south end were staged off the bridge deck. The materials for the projected 750-foot overlay from pier# 6 in the other direction towards pier 8 were staged on the bridge deck and off the bridge past the north abutment. The equipment and aggregates staged on the deck for this overlay consisted of an arrangement similar to how it was arranged on the day of the collapse except for two additional loads of sand and two additional loads of rock that was off of the bridge. The deck staging area was bordered on the north end by the expansion joint at pier# 11 south to the finger joint near pier# 8. This area was approximately centered over the mid-point between spans 10 and 11.

The PCI job foreman indicated that he had asked the state construction inspector for permission to place the loads on the bridge deck, and was authorized to do so. However, the MN/DOT bridge inspector did not recall this conversation. PCI viewed the inspectors as acting on behalf of the engineers. On another occasion the PCI Vice President had requested to use a planing machine to remove unsound concrete at depths deeper than the standard two inches. The inspector/project supervisor went directly to the bridge office and set up an experiment at another location. The bridge engineers determined there was too much vibration when the machine was used to remove deeper depths. Again PCI relied on the guidance of the inspectors.

See Attachment 3 for diagrams of the overlays and staging areas. The weight of the equipment and materials of this overlay was similar to the weight of materials on the deck at the time of the collapse.

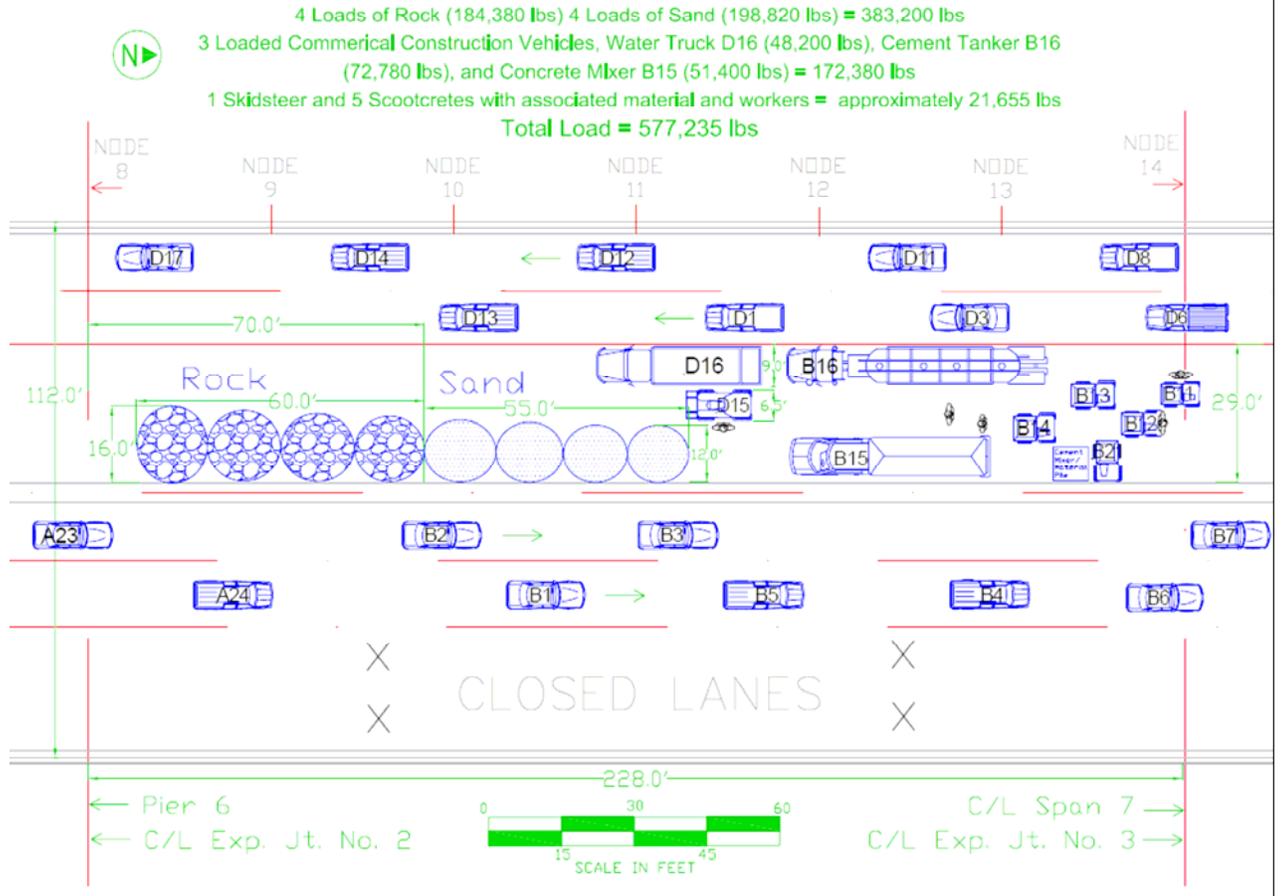
Construction Material Staging on Center Span Truss

The positions of the materials and vehicles were changed after the 3:30 p.m. photograph was taken. Construction workers from PCI used a skidsteer to move the materials closer to the median barrier to make room for the movement of construction vehicles and traffic moving in the outside lanes. (See Photo 1 in Highway Construction Factors Group for Details)

In the right center of this photograph the plastic covering can be seen over previously repaired areas that had not yet cured. For that reason the length of the material staging area was reduced to what can be seen here. The gray colored material is the load of rock and the brown colored material is the sand. In the photograph the edge of the rock is over pier 6 and the center of the aggregate piles of sand and rock is located over structural truss node U-10.
