# NATIONAL TRANSPORTATION SAFETY BOARD

MATERIALS LABORATORY STUDY

Report No. 08-118

Place : Minneapolis, Minnesota  
Date : August 1, 2007  
Vehicle : I-35W Bridge  
NTSB No. : HWY07MH024  
Investigator : Mark Bagnard

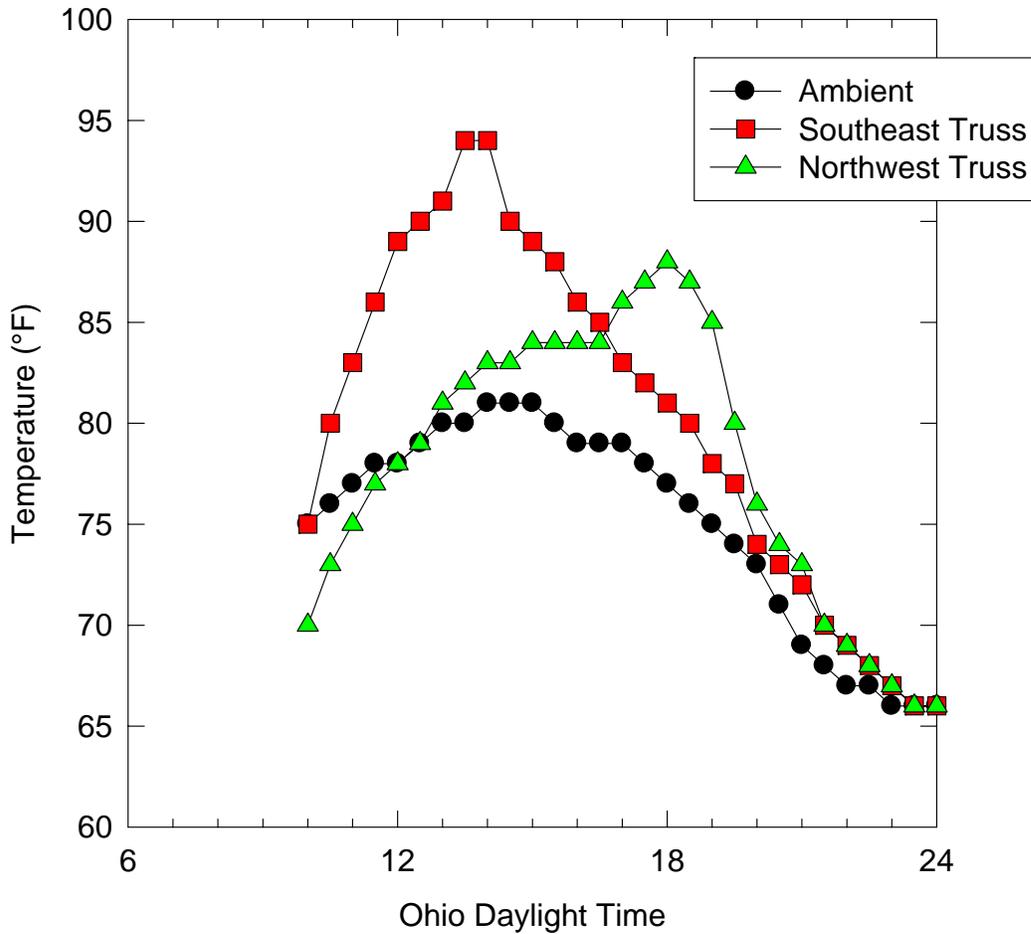
Following the gusset plate failure and near collapse of the Grand River bridge (LAK-90-2342 R) in Ohio on May 24, 1996, data were obtained from temperature sensors and strain gages placed on the main trusses of that bridge. The instrumentation and the data are described in a presentation attached as Appendix A. Temperature data were measured on September 4-5, 1996, showing that the exposed faces of the trusses reached temperatures above ambient as a result of solar heating. The Grand River bridge was aligned at approximately 45 degrees from North, and the data showed that the Southeast truss heated more quickly, reaching a peak temperature about 14 °F above ambient at about 1:30 pm, after which it began to cool. The Northwest truss began to heat up later in the day and reached a peak temperature about 11 °F above ambient at about 6 pm. The data from September 4, 1996 are shown in figure 1.

Figure 1. Temperature data from Ohio bridge LAK-90-2342 R taken on September 4, 1996.

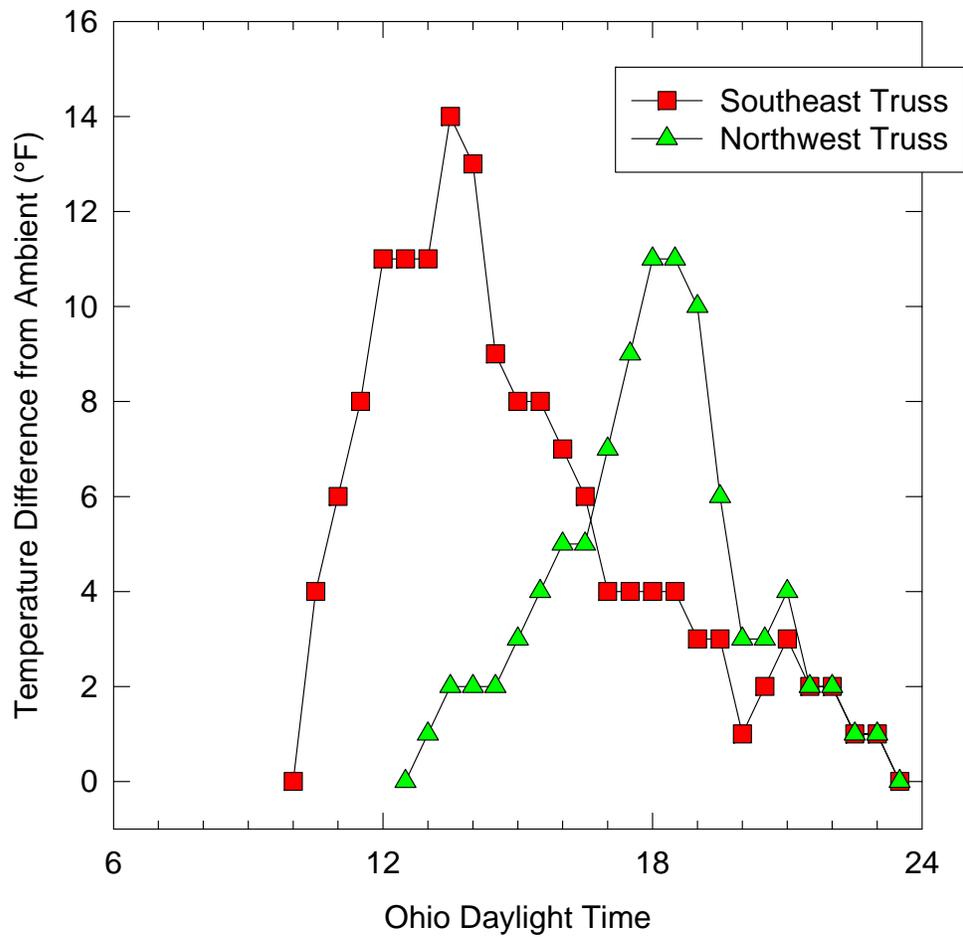
The orientation of the Grand River bridge at about 45 degrees from north was such that the sun would have been aligned along the bridge at about 3:30 pm. When the ambient temperature was subtracted from the temperature data from the two trusses, the temperature profiles from the two trusses had more nearly symmetric shapes relative to the temperature at 3:30 pm, as shown in Figure 2.

Figure 2. Temperature data from the two trusses after subtracting the ambient temperature.

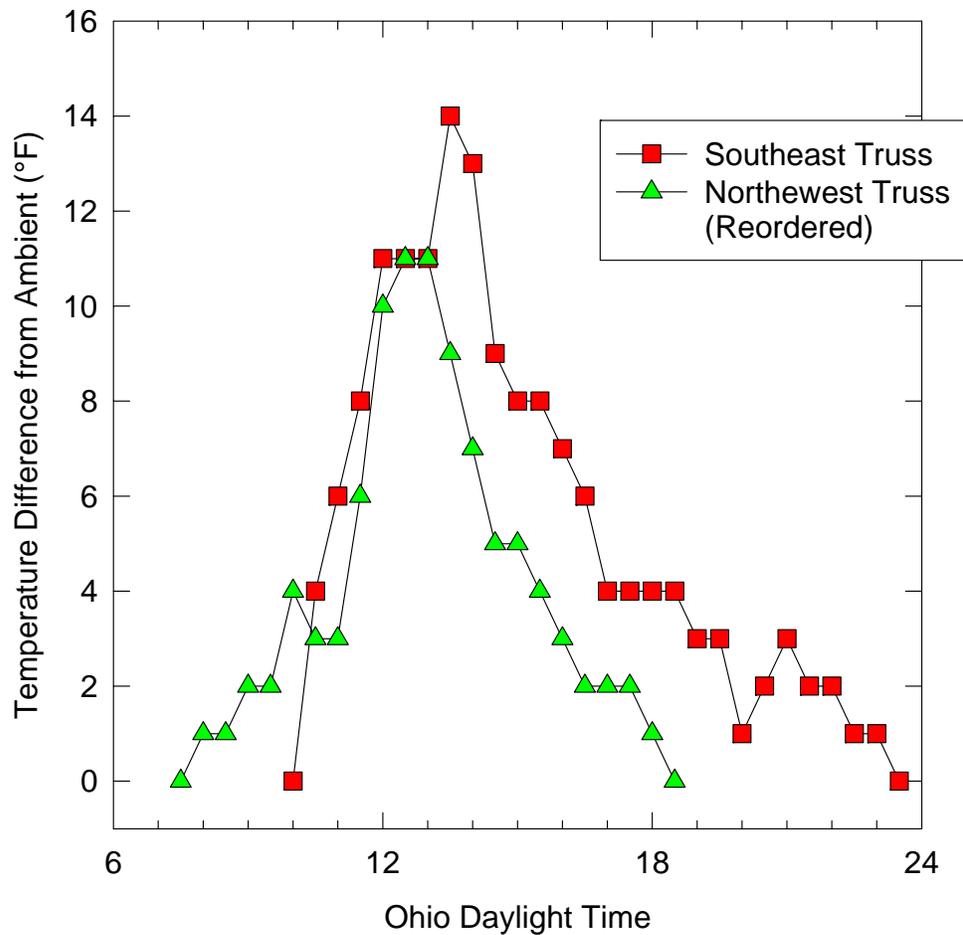
The degree of symmetry is shown in Figure 3, where the temperature data from the Northwest truss has been reordered from last to first, then shifted to align the reordered data from the Northwest truss with the data from the Southeast truss at the time of 3:30 pm. It would be expected that the peak for the Southeast truss would be somewhat higher, as the sun did not begin to heat the Northwest truss until somewhat late in the day.

Figure 3. Temperature data from the two trusses after subtracting the ambient temperature, reordering the data from the Northwest truss from last to first, and then realigning the data to 3:30 pm.

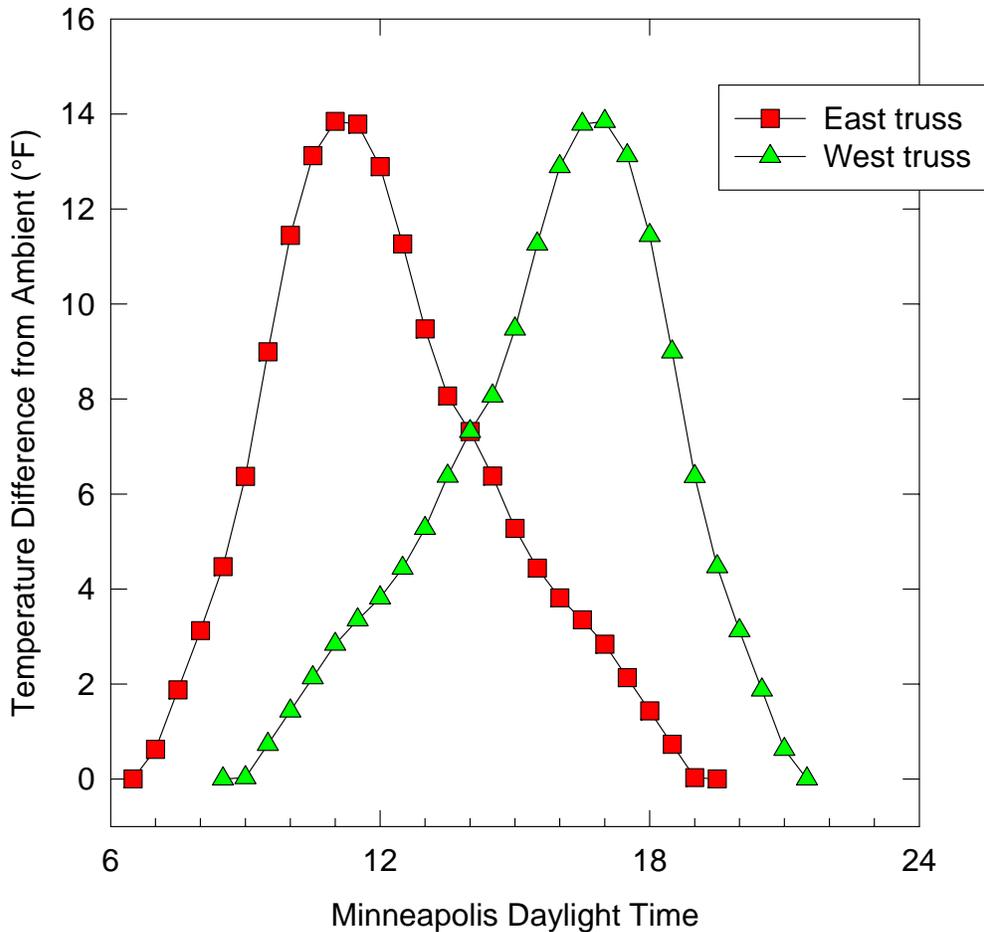
The I-35W bridge was aligned at about 16 degrees from north, making it more nearly directly north and south than the Grand River bridge. Sun position data from the United States Naval Observatory shows that the sun would have been aligned with the bridge at about 2 pm (Daylight time) on August 1, 2007. Assuming that the temperature profiles on the two I-35W trusses would have been more symmetric around the 2 pm time, the two sets of data in Figure 3 were averaged together. The result was then smoothed using a 3-point averaging filter, and the peak difference from ambient rescaled to 14 °F. The time scale for the temperature change was also expanded to account for the longer day on August 1 compared to September

4 (14.5 hours versus 13 hours). The estimated temperature profiles for the two trusses are shown in Figure 4.

Figure 4. Estimated temperature deviation from ambient for the East and West trusses of the I-35W bridge on August 1, 2007.

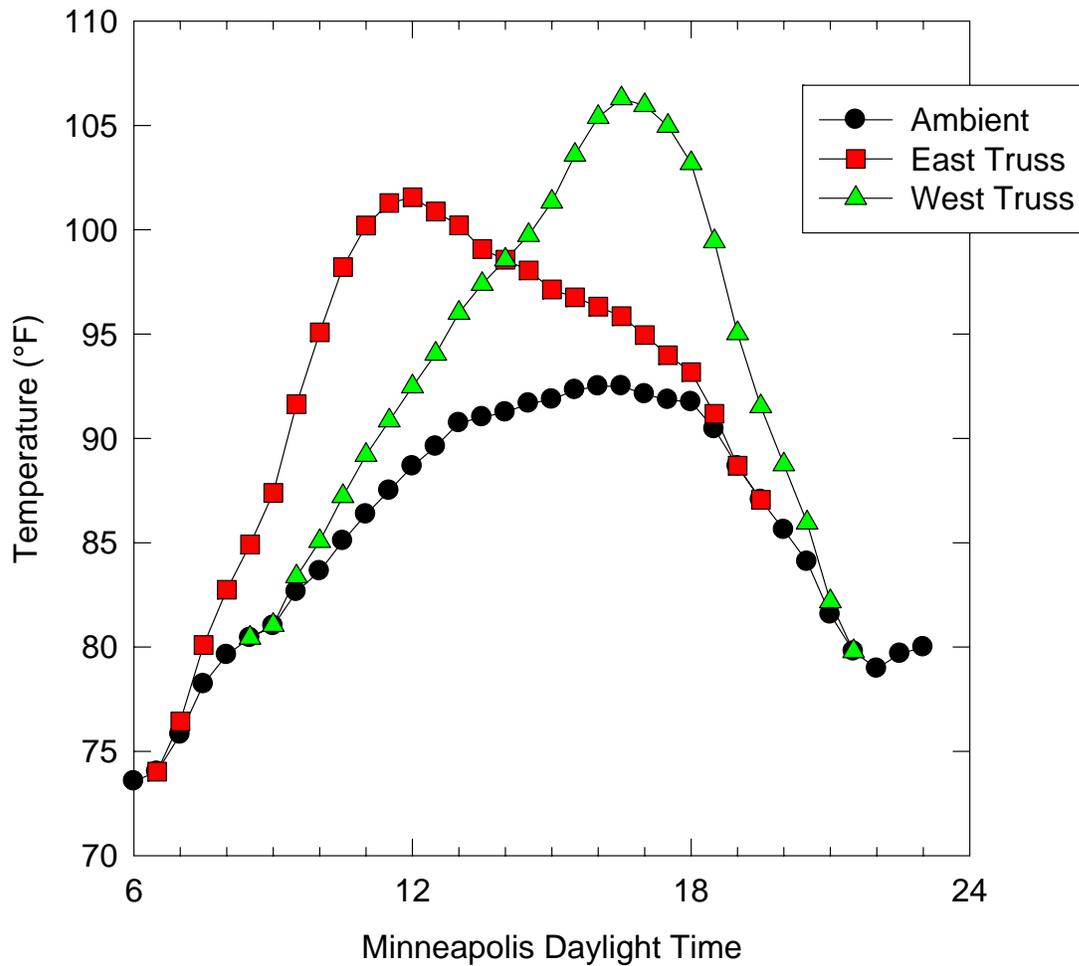
The temperature data from the weather station on the University of Minnesota campus was interpolated to half-hour increments and smoothed with a 3-point averaging filter. Figure 5 shows the result of adding the data from Figure 4 to the ambient temperature from the University.

Figure 5. Ambient temperature data plus estimated temperatures in the East and West trusses of the I-35W bridge on August 1, 2007.

All of the data shown in the figures are tabulated below. The results provide an estimate that at 6 pm on August 1, 2007, the east truss was about 1.5 °F above ambient and the west truss was 11.5 °F above ambient.

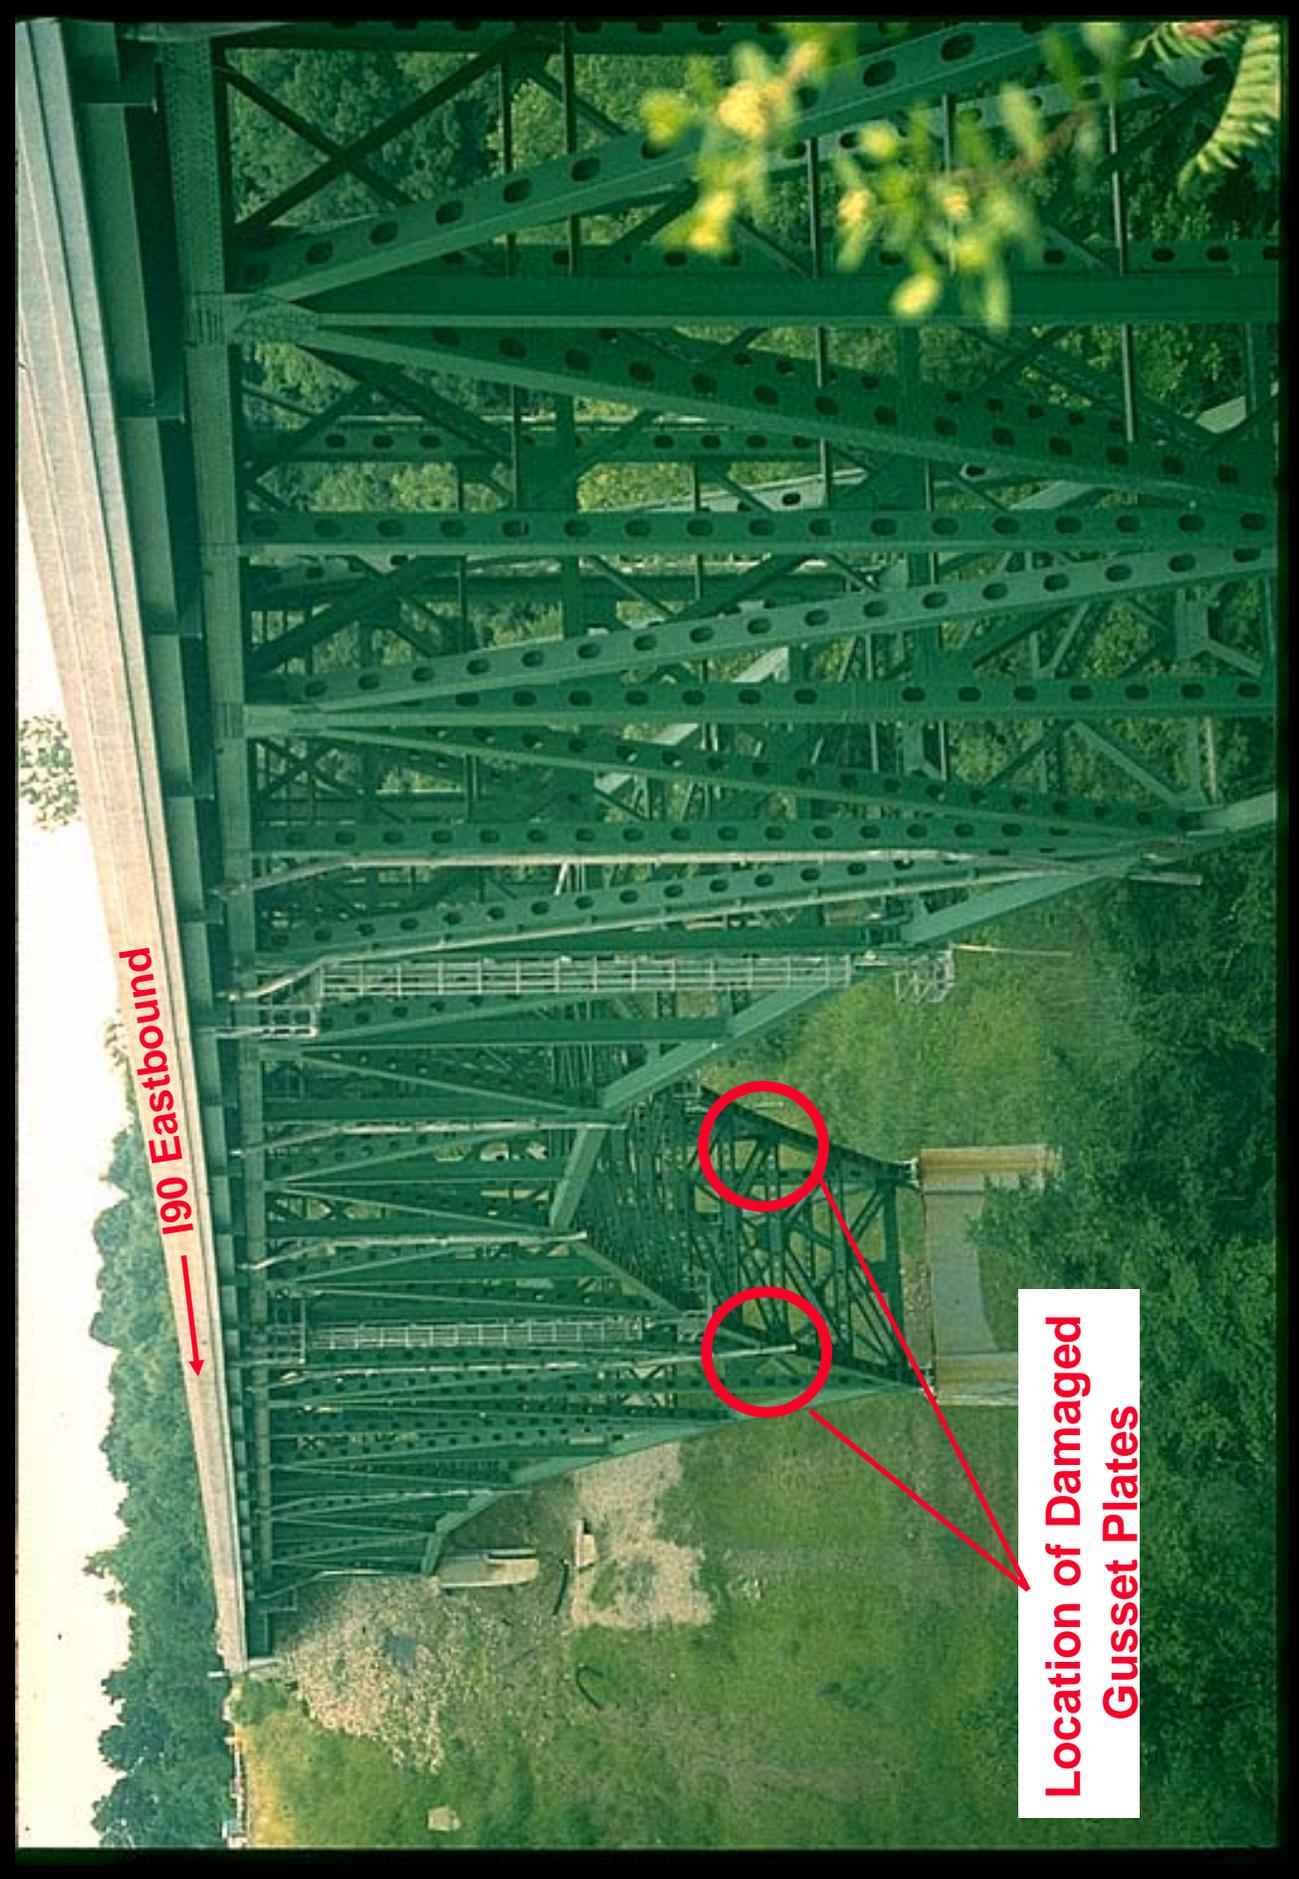
On May 24, 1996 the truss connection at joint L8' at the east end of the eastbound structure failed in the north and south trusses. The gusset plates supporting the verticals and compression diagonals buckled and allowed the member ends to drop about 3 inches and move laterally about 3 inches. The damaged members were in the truss cantilever supporting the center suspended span. The bridge was closed to traffic.

Location of Damaged  
Gusset Plates

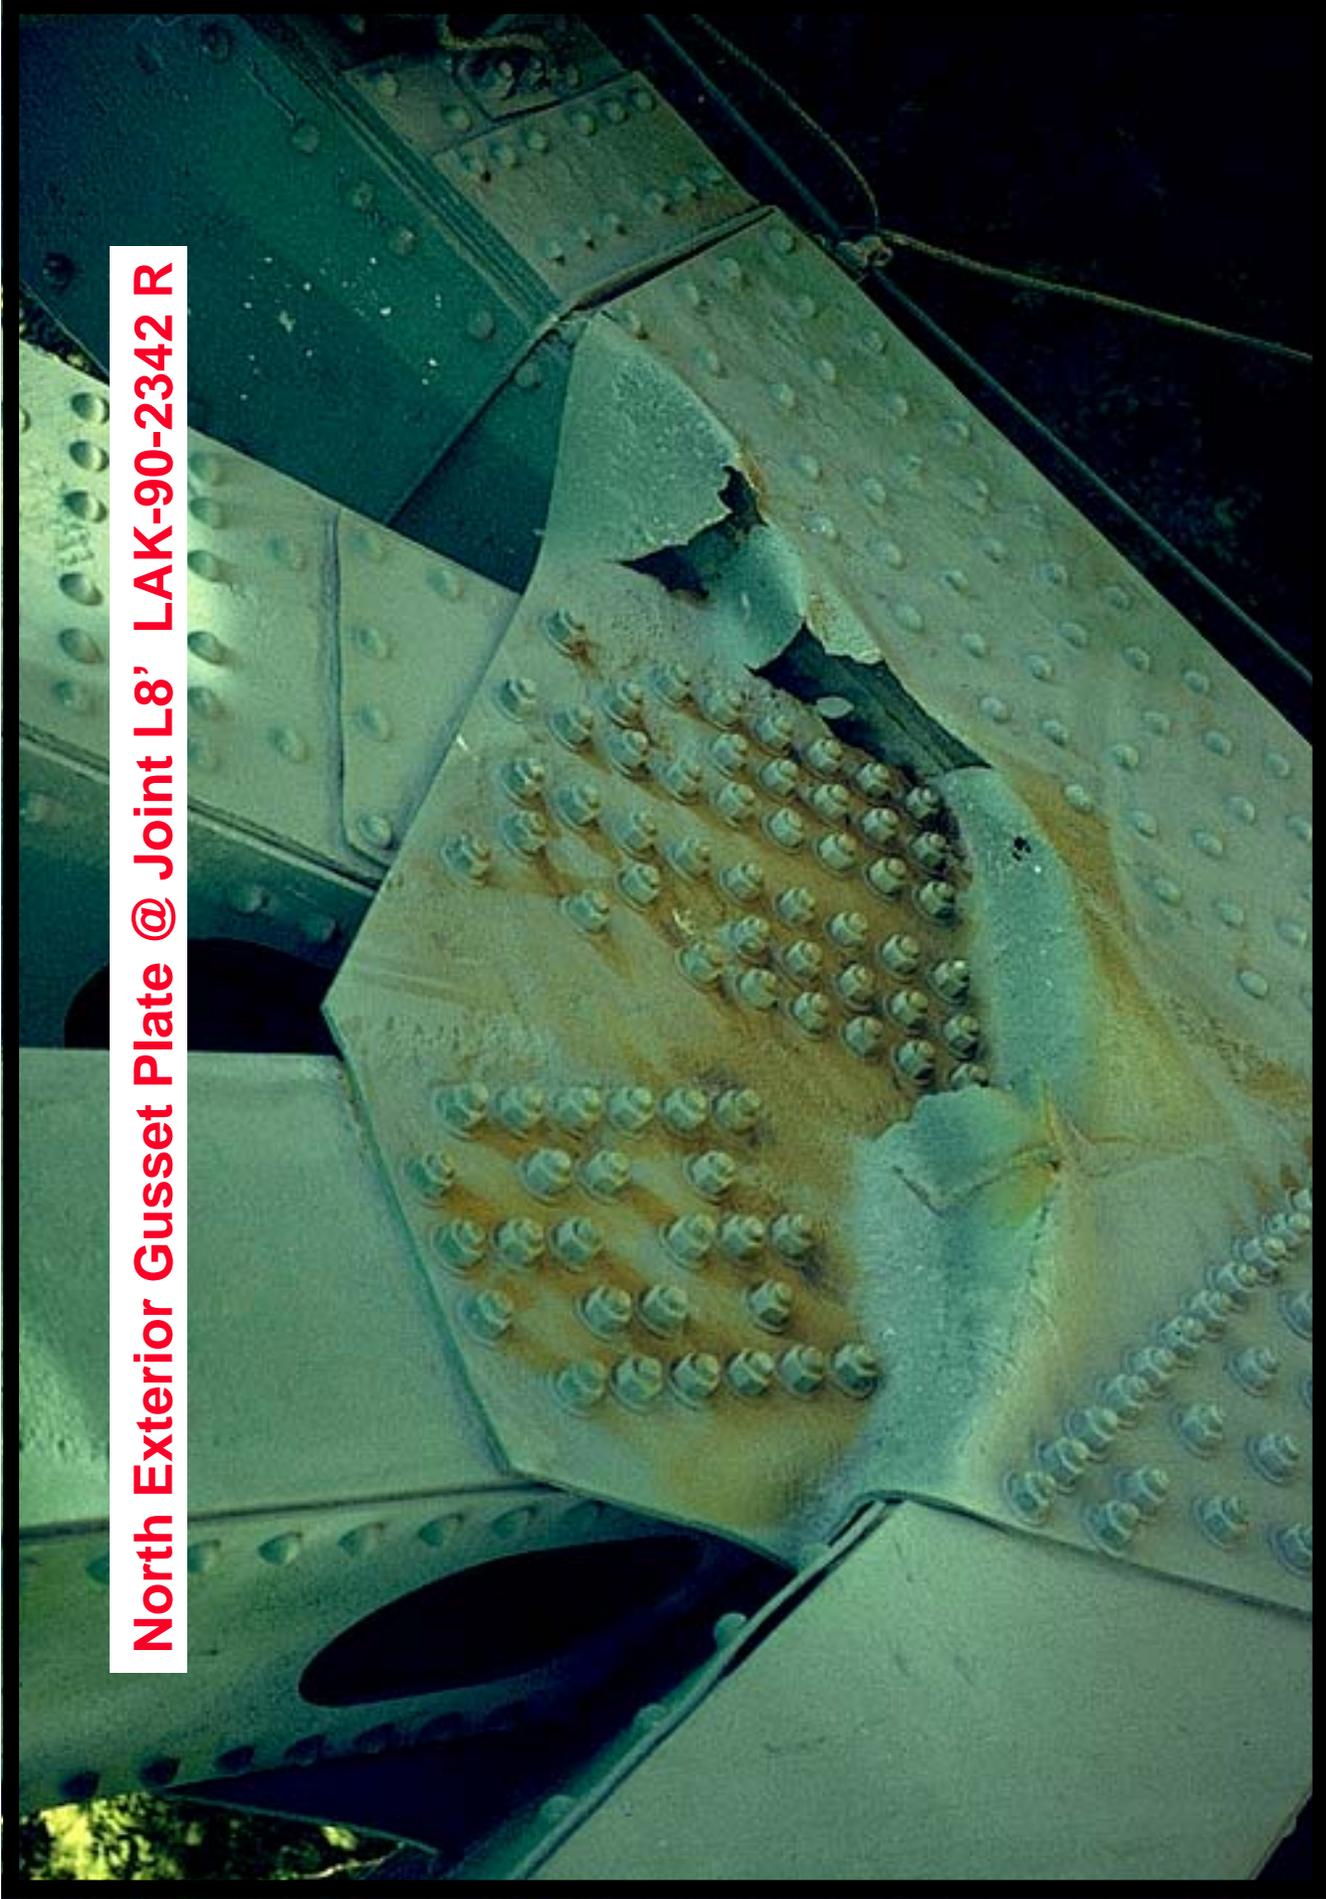
**North Exterior Gusset Plate @ Joint L8' LAK-90-2342 R**

All other gusset plates similar to L8' in the twin bridges have been strengthened with the addition of stiffening angles bolted to the plates. The failed truss connections at joint L8' of the eastbound structure have been lifted, realigned and reconstructed. Temporary support (rods) were removed (from between joints L8' and U7') on October 14 (and 16), 1996.

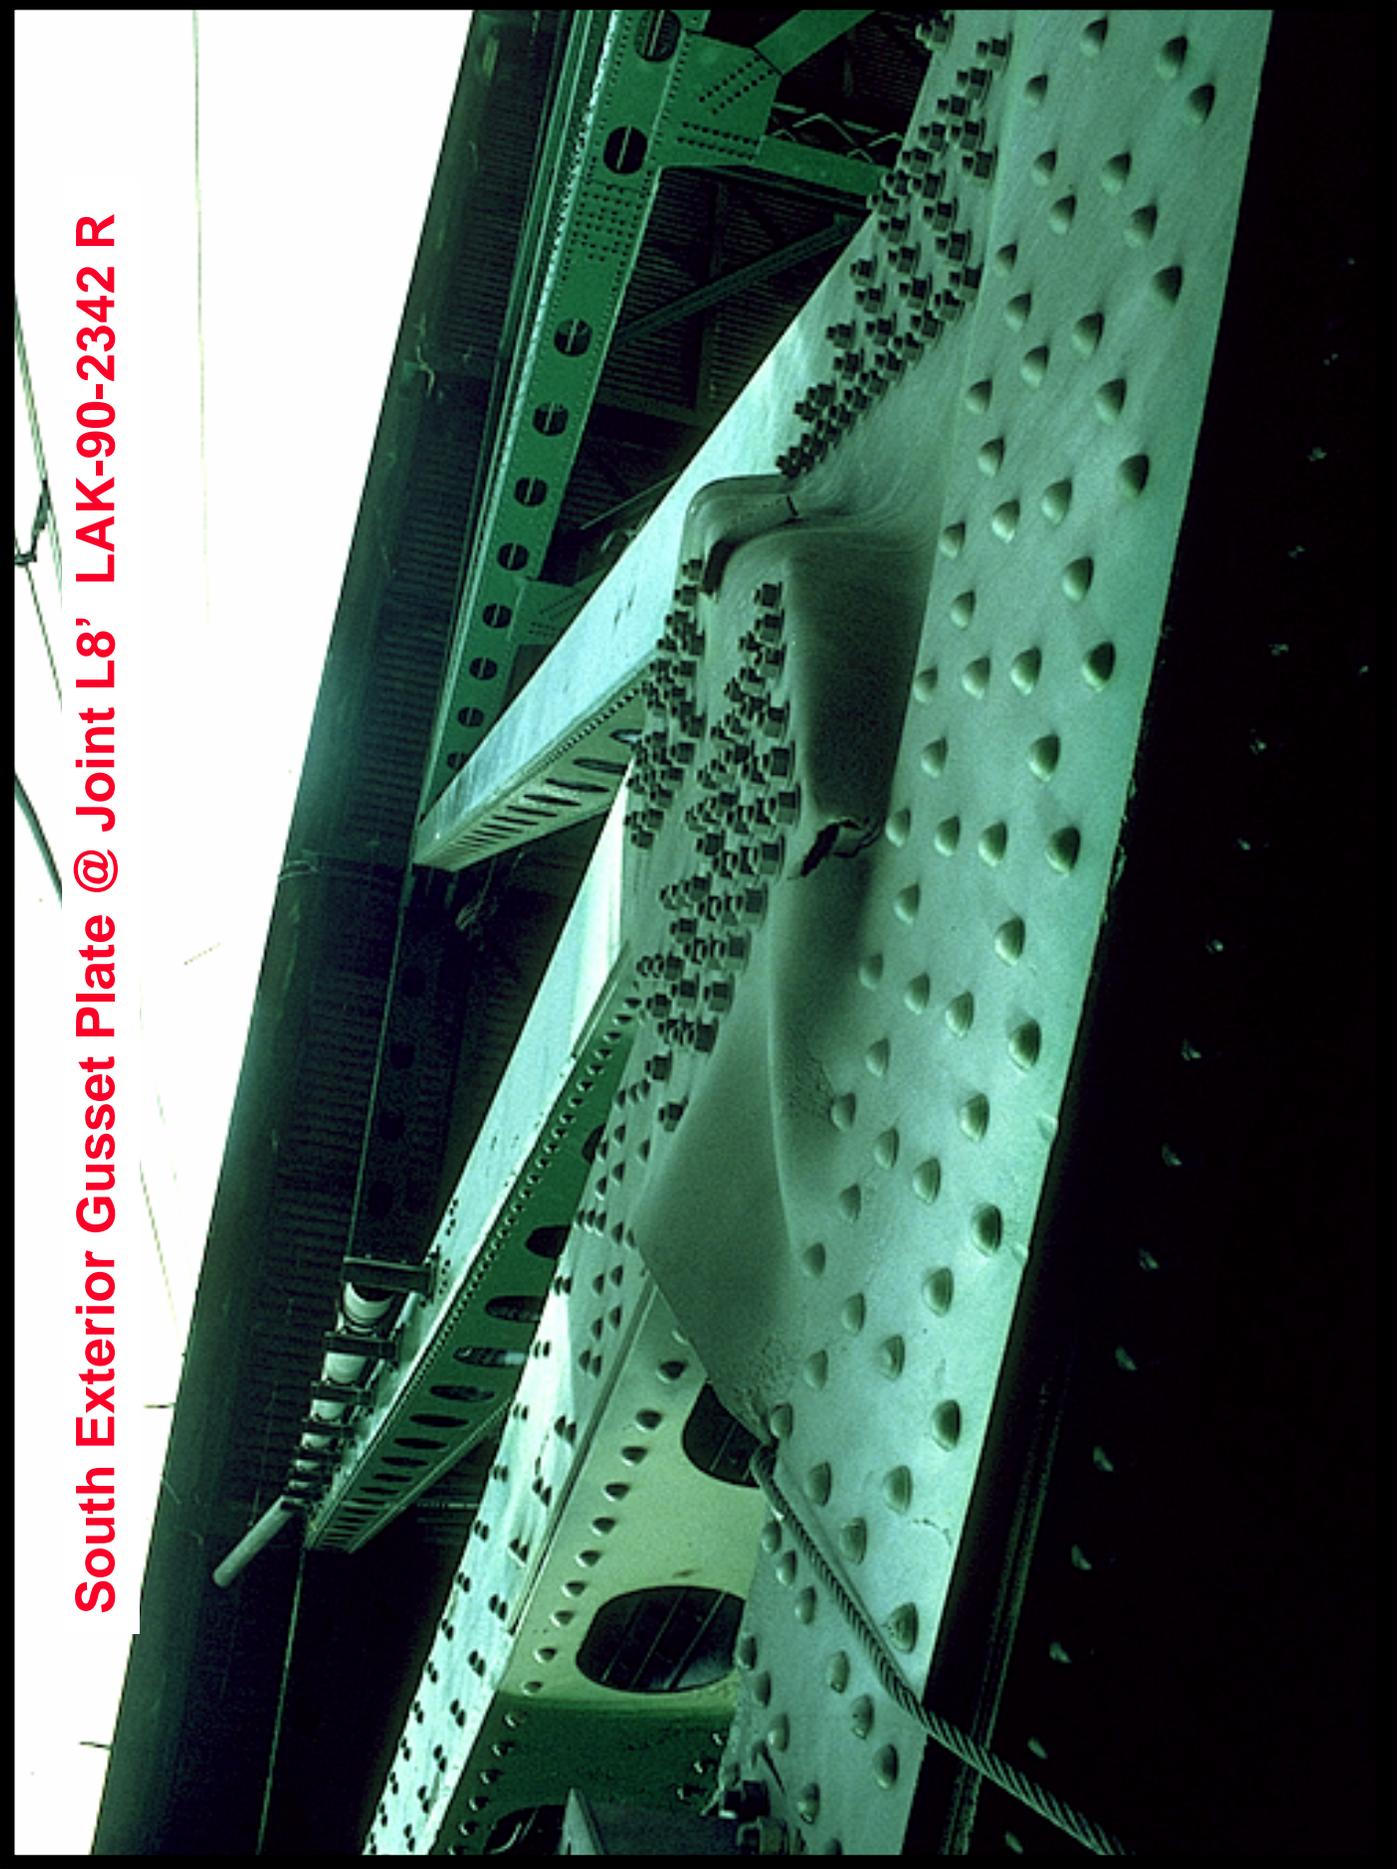
**South Exterior Gusset Plate @ Joint L8' LAK-90-2342 R**

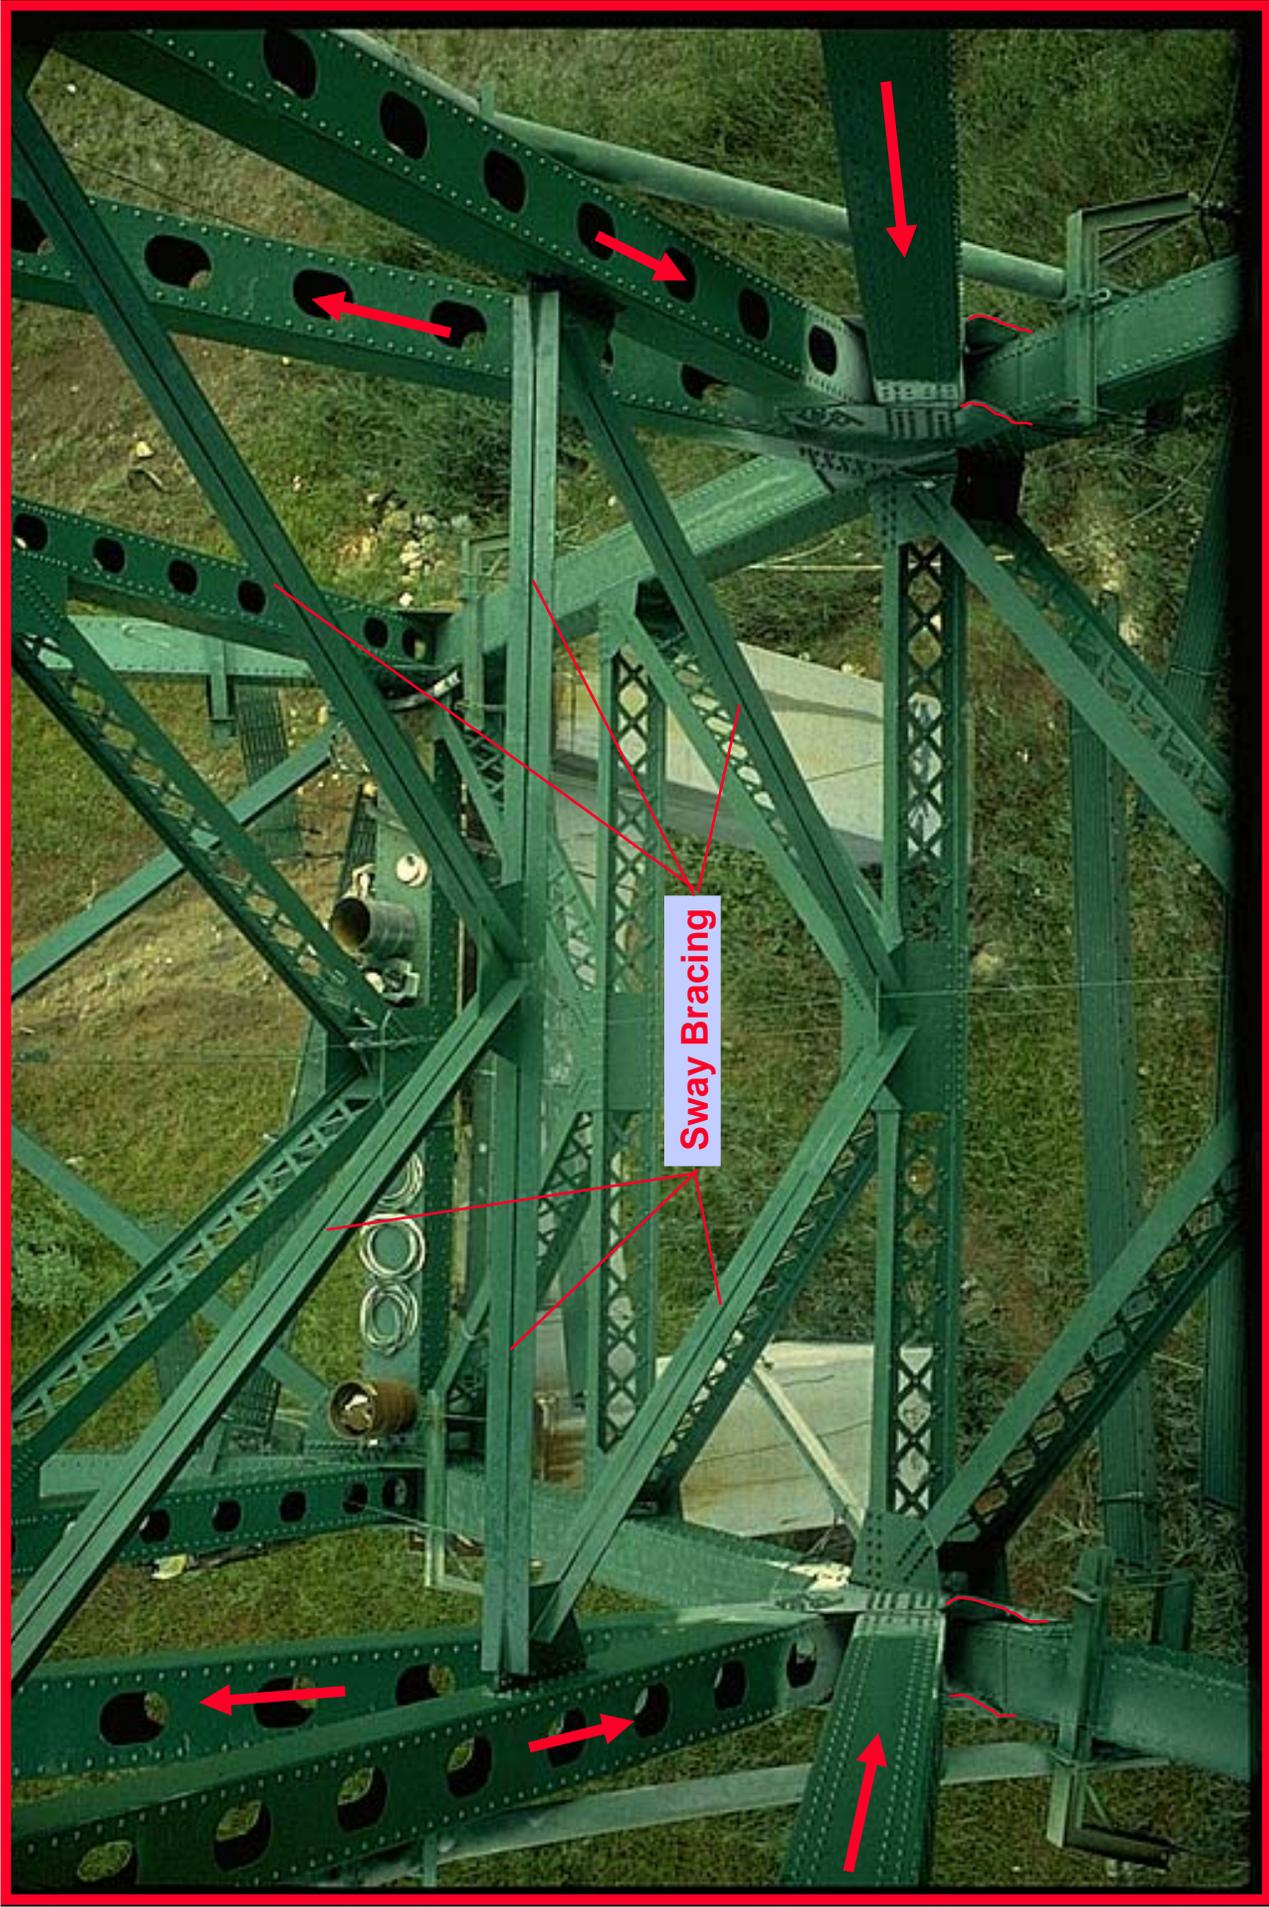
View of Failed Joints @ L8' Taken From Catwalk Below U9'

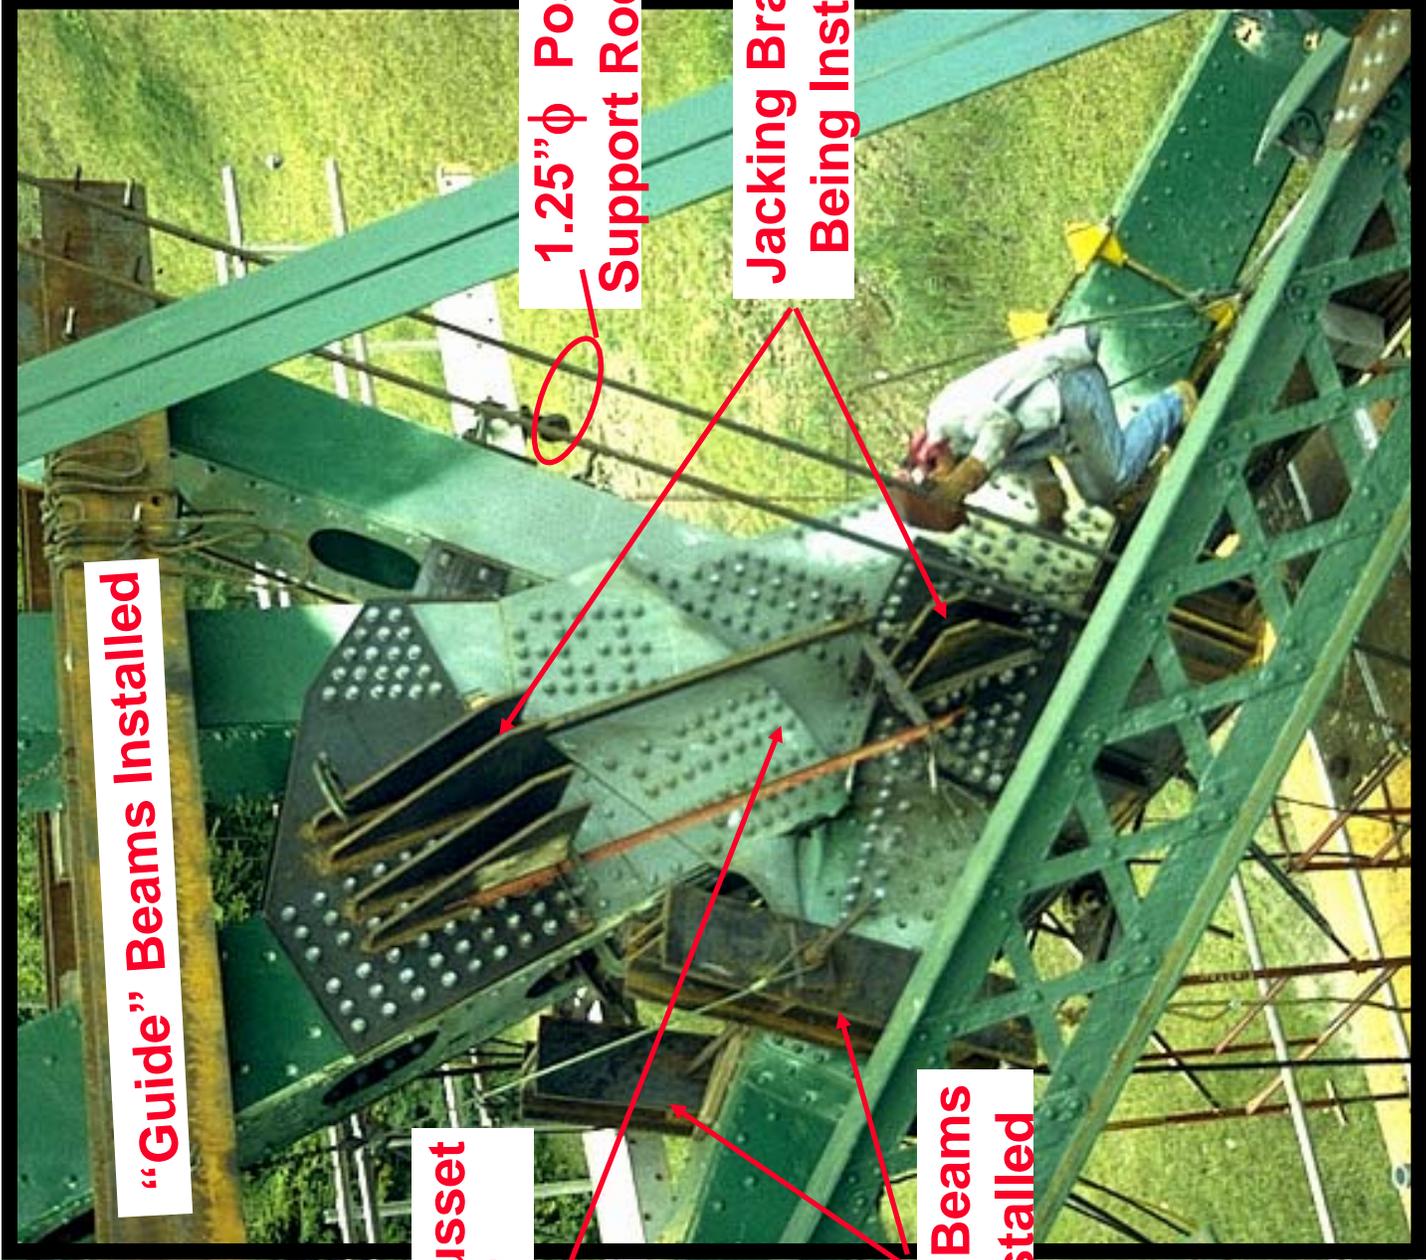
**Buckled Gusset Plate @ L8’**

**“Guide” Beams Installed**

**1.25” $\phi$  Post-Tensioned Support Rods @ L8’-U7’**

**Jacking Brackets Being Installed**

**“Clamp” Beams Being Installed**
