NATIONAL TRANSPORTATION SAFETY BOARD

MATERIALS LABORATORY FACTUAL REPORT

Report No. 08-054

Place : Mexican Hat, Utah
Date : January 7, 2008
Vehicle : MCI Motorcoach
NTSB No. : HWY08MH012
Investigator : Ron Kaminski

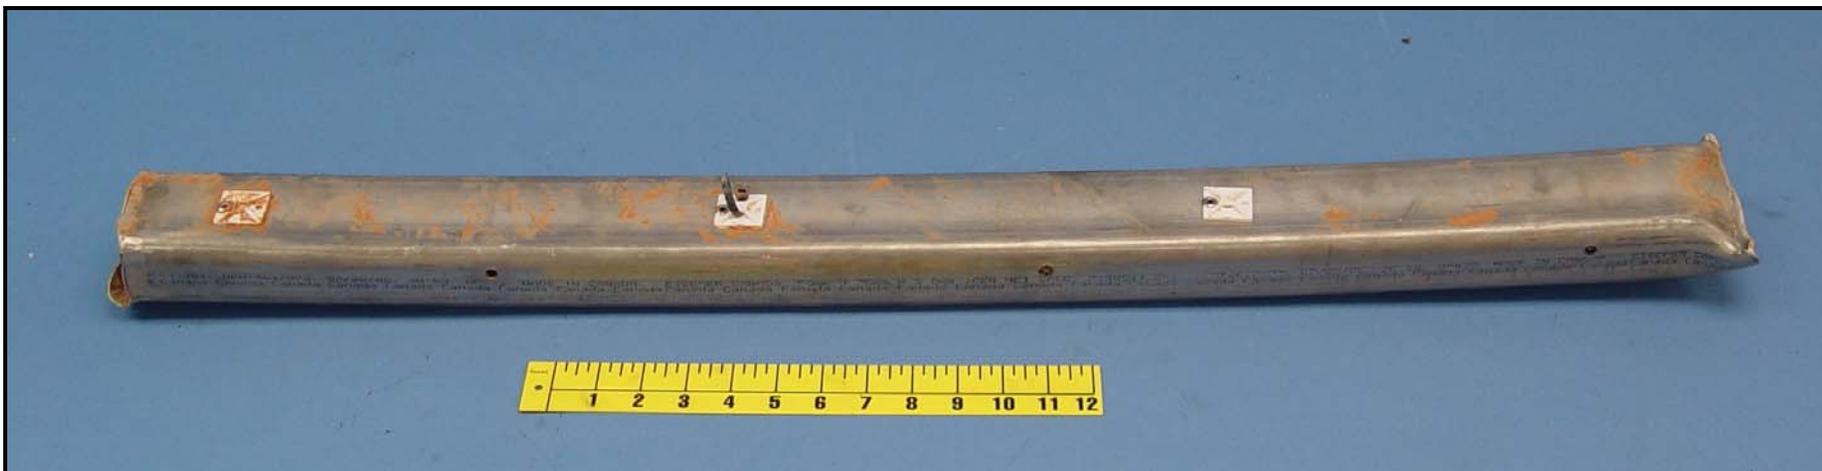
A portion of a window post, approximately 3 feet long, was submitted for examination, as shown in figure 1. The post had a hollow rectangular cross section. One end of the post (the end on the right in figure 1) contained an overstress bending/buckling fracture. The other end of the post (the end on the left in figure 1) was intact to where it was welded to a horizontal member. The welds were limited to the two longer sides of the rectangular cross section of the post. Fractures in the horizontal member were also typical of overstress separation. The portion of the post contained overall bowing deformation, as can be seen in figure 1.

Figure 1. Overall view of the portion of the window post submitted for examination.
