**HUMAN PERFORMANCE INVESTIGATION
FACTUAL REPORT
HWY-08-MH-012
Mexican Hat, Utah
January 6, 2008**

**NATIONAL TRANSPORTATION SAFETY BOARD
OFFICE OF HIGHWAY SAFETY
WASHINGTON, D.C. 20594
April 30, 2008**

**HUMAN PERFORMANCE INVESTIGATION
FACTUAL REPORT**

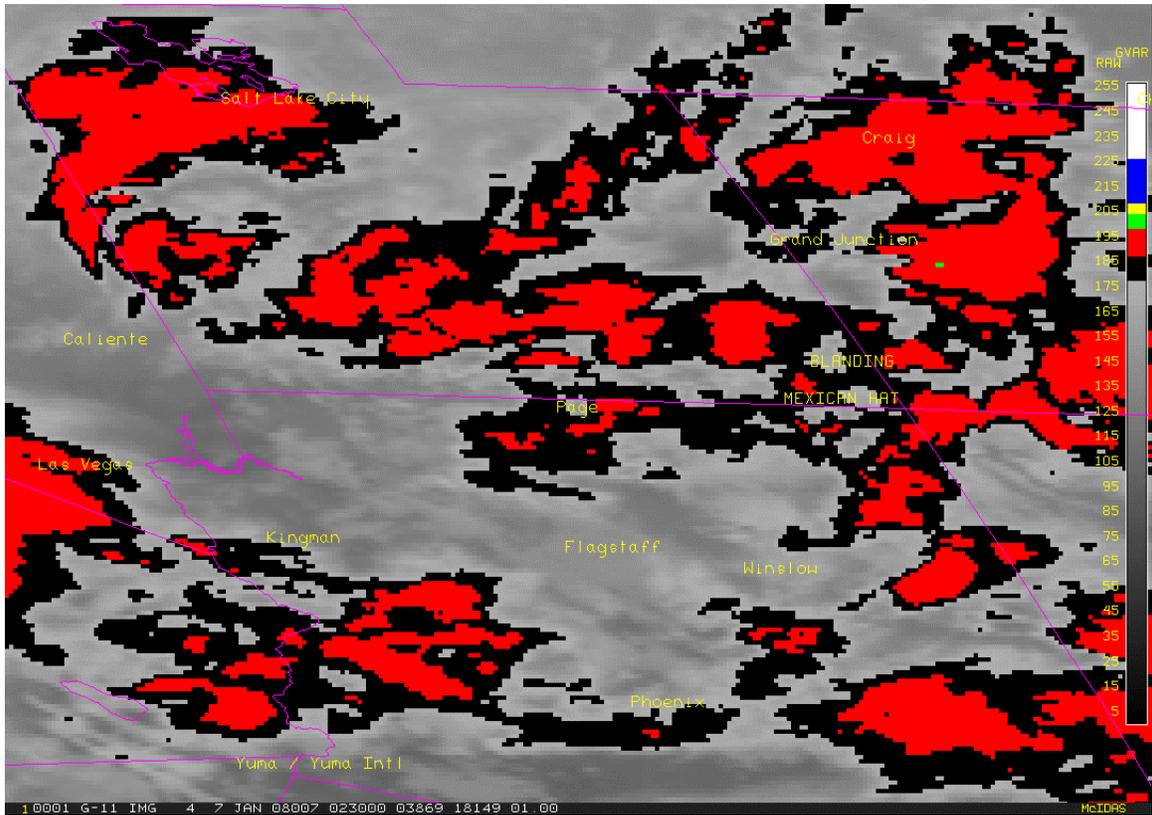
Regional radar images surrounding the period did not depict any significant weather echoes in the vicinity of the accident site surrounding the time of the accident, however drizzle is not depicted. Infrared satellite data depicts an area of cumulus clouds, indicated by enhanced red color, with higher tops capable of producing precipitation immediately north of Mexican Hat and between Blanding, see image below.
