HWY-08-M-H012  
Mexican Hat, Utah

# **Utah Highway Patrol - Vehicle Report**

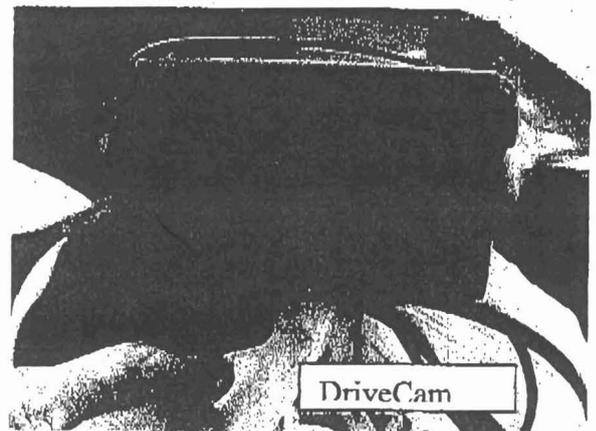
8. Todd Koehler, General Manager for Corporate Transportation 'N Tours, found the DriveCam and I took possession of it. The DriveCam is a video camera that is mounted on the driver's windshield and has two lenses. One lens is pointed toward the driver and the other lens is pointed toward the road. The DriveCam II Serial Number is: 03463906, and the Model Number: 2.5

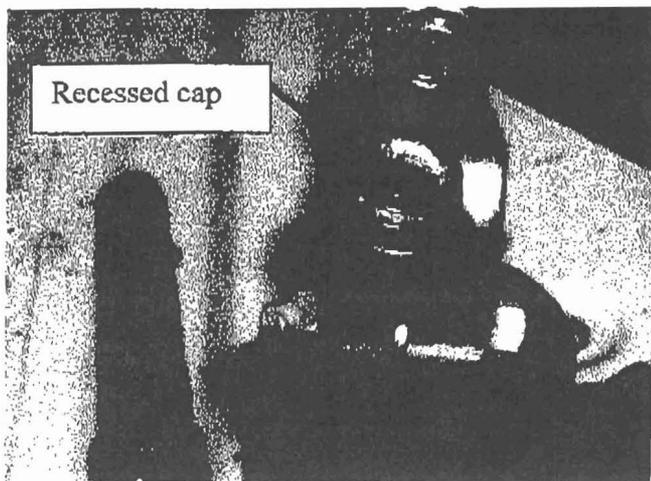
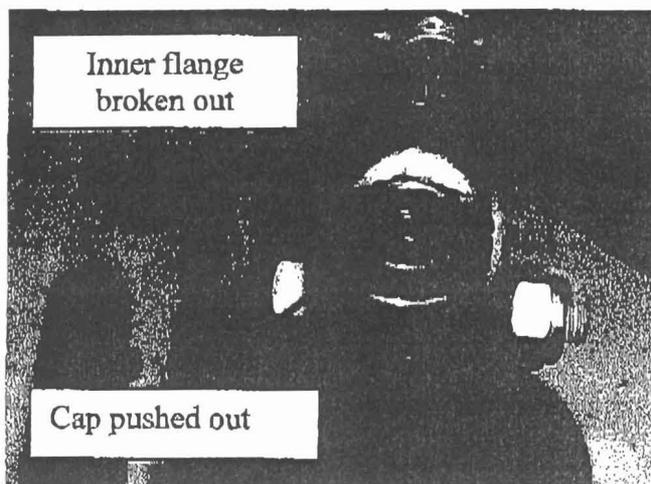
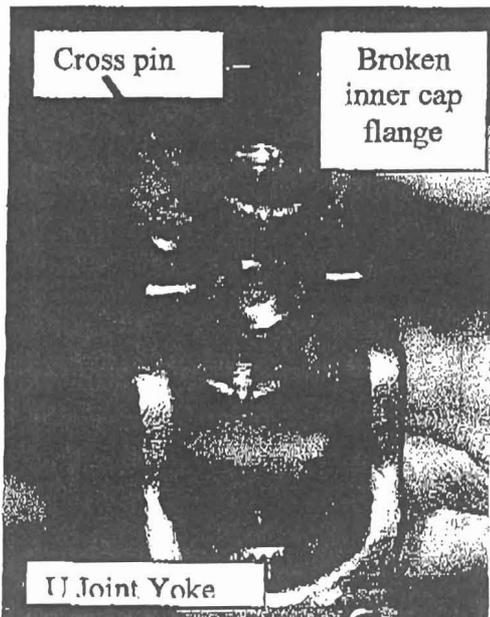
12. The Yoke has two caps that hold the cross pin into the yoke. These caps are normally recessed into the yoke. The one cap has been pushed outward, and the other cap has had part of the inner flange broken out.

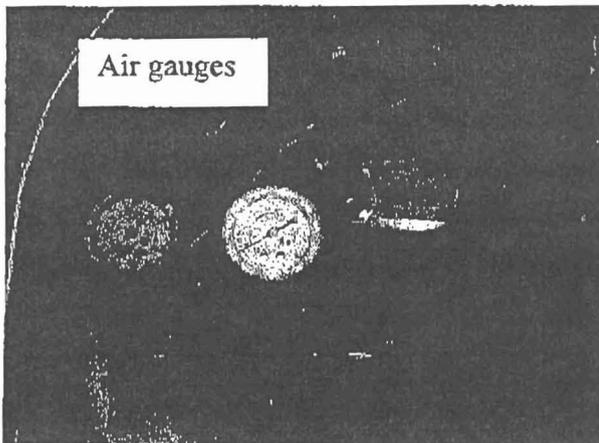
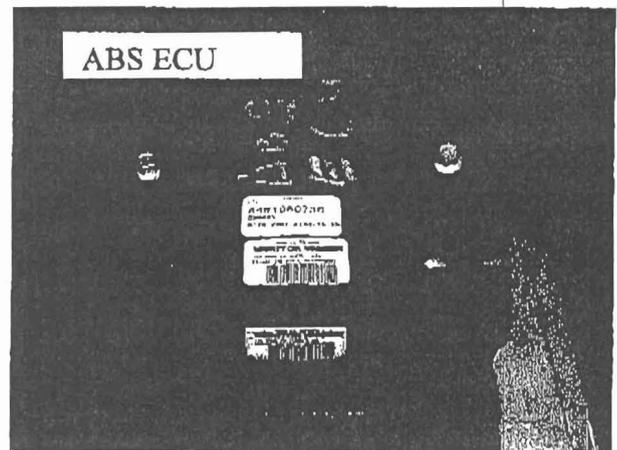
17. We hooked up some air gauges to the front and rear air brake system and noted that approximately 70 psi of air pressure remained in the system.
