**HIGHWAY FACTORS FACTUAL REPORT
MEXICAN HAT, UTAH 1/6/-8
HWY08-MH012
(16) PAGES**

**NATIONAL TRANSPORTATION SAFETY BOARD
OFFICE OF HIGHWAY SAFETY
WASHINGTON, D.C. 20594**

**HIGHWAY GROUP
FACTUAL INVESTIGATION NARRATIVE**

Type: Motorcoach, overturn
Date and Time: January 6, 2008, 8:02 p.m. MST
Location: Southbound US Rt. 163, near MP29
Mexican Hat, San Juan County, Utah
Vehicle #1: 2007 MCI Model J4500, 56-Passenger Motorcoach
Motor Carrier: BUSCO, Inc. DBA Arrow Stage Lines
Fatalities: 9
Injuries: 44
NTSB#: HWY-08-MH-012

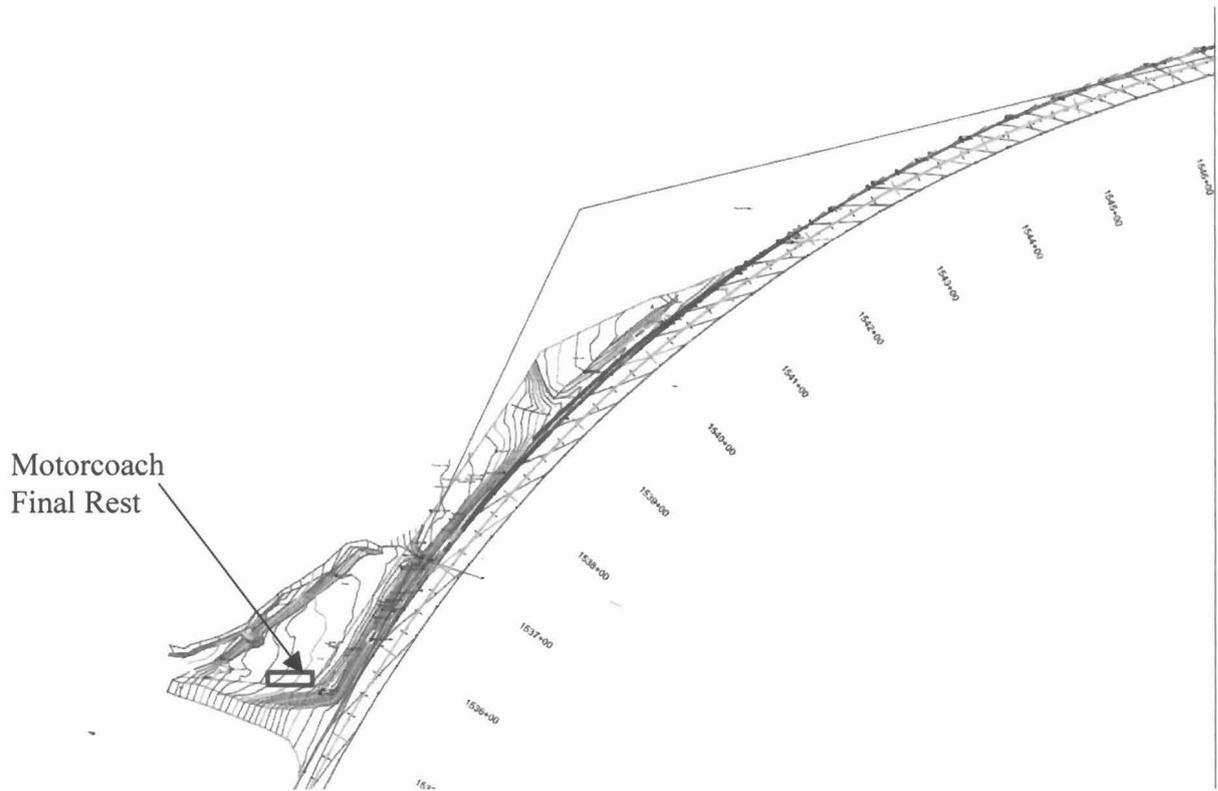
Figure 2.

On January 14-15, 2008, the NTSB, UDOT, and the Utah Highway Patrol used a total station and Tinco Satellite survey equipment to take precise measurements of the slope, roadway, dashed yellow lines, guardrail, tire marks, ground scars, and vehicle debris. (See Figures 2,3,4, Scene Diagrams with elevation contours and profiles below)

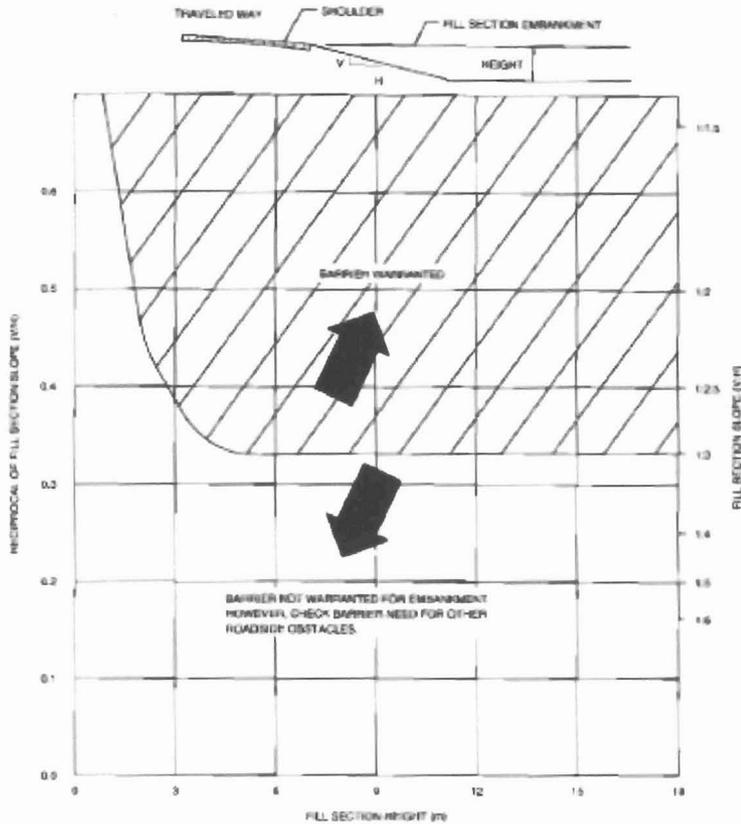
Figure 5.

These criteria are based on studies of the relative severity of encroachments on embankments versus impacts with roadside barriers. Embankments with slope and height combinations on or below the curve do not warrant shielding unless they contain obstacles within the clear zone. Figure 5.1 however, does not take into account either the probability of an encroachment occurring or the relative cost of installing a traffic barrier versus leaving the slope unshielded. The embankment at the accident location had several rocks and a drainage ditch on the downslope in the clear zone.

After reviewing the embankment, UDOT advised they would evaluate the box culvert area, and guardrail standards only if a reconstruction project was slated for this area.

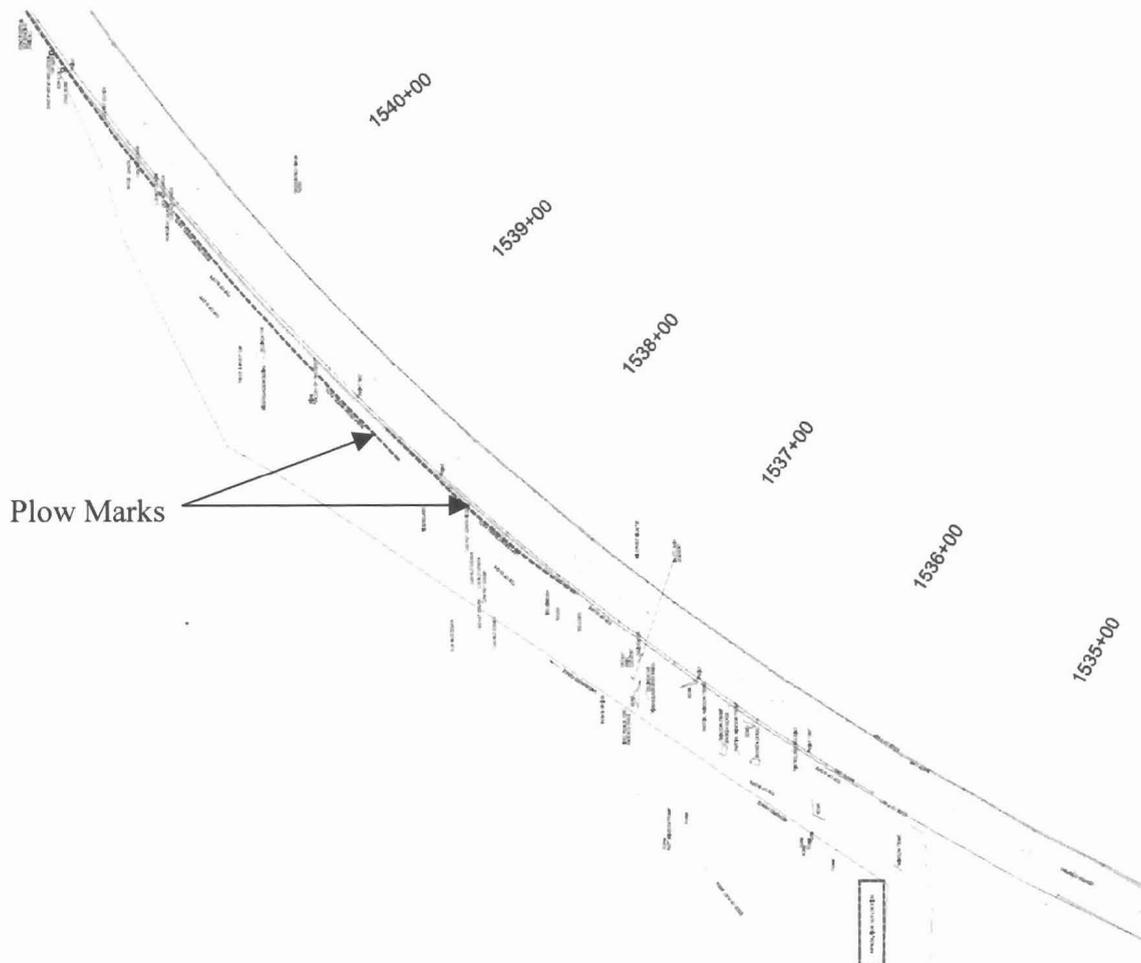
Figure 6.

Two sets of plow marks on the side slope showed the front tires were tracking near the top of the embankment and the rear tire furrows were farther down the embankment. One scar near the roadside showed the front of the bus impacted the ground with the bus angled at 37 degrees relative to the roadside. About 30 feet forward of that mark was an oval shaped indentation that was 7-foot-long by 5-foot-wide and 5 inches deep. This mark was next to the roadside where the front windshield was found. The other ground scars were photographed and measured by the Utah Highway Patrol. (See Figures 6, 7, Drawings Below)
