**SURVIVAL FACTORS GROUP FACTUAL REPORT**  
**(23 Pages)**

**Survival Factors Group Factual Report**

**NTSB File # HWY-08-MH-012**

Date and Time: January 6, 2008 at 8:02 p.m. MST  
Accident Type: Motorcoach Run off Roadway and Overturn  
Accident Location: Southbound US Rt. 163, near MP29  
Mexican Hat, San Juan County, Utah  
Vehicle #1: 2007 MCI Model J4500, 56-Passenger Motorcoach  
Motor Carrier #1: BUSCO, Inc, DBA Arrow Stage Lines  
Fatalities: 09  
Injuries: 44

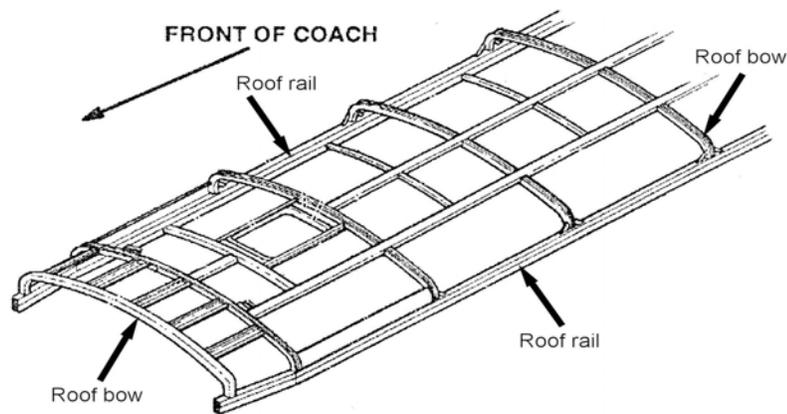
*Figure #1* Roof Structure

The roof panel was made of aluminum and was secured to the stainless steel roof bows using structural adhesive, however the edges of the panel and the periphery of the roof hatches were riveted. The roof had 5 longitudinal supports running from the front upper structure to the rear upper structure (See *Figure #1*). The roof was supported by 8 stainless steel post on each side, which extended from the belt rail to the roof rail (See *Figure #2*). The stainless steel tube vertical posts were welded at the belt rail and again at the roof rail (See *Figure #2*). Although not a single continuous tube, these 8 vertical posts continue across the roof becoming roof bows.

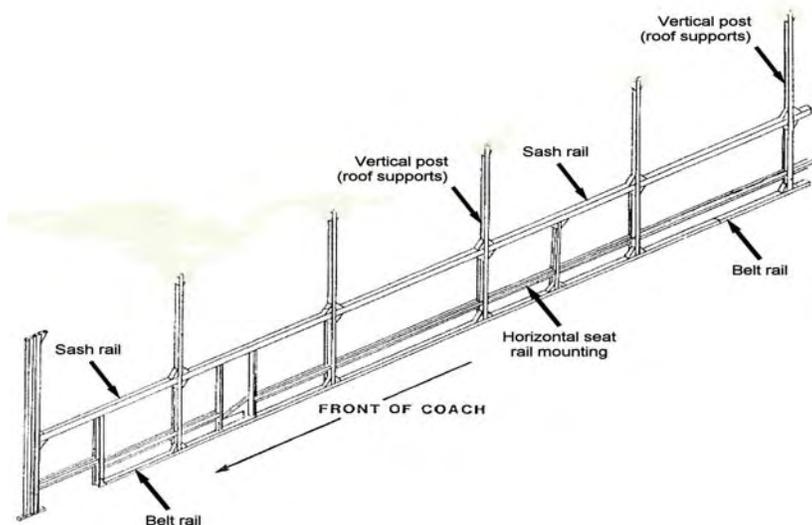
*Figure #2.* Side wall structure

The roof of the vehicle sustained catastrophic damage from rolling over. As previously mentioned, the roof became detached from the body at the sash rail (See *Figure #2*) along the entire right side and vertical support post of the window on the left side, pushing the majority of the left passenger sidewall outward.
