**SHERMAN, TEXAS FATAL MOTOR COACH ACCIDENT
HIGHWAY FACTORS FACTUAL REPORT
AUGUST, 08, 2008
HWY-08-MH022
(18 Pages)**

**HIGHWAY FACTORS GROUP CHAIRMAN'S
FACTUAL REPORT**

NTSB #: HWY-08-MH-022

Description: Run Off Roadway Bridge and Rollover

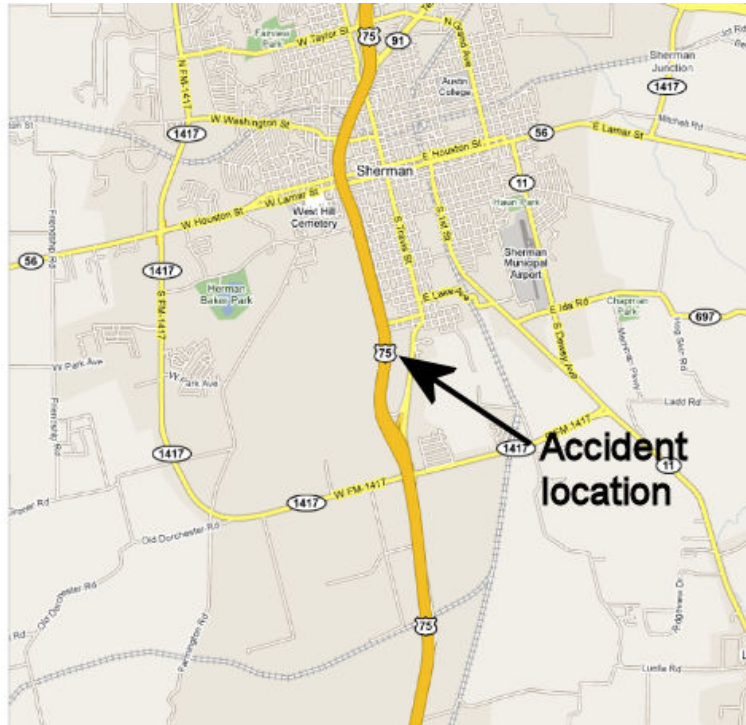
Figure 1 - Accident location

About ½ mile south of the accident site a curved right descent began; the design plan profile showed the roadway had a 3.75 percent downgrade for 1600 feet in a 2.3 degree curve to the right that was 1,389 feet long. Next, the roadway became tangent or straight for a short distance and then a 1.5-degree, left-hand curve, 768-foot-long began (see Figure 1).

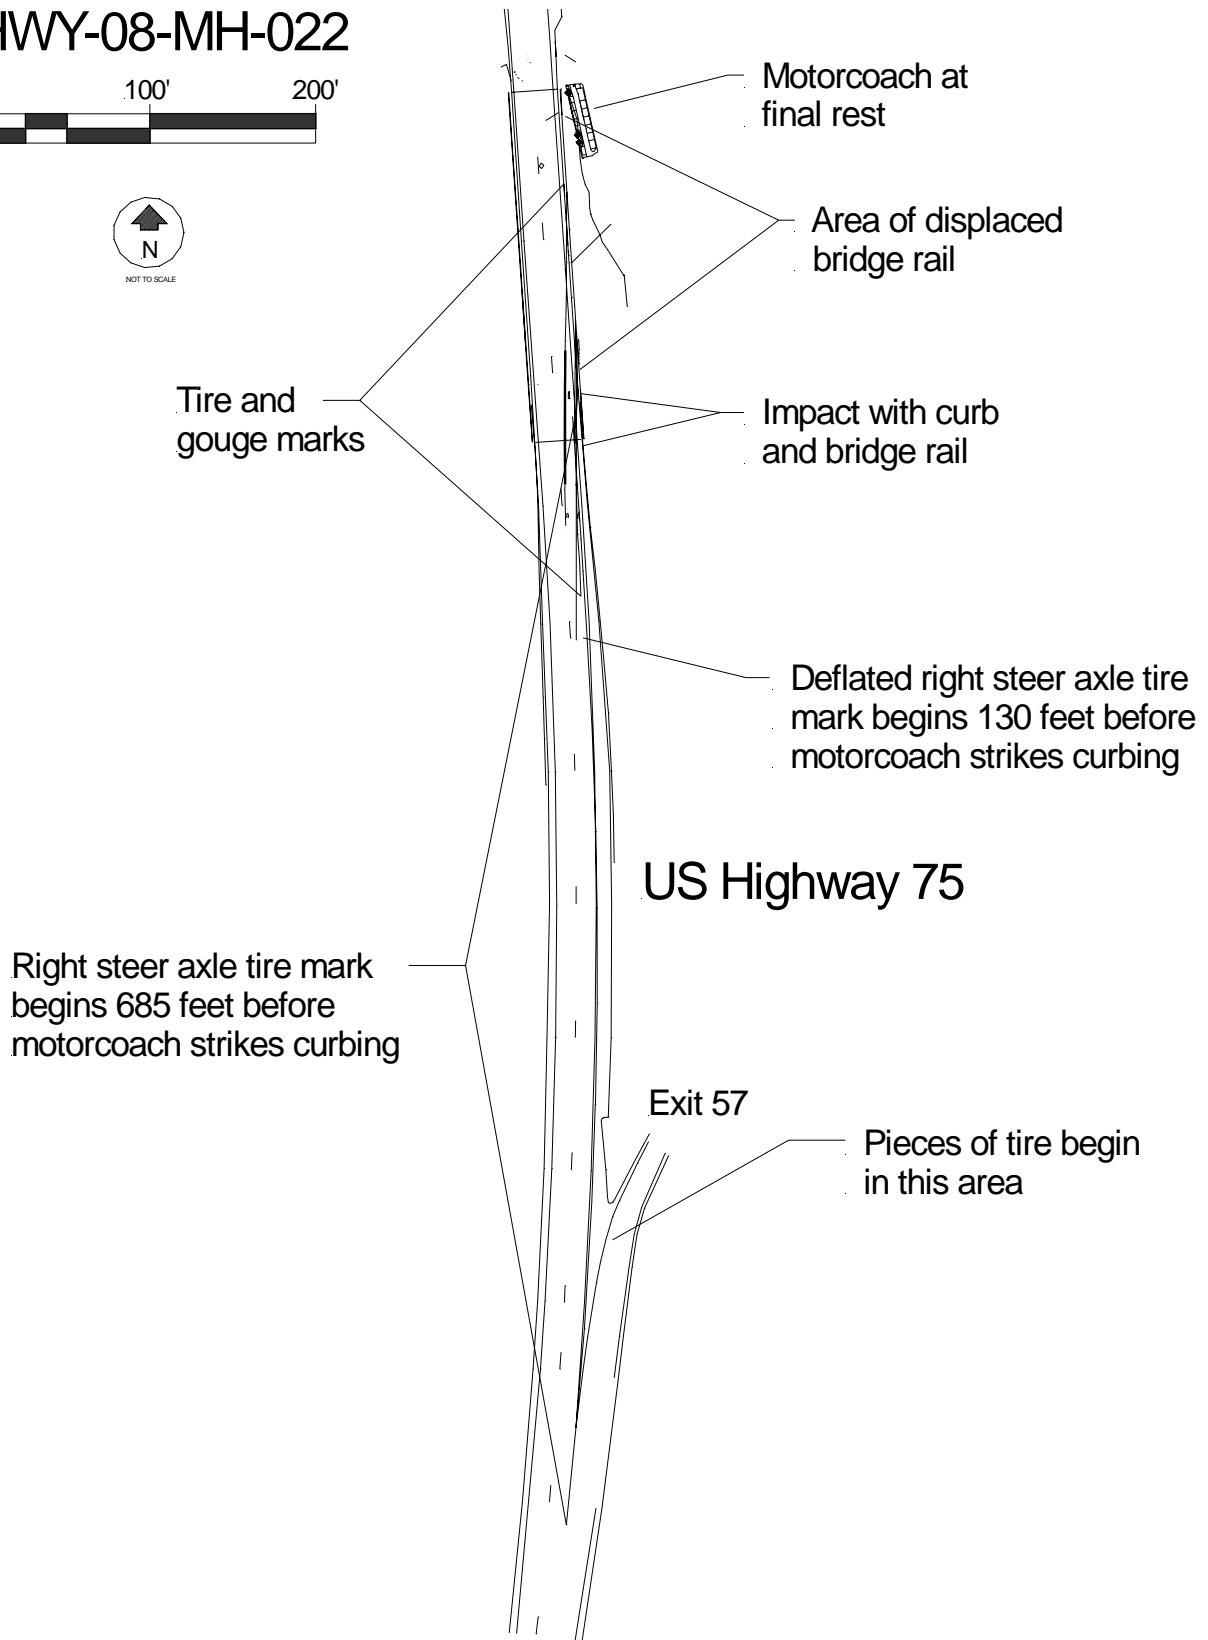
Figure 2 - Map of Accident Scene

Following the collision, the accident scene and related physical evidence was examined and evaluated by members of the Sherman, TX Police Department (SPD). Using a total station, the accident scene was documented by the SPD, and the SPD was contacted and a request was made for the data obtained during their mapping of the accident scene, see Figure 2. Based on data obtained from the Engine Control Module (ECM) in the Vehicle Group Chairman's report the relative time and distance from the beginning of the tire mark to the impact with the bridge rail was determined, see Figure 3.
