**National Transportation Safety Board  
Washington, DC**

**Engineering Group Chairman's  
Factual Report**

February 6, 2001

Location: Juneau, Alaska  
Date: June 6, 2000  
Time: 1207 Alaska daylight time (ADT)  
Vessel: *M/V Columbia*  
Case number: DCA-MM-00-030

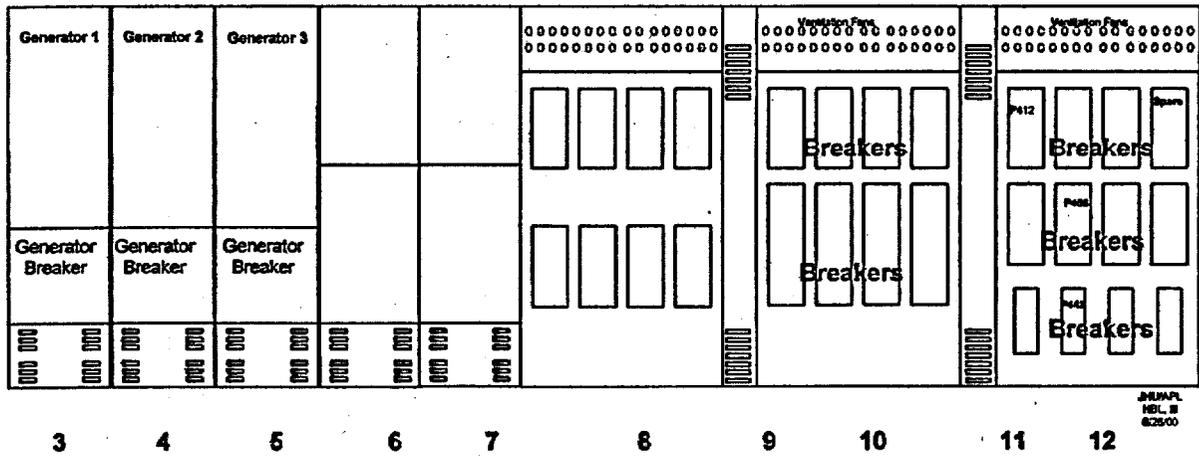
Figure 2 Outline view of main switchboard, showing arrangement of units 3 through 12

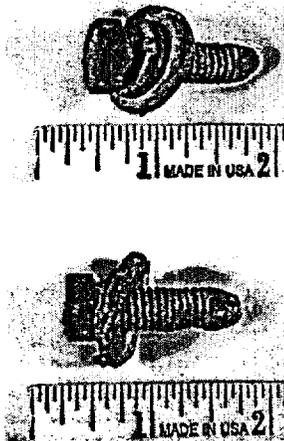
A 3/8 inch diameter by 1-1/4 inch long steel bolt with an oversized flat washer and a lock washer (the washers appeared to be attached to the bolt by melting) was found to the left and behind and just below the line side connections of breaker P442 on an angle support bracket. Arcing, melting, or spatter marks were present on the bolt and washer. The bolt found near breaker P442 was of the same size and had the same washer arrangement as those bolts used to connect the tulip clip post to the angle bracket.

9.2.2. **Significant findings.** The material between the bolt and the washer of the subject bolt was determined to be copper. The report makes no conclusions regarding the metallurgical conditions found, and any conclusions made will be discussed in the engineering analytical report.

**Figure 4** Bolt found on front (aft side) framework of switchboard

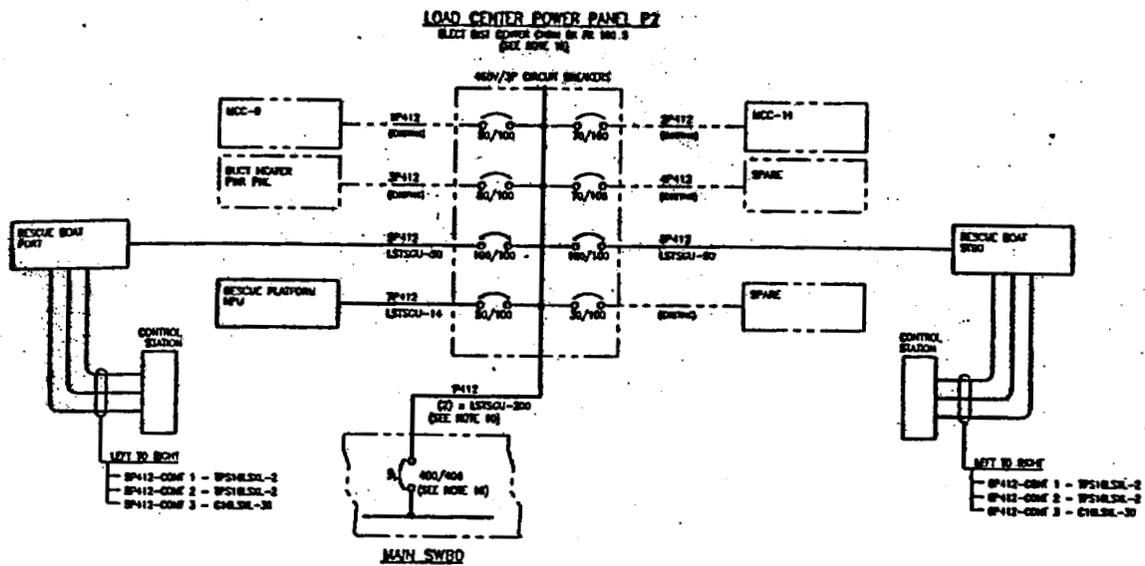
The work item that required entry into the main switchboard was the installation of rescue boat on the boat deck. The davits for the rescue boats required an electric source of power – they had electric motors and related controls. The source of this power was power panelboard P2, located outside the near the emergency diesel generator room. (See figure 6). The pre-existing P2 panelboard was inadequate in size to handle the additional loads, so the panelboard was upgraded (changed-out) to allow the addition of more breakers (to support additional new circuits to be supplied to the rescue boats). The Coast Guard approved changes to electrical system drawing.<sup>3</sup> Since the original panelboard P2 was only a 200-amp panel, there was a need to run an additional source of power in parallel with the existing power cable to supply the additional 200 amps. Upgrade of power service to P2 panelboard required the connection of the new cable to a breaker mounted on unit 12 of main switchboard. The new 200A cable entered the main switchboard at the unit 10, on forward side (rear) of the switchboard. The new cable was connected to the existing breaker base (circuit P412). Since the shipyard electricians did not have the cable connector lugs to connect the cable to the base stabs, they removed the connector lugs from the spare breaker base located at the upper right corner of unit 12. The cable that they removed the connectors from was secured to the rear of the main switchboard with nylon cable ties.

Figure 5. Modifications to main switchboard and electrical system done by shipyard during federal project. Electrical One Line Drawing Modifications, Dwg. No. 00008-6-8050 Rev.-, page 2.

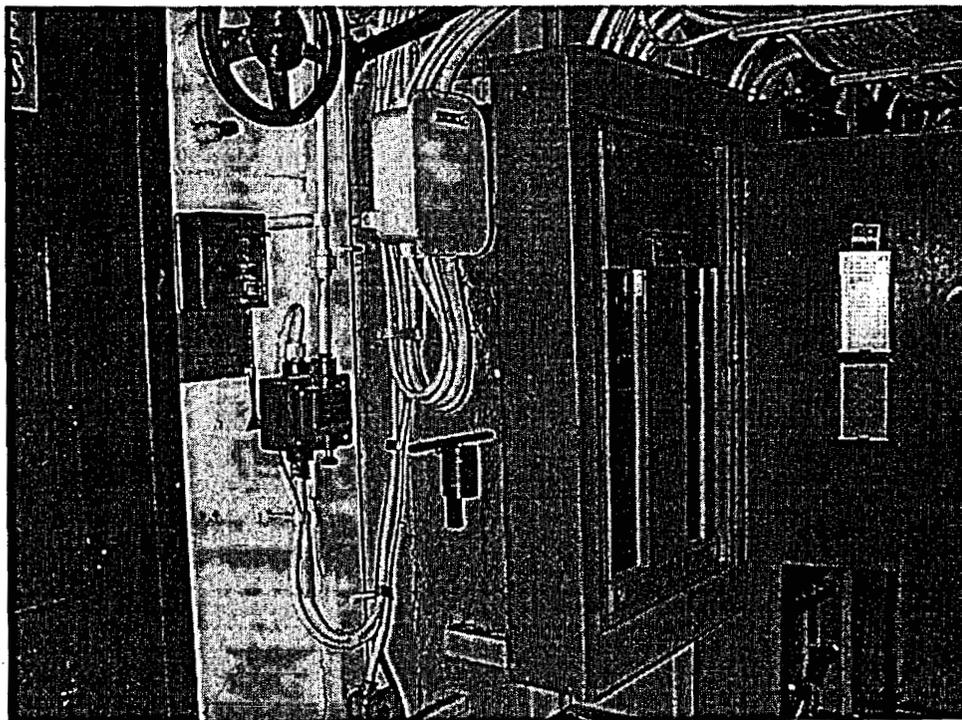
Figure 6 Power panelboard P2 installed during shipyard period
