NATIONAL TRANSPORTATION SAFETY BOARD

MATERIALS LABORATORY FACTUAL REPORT

Report No. 03-015

Place : Everglade City, Florida
Date : December 30, 2002
Vehicle : Tour boat: Panther
NTSB No. : DCA03MM018
Investigator : Robert Ford

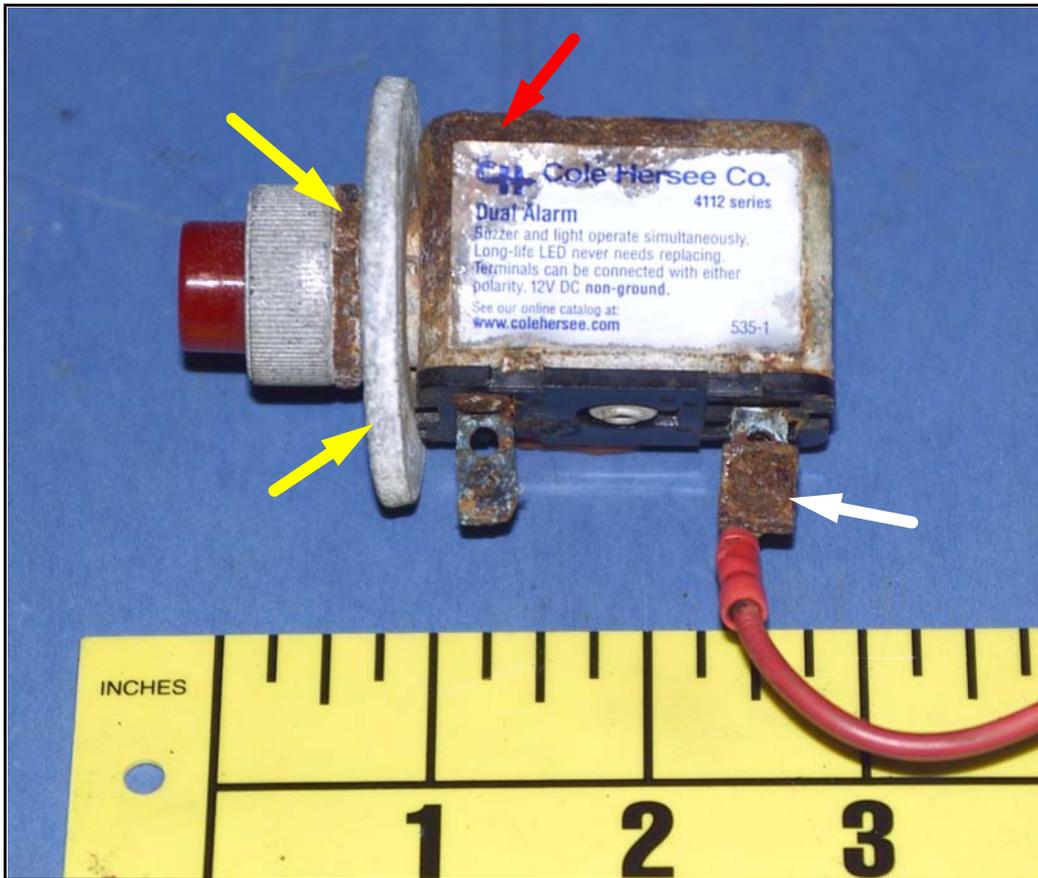
The dual alarm submitted for a function test is illustrated in figure 1. The label on the side of the alarm identified it as a Cole Hersee dual alarm, 4112 series, which buzzes and illuminates the red light when the alarm is activated. Examination of the alarm revealed significant corrosion on the metal case, indicated by the red arrow in figure 1, and on the attaching hardware, indicated by the yellow arrows in figure 1. The white arrow in figure 1 indicates a heavily corroded screw and cable connector on one of the alarm's terminals.

The manufacturer's specification sheet for the 4112 series of dual alarms indicates that it operates on 12 volts DC. A suitable supply was connected to the terminals and the circuit produced was switched on. The light illuminated and the buzzer sounded, indicating that the alarm was functioning.

Figure 1. The dual alarm submitted for examination and functional testing with the arrows indicating various degrees of corrosion.
