NATIONAL TRANSPORTATION SAFETY BOARD

MATERIALS LABORATORY FACTUAL REPORT

Report No. 03-099

Place : Everglade City, Florida
Date : December 30, 2002
Vehicle : Tour boat "Panther"
NTSB No. : DCA03MM018
Investigator : Robert Ford

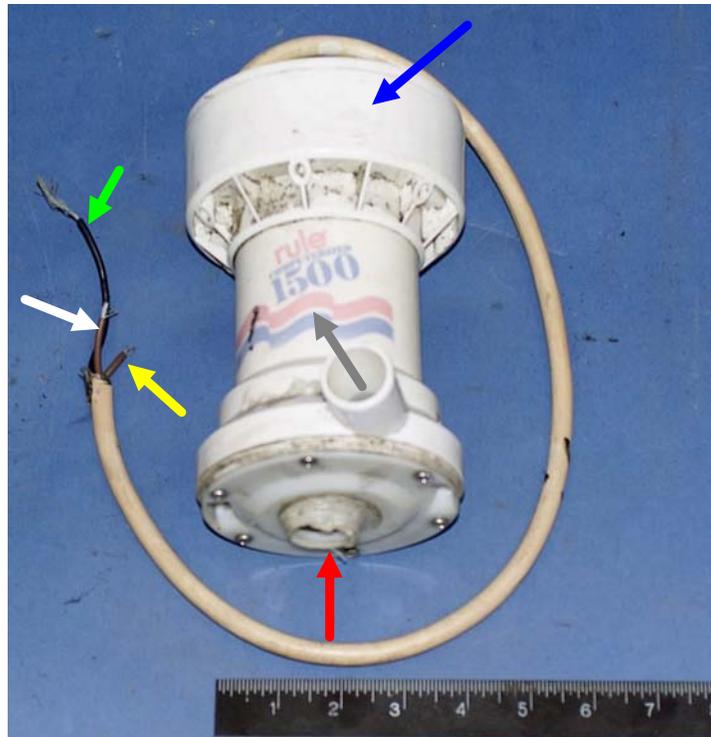
The body of the bilge pump submitted for examination identified it as a "rule computerized 1500" (manufactured by Rule Industries) as illustrated in figure 1. The upper cap, where the electrical cord entered the pump, was flat and displayed the identifications "submersible bilge pump", "fully automatic", "rule 12 vdc" and "self contained computer switch". A web search revealed that this pump operated on the principle of impeller resistance. The pump switches itself on every 2¹/₂ minutes for about one second to check for water. If water is present the pump senses the resistance and continues to run until the water is removed. The pump then returns to its 2¹/₂ minute checking routine.

Examination of the lower portion of the pump revealed a housing containing an impeller. Water would be induced into the intake, indicated by the red arrow in figure 1, and expelled out of the outlet, indicated by the gray arrow in figure 1. The impeller rotated freely in the housing and the housing contained no debris or projections to impede water flow. The center of the intake was offset approximately 1/4-inch to the center of the impeller and displayed an uneven swirled pattern on its inner and outer surfaces.

The electrical cord contained the three conductors colored black, brown and brown/white that are indicated in figure 1 by the green, yellow and white arrows respectively. Contact with a Rule Industries representative revealed that the black conductor was the ground, the brown conductor was the power and the brown/white conductor was the power wire to an alarm, which indicates that the pump is operating. The pump was tested by applying a 12-vdc supply to the black and brown conductors, and it did not operate.

Figure 1. The Rule 1500 bilge pump received for examination.

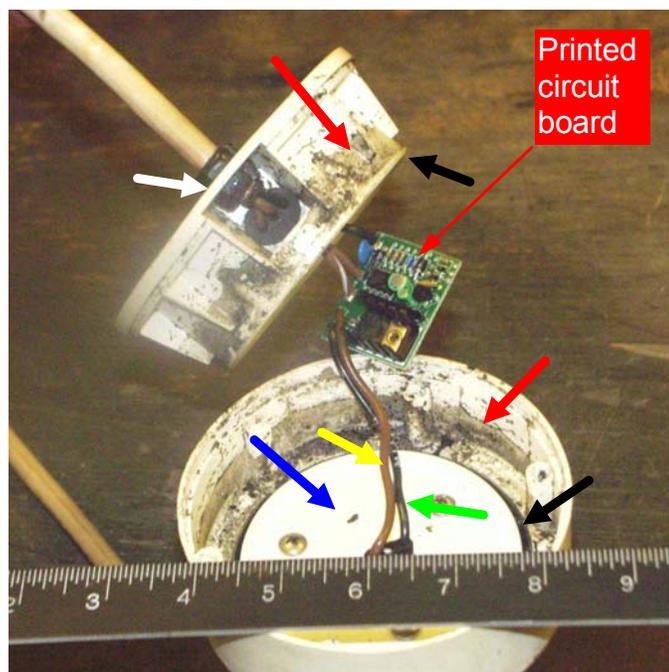
The upper cap was removed to reveal the printed circuit board (PCB) that controlled the pump. Examination of the PCB revealed that the three conductors (black, brown and brown/white) in the electric cord were firmly attached. Two other conductors, colored black and brown, were also firmly attached to the PCB and continued into the pump body. The PCB is identified in figure 2. A 12-vdc supply was connected to the two other conductors indicated by the green and yellow arrows in figure 2 and the pump motor operated.

Examination of the PCB cavity surface, indicated by the blue arrow in figure 2, revealed that it was dry and displayed no indications of immersion. An annular chamber around the PCB cavity did display indications of immersion as indicated by the red arrows in figure 2. The white arrow indicates a snap-in cord grip fitting retaining the electrical cord in the upper cap. Such fittings provide strain-relief for the cord in applications that do not require a moisture proof seal. The annular chamber is isolated from the PCB cavity when the upper cap is installed and the lower edge of the upper cap, indicated by the black arrow, contacts the seal in the pump body, also indicated by a black arrow.

Figure 2. The disassembled upper portion of the pump indicated by the blue arrow in figure 1.
