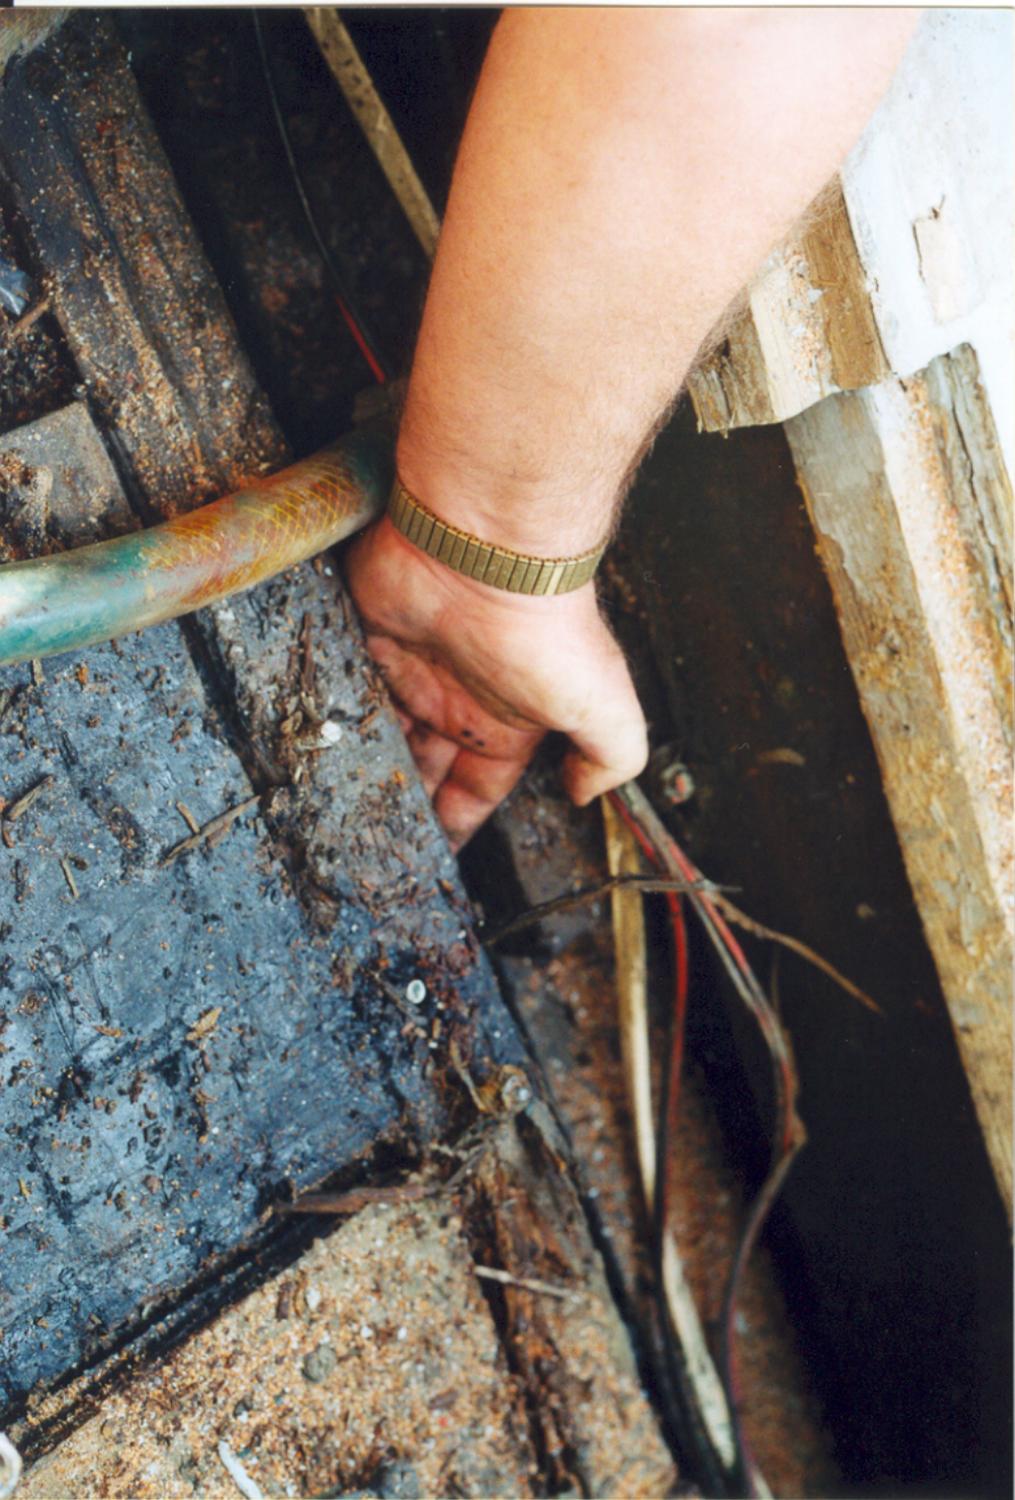
Photo of defected stringer
