TEST REPORT

WR116 - 90/142

S/S "NORWAY"

Upper Drum

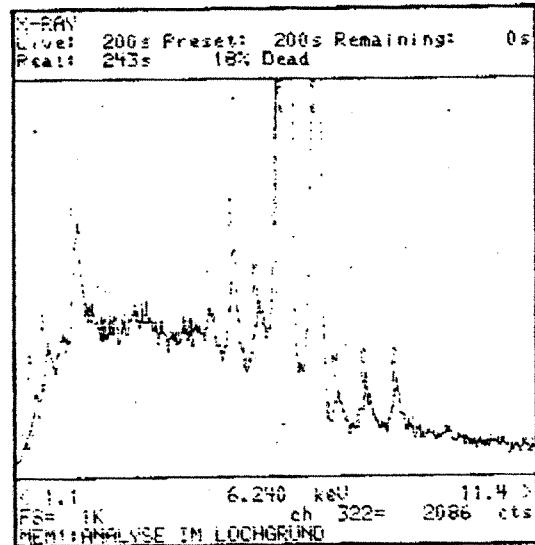
The chip was tested in the electron scan microscope with attached energy-dispersive X-ray analysis system. View of the corroded areas is given in enclosure #1. Various analyses were done in the pitting ground in way of the corrossions. It was found that the corrosion products, which mainly consisted of ferrous oxides, were accompanied by the elements sulfur, vanadium, chromium, nickel, copper and zinc as non-typical iron associates (enclosure #2).
