NATIONAL TRANSPORTATION SAFETY BOARD
Office of Research and Engineering
Washington, D.C. 20594

Vehicle Performance Factual

NTSB Number:	DCA04MM015
Description:	Capsizing of small passenger ferry
Location:	Northwest Harbor, Baltimore, Maryland
Date:	March 6, 2004
Time:	~1600 EST
Vessel:	M/V Lady D, fully enclosed pontoon boat
Operator:	Seaport Taxi (Living Classrooms Foundation)

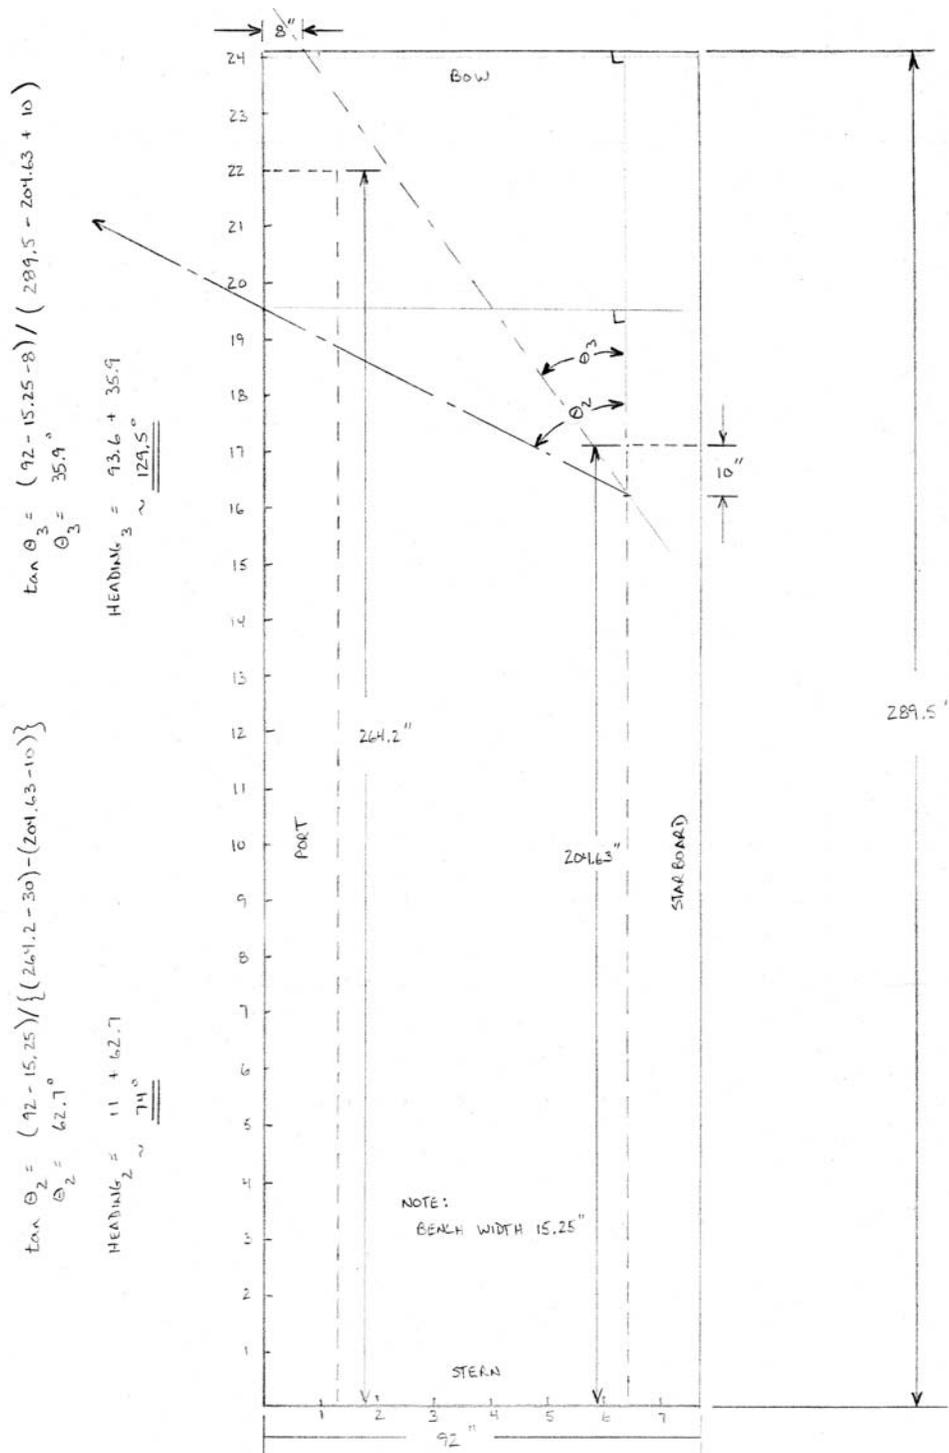
Figure 6: Vessel heading estimates based on 2 passenger photographs taken during the Lady D accident voyage, reconstructed passenger cabin dimensions, and known passenger seating arrangement.

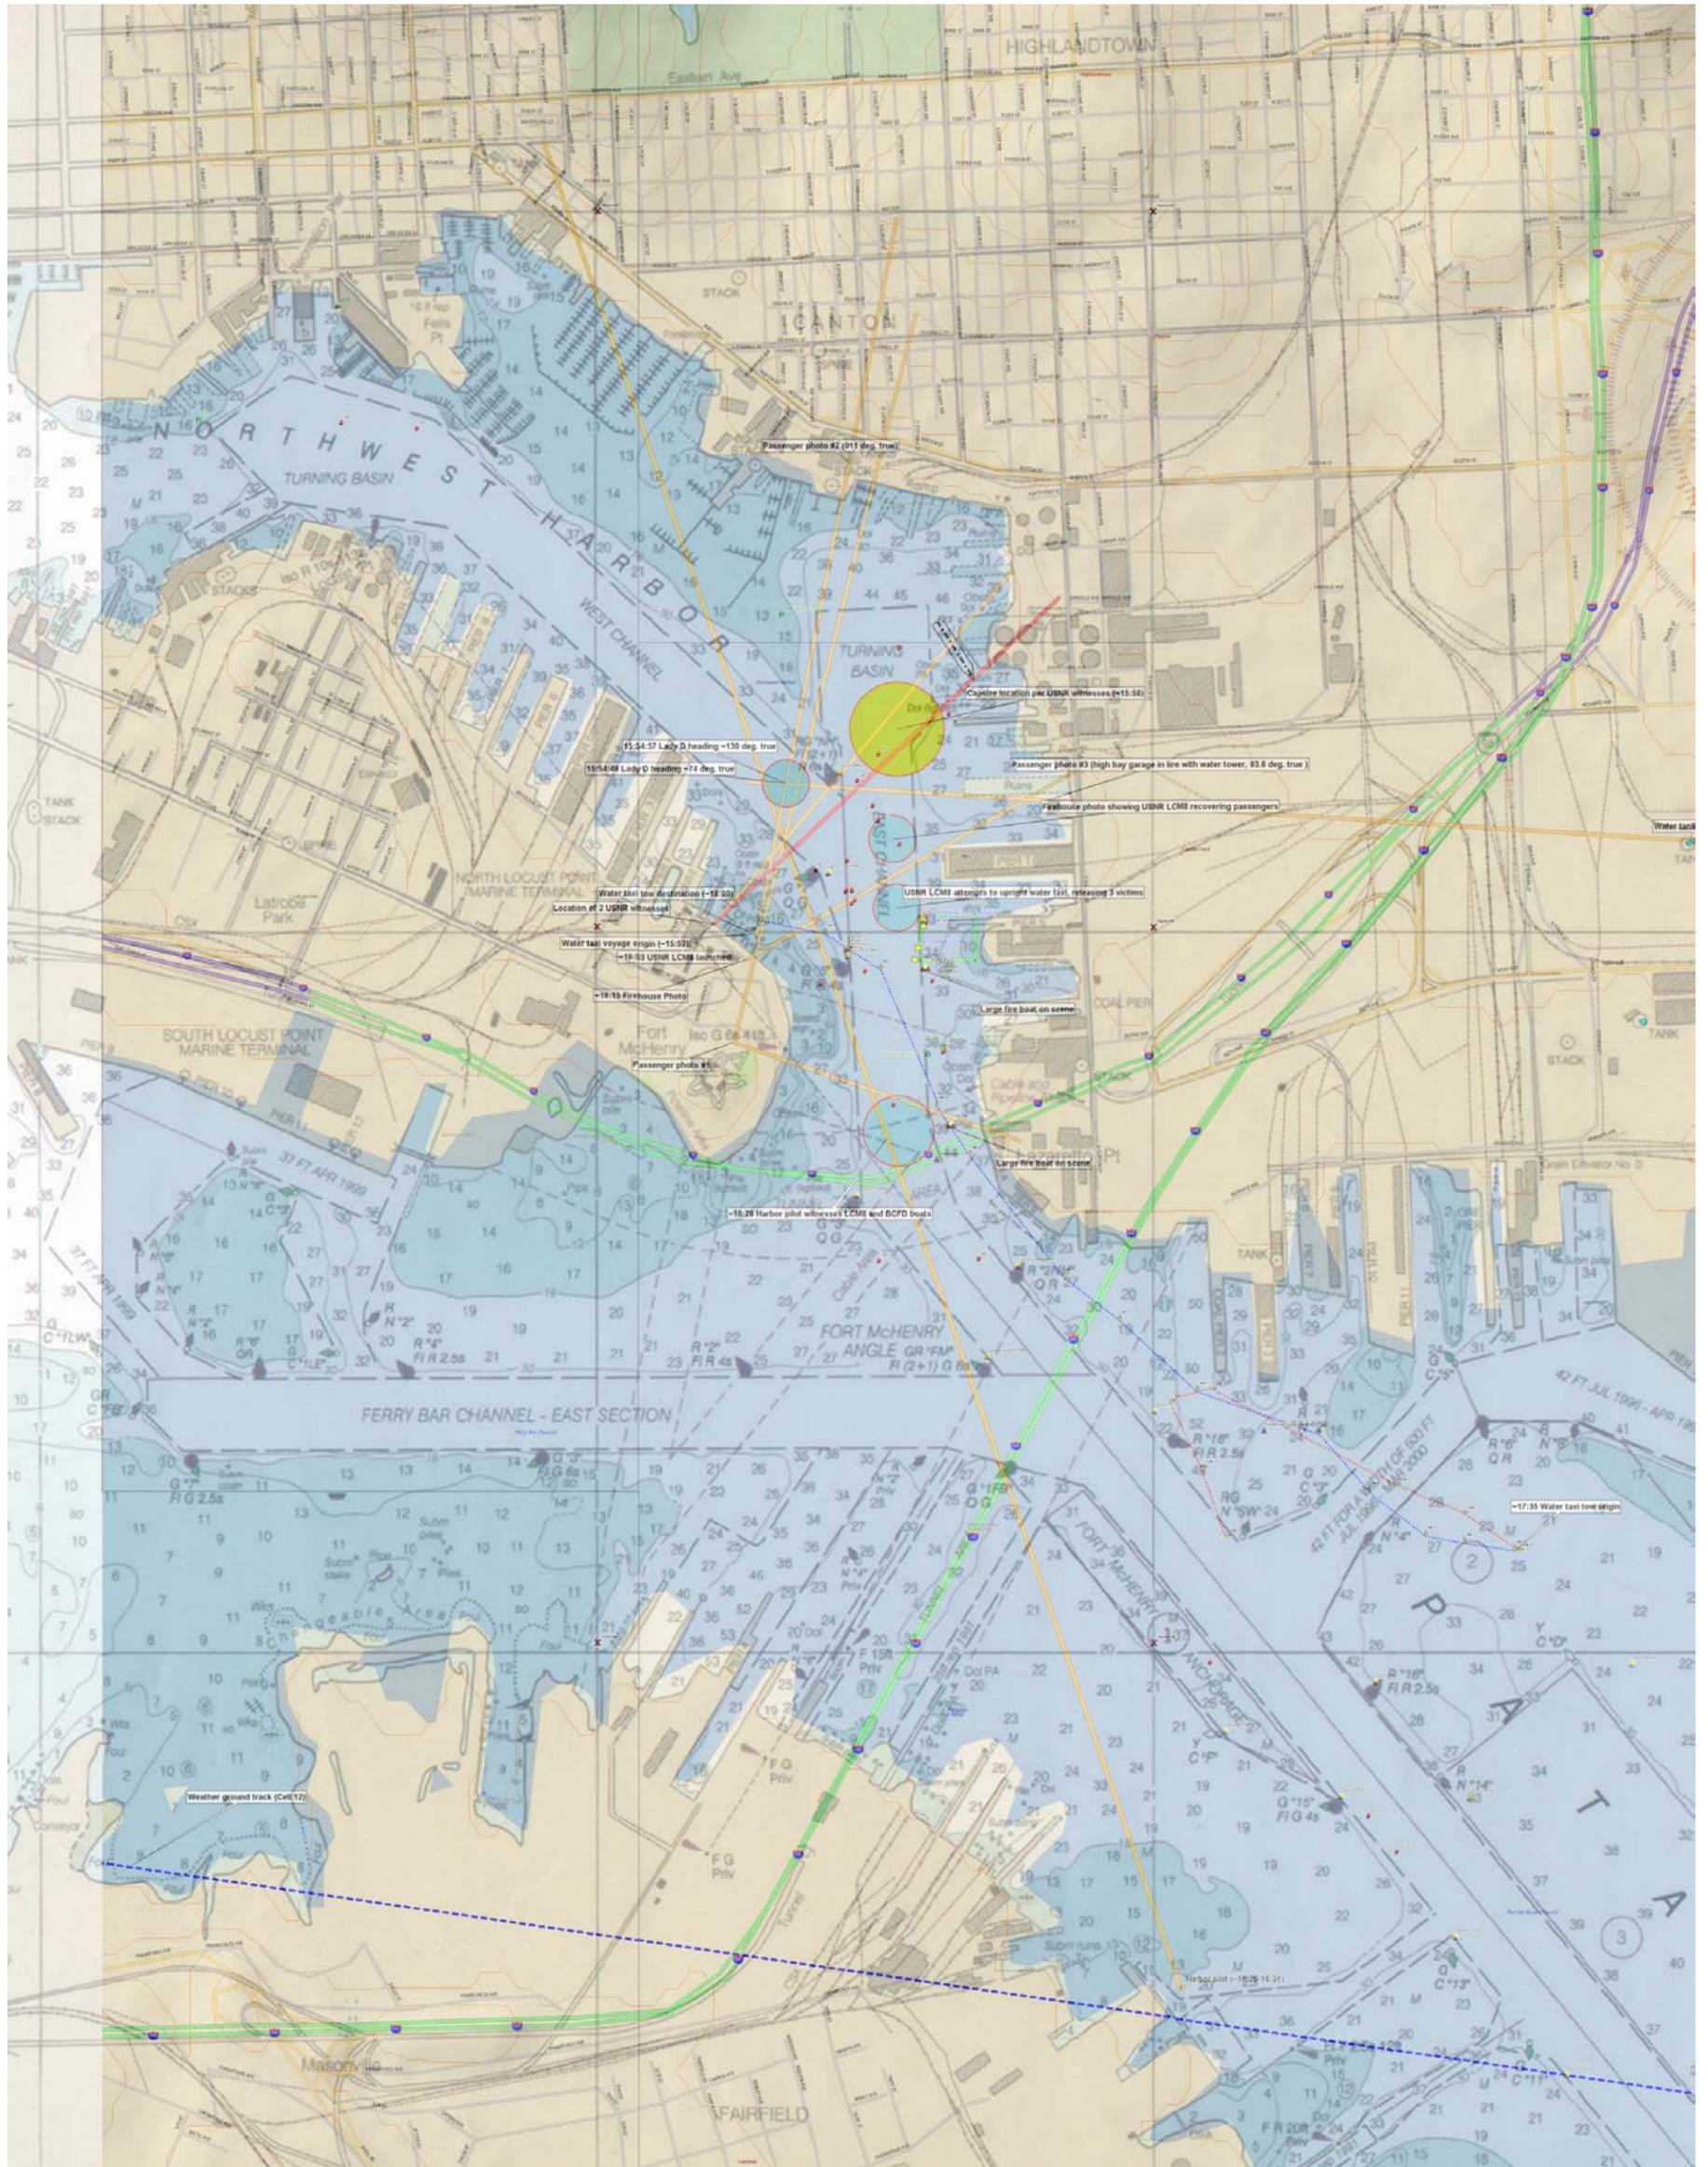
Significant events (position and/or time) are noted in black text with a white background. Bearing data are represented by straight lines (yellow or red). Circular areas depict reported or estimated water taxi positions. The large, light green, shaded circle represents the probable vessel capsized location. The tow vessel's approach path to the accident vessel is represented by the red dotted line and the accident vessel tow path is defined by the blue dotted line. Large yellow dots represent nominal channel buoy locations. The blue dashed line in the lower portion of Figure 7 identifies the path of NS SL storm cell identification number 12.

Figure 7: Composite overlay of accident, rescue, and recovery data. The last known vessel position and heading data place the Lady D in the small circular area north of Ft. McHenry, heading 129.5° true (shaded dark blue, 200 foot radius). The estimated capsizelocation is depicted by the large circular area to the northeast (shaded yellow, 400 foot radius).
