NATIONAL TRANSPORTATION SAFETY BOARD
Office of Research and Engineering
Washington, D.C. 20594

Vehicle Performance Factual

NTSB Number: DCA04MM015
Description: Capsizing of small passenger ferry
Location: Northwest Harbor, Baltimore, Maryland
Date: March 6, 2004
Time: ~1600 EST
Vessel: M/V Lady D, fully enclosed pontoon boat
Operator: Seaport Taxi (Living Classrooms Foundation)

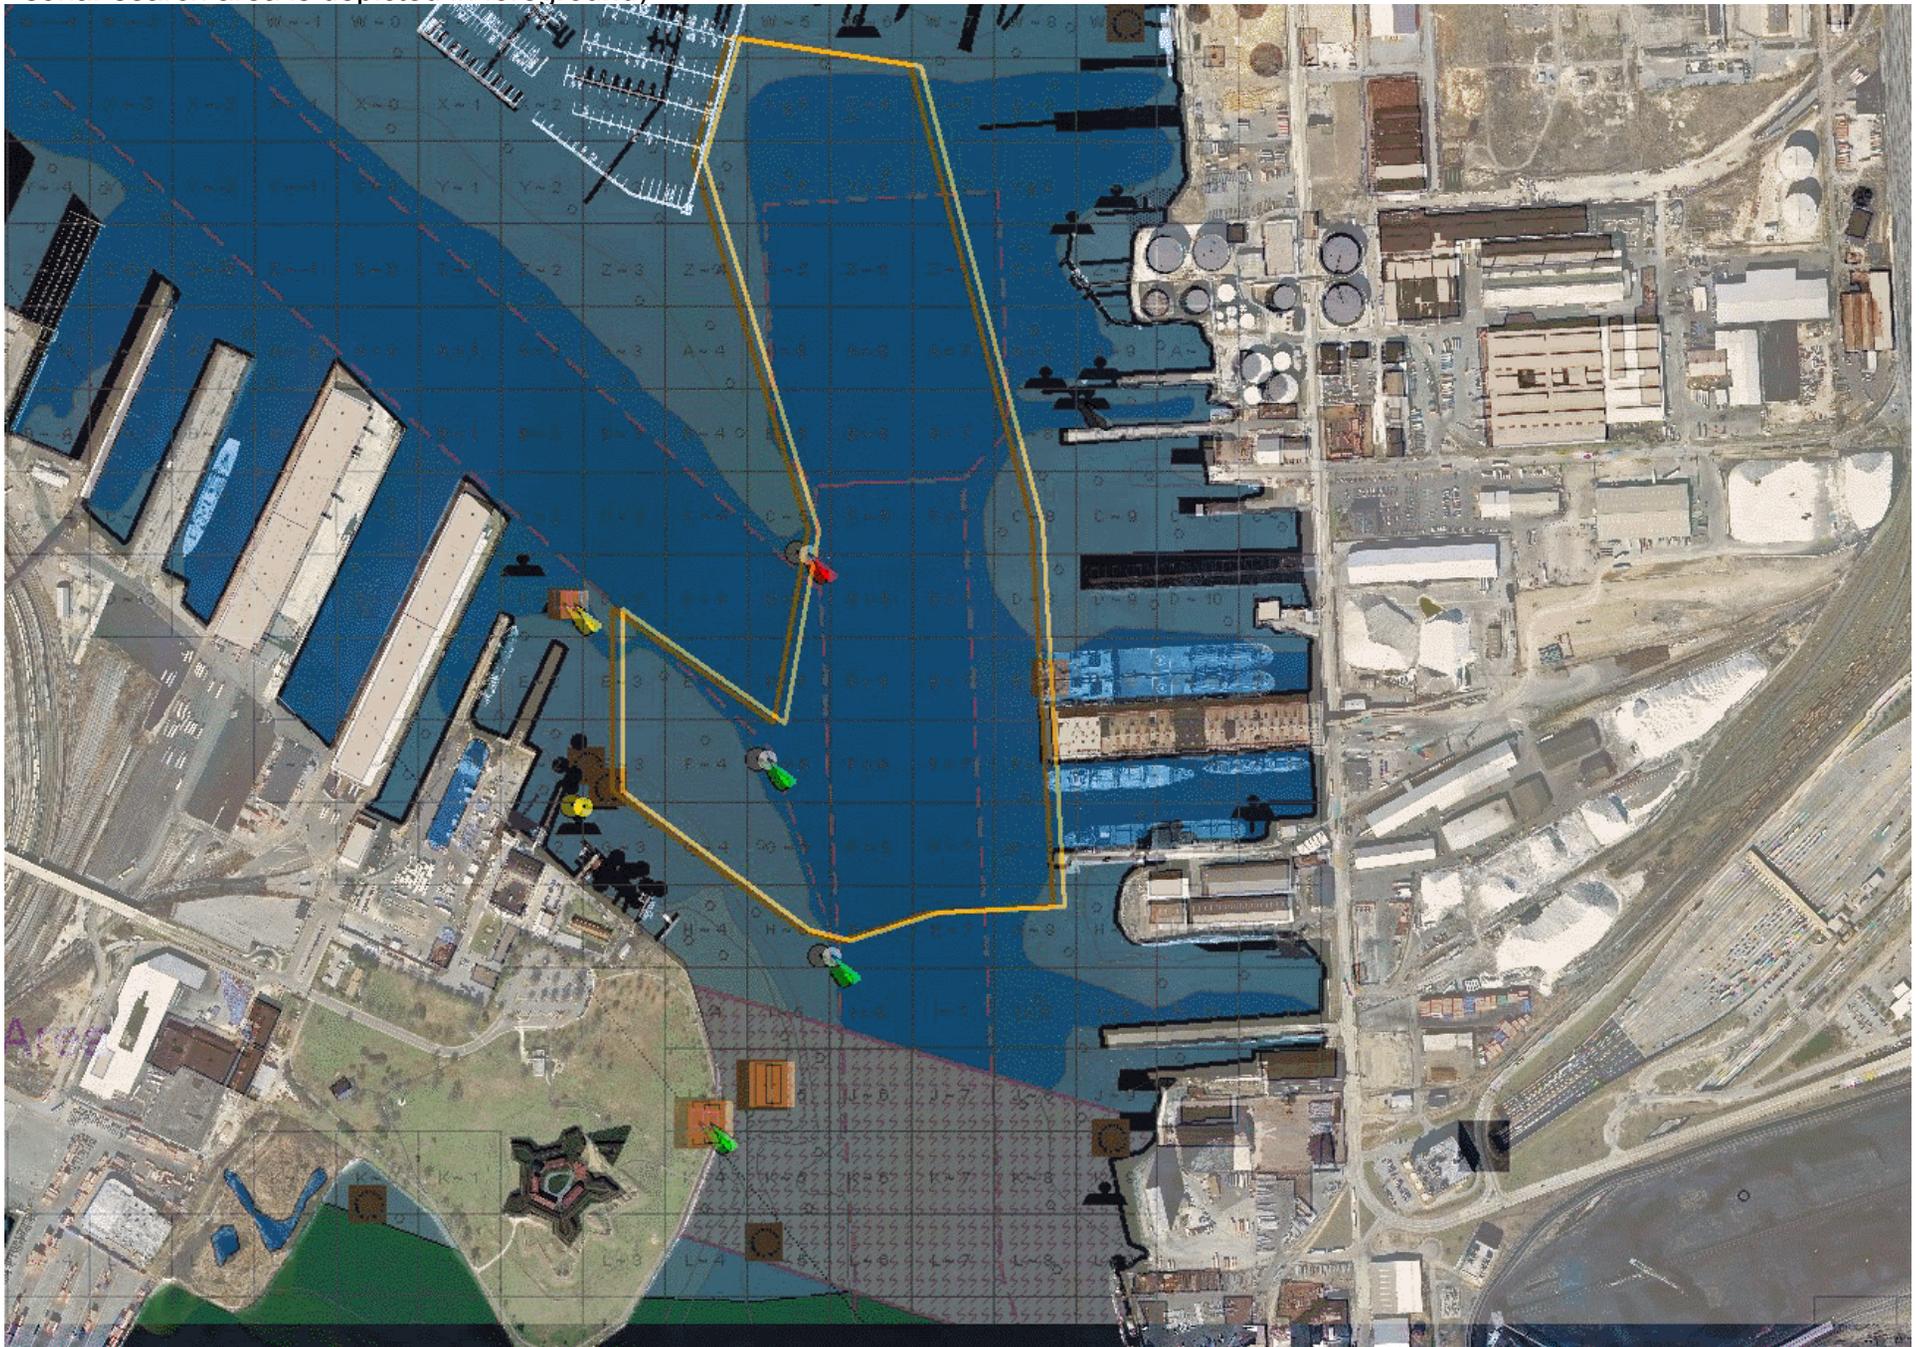
Figure 2: March 2002 aerial image overlaid on Baltimore City Mayor's Office electronic database (approximate MarineSonic side scan sonar search area is depicted in foreground)

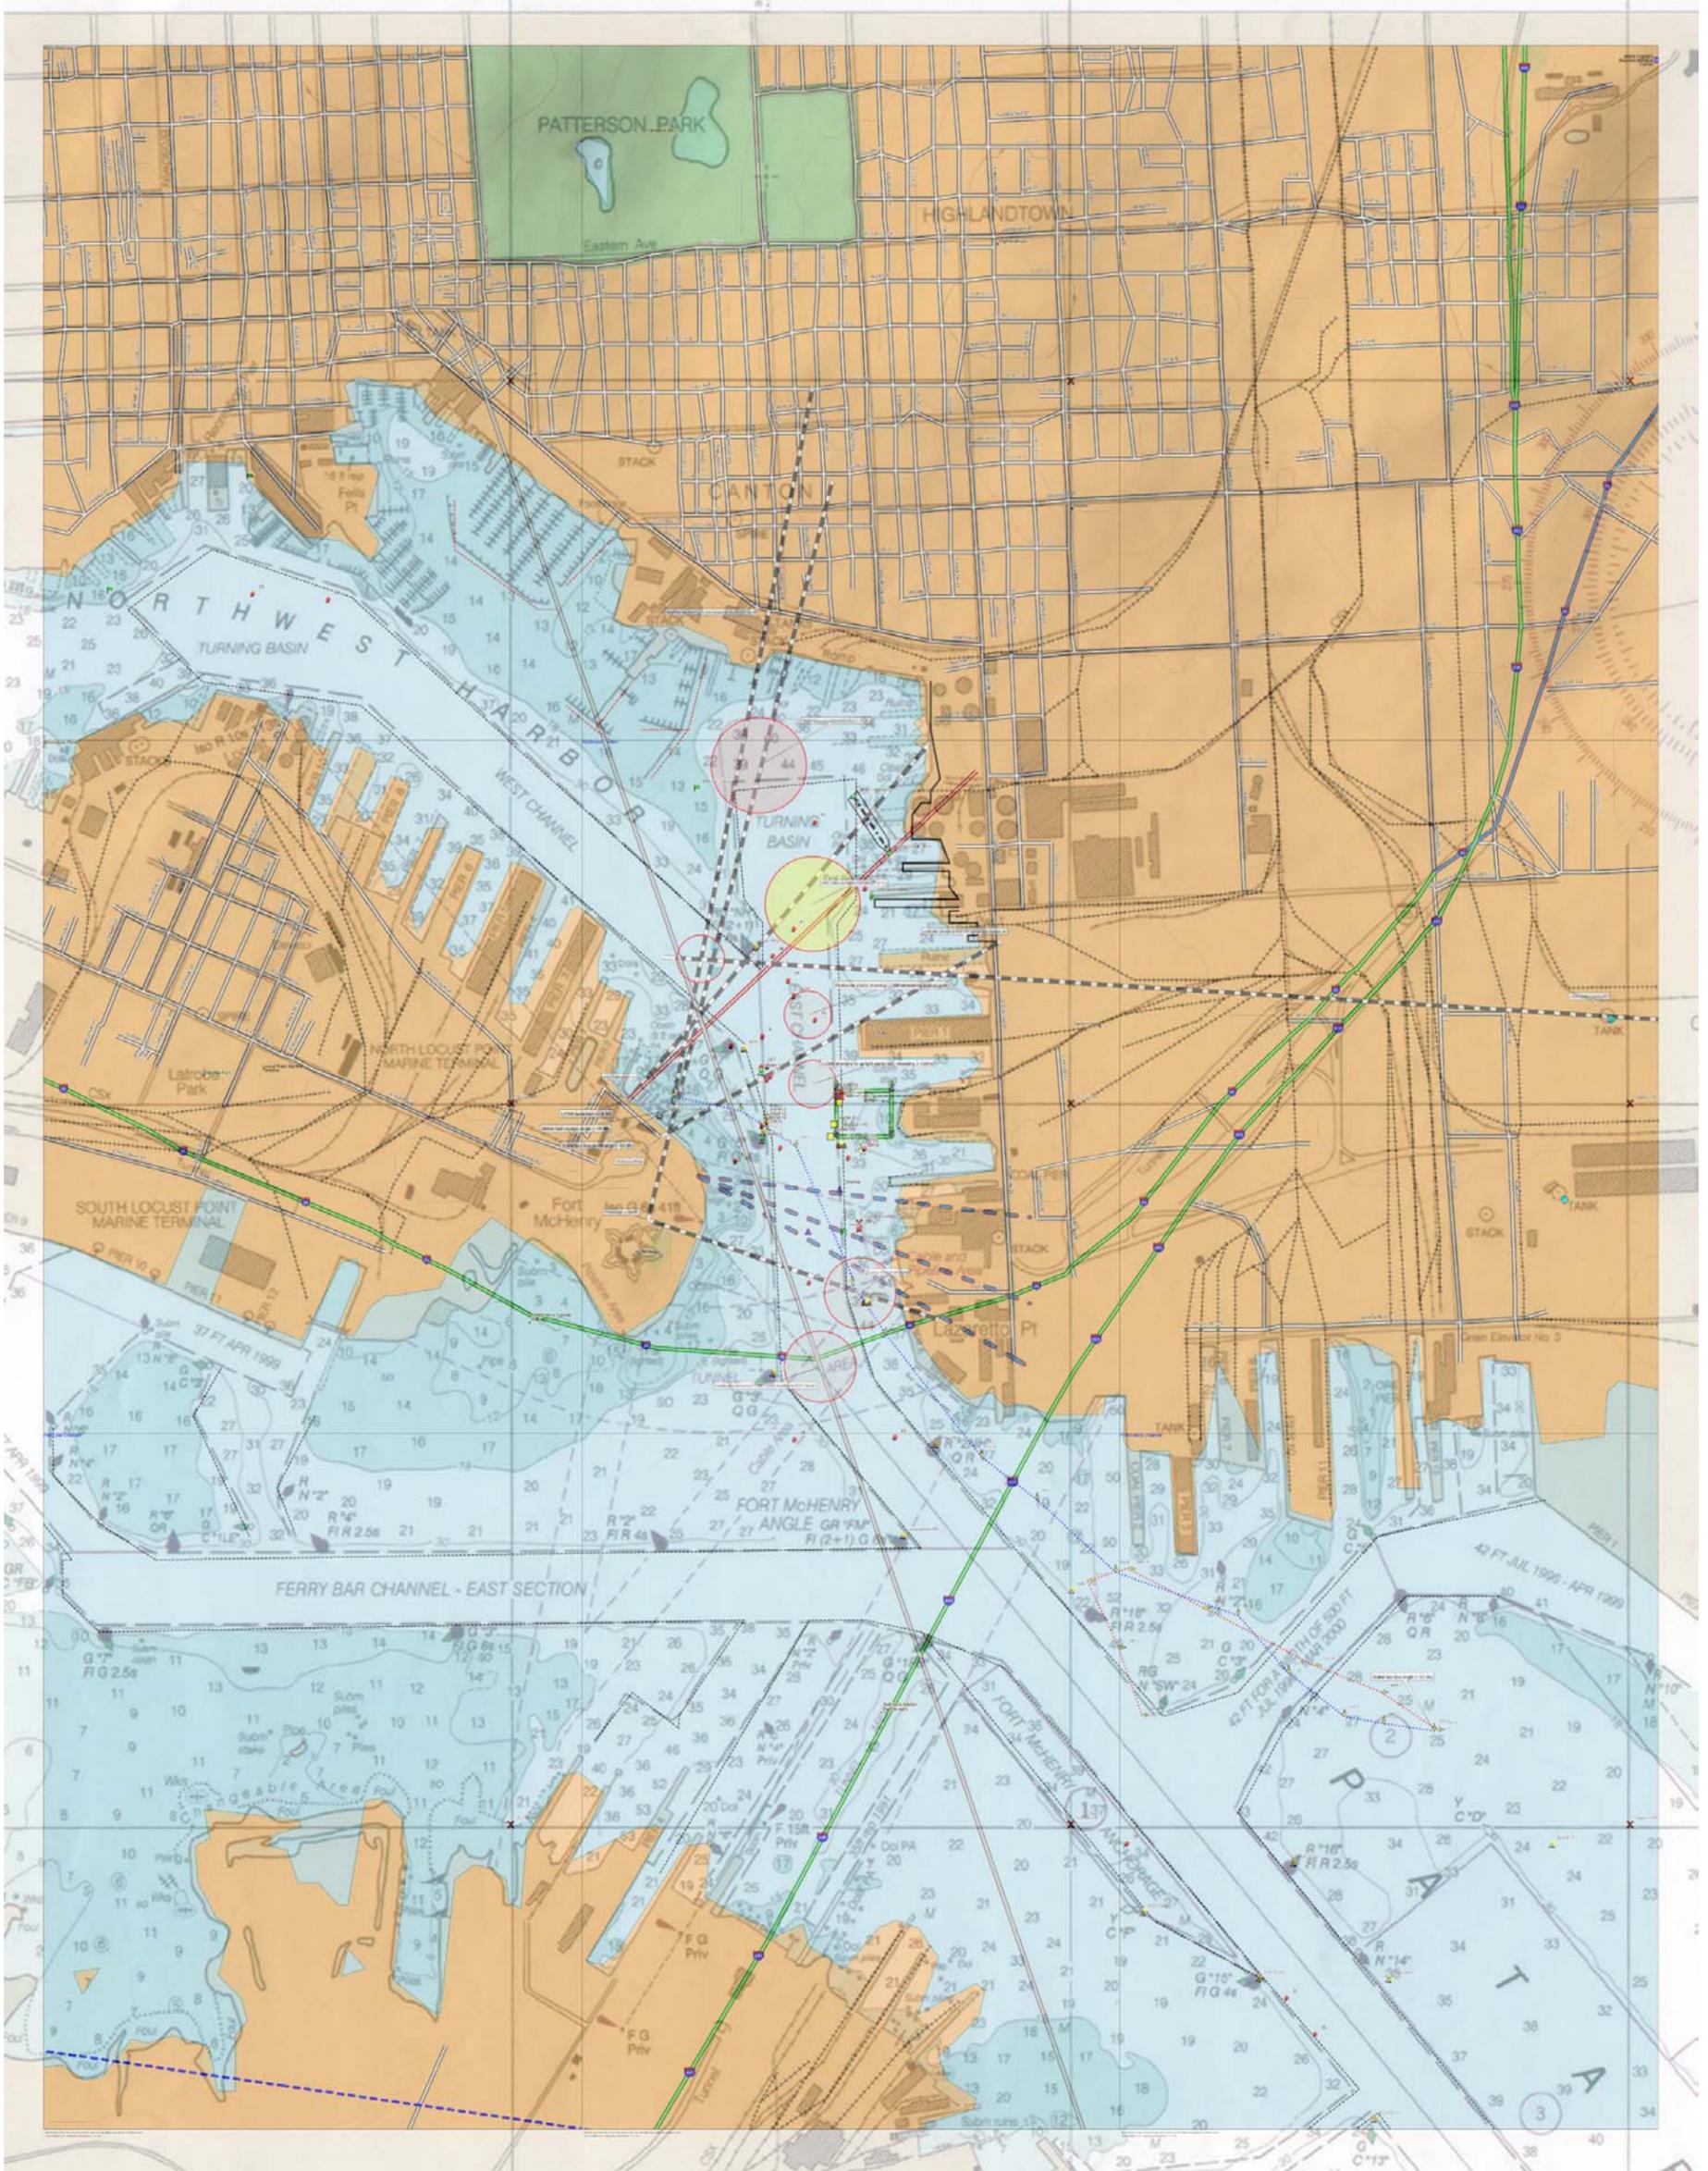
Significant events (position and/or time) are noted in black text with a white background. Bearing data are represented by straight lines (black and white, gray, or blue long dashed). Circular areas depict reported or estimated water taxi positions. The large, light green, shaded circle represents the probable vessel capsizelocation. The tow vessel's approach path to the accident vessel is represented by the red dotted line and the accident vessel tow path is defined by the blue dotted line. Large yellow dots represent nominal channel buoy locations. The blue dashed line in the lower portion of Figure 3 identifies the path of NS SL storm cell identification number 12.

With respect to victim recovery operations, red dots denote targets of interest identified by side scan sonar operations. The *Tyco Decisive* search grid is illustrated by the large green square, with ship-based ROV detailed search locations shown by the small yellow dots. Victim recovery locations are denoted by the yellow squares. The vessel canopy location is identified by the green star. The side scan sonar search areas were plotted on a day-by-day basis, but not shown because these data obscure other data of interest in a two-dimensional presentation.

Figure 3: Composite overlay of evidence.
