NATIONAL TRANSPORTATION SAFETY BOARD

MATERIALS LABORATORY FACTUAL REPORT

Report No. 04-138

Place : Port Richey, Florida
Date : October 17, 2004
Vehicle : Express Shuttle II
NTSB No. : DCA05MM002
Investigator : Brian Curtis, MS-10

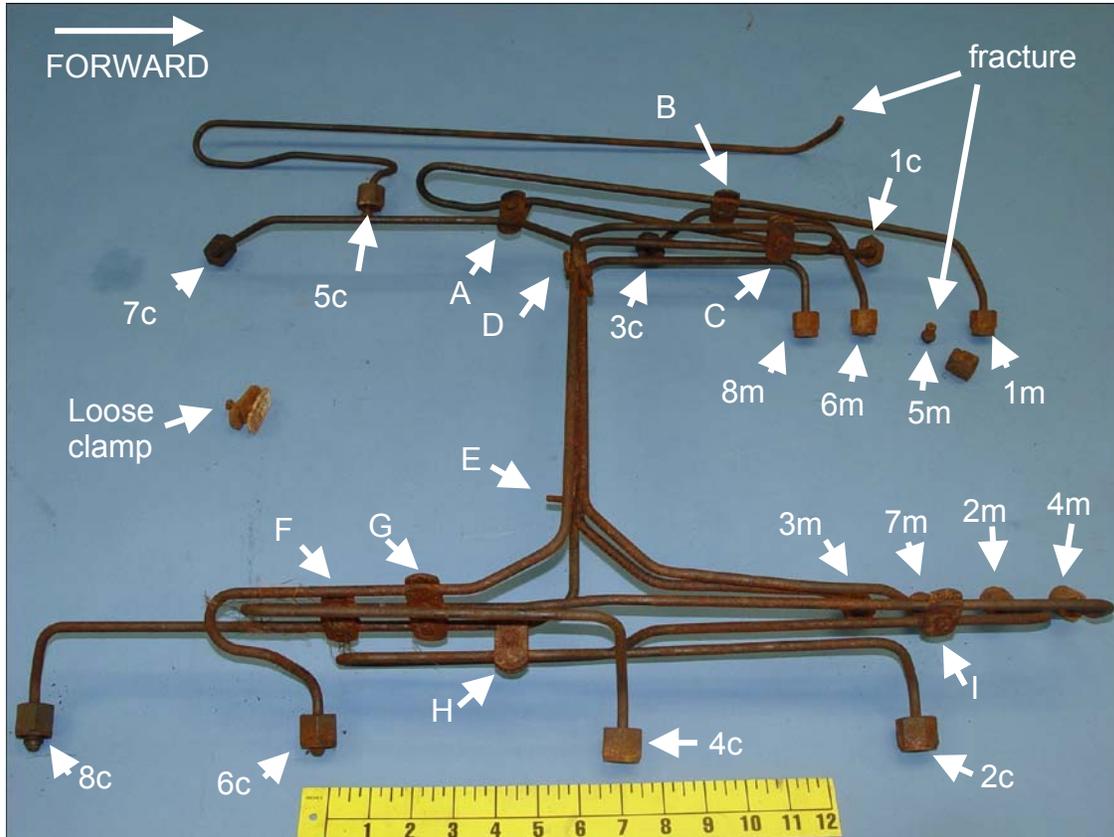
An overall view of the submitted fuel injection lines and clamps is shown in figure 1. Each fuel injection line was a 0.25-inch outer diameter tube connected to the fuel pump manifold at one end and to each of the eight engine cylinders at the other end. For this examination, the fuel injection lines were numbered according to the cylinder number to which the line was attached. The cylinders were numbered from the forward port number 1 to the aft starboard number 8. Odd numbered cylinders 1 to 7 were located on the port side of the engine. Even numbered cylinders 2 to 8 were located on the starboard side of the engine. As-received, fuel injection line number 5 was fractured at the pump manifold attachment location.

A total of nine line-to-line clamps were connected to various fuel injection lines. The clamps are shown lettered "A" to "I" in figure 1. Fuel injection line number 5 was not clamped at any location along its 38-inch length. One loose (unattached) clamp shown in figure 1 was found on-scene on the starboard engine block. The loose clamp was recovered in the unscrewed position with the end of the attachment screw shank located flush to the clamping plate surface.

Also, when examined on-scene, none of the fuel injection lines were found clamped to the engine block. Once the pump manifold and cylinder attachment locations were detached from the engine on-scene, the entire fuel injection line assembly as shown in figure 1 was free to separate from the engine.

Figure 1. Overall view of the submitted fuel injection lines from the starboard engine as viewed looking from above with the starboard side in the foreground. Lines were numbered according to the cylinder to which they were connected. The ends of each line are labeled in the figure with the line number followed by a letter, where "c" indicates the cylinder end and "m" indicates the pump manifold end. Clamps are lettered "A" to "I" from aft to forward and from port to starboard.

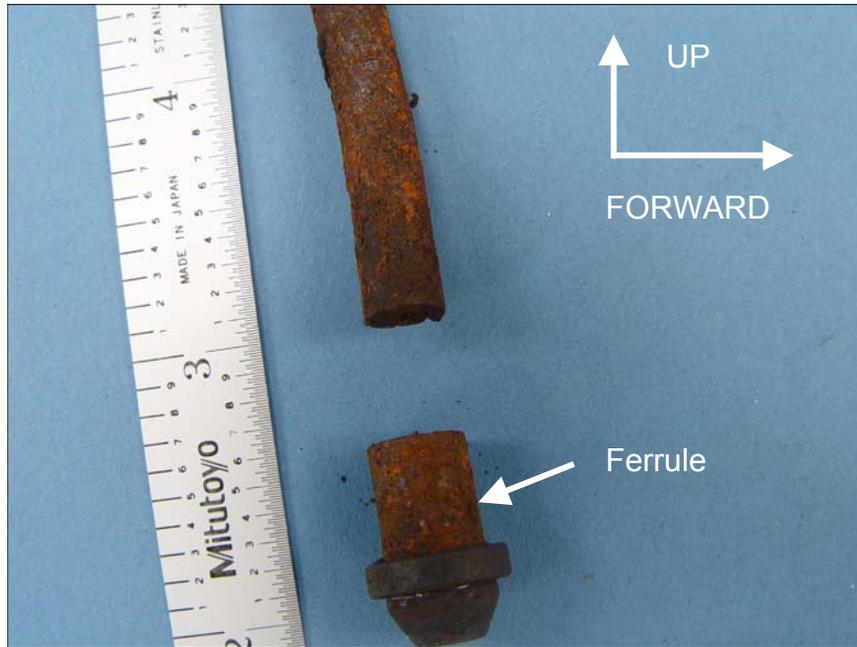
A closer view of fuel injection line number 5 at the fracture location is shown in figure 2. The fracture occurred at the upper edge of the ferrule for attaching the fuel injection line to the fuel pump manifold. The fracture was relatively flat and perpendicular to the longitudinal axis with no macroscopic deformation adjacent to the fracture, features consistent with a macroscopically brittle fracture mechanism.

Figure 2. Close view of the fracture area in line 5.

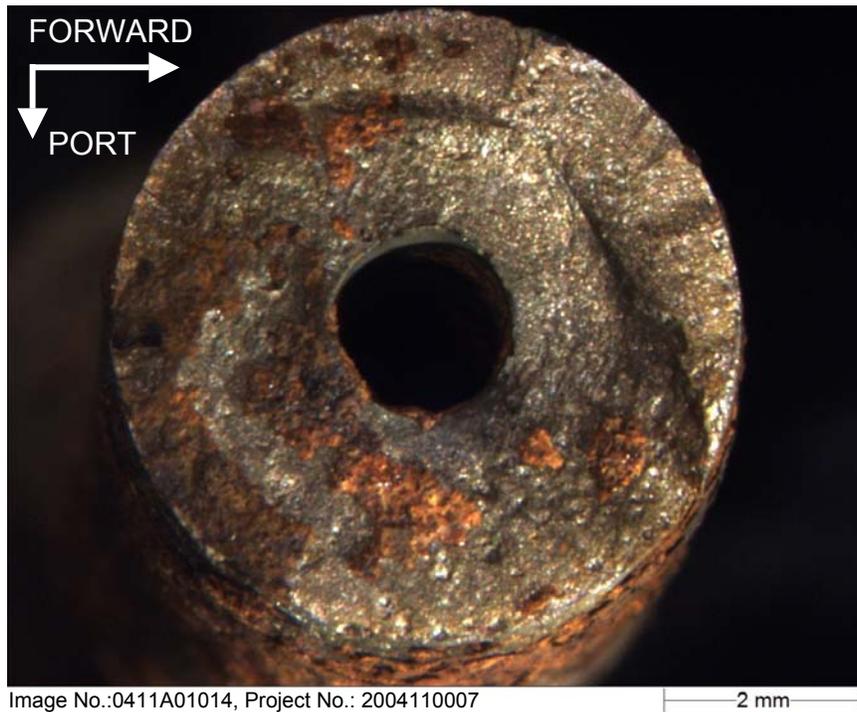
The upper fracture surface was cleaned with soap water and a brush followed by cleaning with a deoxidizer. Views of the cleaned and deoxidized fracture surface are shown in figures 3 and 4. Some areas of oxide remained, visible as orange areas in figure 3.

Figure 3. Close view of the upper fracture surface in line 5 after cleaning with a deoxidizer. Some oxide remained on the surface, appearing orange in the figure. The fracture surface had fatigue features labeled in detail in figure 4.

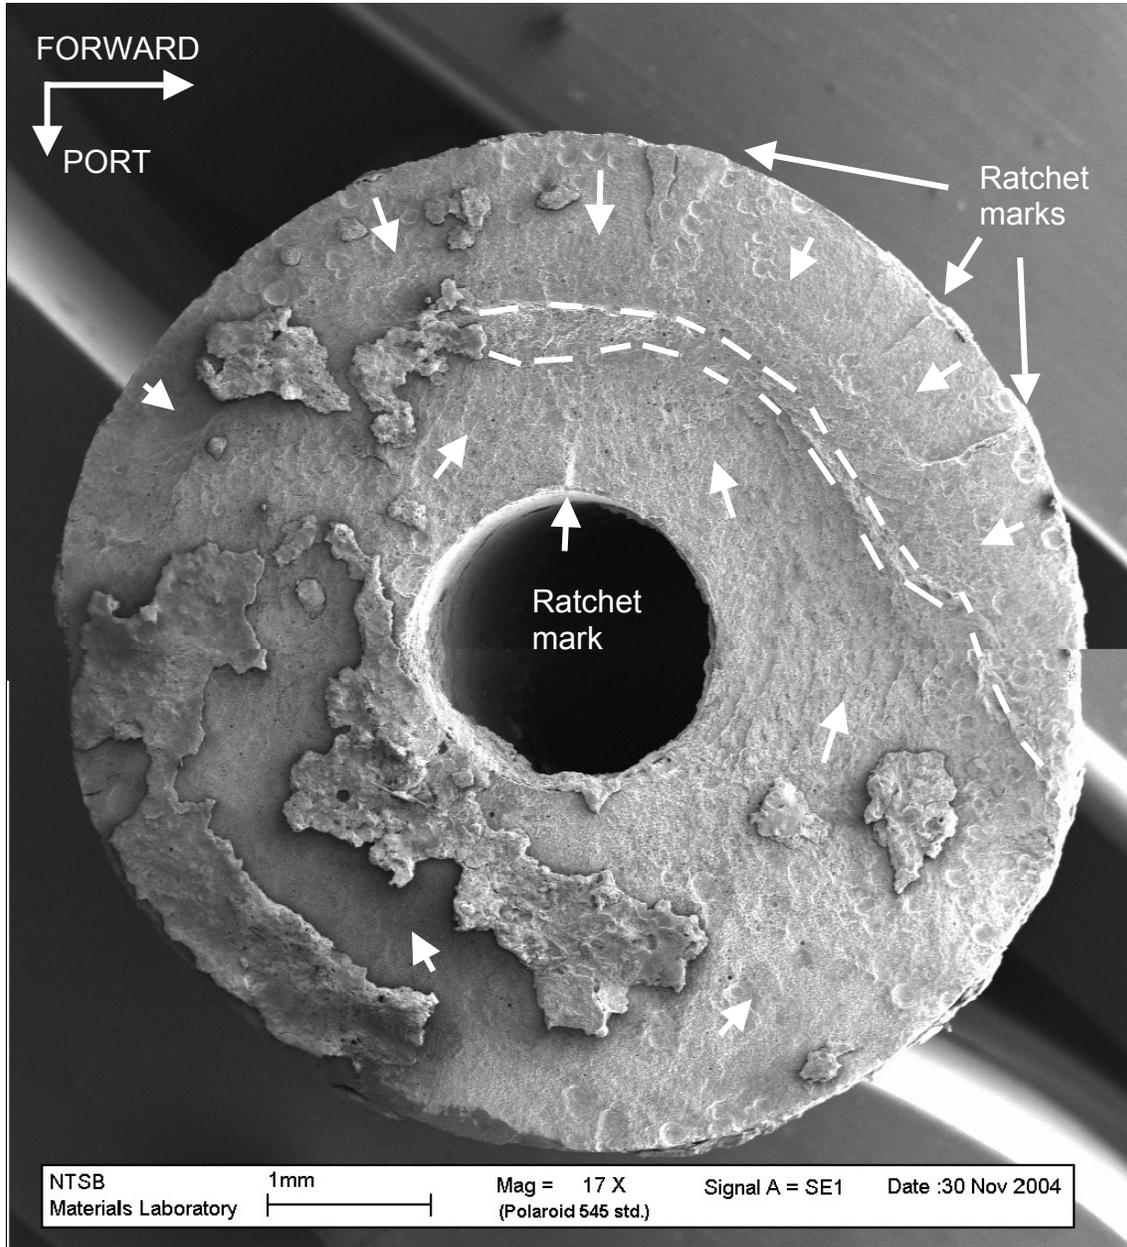
The fracture surface had relatively flat fracture features on offset planes consistent with fatigue fracture across approximately 95 percent of the fracture surface. Dashed lines in figure 4 indicate approximate fatigue boundaries, and unlabeled arrows indicate local directions of fatigue propagation. Most of the fatigue region had features that emanated from a single origin area on the port side of the fuel injection line, propagating around the center of the tube and forming a ratchet mark¹ on the opposite side of the center hole as indicated in figure 4. The remainder of the fatigue region emanated from multiple origins around more than half the circumference on the starboard side. Many ratchet marks were observed around the circumference, and several of these ratchet marks are indicated in figure 4.

¹ A ratchet mark is a small step in the fracture surface formed when two adjacent fatigue cracks propagate on slightly offset planes. Although ratchet marks are typically associated with fatigue cracks originating on different planes, the ratchet mark shown adjacent to the center hole in figure 4 resulted from an intersection of fatigue crack fronts on slightly different planes after propagating around the center hole.

Figure 4. SEM view of the fracture surface shown in figure 3. Dashed lines indicate approximate fatigue boundaries, and unlabeled arrows indicate local approximate fatigue propagation directions.

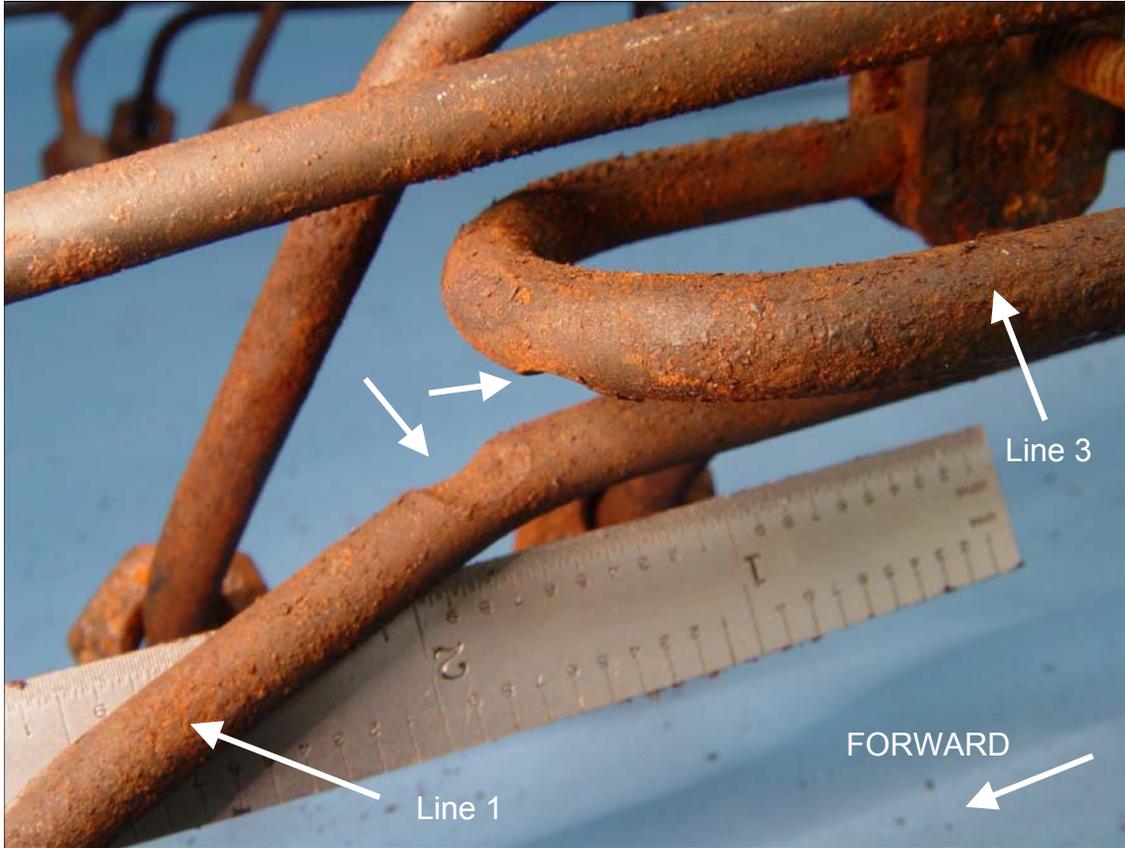
An area of wear was observed corresponding to contact between lines 1 and 3, as shown in figure 5. At the location with the greatest reduction in cross-section, approximately 0.055 inch of material was removed from line 1 and 0.042 inch from line 3.

Figure 5. View of wear as indicated by unlabeled arrows corresponding to contact between lines 1 and 3.
