National Transportation Safety Board

Factual Report of Operational Factors

Accident No.: DCA07FM013

Accident Type: Allision with I-10 bridge pier, Mississippi River, Mile 229.3 LMR ¹

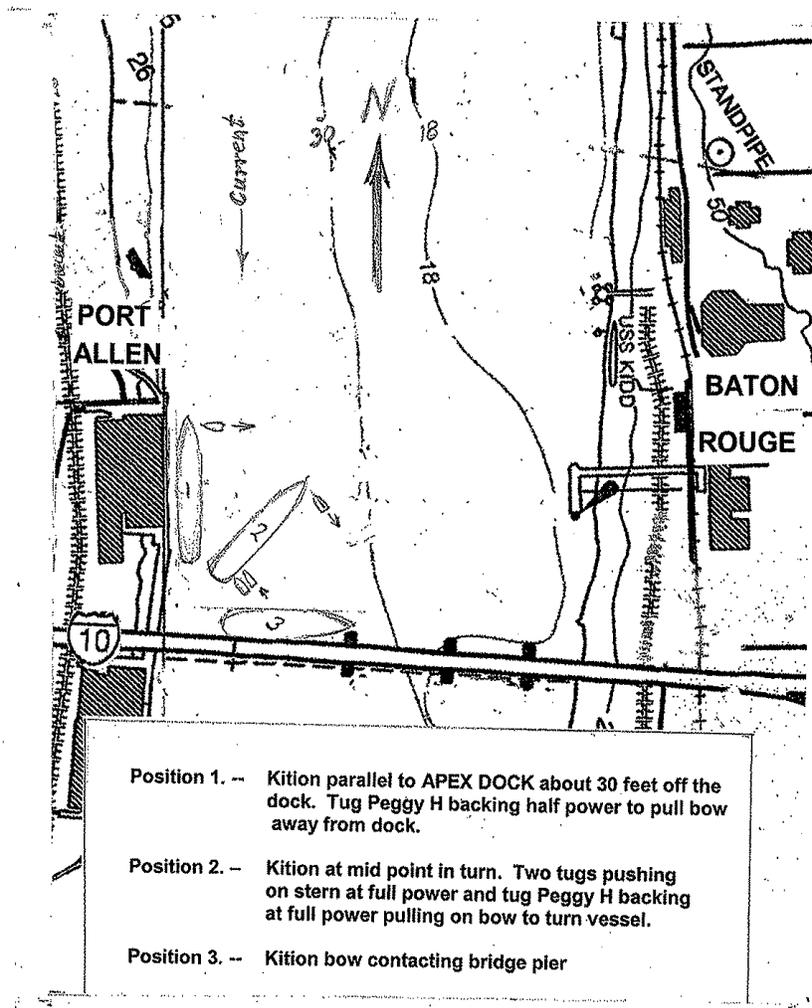
4
5 According to the tug masters soon after the *Peggy H* started backing half,
6 the pilot ordered the *Peggy H*, to “back hard” astern and he ordered the other
7 two tugs to move aft and push hard (full power) on the stern. The third officer
8 recalled looking over the starboard quarter and seeing two tugs pushing on the
9 stern as the vessel’s head swung to the right. About this time the pilot ordered
10 the rudder to hard starboard. As the vessel swung to the right, its stern moved
11 slowly away from the berth in response to the slow ahead bell. See figure 2.
12 Graphic of *Kition* moving from dock to collision with the bridge pier.

Figure 2. Graphic of *Kition* Moving from the Dock to Allision with the I-10 Bridge Pier

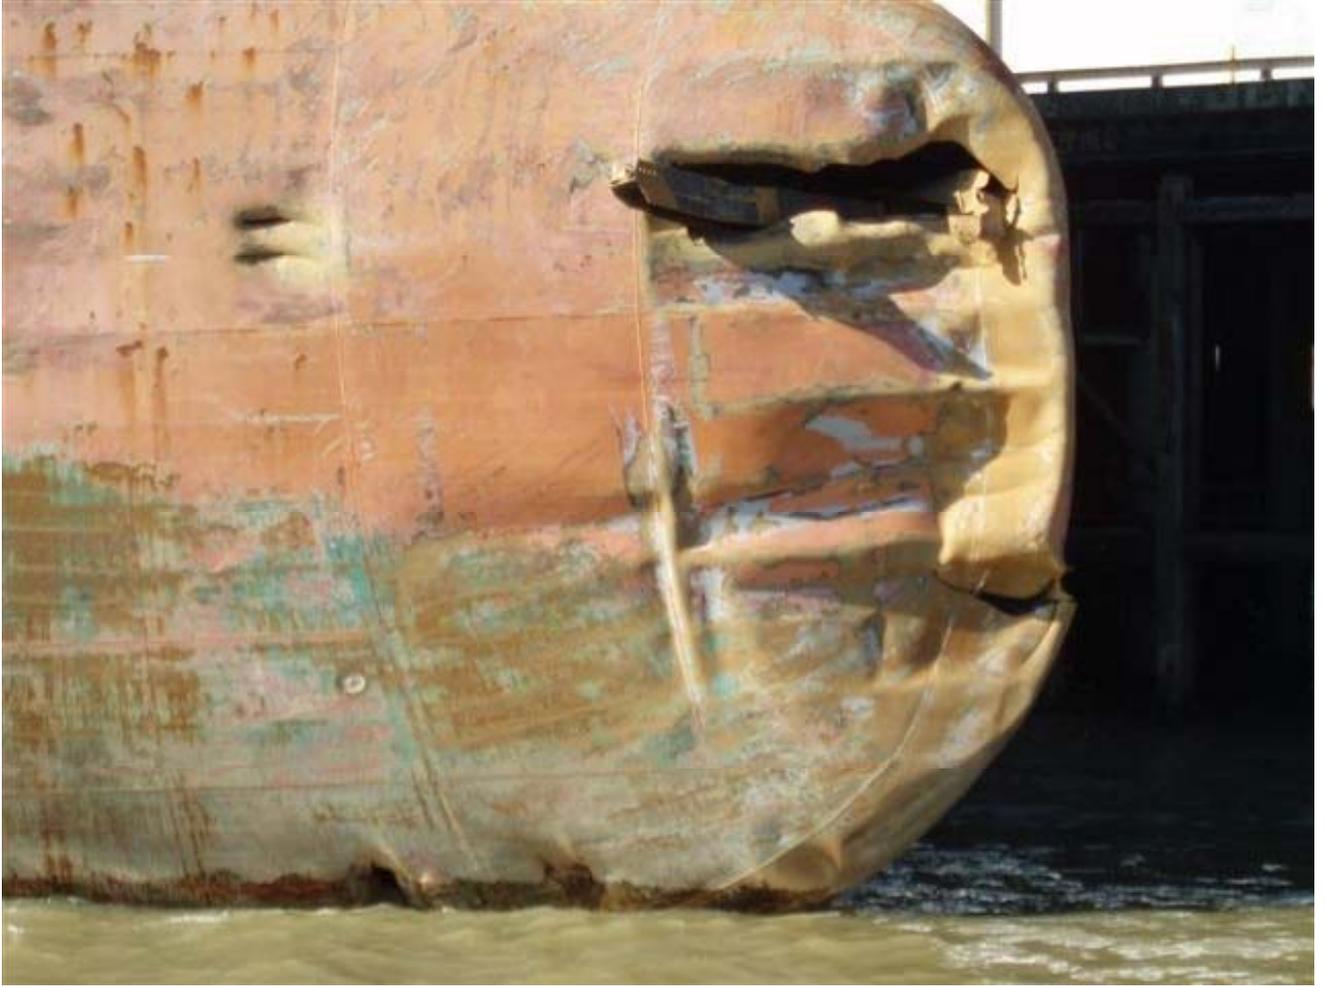
1 downriver and thence to sea. When the nearly 800-foot long vessel was about
2 parallel to the bridge, which provided a horizontal clearance of about 1100 feet,
3 the second officer on the bow reported that the bow of the vessel appeared to be
4 headed toward collision with the bridge pier. The master and pilot both ordered
5 the engine to full astern, but the vessel did not appear to move astern.
6 Approximately two minutes later, about 0737:30, the underwater hull (bulbous
7 bow) struck the bridge fender system around the pier and the fender system
8 commenced to collapse. As the fender system was collapsing, the tug at the
9 bow let go of its line and backed clear. Moments later the bulwark on the
10 starboard bow of the *Kition* struck the bridge pier knocking a 2-3 foot section of
11 concrete out of the bridge pier. The *Kition*'s bulbous bow was holed and the
12 forepeak tank quickly flooded to the waterline.

Figure 3. Damage to *Kition's* Bulbous Bow

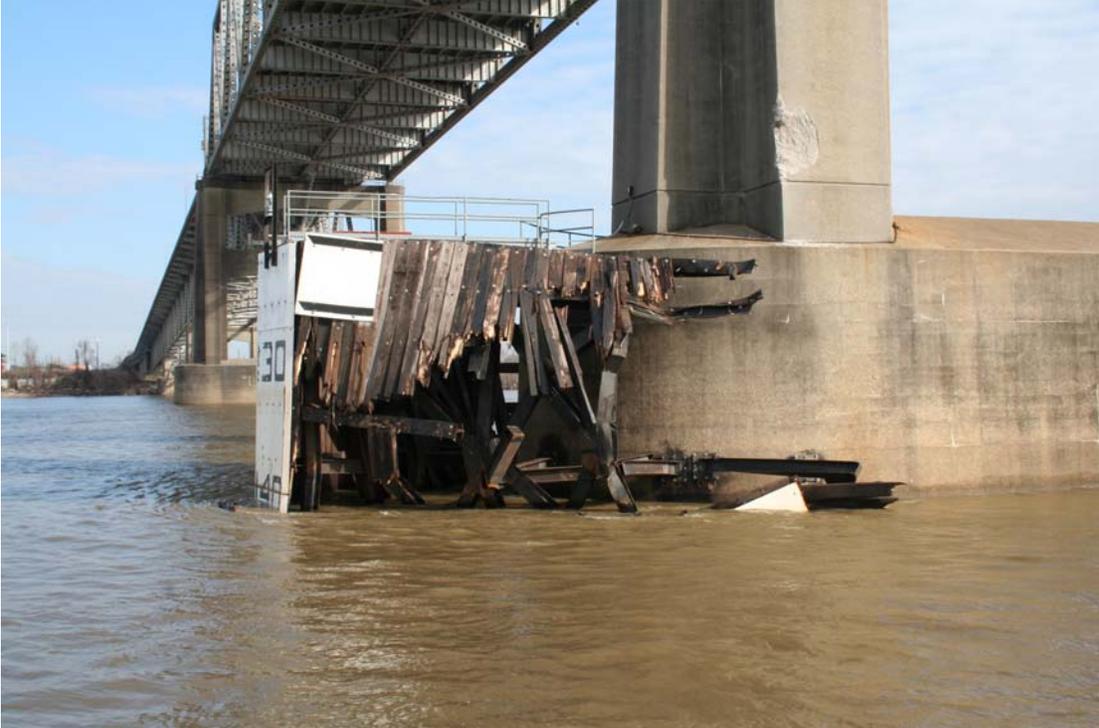
¹⁸ The AIS indicates about 0737, the video indicates 0737:40, and an extract of bell log prepared by the chief officer indicates 0737:30.
¹⁹ The bridge was inspected by Louisiana DOT bridge inspectors and found to be safe for use. Early estimates for reconstructing the fendering systems were approximately \$2 million.

Figure 5. Damage to Bridge Fender System and Section of Concrete Knocked out of Bridge Pier
