Figure 1. Site where construction barge *Athena 106* dropped a 5-ton mooring spud on the West Cote Blanche Bay natural gas sales pipeline. The pipeline carried excess natural gas from the Gulfport sales platform (where extracted natural gas was processed and injected back into oil-producing wells to aid in oil production) to a junction with Chevron’s Vermilion Bay gas sales pipeline. The pipeline between the Gulfport sales platform and the Chevron bay junction platform was about 19,650 feet long. The pipeline between the Vermilion Bay platform and the bay junction platform was about 32,300 feet long.

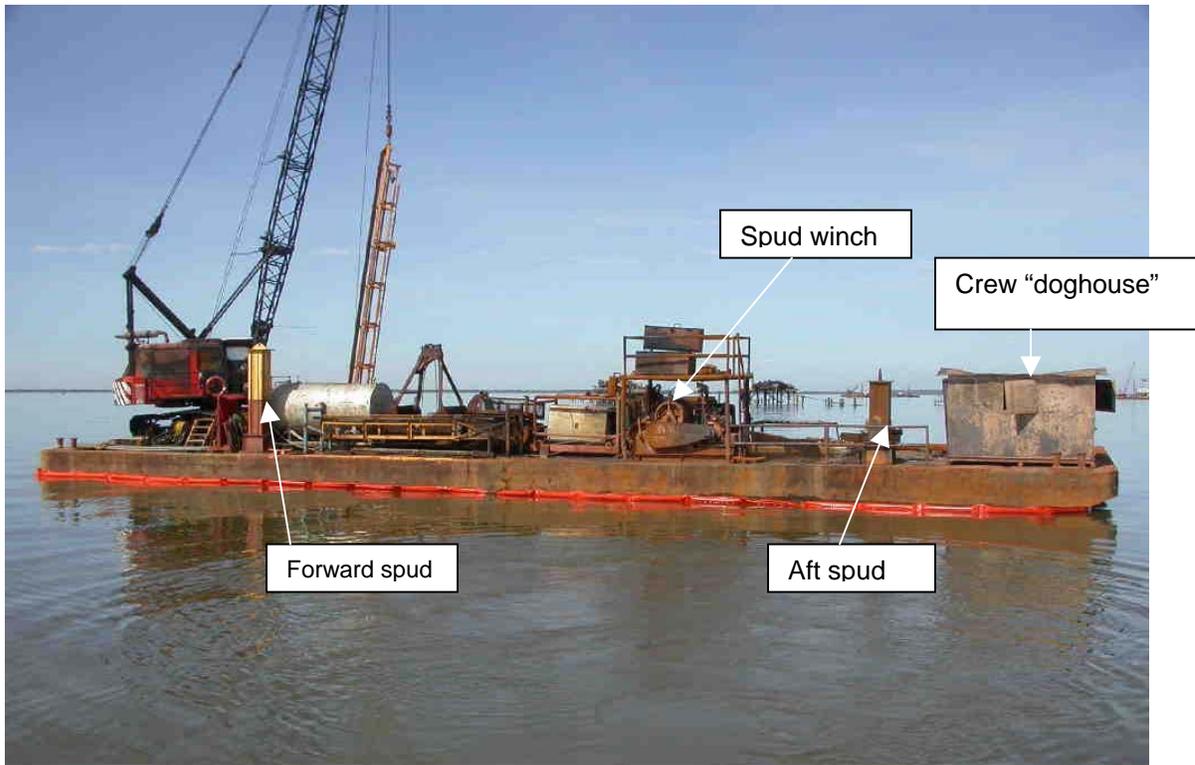
Figure 2. *Athena 106* after the fire. The construction barge was equipped with two mooring spuds (shown in the lowered position), both on the port side, one forward and one aft, controlled by a single winch. At the front of the barge was the crane used to hoist and position pilings for driving or to maneuver them to a barge alongside for storage.

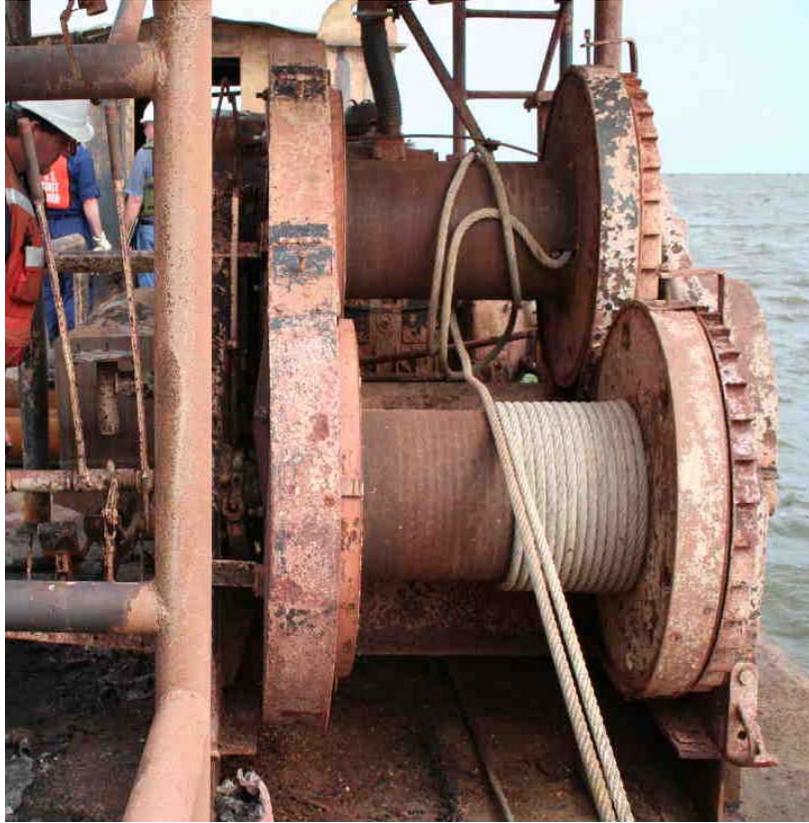
Figure 6. Photo showing cable “birdneste’d” on the winch drum (upper rear) that led to the *Athena 106*’s aft spud. The cable on the lower winch, which led to the forward spud, is properly wound.

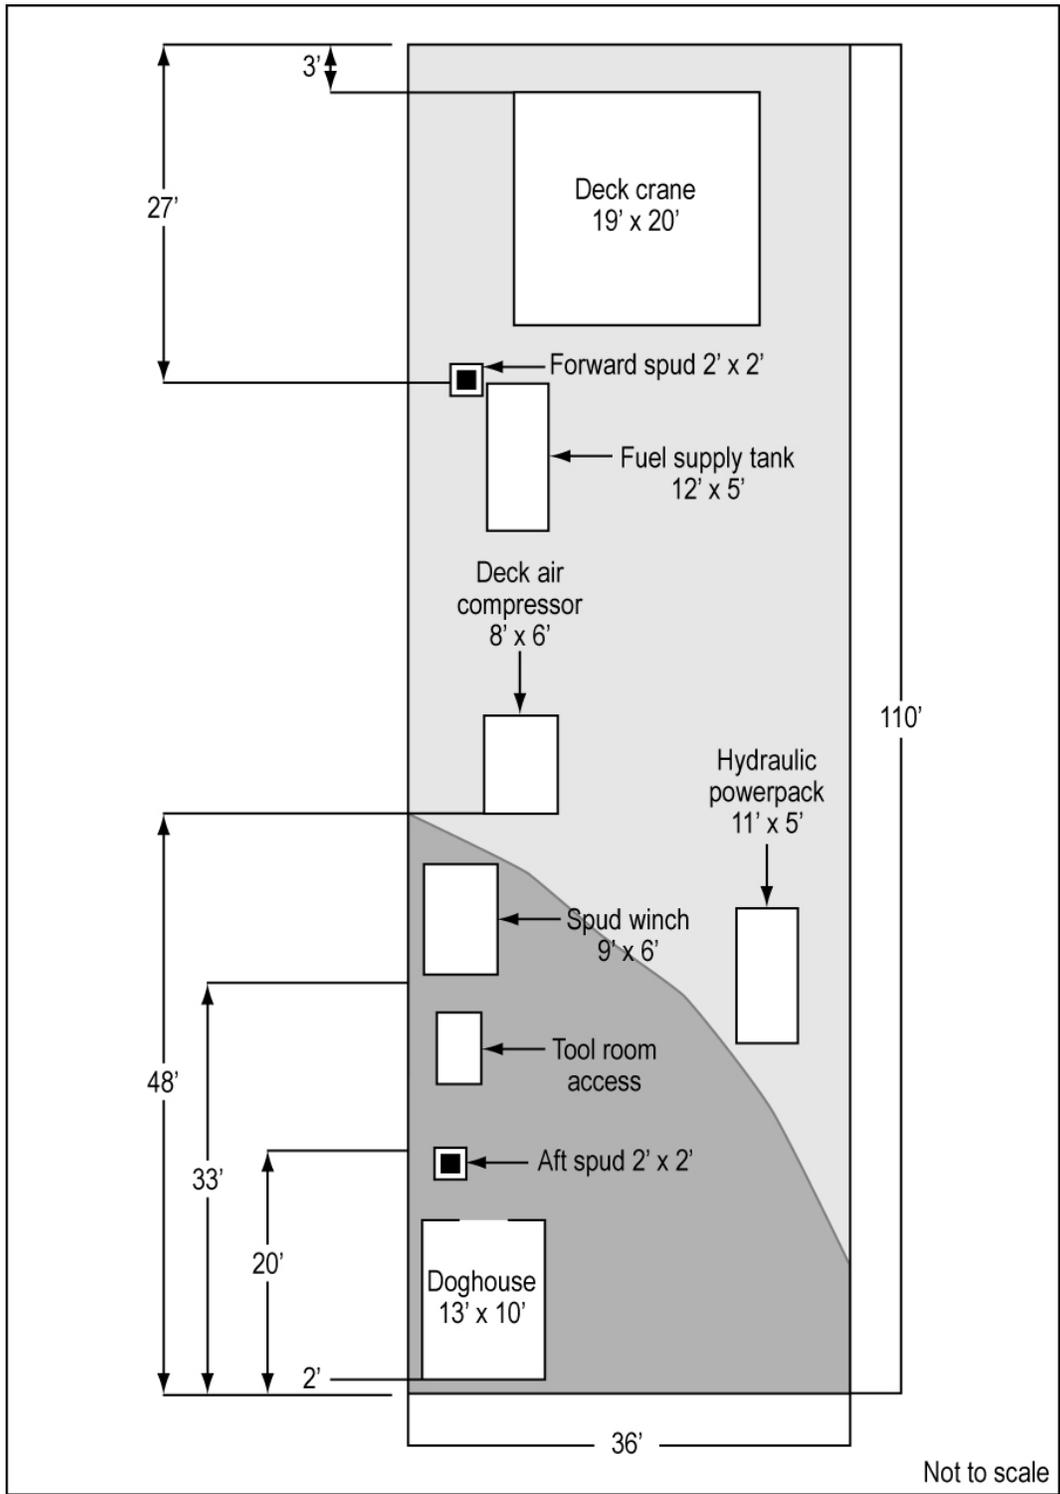
Figure 7. General layout of *Athena 106* construction barge. Fire damage to equipment on the barge deck was greatest in the dark-shaded area.

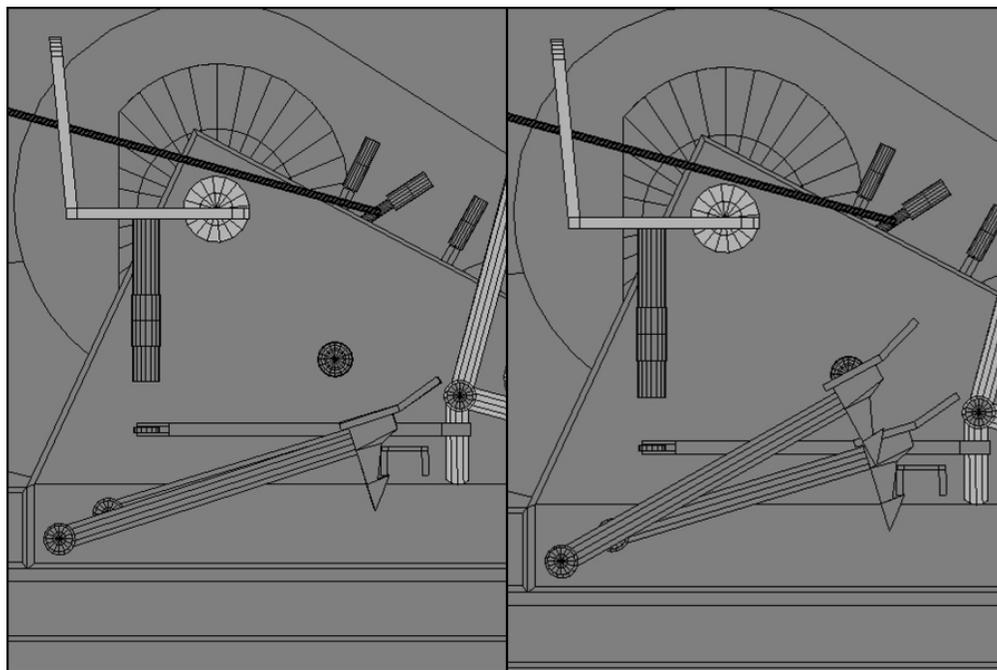
Figure 9. Operation of *Athena 106* foot brake pedals (shown at bottom of both illustrations). On the left, both pedals are engaged (depressed) and latched in place by the fixed steel piece shown pressing on a triangular section at the bottom of the pedals. On the right, the front pedal is released and the back pedal is still engaged. To release the pedal, the operator would push down on the pedal and twist the latch out of place, allowing a spring to raise the pedal. Objects in white are the operator's seat (upper left) next to a round bearing for the upper winch, and the hand friction control lever (lower right) that could be used to brake the winch if the foot pedals disengaged.

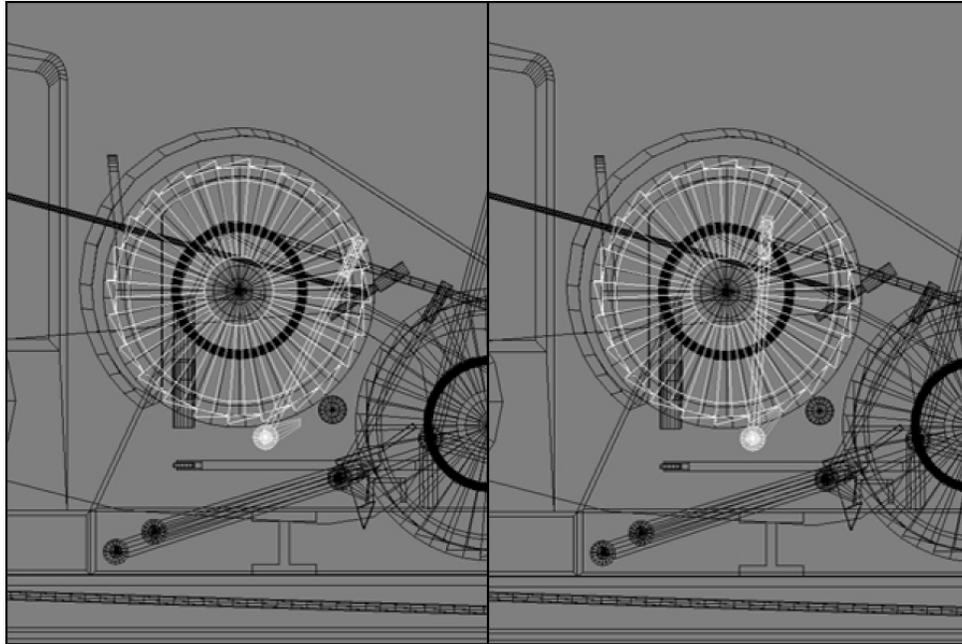
Figure 10. Operation of the winch pawl on the *Athena 106*. Both winch drums are shown. The white ring on the upper drum (which controlled the aft spud) is a ratcheted gear bolted to the outside of the drum. The operator engages or disengages the pawls using the lever, shown in white, that extends downward across the gear. The pawl is the tongue-shaped piece at the bottom of the lever. When disengaged (left illustration), the pawl is outside the gear teeth, allowing the gear to move freely in either direction. When engaged (right illustration), the pawl falls into the spaces between the notches so the gear can move in only one direction. (See **figure 8** for location of pawl lever at operator's station.)

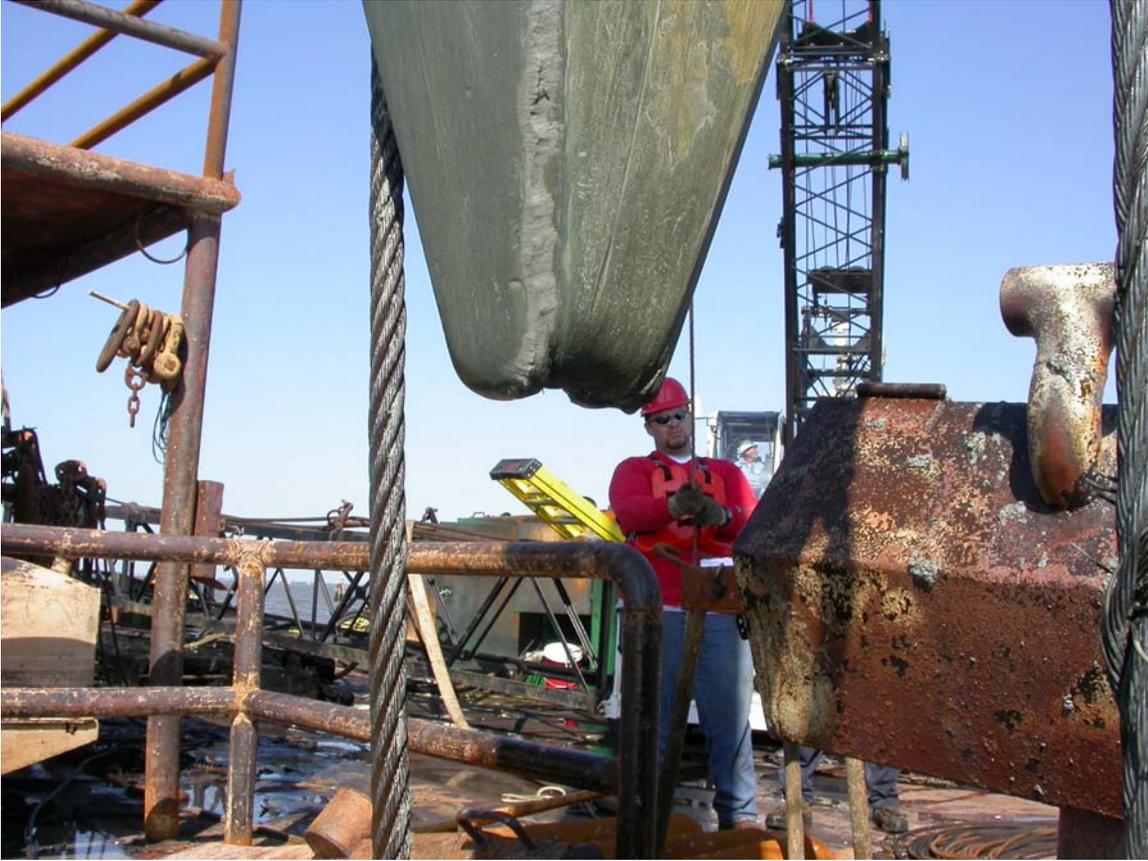
Figure 12. Aft spud of the *Athena 106* when raised after it had released from its fully raised position and hit a submerged, buried high-pressure natural gas pipeline.

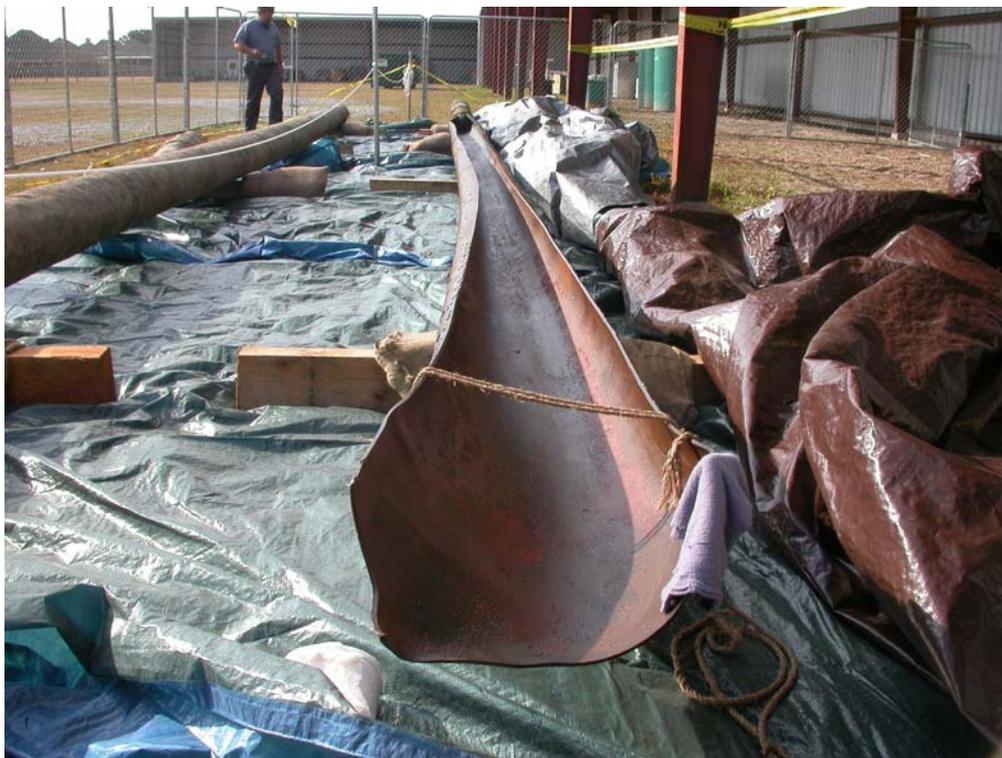
Figure 13. Fracture on the east piece of the ruptured pipeline.

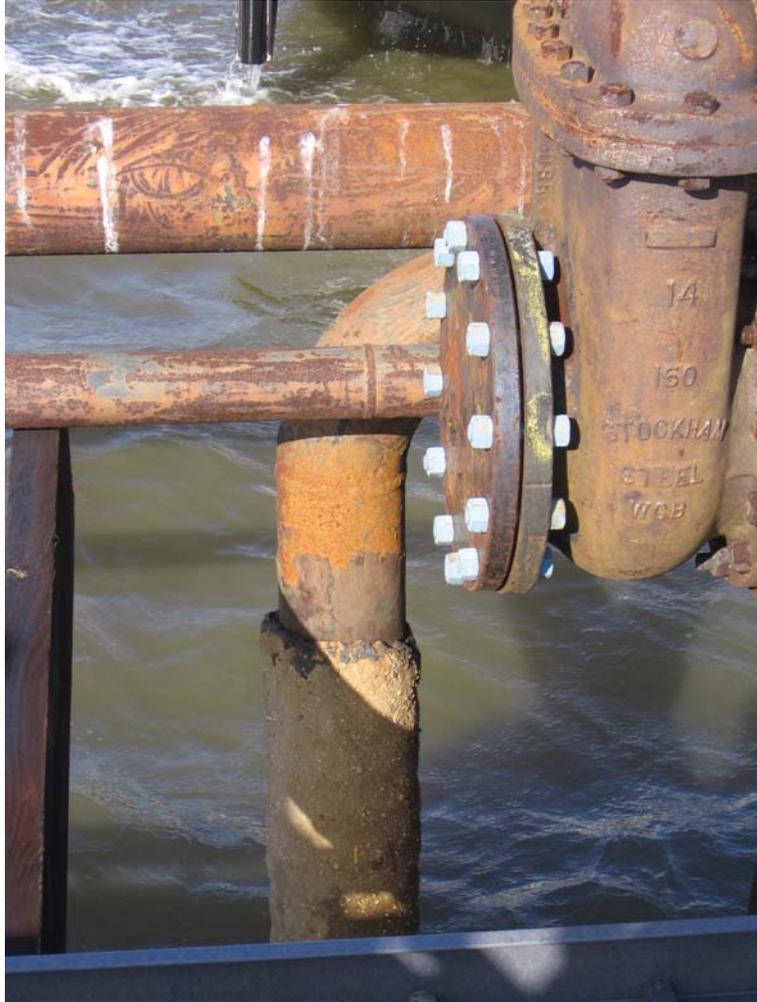
Figure 14. Beginning of the gas sales pipeline (vertical pipe entering water) at the Gulfport sales platform in the West Cote Blanche Bay oil field. The pipeline was ruptured by the *Athena 106*'s aft spud in an east-west section near the Gulfport platform. The pipe's concrete coating is visible above the waterline.

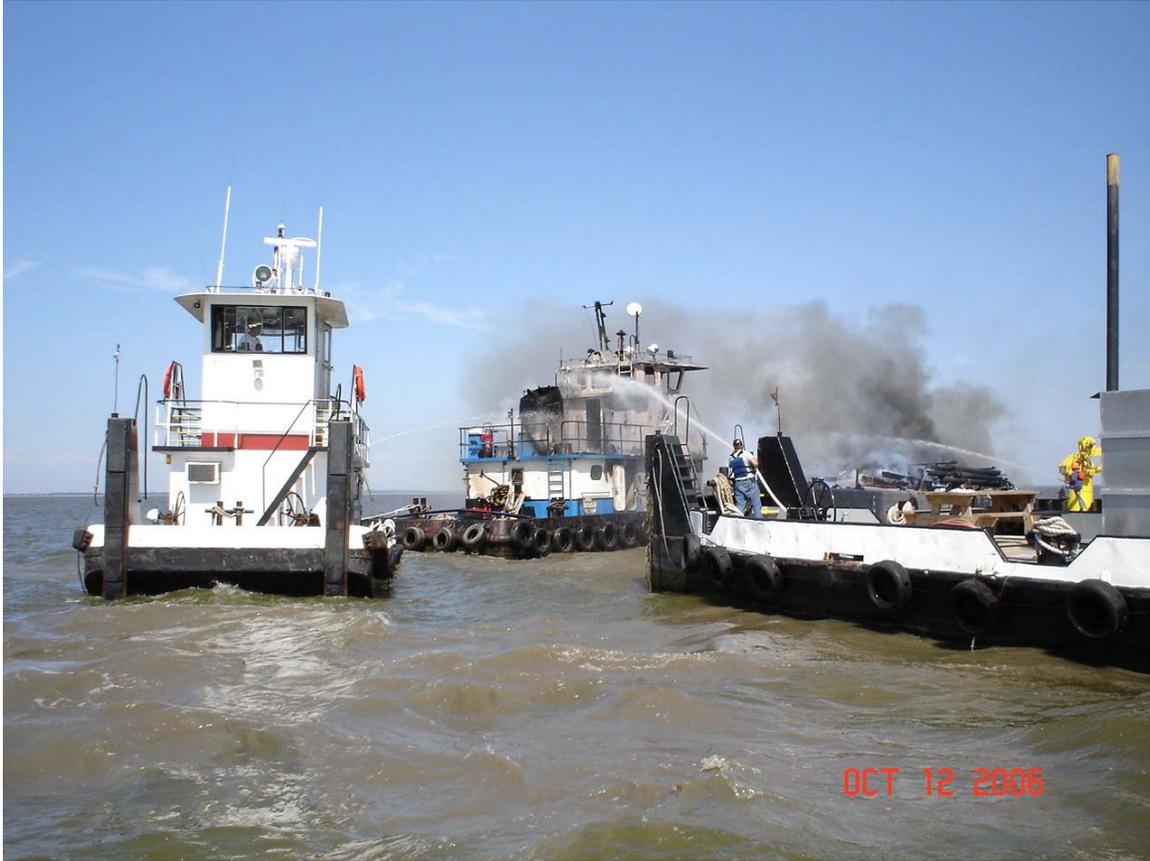
Figure 15. Towboats *Miss Joann* and *Yancy O* fighting the fire on the *Miss Megan* and the deck barge *IBR 234*. (Photo courtesy Louisiana Department of Wildlife and Fisheries)
