National Transportation Safety Board

Factual Report of Operational/Other Factors

Accident No.: DCA08FM002

Accident Type: Allision with Ambrose Light tower, Entrance to New York Harbor

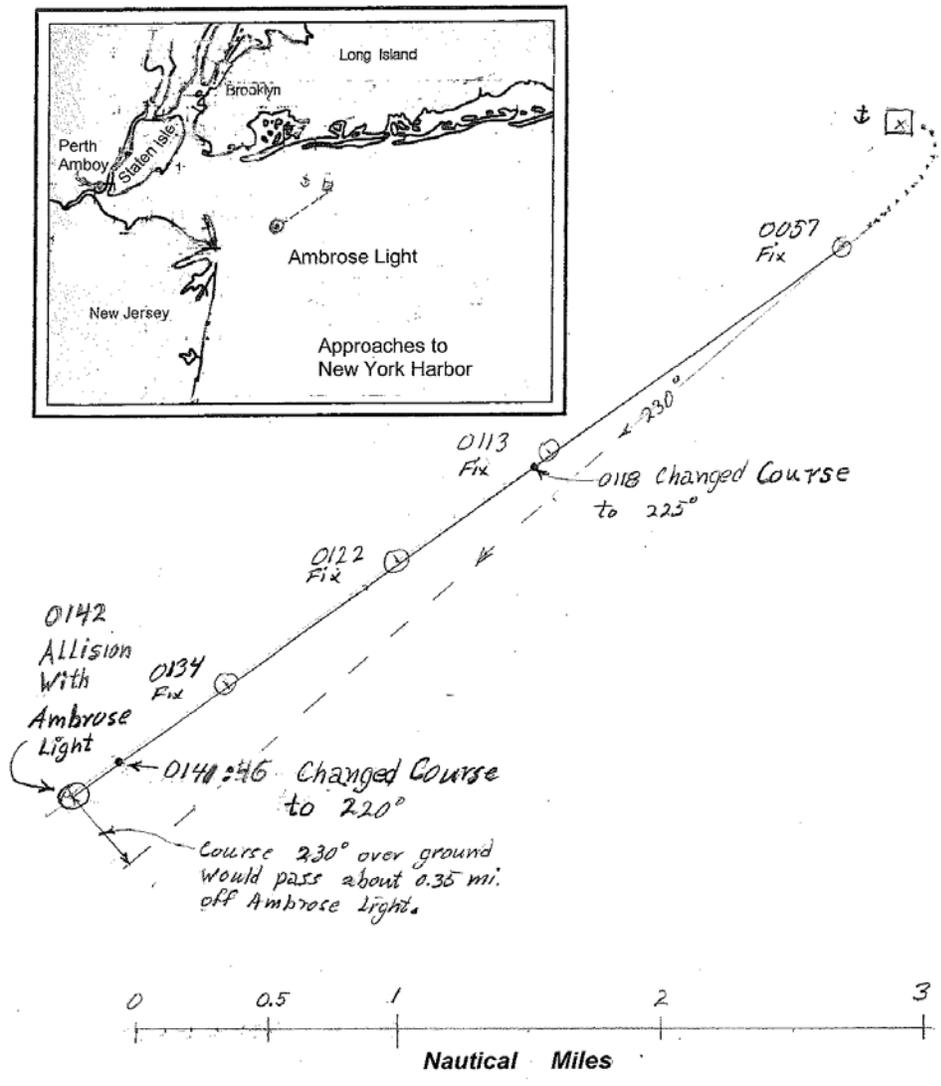
Figure 2. Vessel track to the allision showing fixes plotted by the second officer and locations of course changes.

Second Officer -- Three of the positions plotted on the chart by the second officer showed the vessel setting toward Ambrose Light on a steady bearing of 235°, as follows:

- 0113 - Ambrose Light bearing 235°, range 2.2 miles
- 0122 - Ambrose Light bearing 235°, range 1.6 miles
- 0134 - Ambrose Light bearing 235°, range 0.7 miles

See Figure 2 for the location of the three fixes.

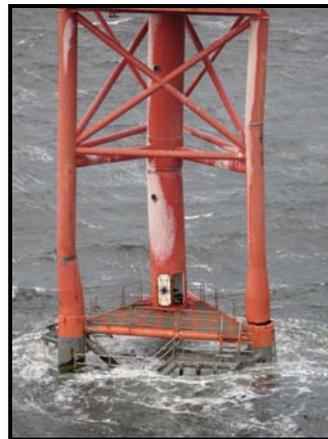
Fig 5. Ambrose Light (Post Allision)¹¹

At 0143:14 the starboard side of the *Axel Spirit* struck the Ambrose Light tower, causing extensive damage to structure and causing the rotating beacon to stop rotating. At this time, the sound of two impacts are heard on the VDR. At 0143:23, a third impact is heard and at this time, the master ordered the rudder to starboard 10°; and at 0143:42 he ordered starboard 20°, and at 0144:06 he ordered hard starboard. At 0144:23, the master is heard to say “we touched” (See Figures 4 and 5, Photos of Ambrose light)

Ambrose Light tower was heavily damaged and was considered beyond repair. Rather than reconstruct a replacement tower or install a large navigation buoy, the Coast Guard decided not to replace the navigation aid. (See Waterway Information section for further discussion relating to Ambrose Light, extending Ambrose Channel, and reconfiguring the pilot area.)

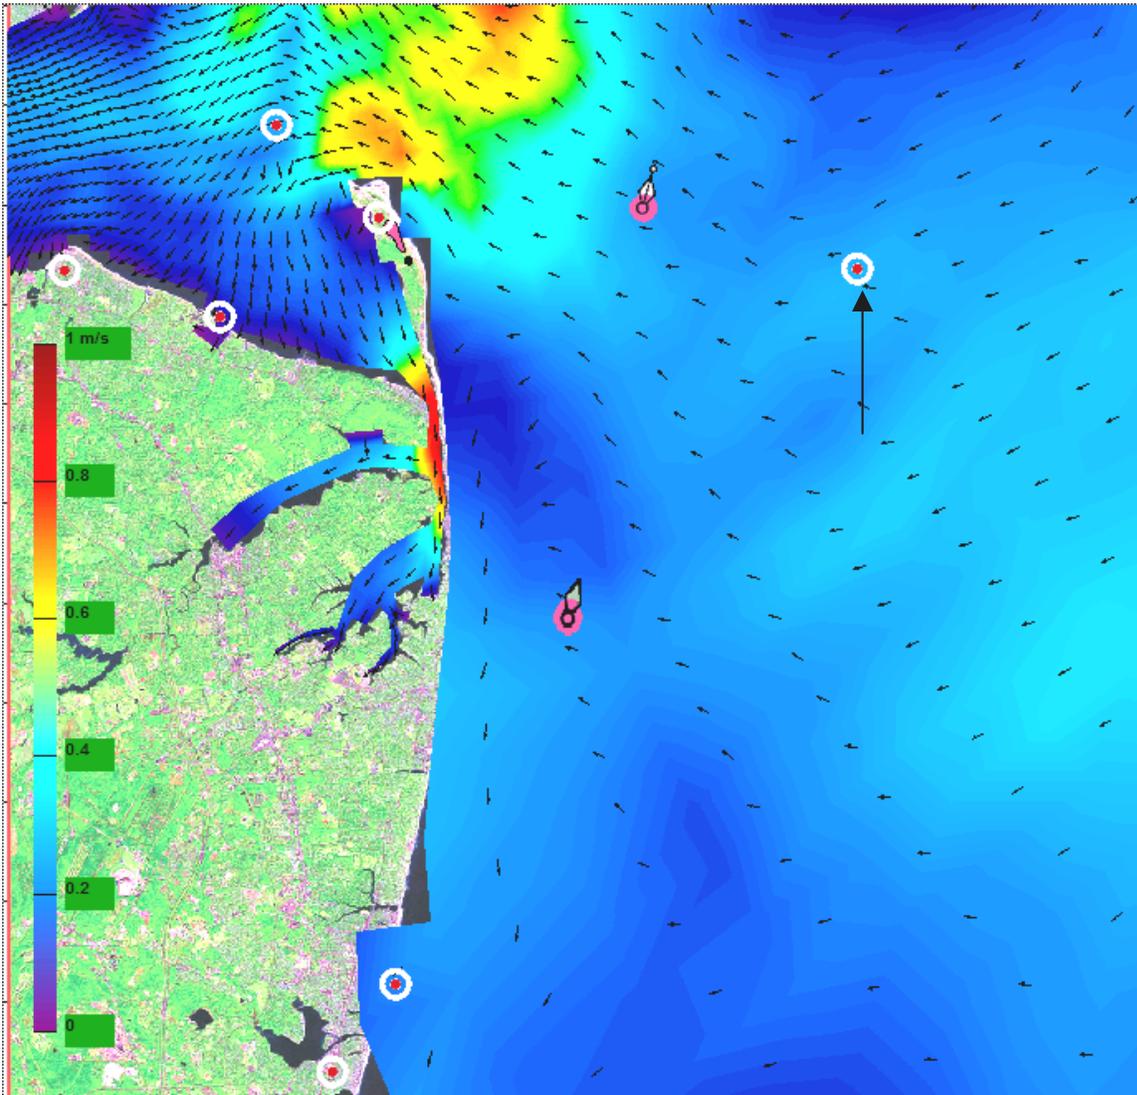
The master estimated that the wind was 22 knots and gusting to 35 Knots from the northeast. The vessel's logbook listed the visibility at 12 miles, wind from the northeast at force 5 to 6 (12 to 21 and 22 to 27 knots). The logbook listed swells from the northeast at 2 meters high (about 6 feet) high. The VDR indicated a wind speed of 15 knots with gusts reaching 30 knots. The master stated that the current, was about one knot or less and was flowing in a westerly direction. See Figure 7 Current direction.

Figure 7. Surface Currents in meters per second (color coded) for November 3, 2007 at 0100 to 0200 EDT. The arrow shows the former location of the Ambrose Light. At that location the current was moving from east to west at about 0.2 to 0.4 meters per second (see the color bar on the left side of the image). From the Stevens Institute of Technology.¹⁶
