National Transportation Safety Board

Safety Recommendation

In reply refer to: H-01-03

Vehicle Group Chairman's Factual Report
(Excerpts)

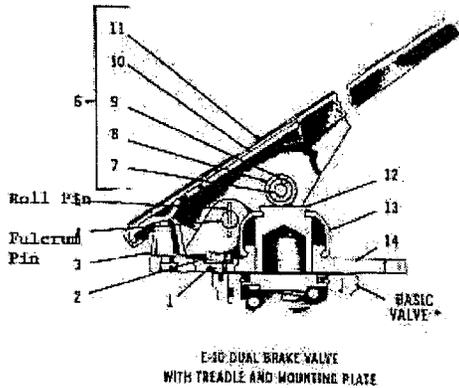
Defects - During Safety Board brake inspections, the brake pedal was found unsecure. The roll pin, which functioned to secure the fulcrum or treadle pin, through the foot pedal and floor mounting plate, was sheared off with a portion of the roll pin remaining in the guide hole of the treadle pin. At the time of inspection, it was observed that the treadle pin had been inserted into the mounting plate backwards. With the roll pin absent, and the treadle pin inserted backwards, the treadle pin was not secured in the mounting bracket.

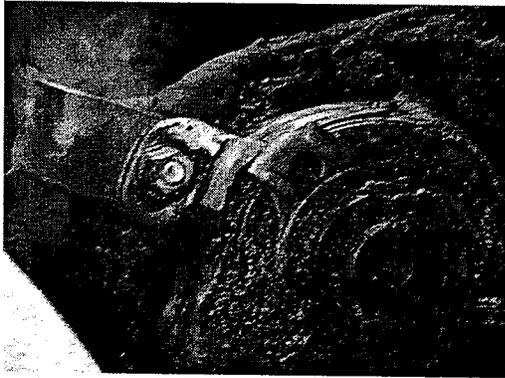
Inspection of the right drive axle slack adjuster revealed that the adjusting hex

Right slack adjuster broken control arm

nut was encrusted in thick, greasy debris. After clearing away the debris from the adjusting nut, the slack adjuster was manually adjusted into an adjustment of approximately 1-½ inches of push rod stroke. While clearing away the greasy road grime from the hex adjusting nut, it was observed that the slack adjuster's control arm was broken and was also covered in greasy road grime. The brakes were then repeatedly

applied and the slack adjuster failed to hold the previously made adjustment. The right drive axle's dual wheel assembly was removed and the slack adjuster, serial number 80310205, was removed for closer visual examination and photographing. The design of the Haldex slack adjuster relies on the proper installation of the slack adjuster, as well as the control arm being securely attached. According to Haldex, the broken control arm bracket would have prohibited the slack adjuster from making automatic brake adjustments as the linings and drums wore.

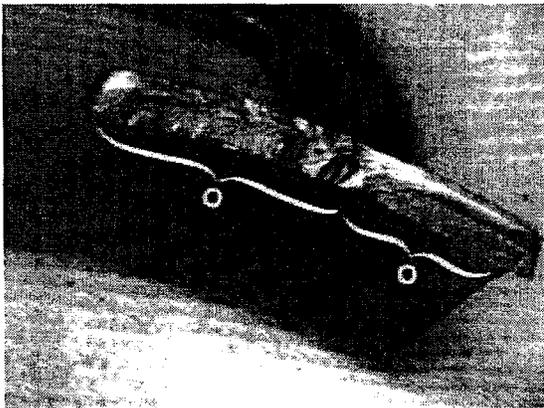
Forensic Examinations – The slack adjuster from the right side drive axle was submitted to the Safety Board Materials Laboratory in Washington, D.C., for further examination. In addition to a metallurgy examination, grease samples from within the slack adjuster were also submitted to determine the type of grease that had been utilized during maintenance intervals. Laboratory analysis indicated that the samples submitted contained a .018 percent concentration of molybdenum disulfide.

Fracture surface of control arm
mechanical damage that obliterated the fracture features.

Metallurgic examinations of the right slack adjuster's control arm indicated the presence of crack arrest marks typical of fatigue. Fatigue progression was observed through at least fifty percent of the wall thickness. The fatigue striations on the fracture surface near the origin also contained corrosion damage. The remaining portion of the fracture contained

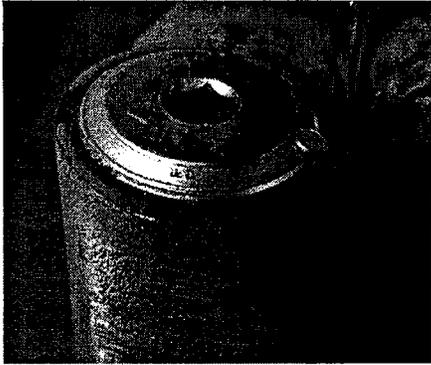
- The internal coil spring force was below factory specifications.
- Brake application pressures were higher.
- Brake application and release times were faster.
- The control arm bracket was slightly constrained in motion, as if fractured and each fracture surface was making contact, or as if the bracket was not secure or properly fastened.

Exposed threads of left adjuster coil spring cover
