**In-Flight Separation of Vertical Stabilizer
American Airlines Flight 587
Airbus Industrie A300-605R, N14053
Belle Harbor, New York
November 12, 2001**

NTSB/AAR-04/04

**NTSB/AAR-04/04
PB2004-910404
Notation 7439B
Adopted October 26, 2004**

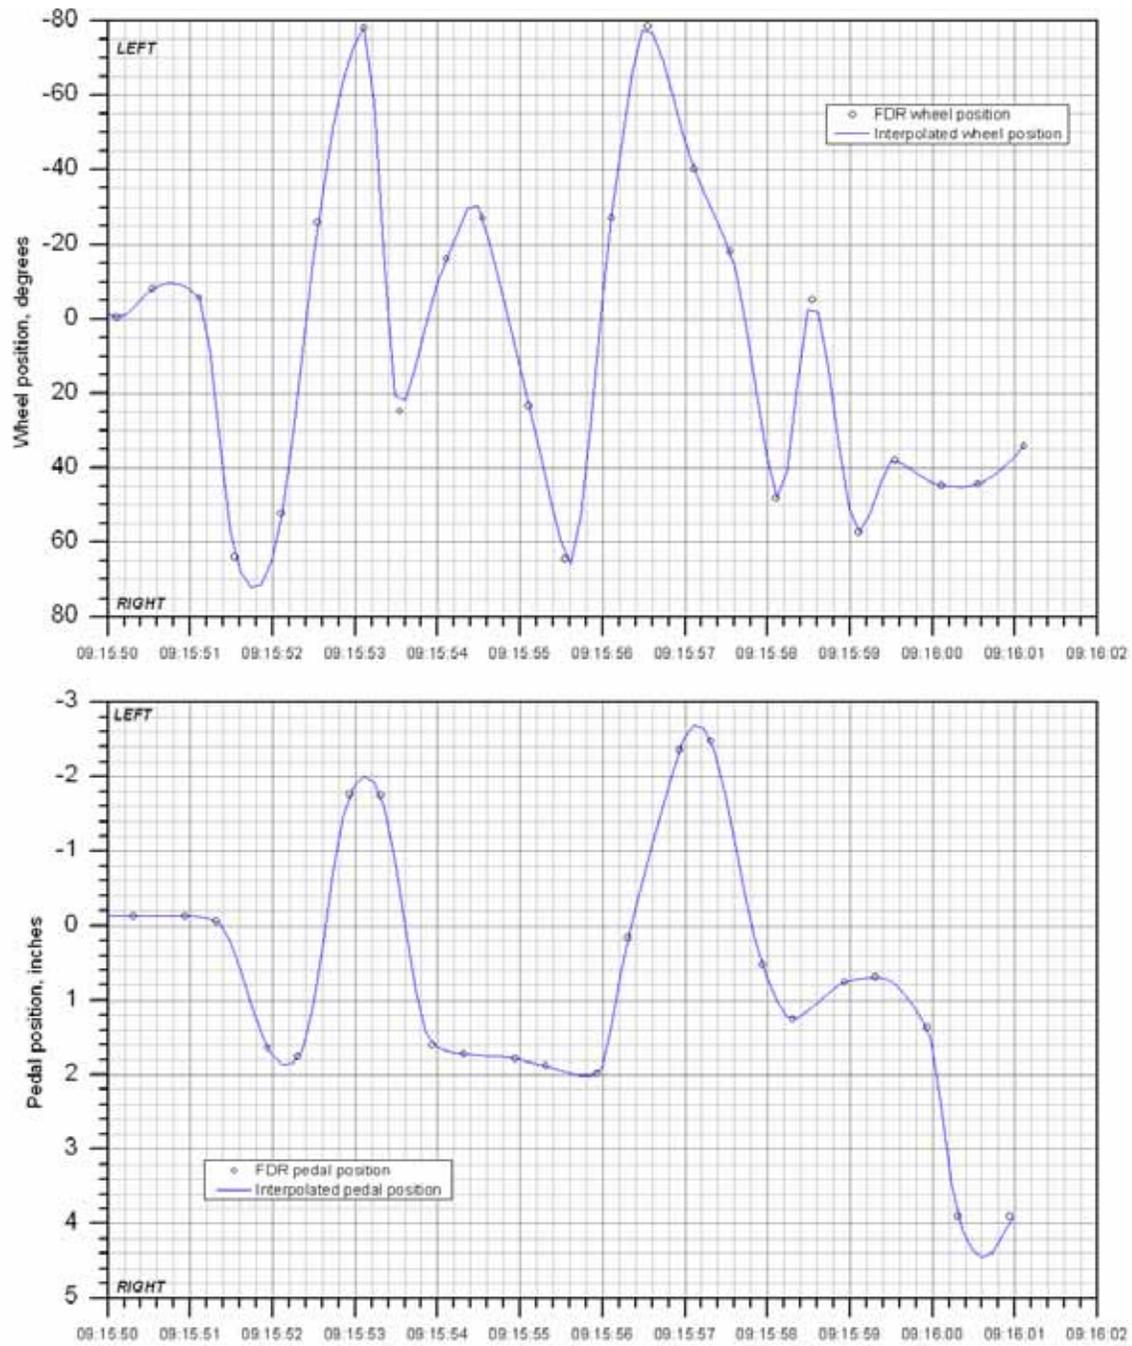
Figure 1. Control Wheel and Rudder Pedal Movements During the Second Wake Encounter

The airplane performance study estimated that, at 0915:53.2, the rudder was deflected 11° to the left,²⁰ and the sideslip angle at the airplane's center of gravity (cg) was about 4° to the left (after peaking temporarily at 5° to the left).²¹ At 0915:56.8, the rudder was deflected 10.2° to the left, and the sideslip angle was about 7° to the left. At 0915:58.4 (the time that the right rear main attachment fitting fractured), the rudder was deflected between 10° and 11° to the right, the sideslip angle was between 11° and 12° to the right,²² and the airplane experienced a 0.2 G shift to the right in lateral load factor.

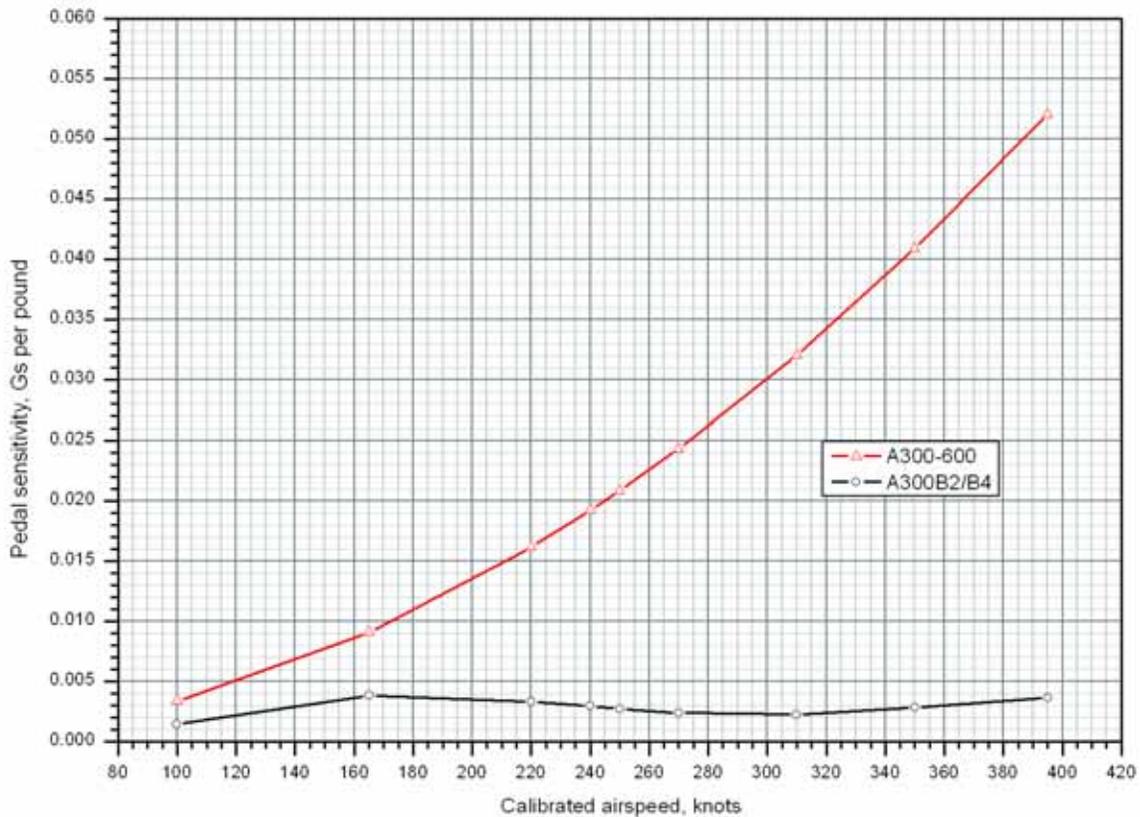
Figure 8. A300-600 and A300B2/B4 Rudder Pedal Sensitivities

The sensitivity of the rudder pedals, measured in this way, is proportional to the square of the airplane's airspeed, the amount of rudder deflection per pedal deflection, and the amount of pedal deflection per pedal force. With either variable ratio or variable stop rudder control systems, the amount of pedal deflection per pedal force remains constant. For airplanes with variable ratio systems, as airspeed increases, the amount of rudder deflection per pedal deflection decreases, which offsets the effect of increasing airspeed and keeps the pedal sensitivity relatively constant. For airplanes with variable stop

systems (such as the A300-600), the rudder deflection per pedal deflection remains constant, so the sensitivity of the pedals increases with the square of the airspeed. These characteristics are illustrated in figure 8, which compares the A300-600 and A300B2/B4 rudder pedal sensitivities as a function of airspeed and shows that the A300-600 is twice as responsive to a pedal displacement at 250 knots KCAS than at 165 KCAS.

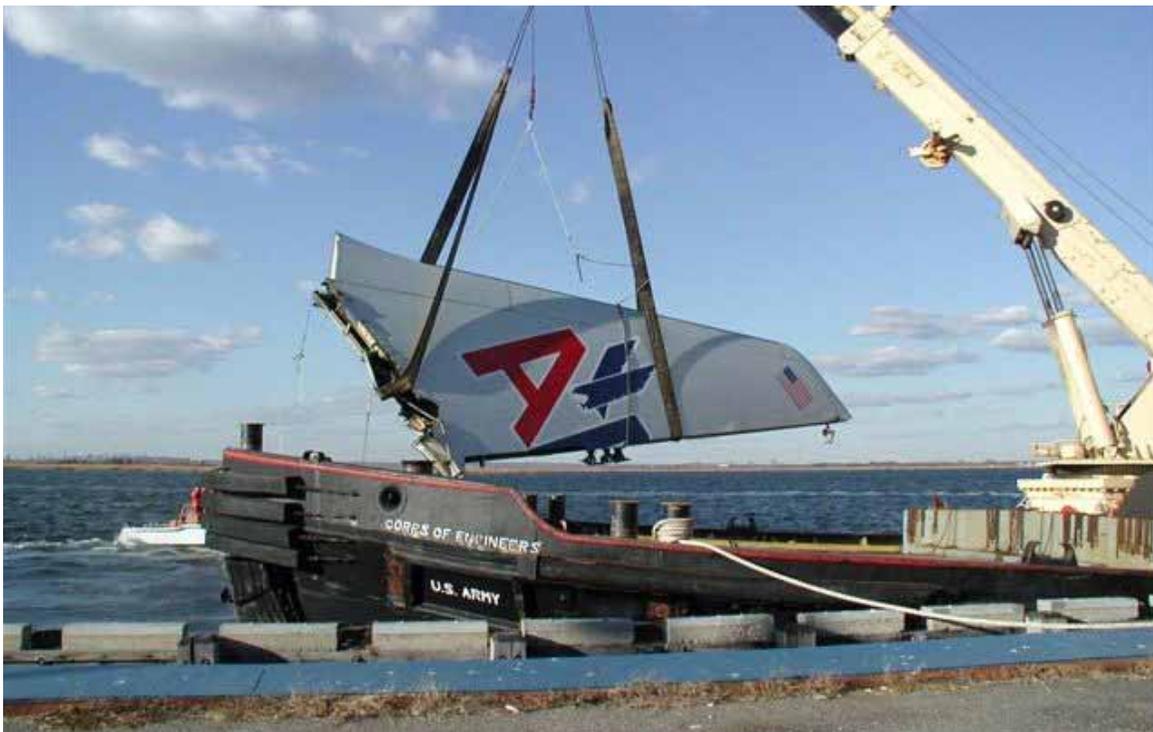
Figure 11. Vertical Stabilizer After Recovery From Jamaica Bay

The vertical stabilizer was mostly intact. The left and right skin panels did not exhibit any significant damage, but the six main attachment fittings and the three pairs of transverse load fittings were fractured.

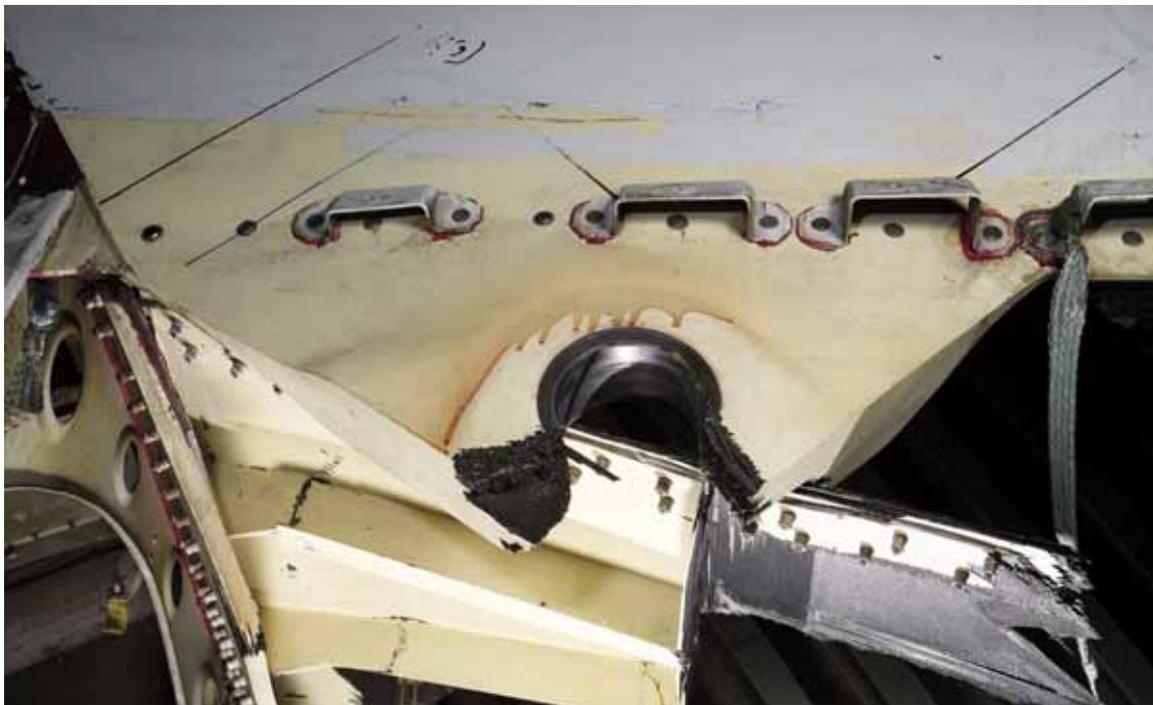
Figure 12. Right Rear Main Attachment Fitting

The right rear main attachment fitting fractured at the lughole (see figure 12). The right center main attachment fitting remained attached to the aft fuselage but separated from the vertical stabilizer when it fractured just above ribs 1 and 4 and the skin/stringer interface. The right forward main attachment fitting fractured at the lughole. The left rear main attachment fitting assembly (that is, the inboard and outboard fitting assembly halves and the lug portion of the skin laminate) fractured from the vertical stabilizer but remained attached to the aft fuselage. The left center main attachment fitting separated from the vertical stabilizer at the fastener line along the rib 1 attach angle. The left forward main attachment fitting fractured at the lughole, but the lower part of the fitting remained attached to the aft fuselage.⁸⁸

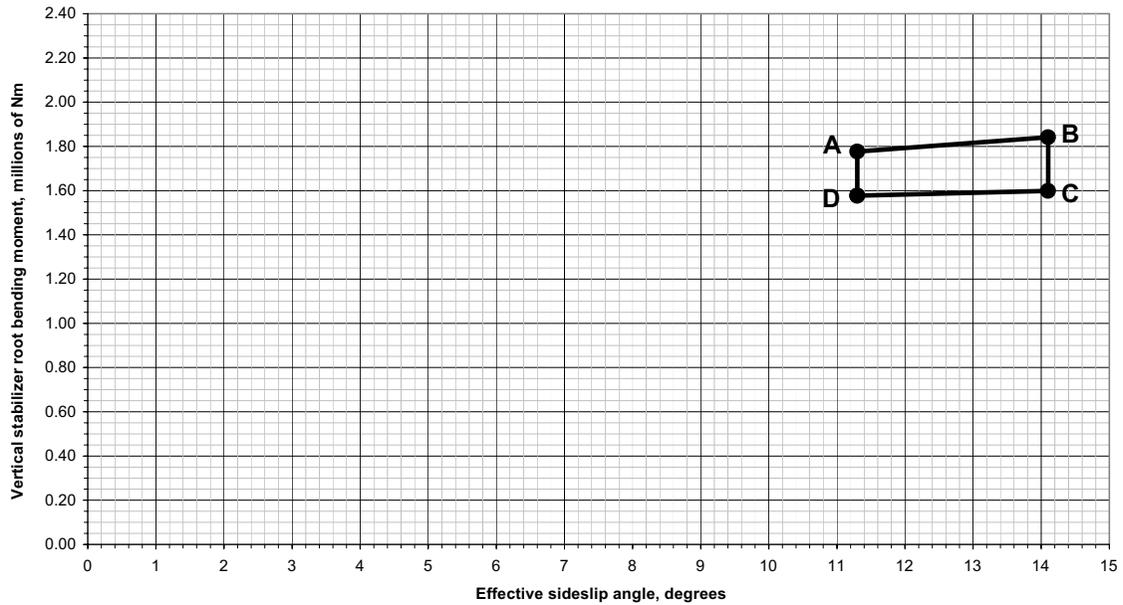
Figure 14. Bending Moment Load Range at the Time of Vertical Stabilizer Separation

Note: The calculated range of the root bending moment is defined by points A through D, which are described in addendum 2 to the airplane performance study. See the public docket for this accident for more information.

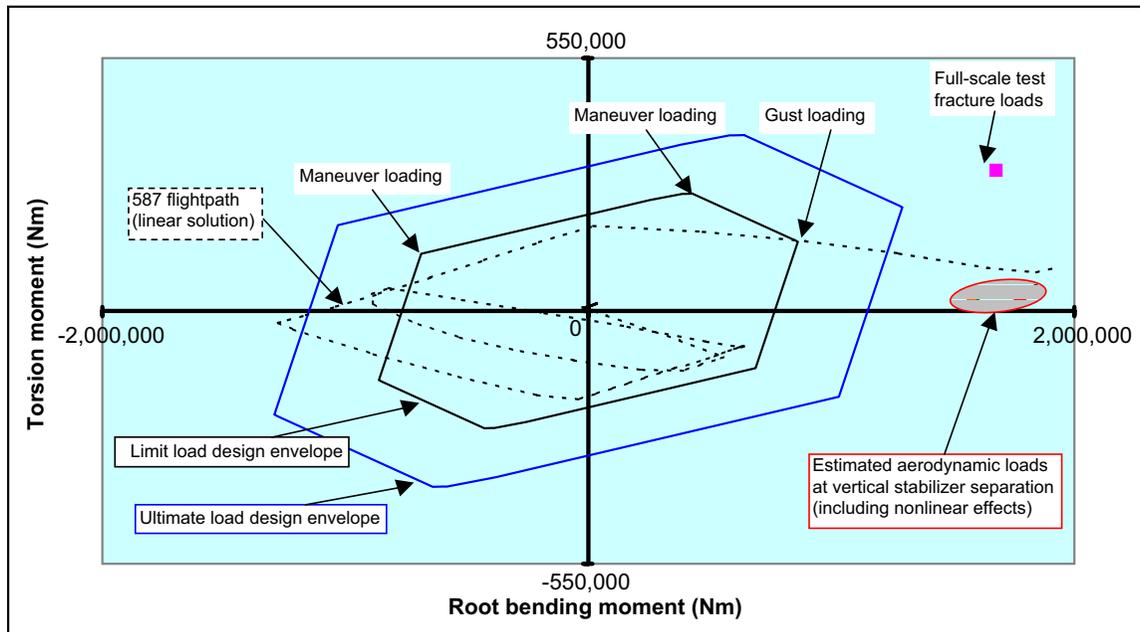
Figure 15. Estimated Aerodynamic Loads in Relation to the Torsion Versus Bending Correlated Shear Force Diagram

Note: The four triangles correspond to the four points in figure 14. Specifically, the red triangle is point A, the gray triangle is point B, the green triangle is point C, and the orange triangle is point D.

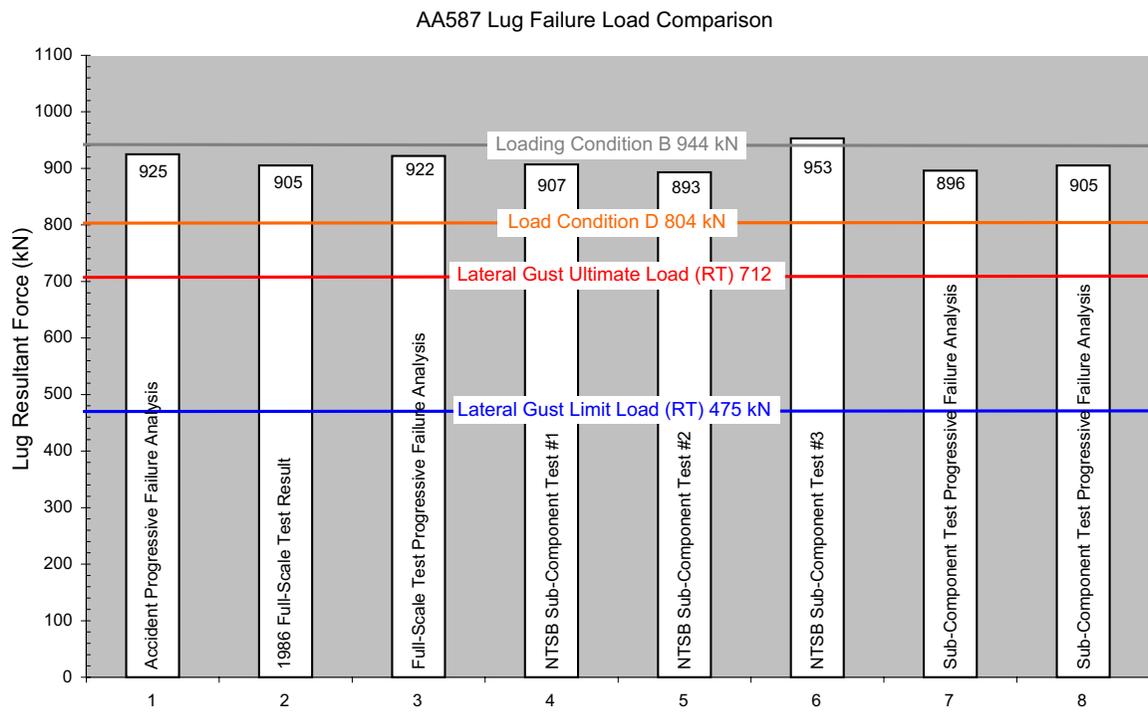
Figure 16. Comparison of Lug Forces at the Time of Fracture

NASA's and Airbus' FEA models determined that failure of the right rear main attachment lug was the most probable initial failure. The FEA models and NASA's PFA model also determined that the failure initiated at the final observed maximum vertical stabilizer root bending condition during the accident flight, when the vertical stabilizer

was subjected to a global root bending moment of more than two times the value defined by the limit load design envelope. (As previously stated, for certification, the vertical stabilizer is only required to support loads of 1.5 times limit load without catastrophic failure.) The structural analyses showed that the large aerodynamic loading produced by the accident scenario would result in the right rear main attachment lug experiencing reaction forces and associated stresses that were equivalent to those that produced lug fractures in the Airbus full-scale certification test (lateral gust condition) and the Safety Board’s static lug tests. Figure 16 compares the resultant lug forces at the time of fracture for the tests and analyses that were pertinent to the flight 587 investigation.

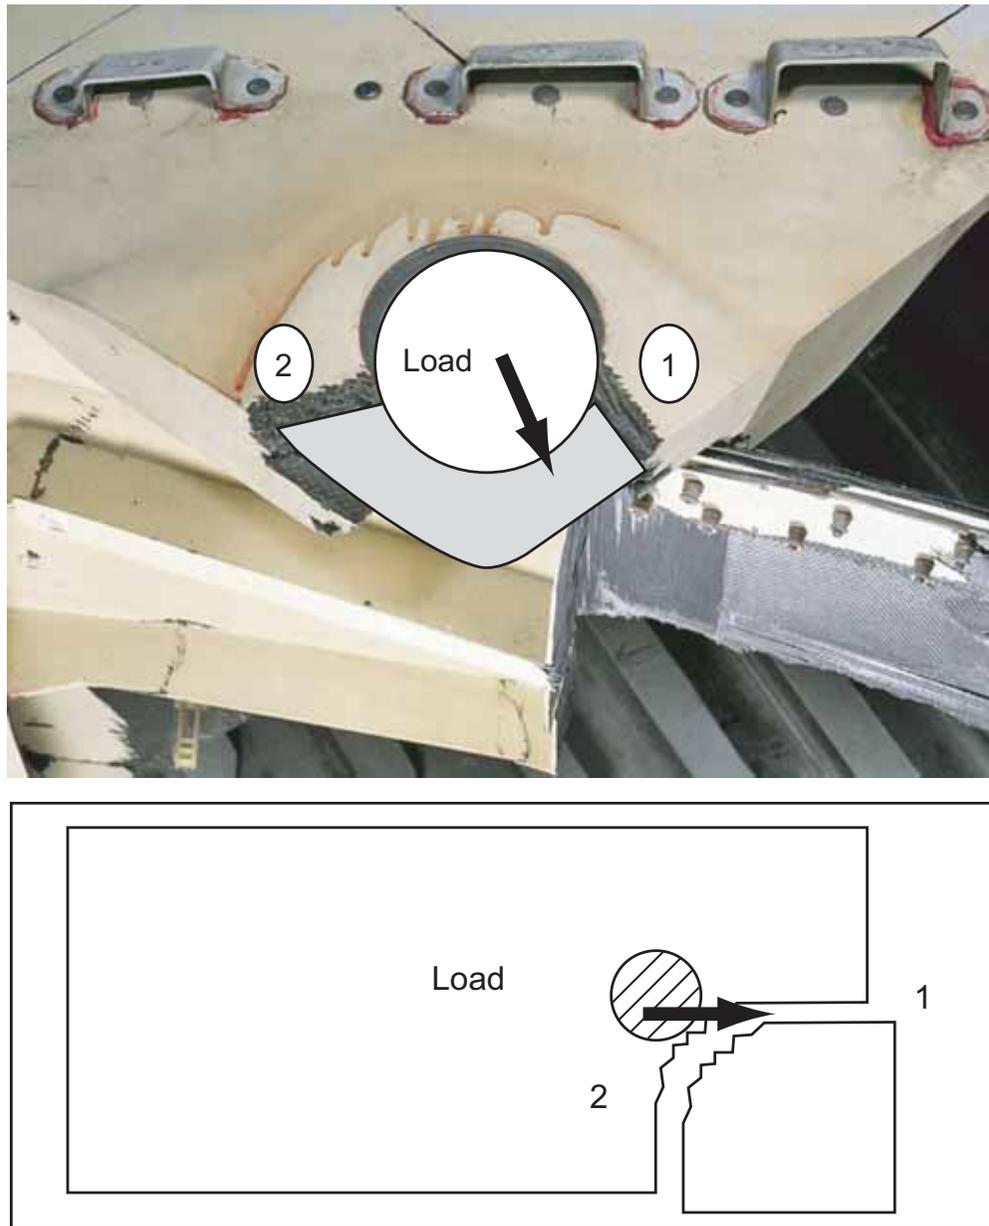
Figure 17. Load on the Flight 587 Right Rear Main Attachment Lug and a Depiction of the Cleavage-Tension Failure Mode

The stresses developed exceeded the strength values for the CFRP material used in the manufacturing of the lugs; thus, the accident lug and the tested lugs fractured because of a tensile static overload. The physical evidence and the structural analyses showed that the accident lug’s and the tested lugs’ fracture features were consistent with a cleavage-tension failure observed in composite-bolted joints. Figure 17 shows the load on the flight 587 right rear main attachment lug and a depiction of the cleavage-tension failure mode.

Note: Number 1 is the initiating fracture, and number 2 is the secondary fracture. The circle indicates the location of the pin and bushing, which were missing from the lug when it was found in the wreckage.
