Collision of Metrolink Train 111 With
Union Pacific Train LOF65-12
Chatsworth, California
September 12, 2008

NTSB/RAR-10/01

National Transportation Safety Board

Railroad Accident Report

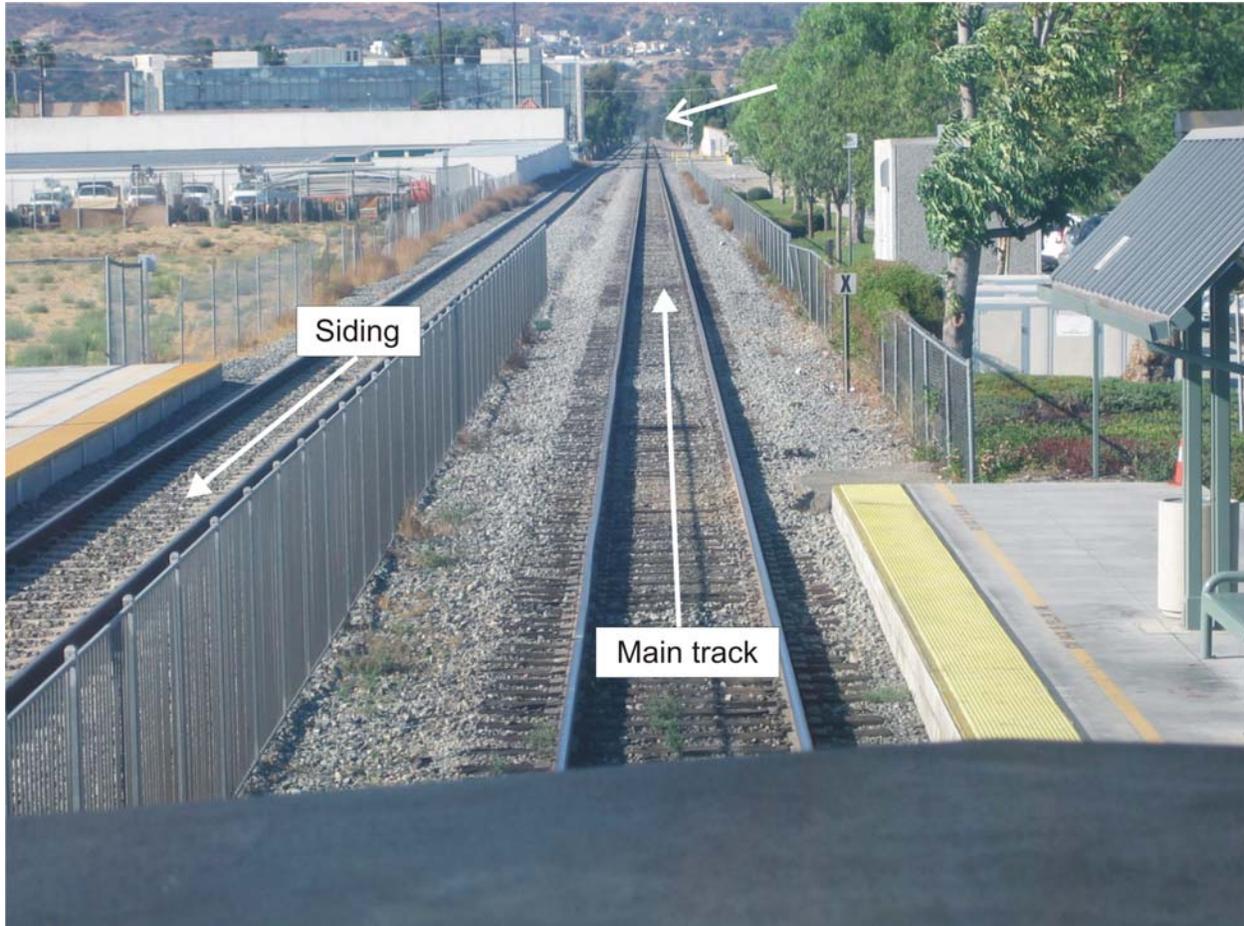
Figure 3. CP Topanga as viewed from the cab of a locomotive positioned at Chatsworth station. Upper arrow indicates approximate location of the CP Topanga signal, which is about 5,288 feet away.

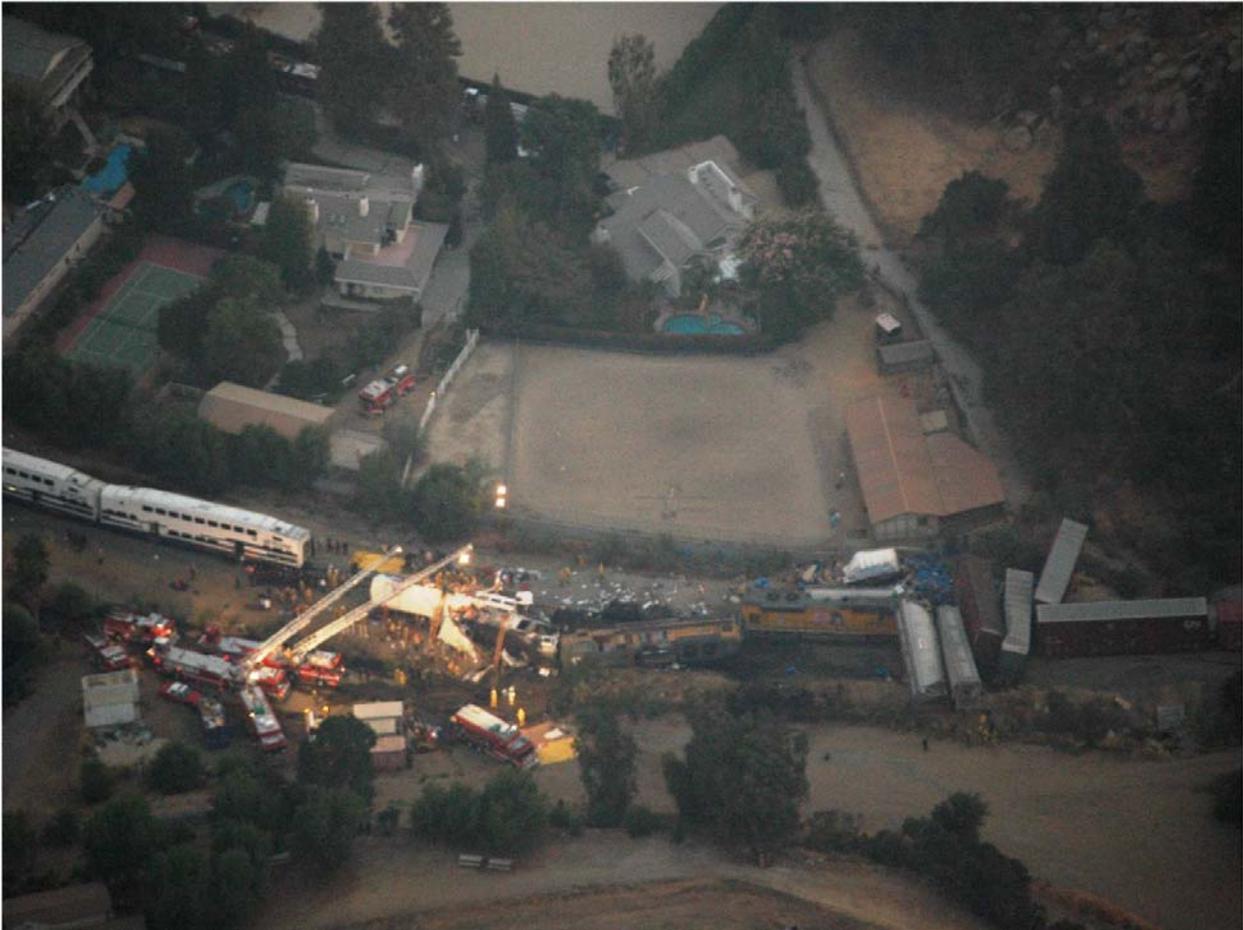
Figure 4. Overview of accident scene looking south.

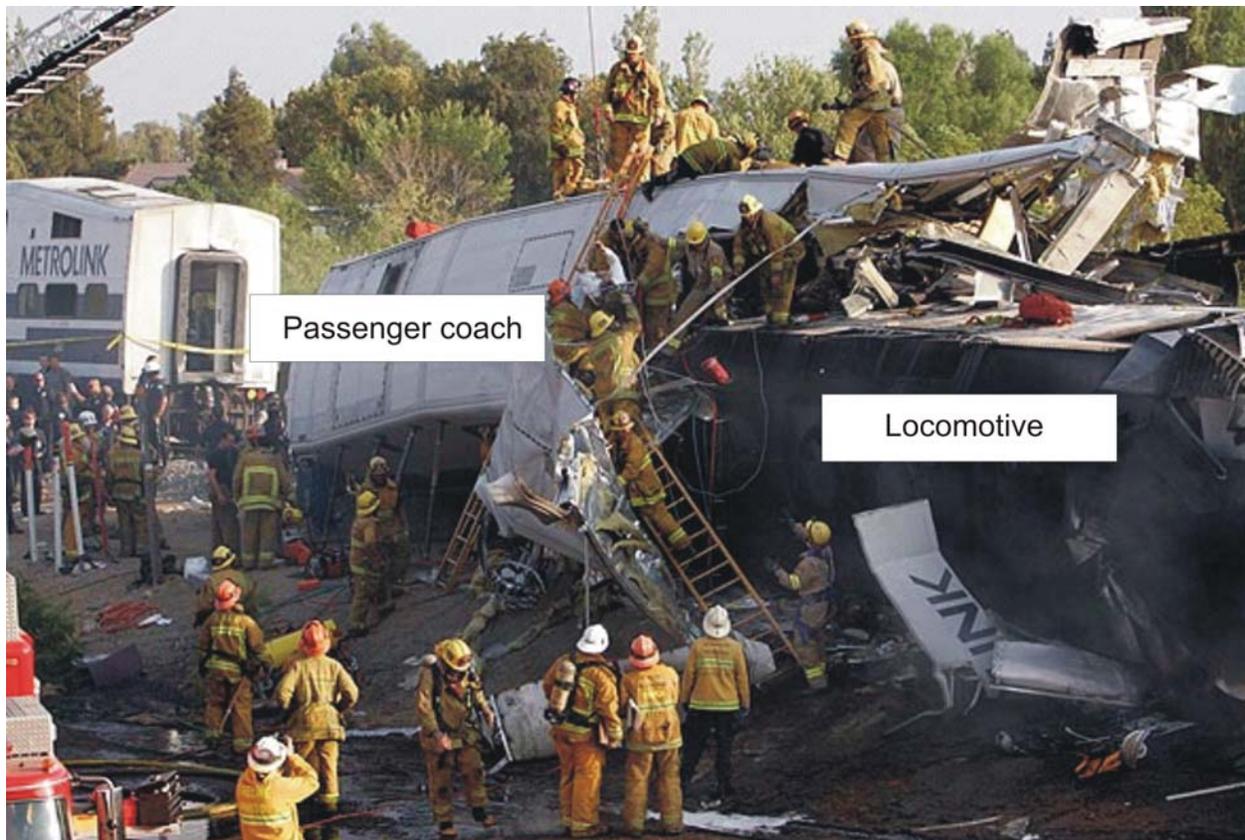
Locomotive. The Metrolink locomotive, which had been operating in a cab-forward orientation, came to rest on its right side (relative to its normal direction of travel) with the locomotive carbody longitudinally oriented roughly parallel to the track centerline. Obvious severe collision impact damage was evident on the front end, both side panel areas, the operator's cab, and aft end of the locomotive. The locomotive's front end was firmly wedged against the front end of the lead UP locomotive, and its aft end penetrated the leading bulkhead panel of the passenger coach to which it was coupled. The rear portion of the locomotive came to rest within the confines of the occupant compartment of that first passenger car. In this position, the locomotive carbody occupied approximately 52 feet, or approximately the forward two-thirds, of the passenger coach. (See figure 6.)

Figure 6. The force of the collision drove the Metrolink locomotive about 52 feet into the passenger space of the first coach behind the locomotive.

The operator's cab, which had been occupied solely by the train engineer, sustained a complete loss of survivable space. Post-recovery measurements of the locomotive indicated that the front and rear ends of the unit had been compressively displaced by about 15 feet and about 1 foot, respectively. The locomotive had thus, as a result of the collision, compressed from its original 58-foot length to a length of about 42 feet.

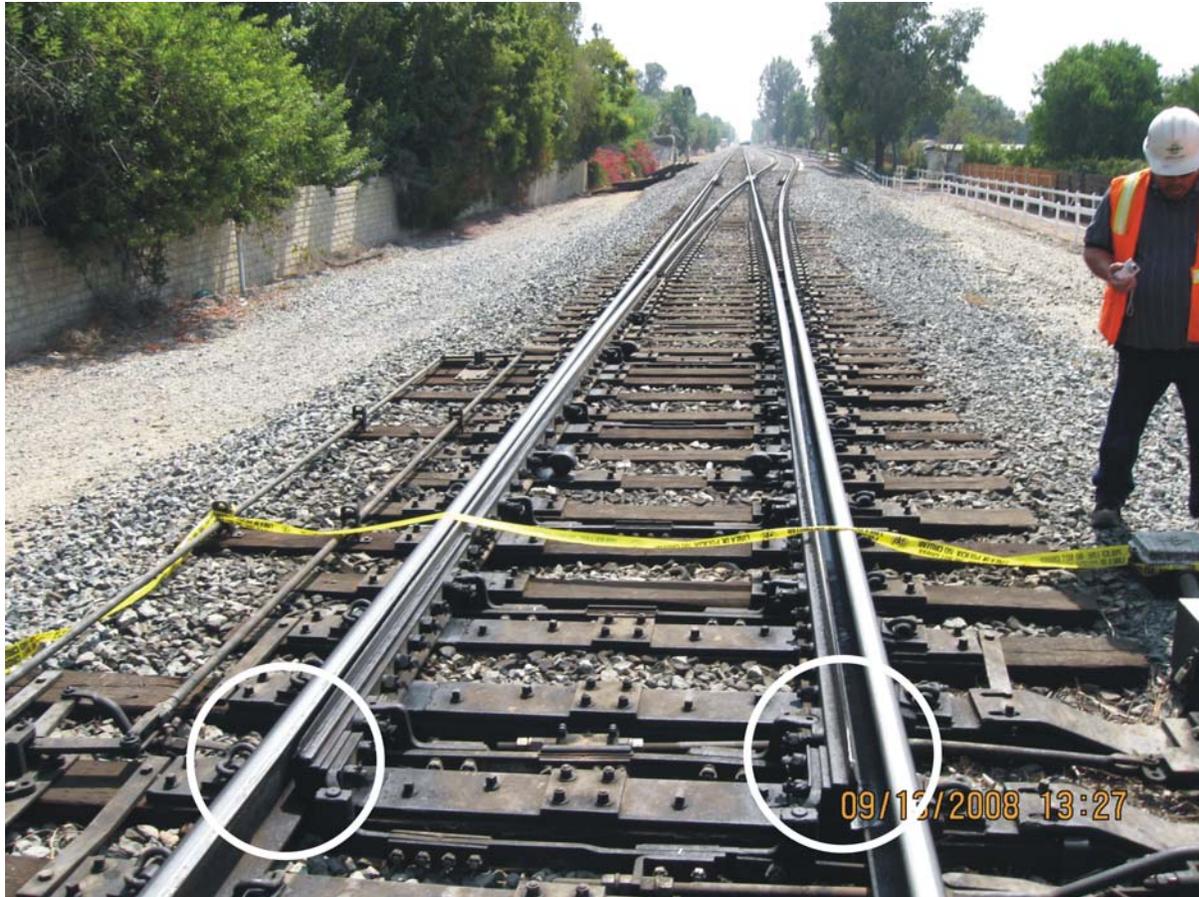
Investigators examined the power switch machine at CP Topanga and found the switch points split in mid-stroke, indicating that the switch had been run through in the trailing position.³¹ (See figure 7.) Additional visual inspection revealed that the throw-rod, basket rod, and switch machine internal throw-rod were bent and damaged. Because of the nature and extent of the damage, Metrolink signal personnel had to replace the switch machine.

Figure 7. CP Topanga switch looking east, in the direction the Leesdale Local was traveling. Circles highlight damage to switch points and components consistent with the switch having been run through in a trailing point movement by the Metrolink train traveling in the opposite direction.

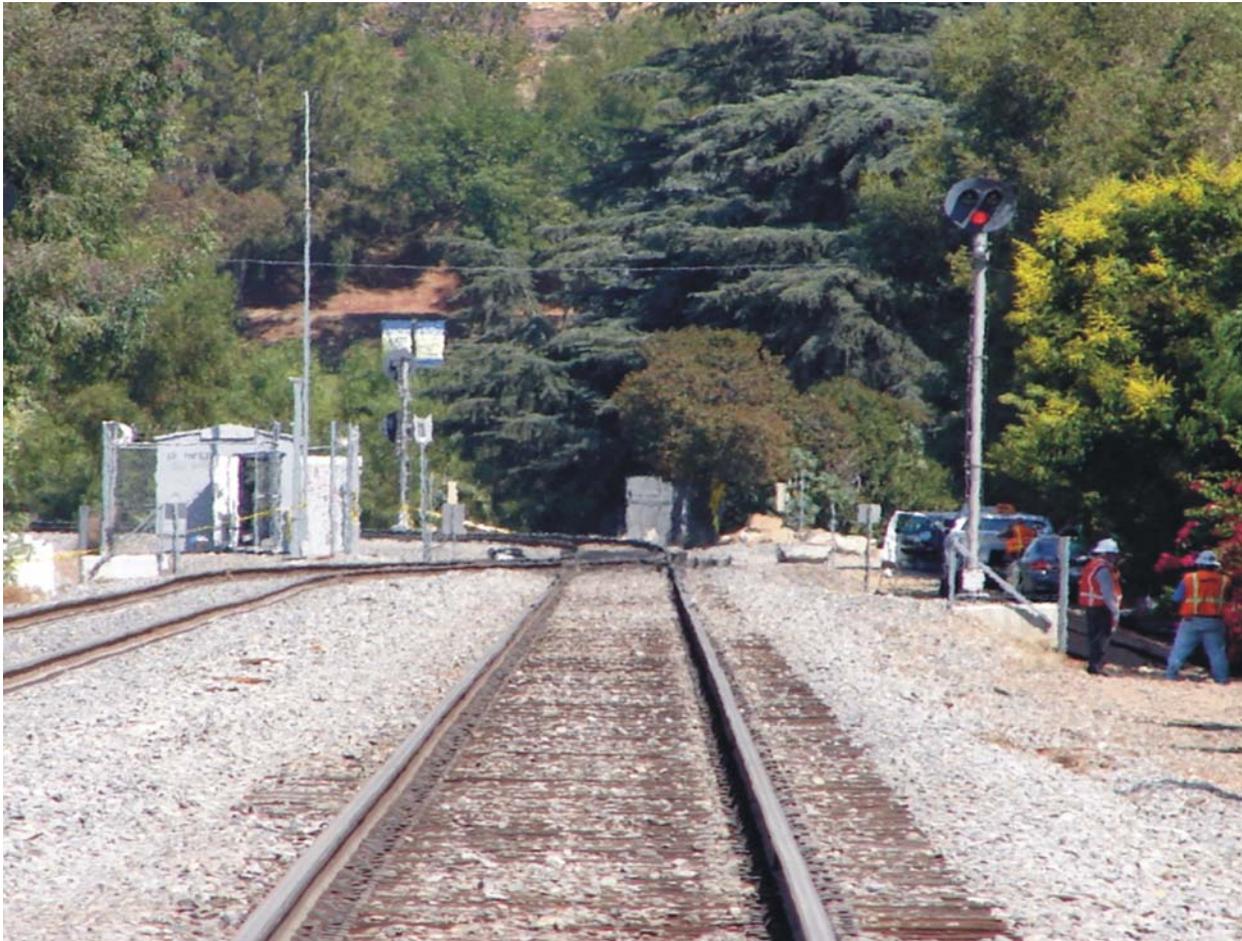
Figure 8. Westbound signal at CP Topanga displaying a red aspect (indicating stop.)

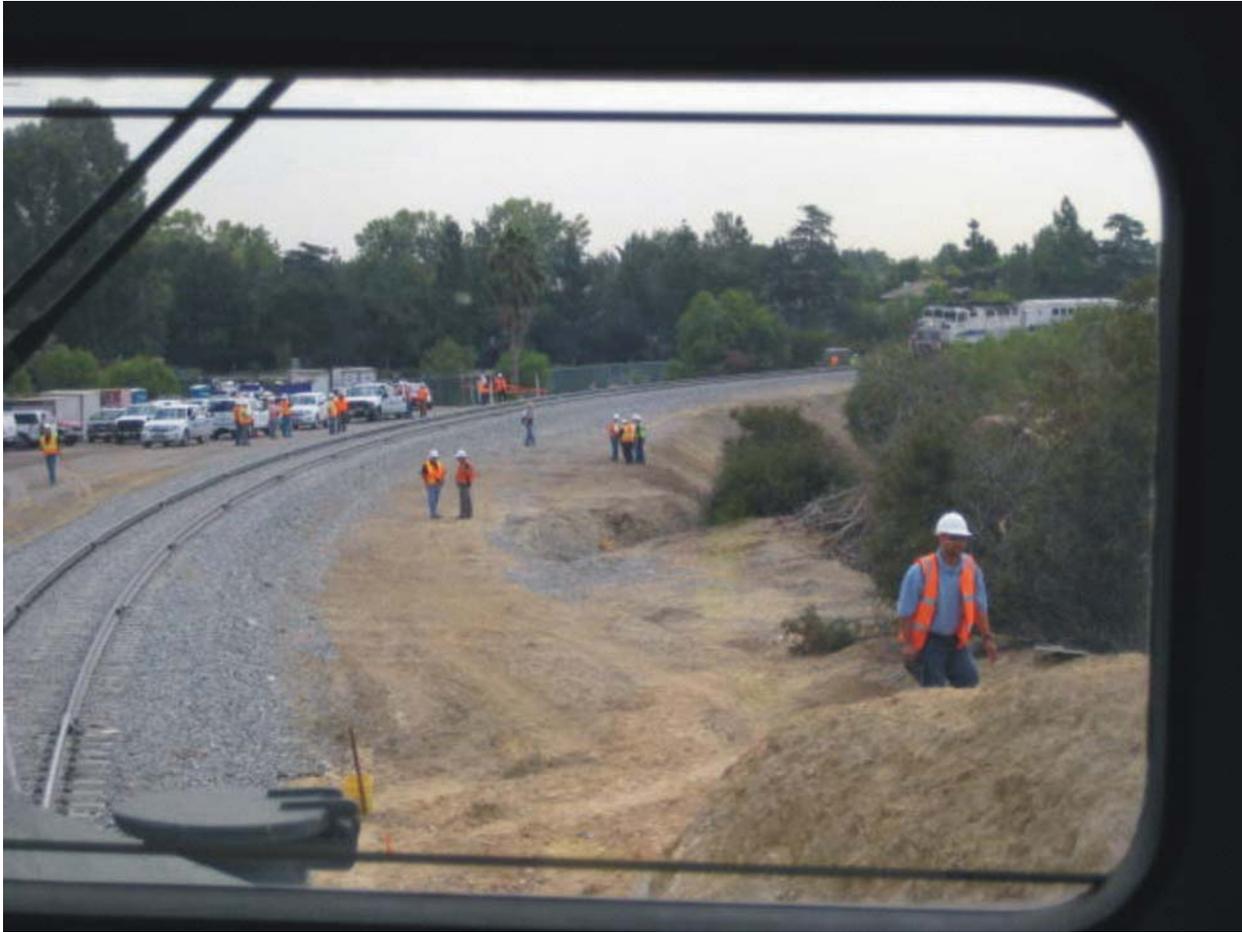
For the sight-distance tests, exemplar locomotives simulating those of the Metrolink and UP trains were positioned facing each other at the point of collision. The locomotives were then moved away from each other in intervals of 60 feet (representing the approximate distance a 40-mph train will travel in 1 second) until the engineer aboard each locomotive could not see the other train. These tests revealed that each engineer's first view of the opposing train would have occurred when the trains were about 540 feet apart. At that point, at a closing speed of about 80 mph, the trains would have been 4 to 5 seconds from impact. (See figure 12.)

Figure 12. View from the head end of a simulated Leesdale Local during train sight-distance testing. At a closing speed in excess of 80 mph, the trains would be only seconds from impact as the Metrolink train becomes visible around the curve.
