Runway Overrun  
American Airlines Flight 2253  
Boeing 757-200, N668AA  
Jackson Hole, Wyoming  
December 29, 2010

NTSB/AAR-12/01  
PB2012-910401

# Aircraft Incident Report

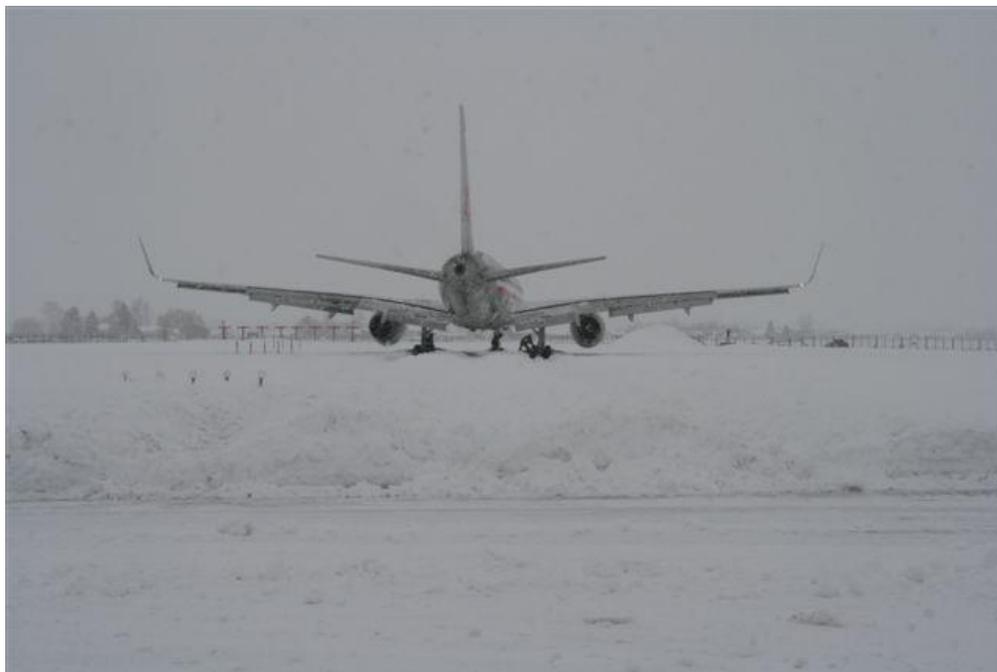
**Figure 1.** A photograph of the incident airplane, viewed from behind, where it came to a stop in the snow off the departure end of runway 19 at JAC.

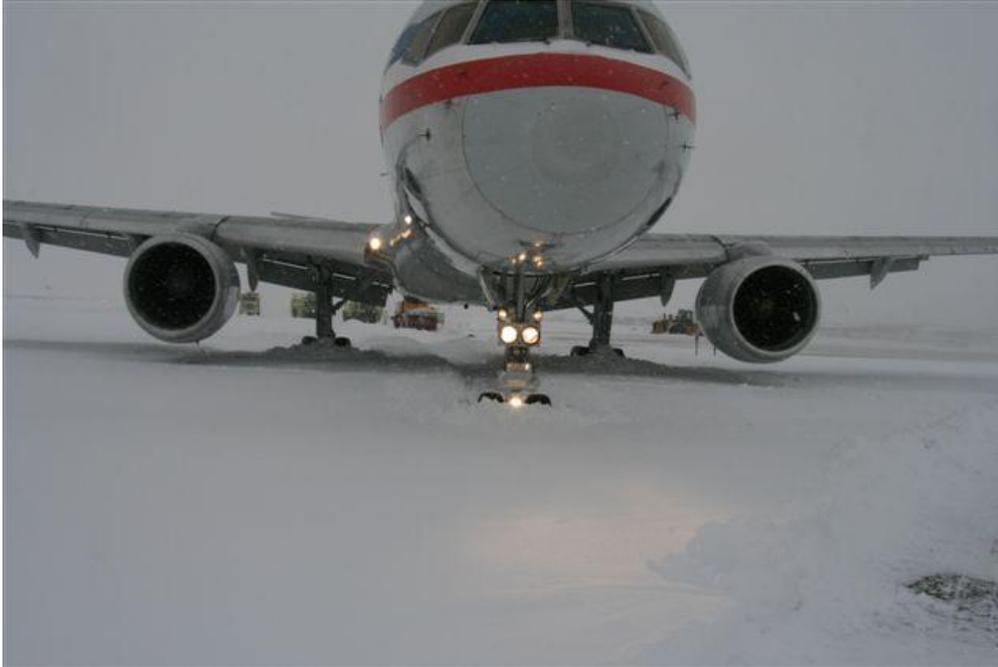
**Figure 2.** A photograph of the front of the incident airplane where it came to a stop in the snow off the departure end of runway 19 at JAC.

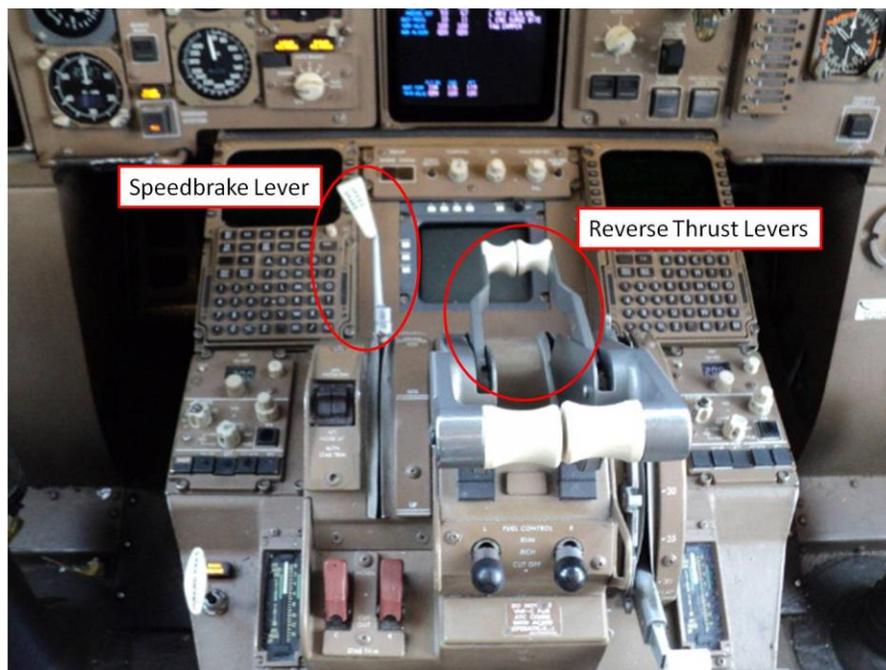
**Figure 3.** A photograph of the center console in the incident airplane’s cockpit, with the reverse thrust lever and speedbrake levers marked.

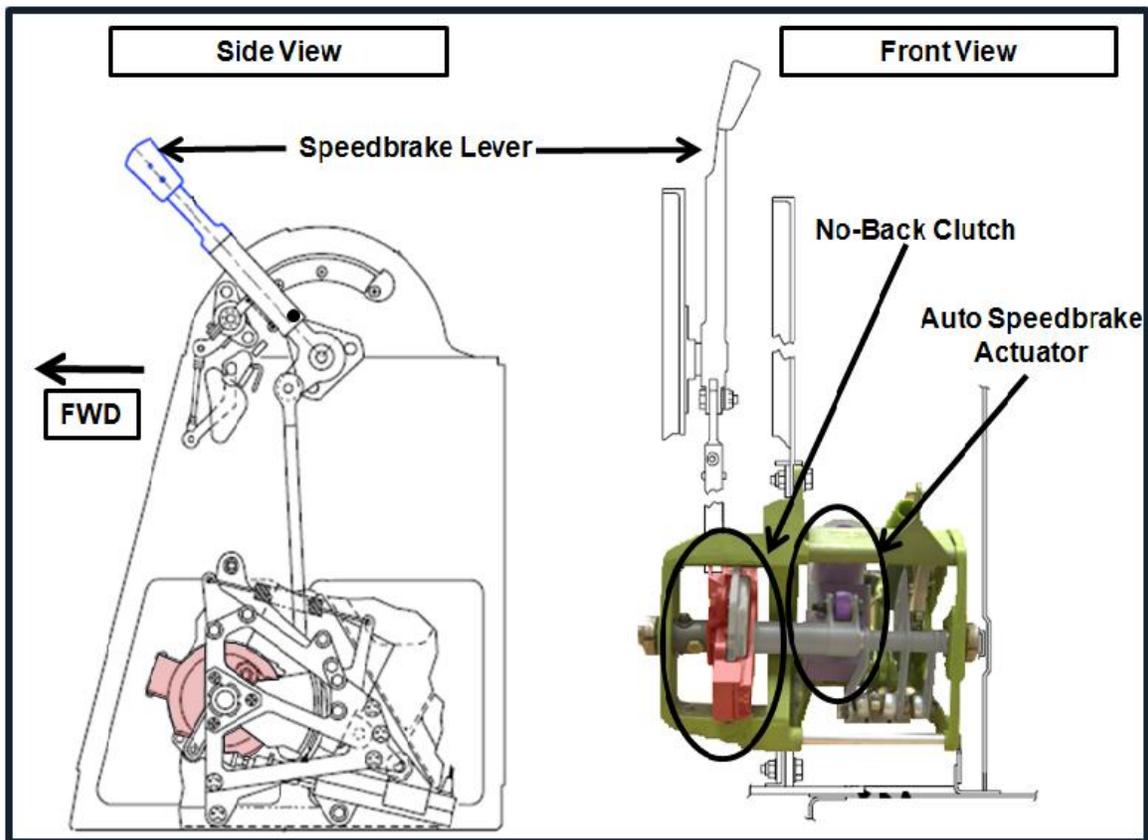
Initial examination and testing of the incident airplane’s automatic speedbrake system and its components revealed no evidence of a malfunction that would have prevented normal operation during the incident landing.<sup>33</sup> However, the automatic speedbrake mechanism was removed and examined after the incident airplane experienced another automatic speedbrake system nondeployment on March 31, 2011.<sup>34</sup> This examination revealed a latent assembly defect in the no-back clutch mechanism<sup>35</sup> that intermittently prevented the speedbrake actuator from automatically driving the speedbrake lever beyond its armed detent to extend the speedbrakes. Specifically, one of the four speedbrake lever braking pins was improperly secured, which allowed it to intermittently rotate within its assembly and prevented the no-back clutch from transmitting the torque from the automatic speedbrake actuator to the speedbrake lever. Additional testing showed that this condition would only occur when the actuator was attempting to drive the speedbrake lever towards the “up” (speedbrakes extended) position and would not occur when the actuator was retracting the speedbrake lever. Further, it was noted that this defect only affected the speedbrakes’ automatic deployment function and would not have prevented the pilots from manually deploying the speedbrakes. Figure 4 contains two diagrams showing the cockpit center console, the speedbrake lever and its linkages, and components of the automatic speedbrake system. The no-back clutch mechanism has been highlighted in the side view

**Figure 4.** Two diagrams showing the cockpit center console, the speedbrake lever and its linkages, and components of the automatic speedbrake system. The no-back clutch mechanism has been highlighted in the side view diagram on the left. A photograph of the speedbrake actuator and no-back clutch mechanisms has been superimposed on the front view to show those components' relative positions within the center console.

The NTSB concludes that a manufacturing defect in the incident airplane’s speedbrake no-back clutch mechanism prevented the speedbrakes from automatically deploying during the incident landing.
