NTSB National Transportation Safety Board

Office of Highway Safety

Collapse Sequence and Postaccident Activities

James F. Wildey II

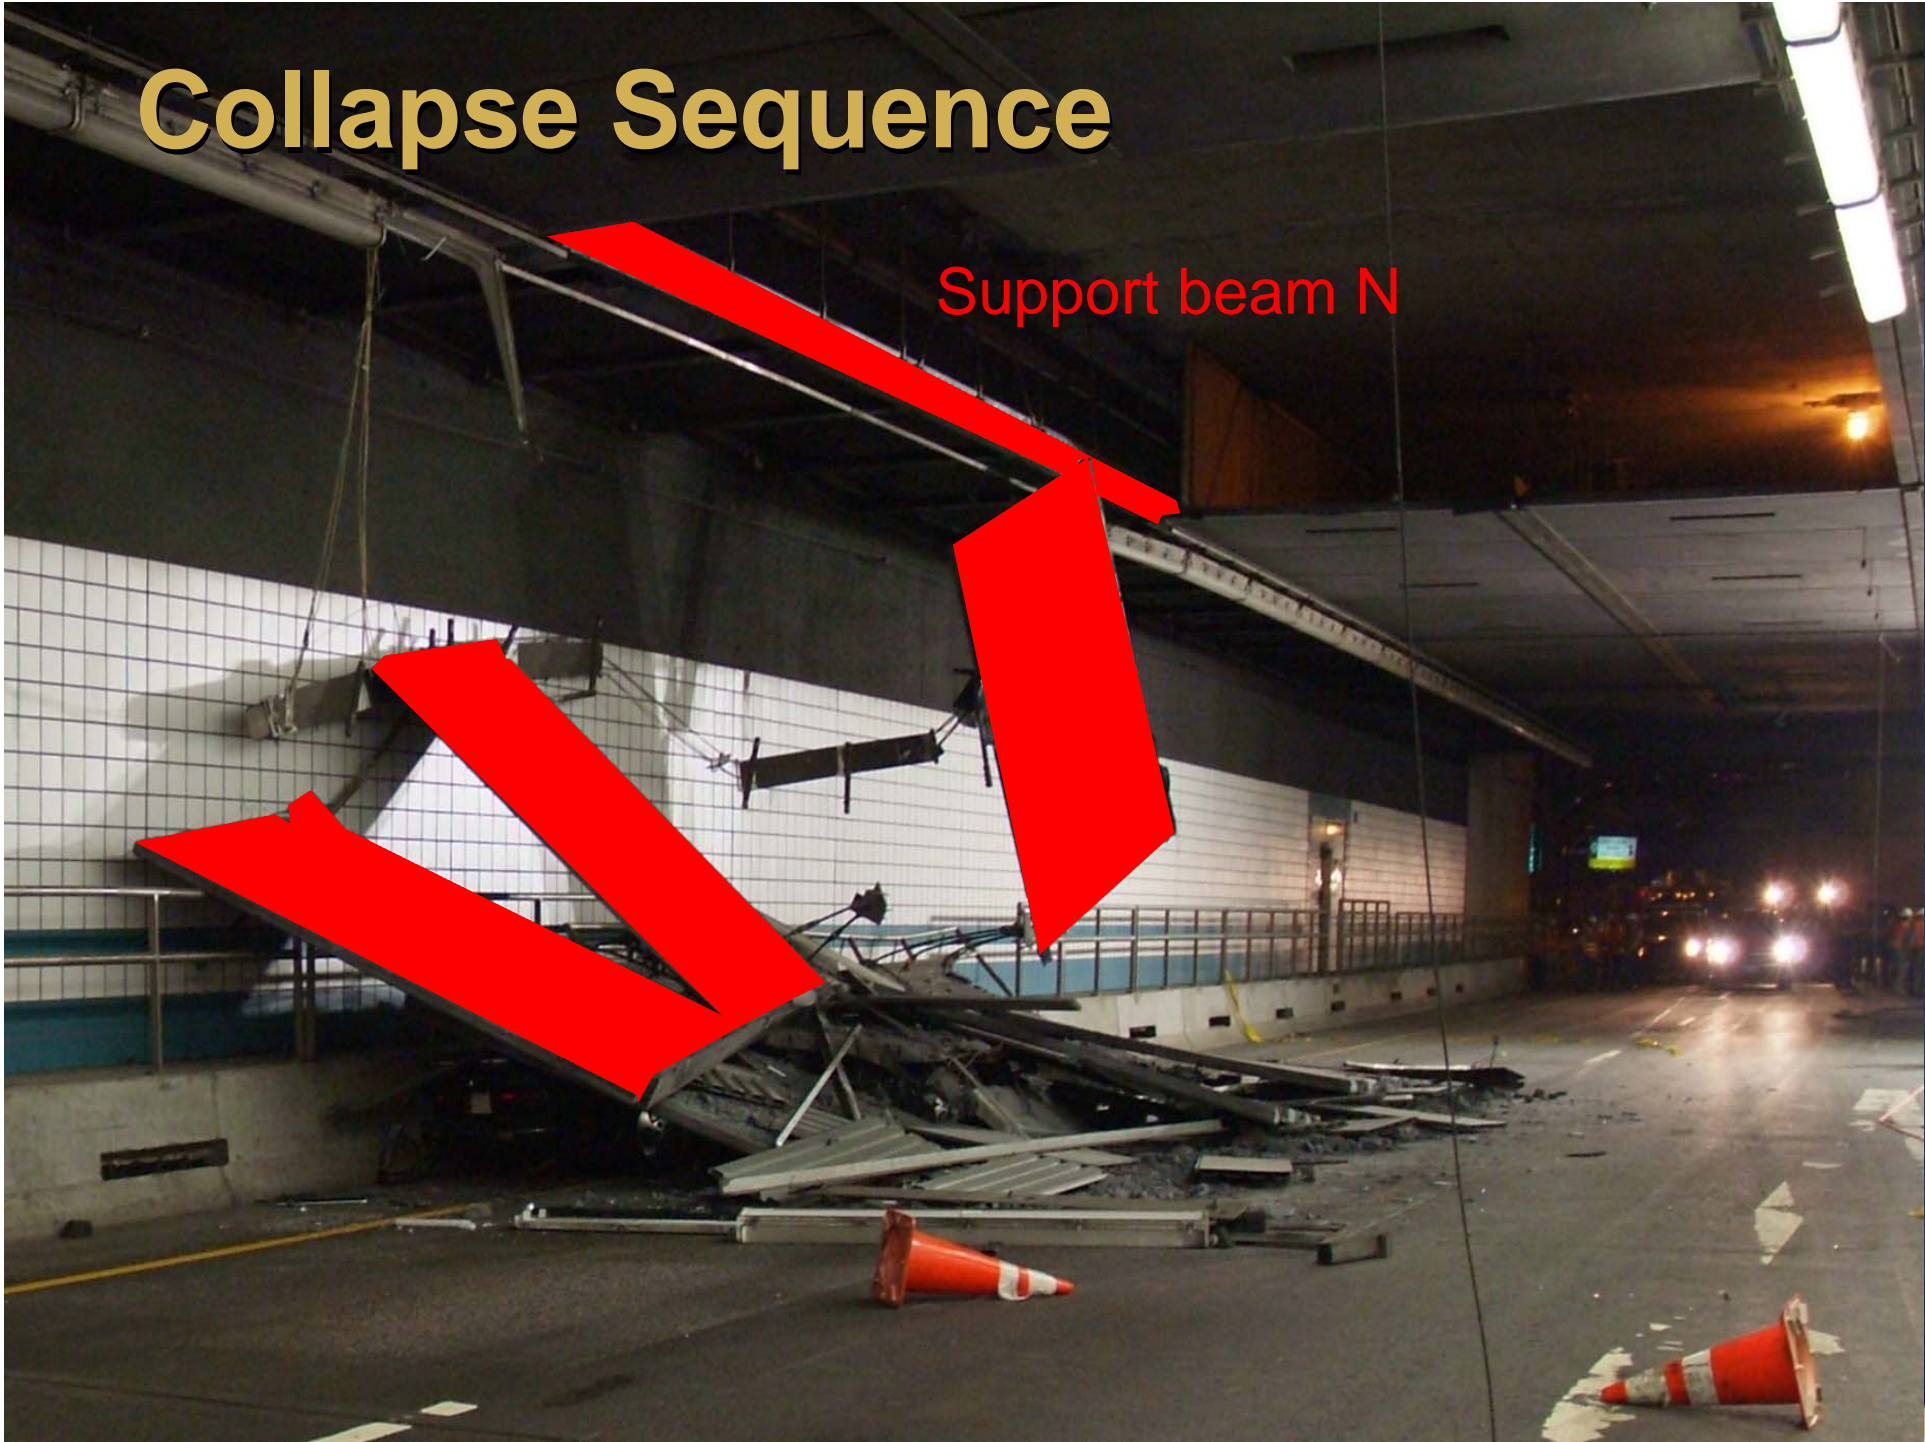
Support beam N

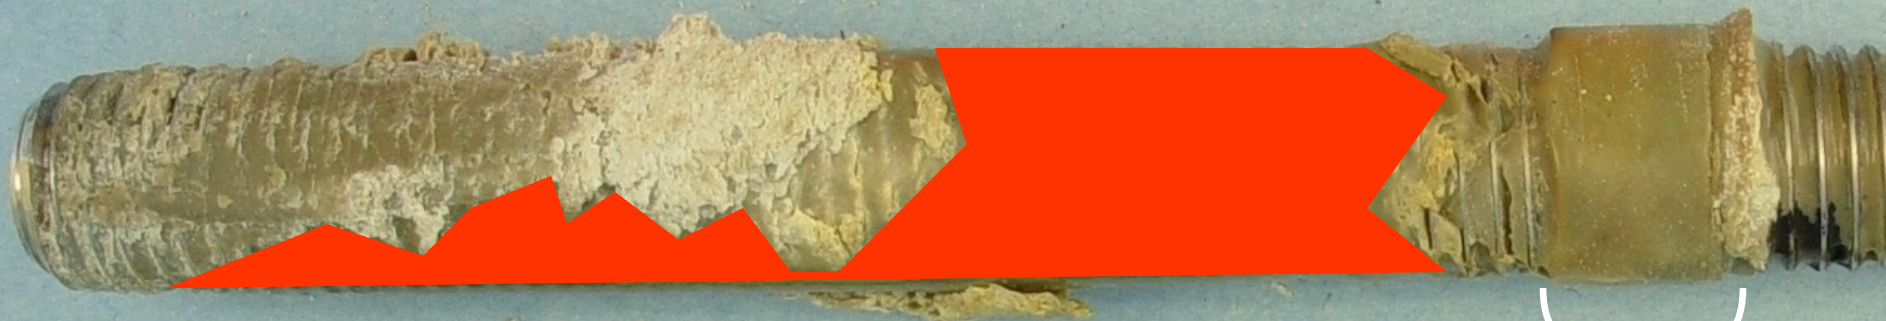
Epoxy Voids

Seal plug
position

- 19 of 20 failure area anchors had voids
- Void areas might have been larger
- Voids decrease load capacity

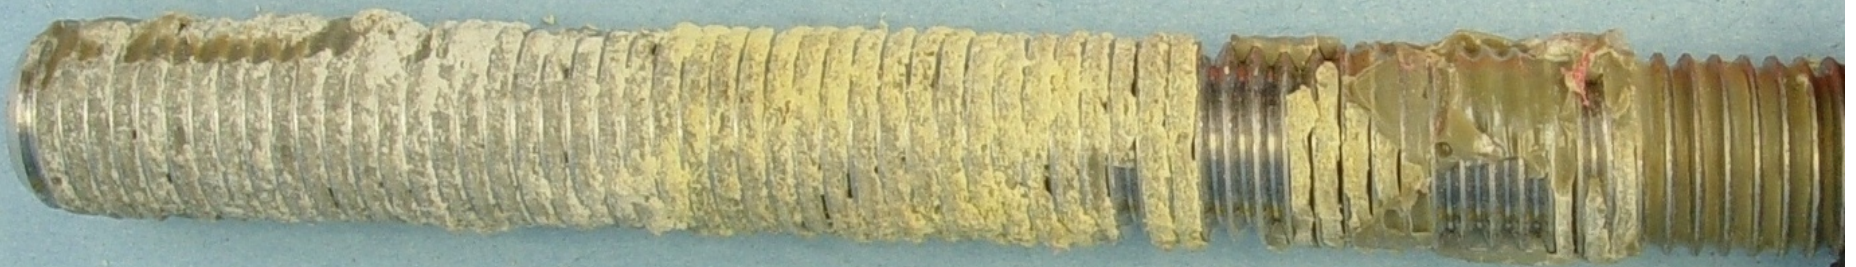
Yellowed Epoxy

Yellow discoloration

Seal plug
position

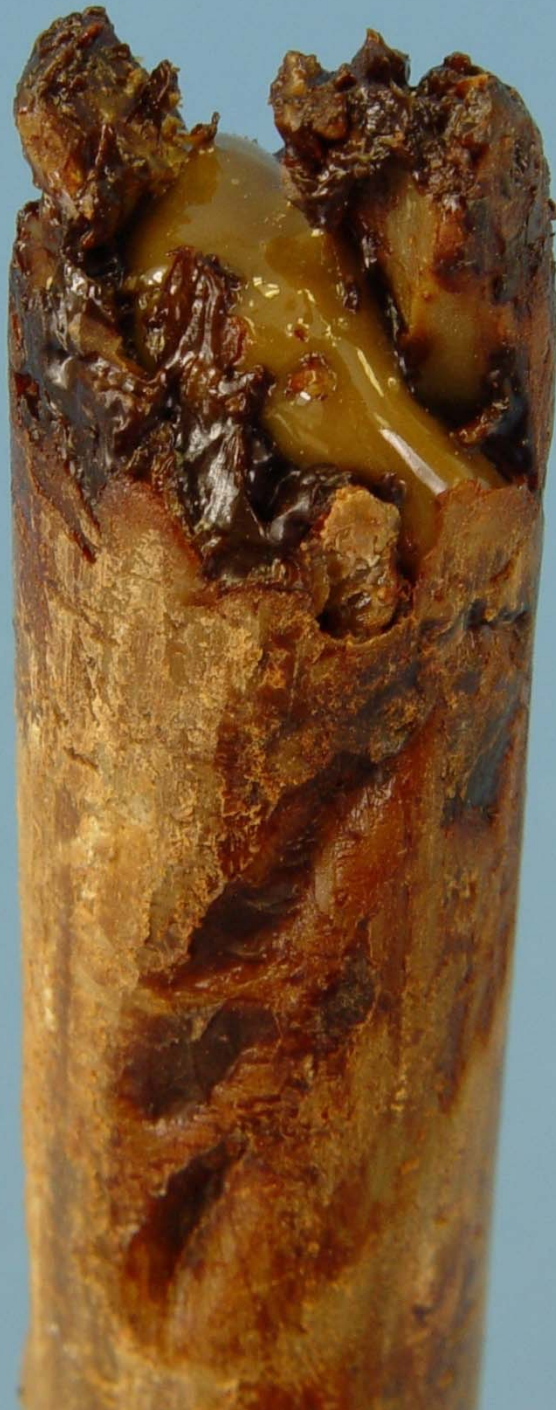
Dark Brown Epoxy

- All samples matched the Powers Fast Set epoxy reference samples
- Samples from the failure area were similar to other typical samples from the tunnels
- Modern Continental used Powers Fast Set epoxy in the D Street Portal
- Brown samples were consistent with epoxy mixed with an excess of hardener
