**Multivehicle Collision on Interstate 90
Hampshire–Marengo Toll Plaza
Near Hampshire, Illinois
October 1, 2003**

NTSB/HAR-06/03

Highway Accident Report

Abstract: On October 1, 2003, a multivehicle accident occurred on the approach to an Interstate 90 toll plaza near Hampshire, Illinois. About 2:57 p.m., a 1995 Freightliner tractor-trailer chassis and cargo container combination unit was traveling eastbound on the interstate, approaching the Hampshire–Marengo toll plaza at milepost 41.6, when it struck the rear of a 1999 Goshen GC2 25-passenger specialty bus. As both vehicles moved forward, the specialty bus struck the rear of a 2000 Chevrolet Silverado 1500 pickup truck, which was pushed into the rear of a 1998 Ford conventional tractor-box trailer. As its cargo container and chassis began to overturn, the Freightliner also struck the upper portion of the pickup truck's in-bed camper and the rear left side of the Ford trailer. The Freightliner and the specialty bus continued forward and came to rest in the median. The pickup truck was then struck by another eastbound vehicle, a 2000 Kenworth tractor with Polar tank trailer. Eight specialty bus passengers were fatally injured, a

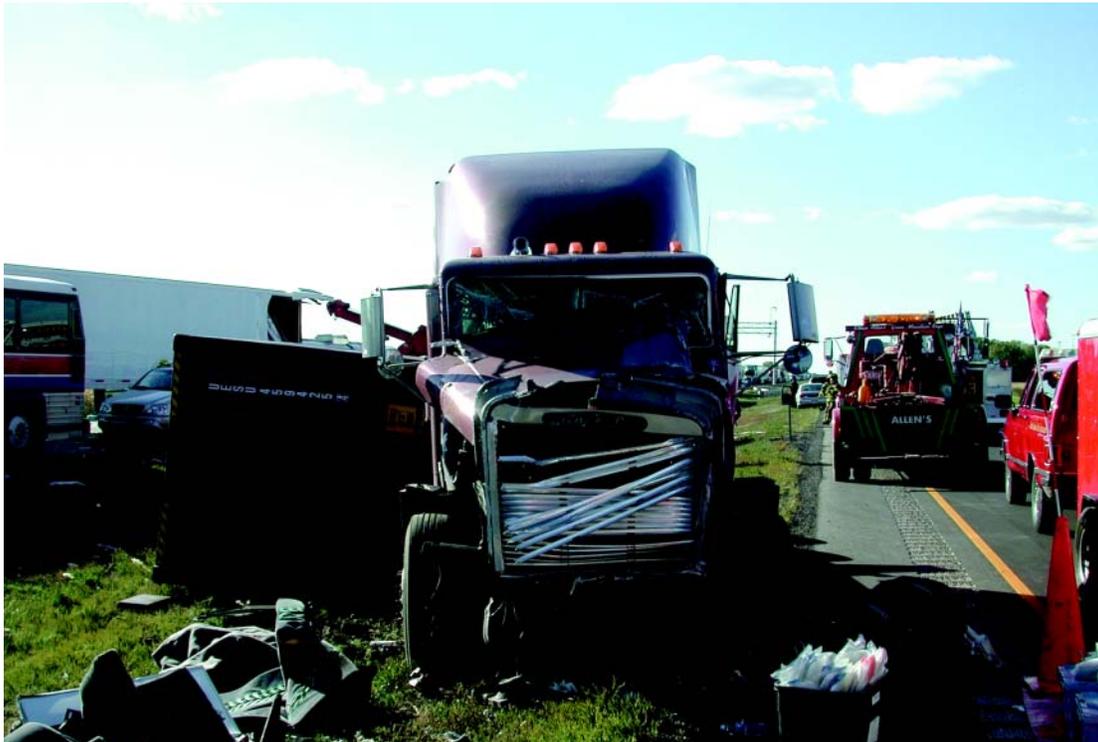
Figure 3. Damaged Freightliner tractor-trailer. (Courtesy of Illinois State Police)

The Safety Board's postaccident inspection of the 1995 Freightliner FLD tractor and Theurer trailer cargo container combination unit revealed tire damage to the steer axle left and right tires and to the outside tires on the second and third axles; the fourth and fifth axle outside tires received superficial cuts. The steering and suspension systems were not damaged. The brake system accessory line had a small air leak due to accident damage. The trailer frame, which had overturned on the roadway and traveled through the median before coming to rest, was deformed; the tractor remained upright and attached to the trailer by the kingpin. The trailer chassis remained engaged to the cargo container at the rear lock pins (the front left and right lock pins were disengaged, and mud was embedded in the lock pin opening).

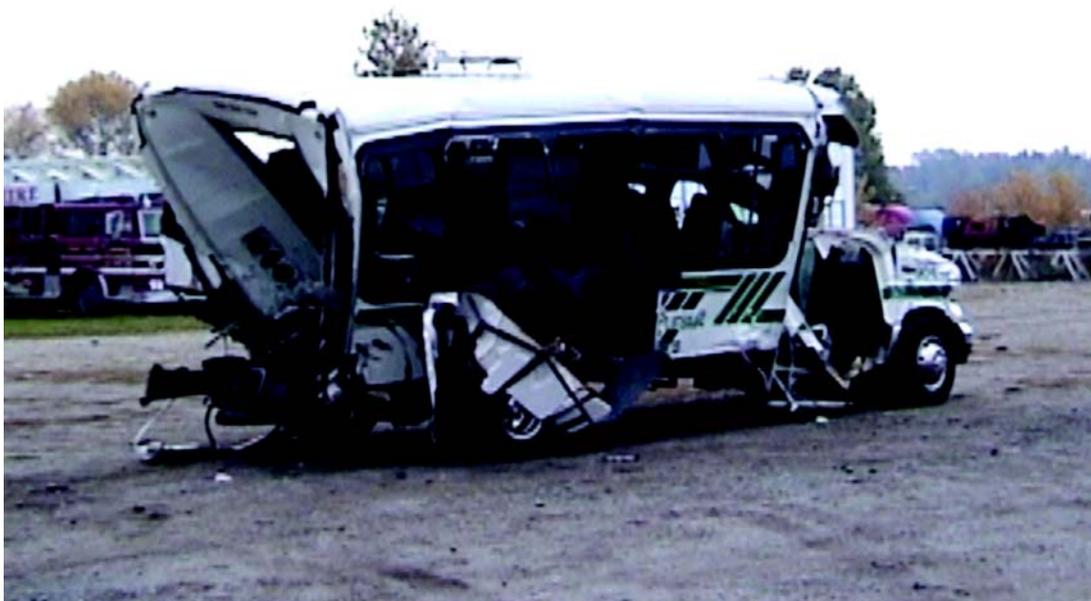
Figure 4. Damaged Goshen specialty bus.

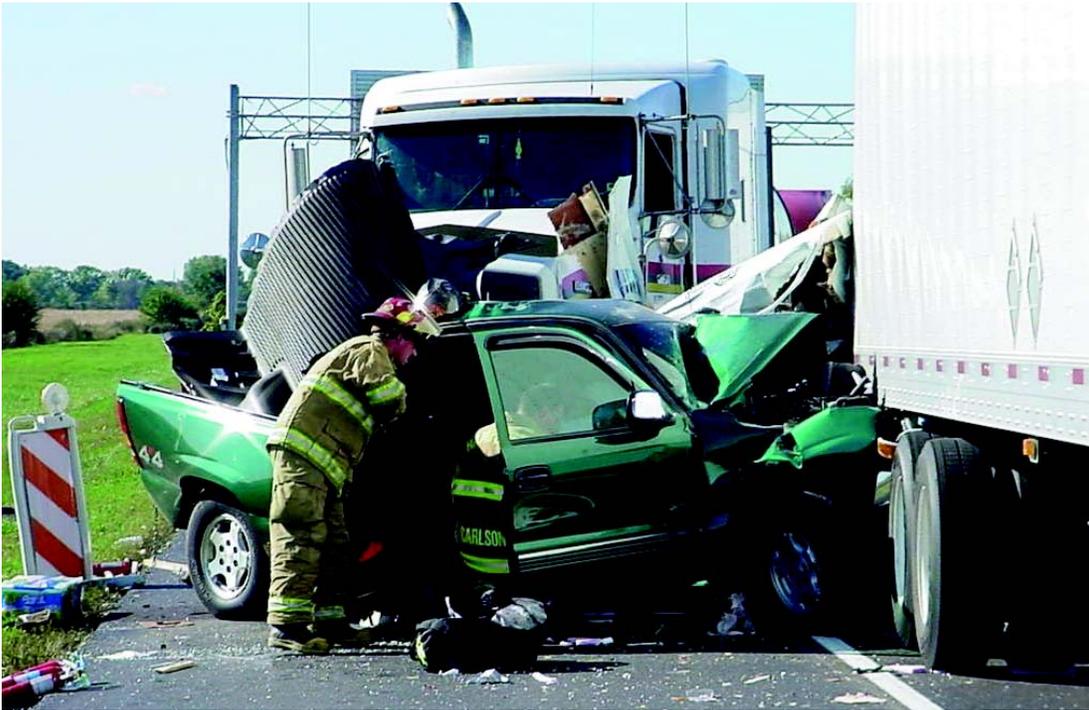
Figure 5. Damaged pickup truck. (Courtesy of Illinois State Police)

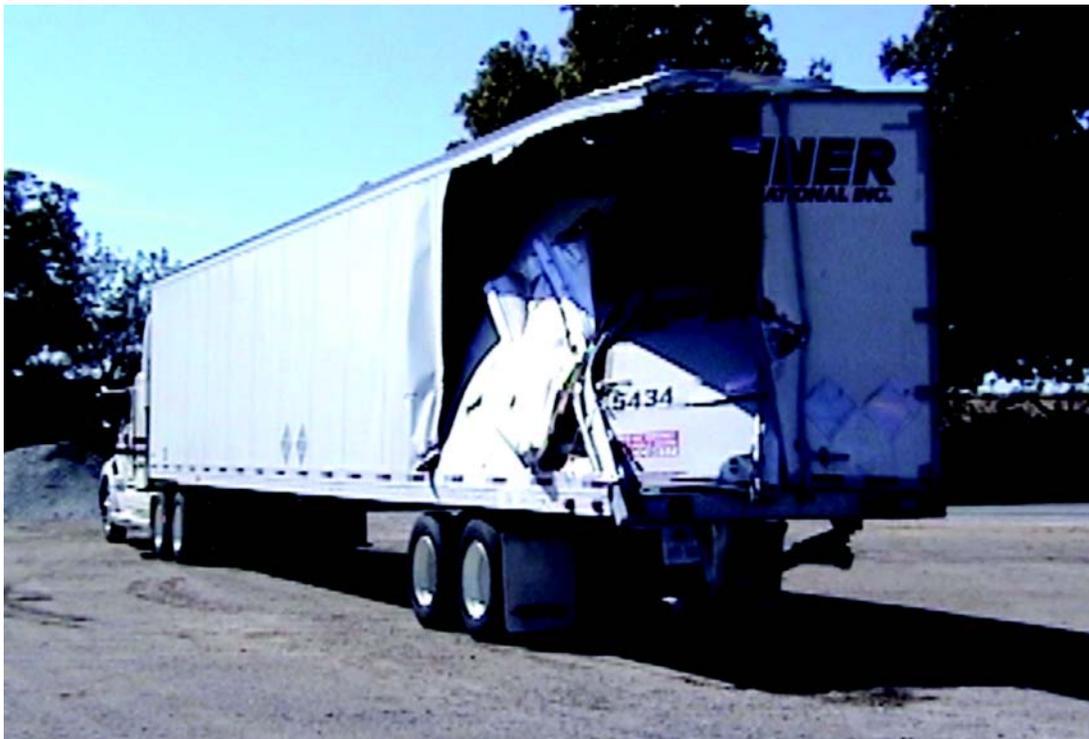
Figure 6. Damaged Ford tractor-box trailer.

The 1998 Ford conventional tractor was not damaged. The Trailmobile box trailer—approximately 53 feet long and 8.5 feet wide—was damaged at the left rear corner, where approximately 11.5 feet had been scraped and crushed downward and inward by the Freightliner trailer as it overturned. Of the two loading doors at the rear of the trailer, the left door and left corner framing were broken and crushed into the cargo area, and the center latch area of the right door was damaged. At the left rear corner, the roof of the trailer had bent upward.

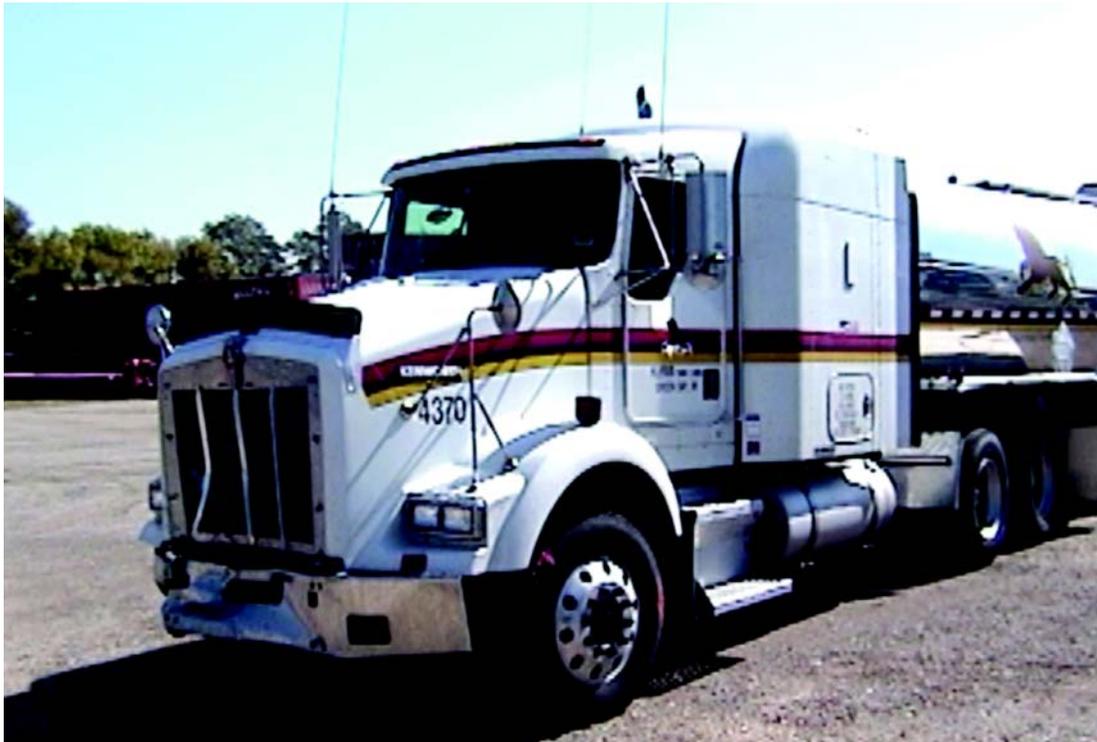
Figure 7. Damaged Kenworth tractor-tank trailer.

The 2000 Kenworth T803 tractor sustained damage to the quick-connect valve on the brake's air system and to the right front of the grill and bumper when it struck the rear of the pickup truck. The Polar tank trailer of this combination unit was not damaged.

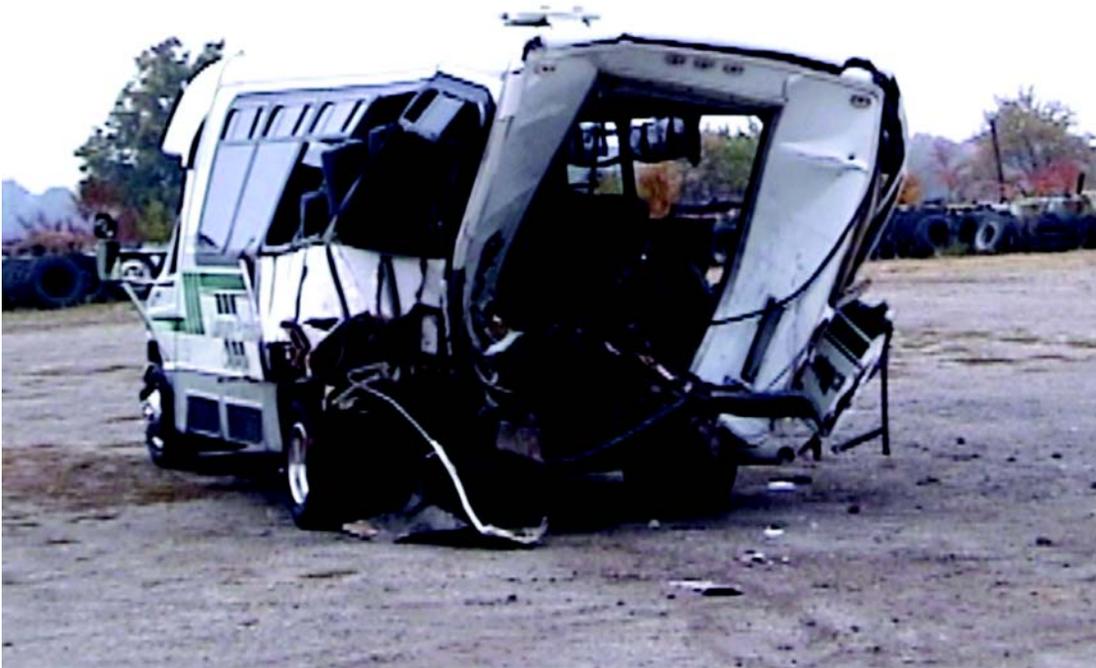
Postaccident inspection of the 1999 Goshen GC2 25-passenger specialty bus showed accident damage both to the front and rear of the vehicle. The right front corner of the bus, which struck the bumper of the pickup truck, sustained damage that continued down the right side of the bus, crushing the boarding door area and sidewall rearward, and intruded approximately 4 feet into the front of the passenger compartment. Impact damage from the Freightliner displaced the rear of the passenger compartment interior forward approximately 5 feet. The right front and right rear tires sustained abrasion damage. (See figure 10.) Longitudinal deformation of the frame rails was less than 5 inches when measured from the inside edge on an exemplar vehicle's bumper. (See figure 11.)

Figure 10. Specialty bus rear-impact damage.

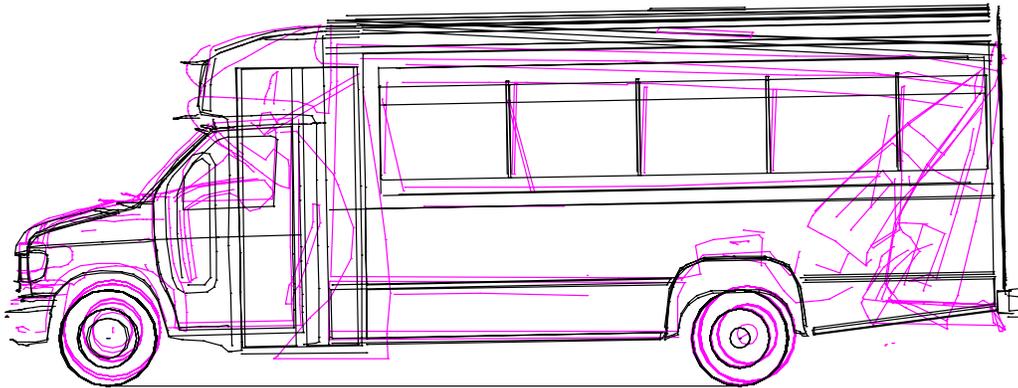
Figure 11. Overlay of exemplar specialty bus to accident vehicle.

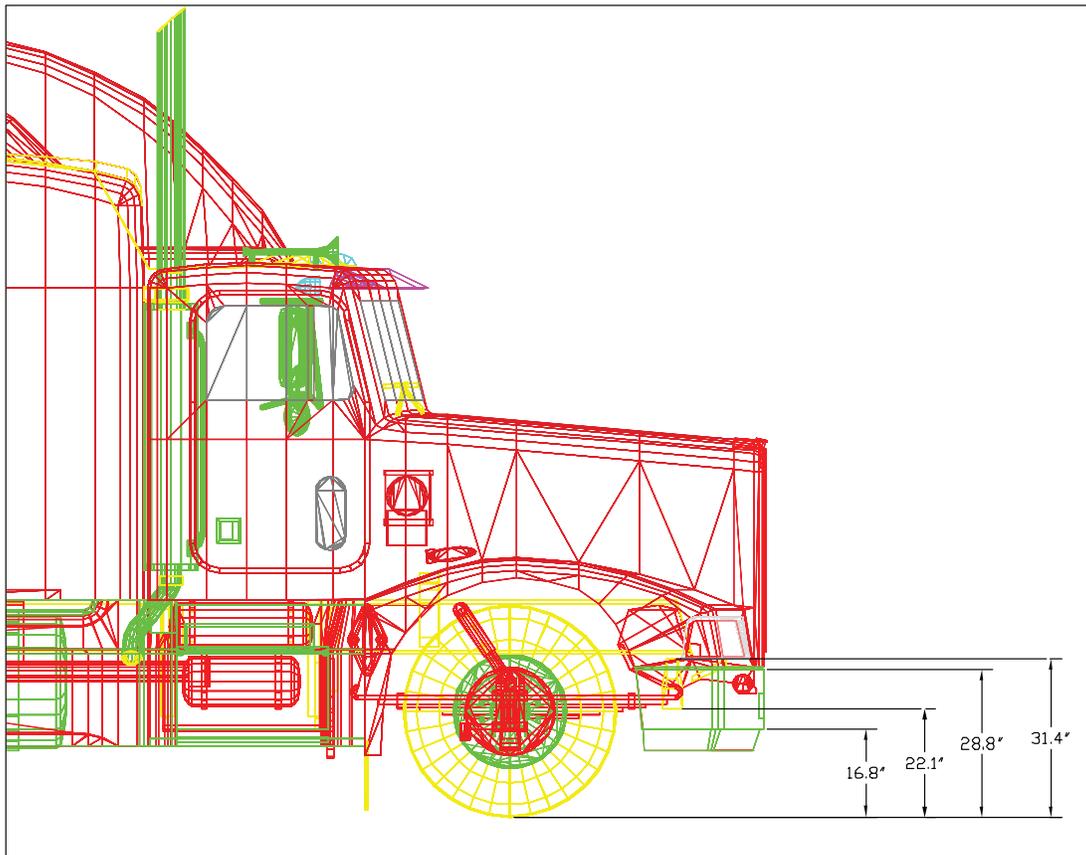
¹⁸ Freightliner LLC told investigators that the structural component behind the bumper is about 1.75 inches higher in the unloaded condition.

Figure 12. Freightliner bumper heights.

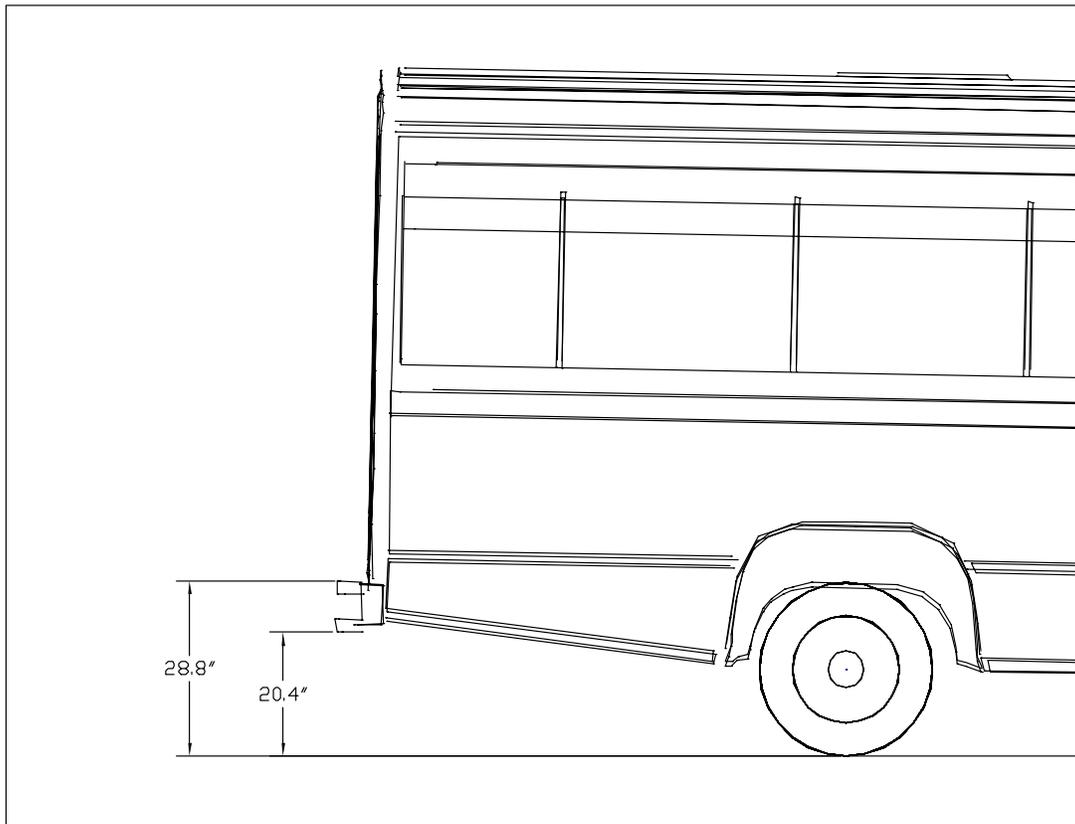
The 1999 Ford E-450 Super-Duty chassis was equipped with a 6.8-liter V-10 engine, a four-speed automatic Ford 4R100 transmission, and a 1999 Goshen GC2 body unit. When inspected postaccident, the odometer indicated 165,457 miles. The chassis was equipped with four-wheel hydraulic disc brakes with two piston calipers. During postaccident inspection, the ISP and Safety Board investigators noted no brake system defects. The GVWR of the specialty bus was 14,050 pounds, and the wheel base was 158 inches. The ISP weighed the specialty bus at 9,860 pounds. On an exemplar bus, the rear bumper, which was 20.4 to 28.8 inches above ground, was about 8.4 inches high. The bumper mounts directly to the end of the frame rails on the chassis. (See figure 13.)

Figure 13. Specialty bus bumper heights.

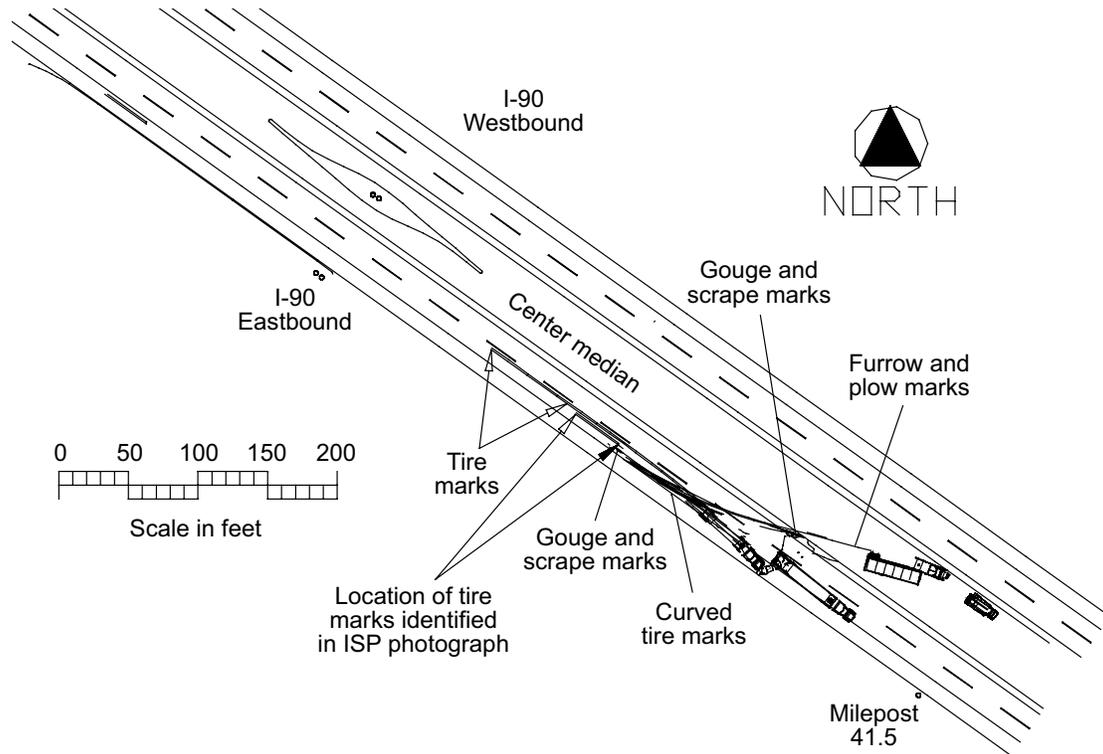
Based on the SDM data and other physical evidence, several scenarios were identified and evaluated. The results of the simulations that most closely matched the physical evidence indicate that the vehicles at the front of the accident queue—the specialty bus, the pickup truck, and the Ford tractor-box trailer—were traveling at substantially lower speeds (0 to 10 mph) than the Freightliner tractor-trailer (50 mph) and the Kenworth tractor-tank trailer (55 to 62 mph), which were approaching from the rear. (See figure 17.)

Figure 17. Accident scene diagram indicating physical evidence.

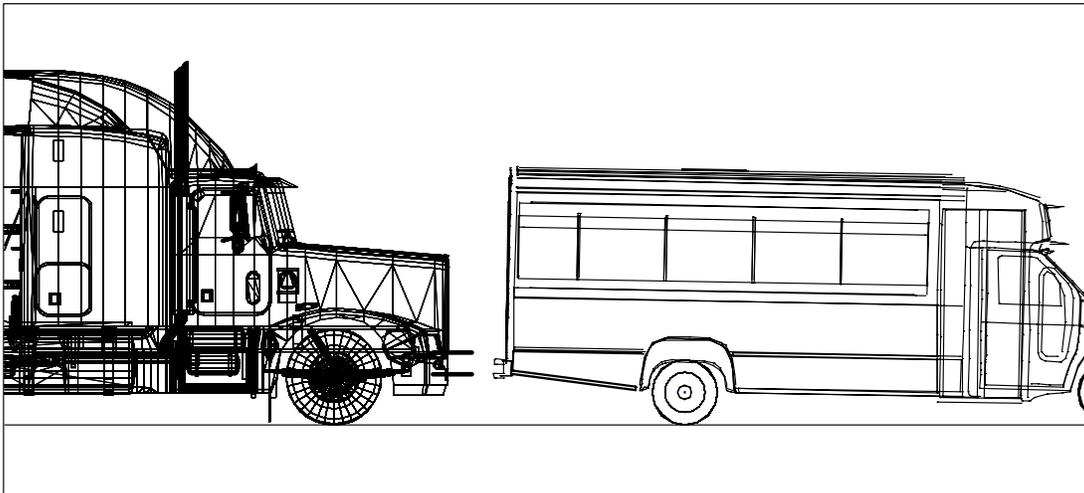
weights¹²¹ and structural stiffness and because of geometric mismatch. (See figure 24.) The differences in weight and stiffness and the geometric mismatch are often referred to as vehicle “aggressivity.” NHTSA’s Web page, “Heavy Vehicle Aggressivity Program,”¹²² last updated in June 2000, states that the common belief is that not much can be done to diminish the consequences of crashes between smaller vehicles and large trucks because of the significant differences in vehicle mass.

Figure 24. Freightliner and specialty bus bumper height comparison.

However, research has shown that geometric height differences and a lack of forgiving front truck structures can be modified to help reduce heavy truck aggressivity and to mitigate the severity of these types of accidents.^{123,124,125} Examples of these modifications, often referred to as “front underride protection systems”—which can result in reduced intrusion or occupant injury—include energy-absorbing front structures to offset the weight differences between two impacting vehicles, as well as bumpers designed to deflect the impacted vehicle away from the front of the truck, thereby reducing the total change in velocity of the smaller vehicle.
