# National Transportation Safety Board

## Pipeline Accident Brief

Accident No.:	DCA-04-MP-006
System Type:	Natural gas distribution
Accident Type:	Leak, explosion, and fire
Location:	DuBois, Pennsylvania
Date:	August 21, 2004
Time:	About 8:54 a.m. eastern daylight time <sup>1</sup>
Owner/Operator:	National Fuel Gas Distribution Corporation
Property Damage and Losses:	\$800,000
Fatalities:	2
Injuries:	None
Material Released:	Natural gas
Pressure:	50 pounds per square inch, gauge
Failure Type:	Butt-fusion joint leak
Component Affected:	2-inch plastic main line

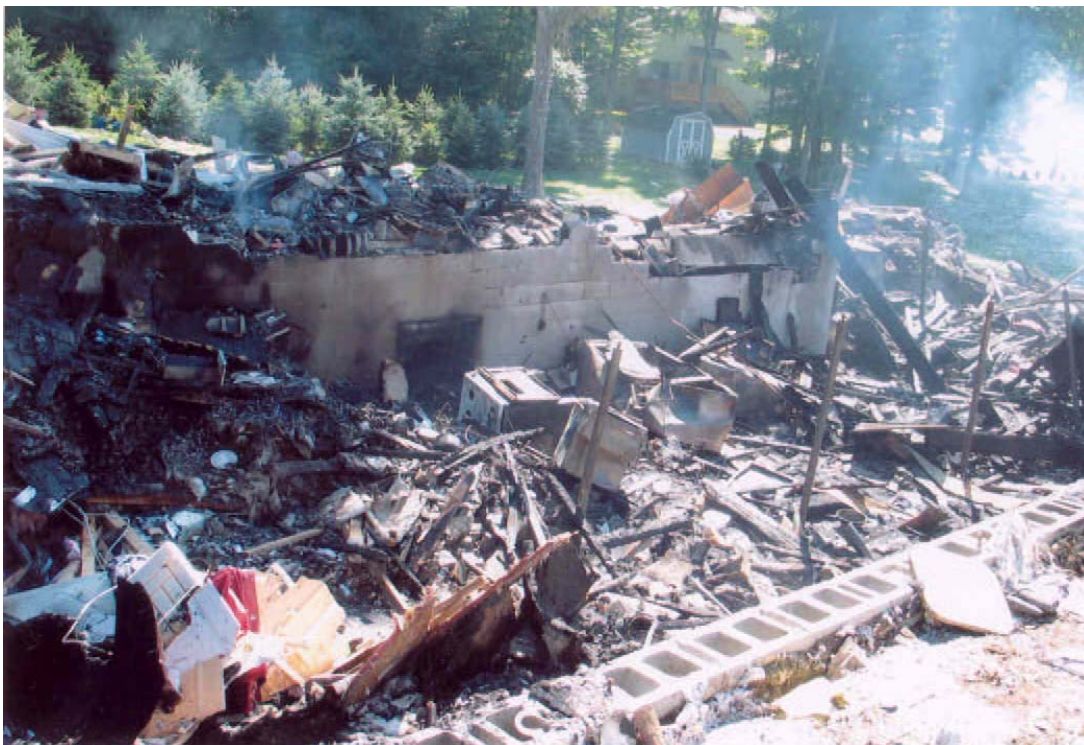
On August 21, 2004, about 8:54 a.m., a natural gas explosion destroyed a residence located at 48 Woodland Lane in DuBois, Pennsylvania. The two residents were killed in this accident. (See figure 1.)

**Figure 1.** Damage to 48 Woodland Lane.

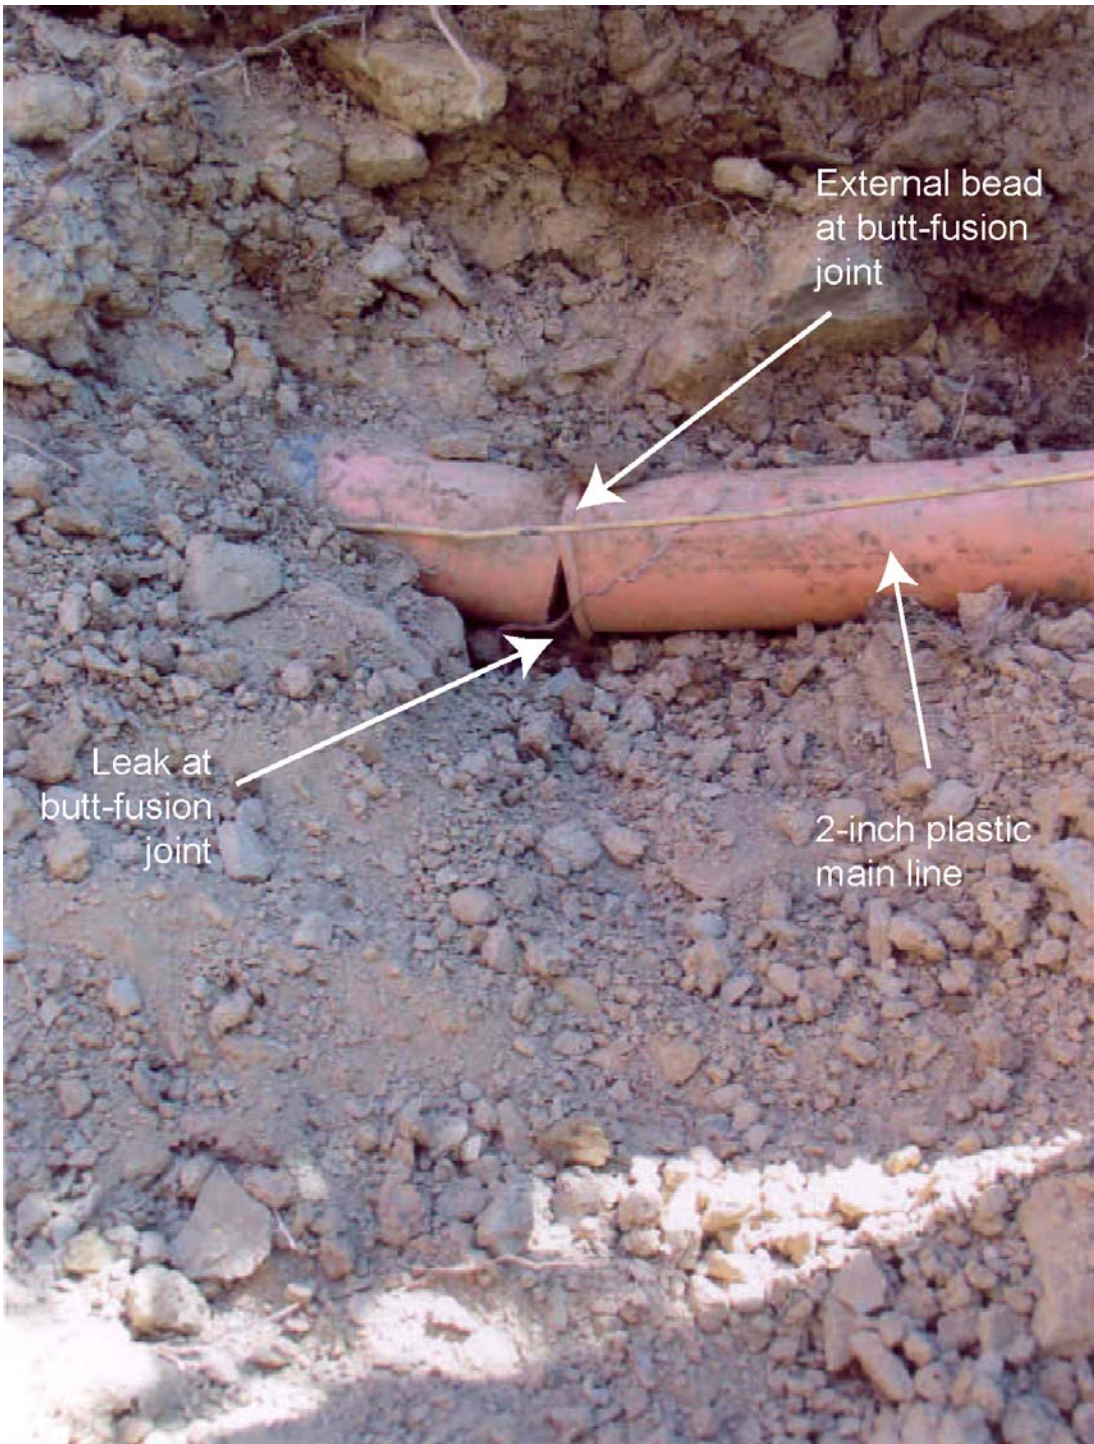
National Fuel Gas Distribution Corporation (National Fuel) probed the ground near the residence for gas leaks. Combustible gas-to-air readings were found in two areas: one area was adjacent to the affected residence, and the other area was directly over the failed pipe on the front lawn. After the explosion, National Fuel excavated the front lawn. The excavation revealed a leaking butt-fusion joint in a 2-inch-diameter plastic main line pipe. (See figure 2.)

The Safety Board's examination of the butt-fusion joint linked to the explosion indicates that the bead widths were not uniform.<sup>2</sup> The bead width on one side of the butt-fusion joint ranged from 0.0535 inch to 0.1135 inch. On the other side of the joint, the bead width ranged from 0.0745 inch to 0.1060 inch. The total bead width ranged from 0.1315 inch to 0.2045 inch. The joint was found to have been visibly mitered,<sup>3</sup> having about a 2° angle. Mitering can concentrate stresses. No evidence was found indicating that the joint was significantly misaligned.<sup>4</sup>

**Figure 2.** Excavated butt-fusion joint.

At the same location where the external bead width was thinnest, the bead was distorted. The external bead on one side of the joint was larger than the bead on the other side. The boundary between the two beads was indistinct. The internal bead was also distorted, with the bead on one side of the joint higher than the other side. On one side of the joint, the internal bead had numerous pockmarks.<sup>5</sup> On the other side, small globules of plastic adhered to the bead, which is consistent with material being pulled from one bead and deposited on the other bead when the joint was made.

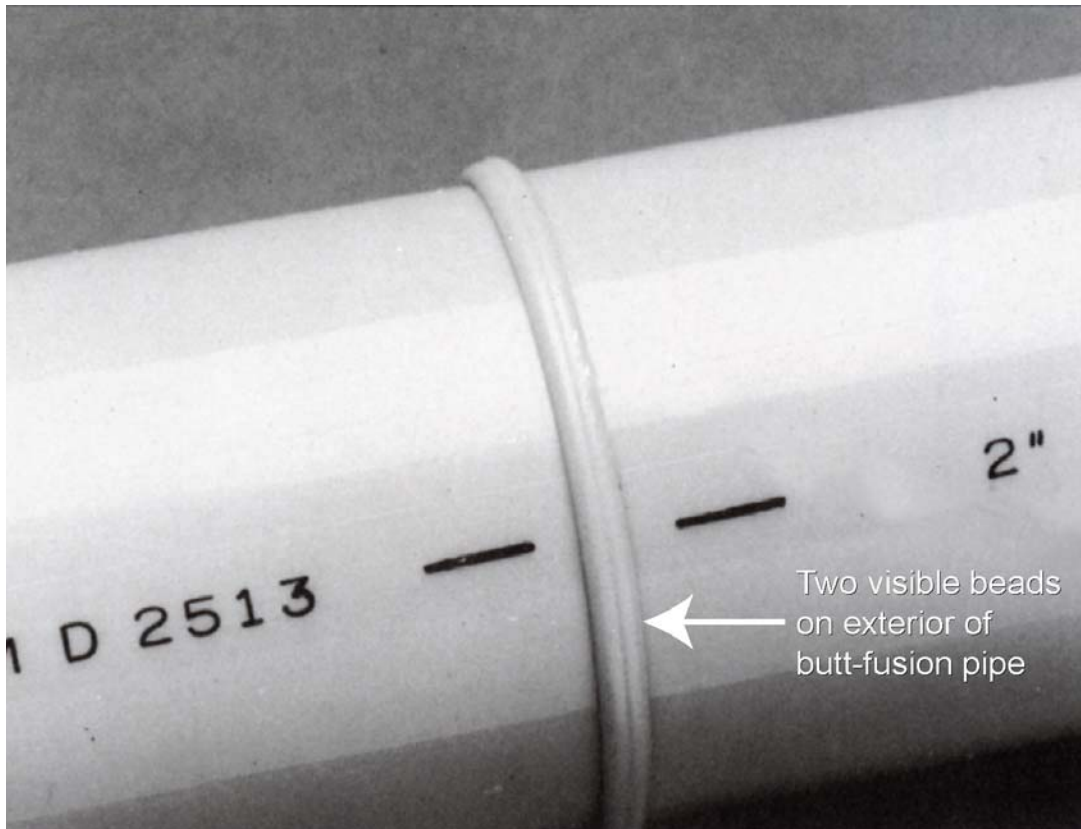
A butt-fusion joint is made by the following process. A heater plate is inserted between two pipe ends, melting the material on each end. The heater is then removed, and the pipe ends are pushed together under applied force. The pipe ends remain under applied force as the pipe ends cool and fuse together. The butt-fusion process forces excess molten plastic onto the inside and outside of the pipe surfaces. Because both sides of the pipe are molten, two visible beads are formed on the exterior and interior of the pipe joint. (See figure 3.) When this material cools and solidifies, it is called a fusion bead.

**Figure 3.** Optimal butt-fusion joint as illustrated in Uponor's Heat Fusion Installer Qualification Manual.

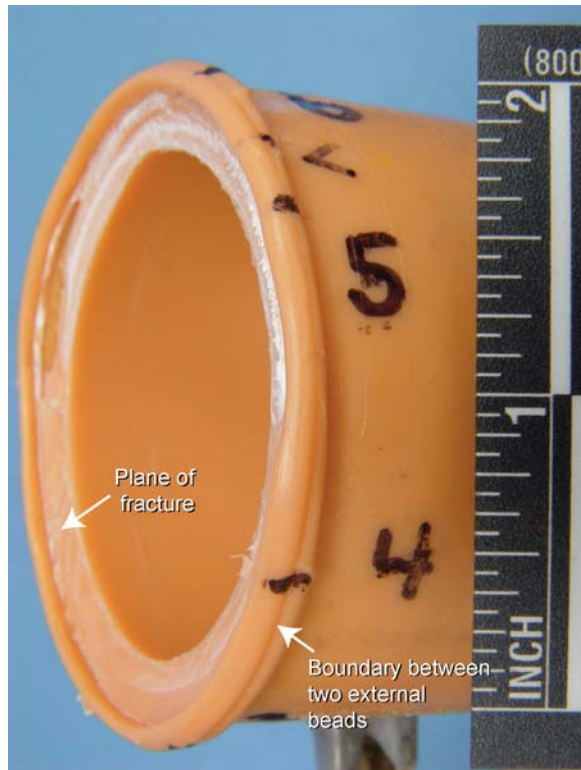
The fracture between the two pipe ends closely followed the plane of the center of the butt-fusion joint. (See figure 4.) The external bead remained attached to one piece of the pipe, and the internal bead remained attached to the other piece of the pipe. (See figure 5.)

**Figure 4.** Fractured end showing external bead and plane of fracture at center of butt-fusion joint.

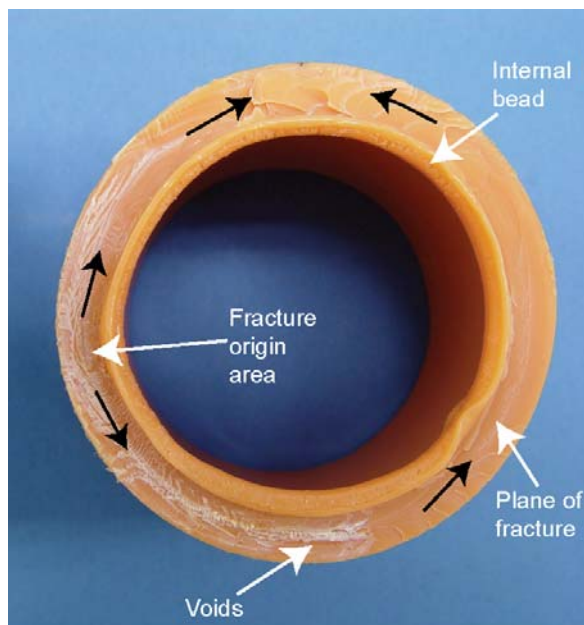
**Figure 5.** View of fracture surface on one piece of pipe. Pipe is oriented as it was found. Fracture origin was at 9 o'clock position as shown. Unlabeled arrows indicate crack propagation directions.

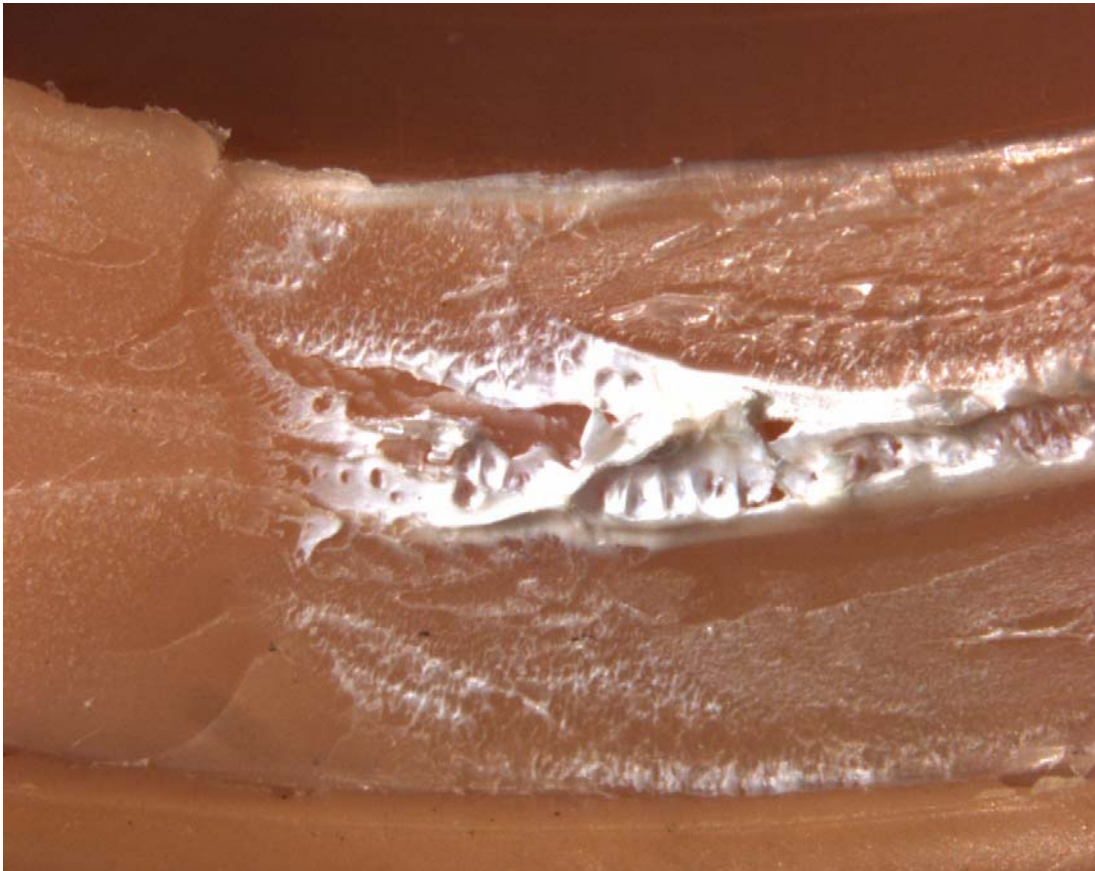
The fracture surfaces at the butt-fusion joint were examined using optical microscopy and an environmental scanning electron microscope. The fracture surface exhibited voids where the internal and external beads were distorted. (See figure 6.) Fracture surface features indicated that the crack initiated near the center of the pipe wall within the butt-fusion joint, followed by a slow progressive crack growth.<sup>6</sup> Ductile ribbons of plastic pipe material present at the inner and outer edges of the fracture surface indicated that the crack did not initiate at the notches<sup>7</sup> of either the internal or external beads.

Studies of butt-fusion joints subjected to elevated temperature and high pressure indicate that a fracture occurring in the butt-fusion area will normally start on the pipe wall surface at the notch of the internal bead or, if bending is involved, the fracture would be expected to start at the outer pipe wall surface. However, the initiation of the fracture in the accident pipe near the center of the pipe wall is consistent with inadequate fusion of the joint.

**Figure 6.** Voids in central portion of fracture surface.
