# National Transportation Safety Board

## Safety Recommendation

**Date:** March 2, 2011

**In reply refer to:** A-11-12 through -15

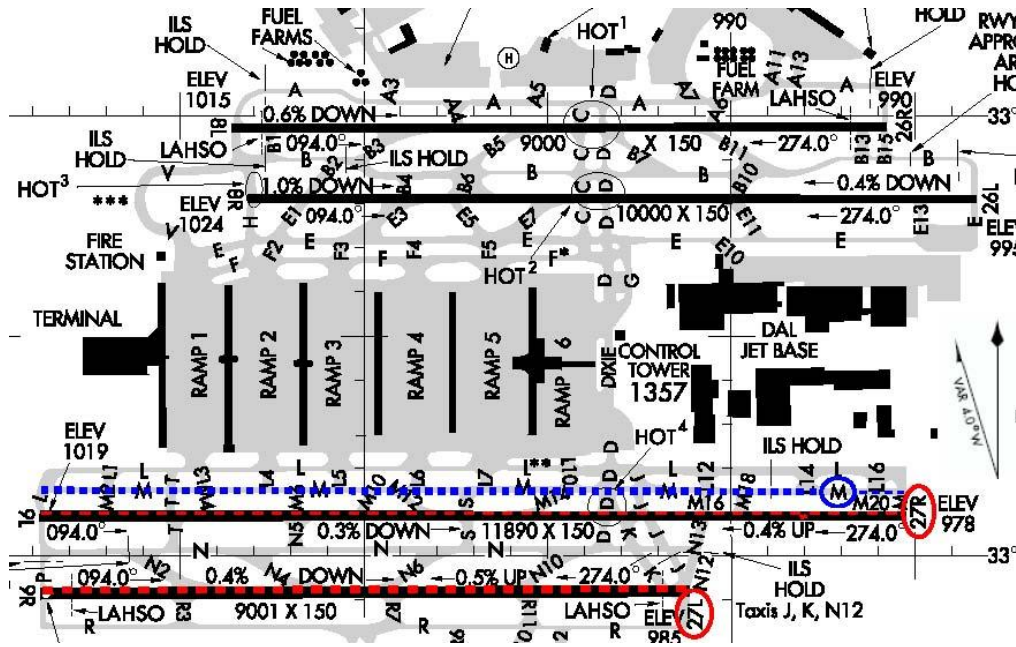
During the descent and approach, the flight crew was assigned a number of runway changes; the last of which occurred near the final approach fix for runway 27L. While the flight was on final approach, the crew was offered and accepted a clearance to sidestep to runway 27R<sup>3</sup> for landing (see figure for a diagram of ATL runway configurations). Although the flight crew had previously conducted an approach briefing for runways 27L and 26R, they had not briefed the approach for runway 27R and were not aware that the approach light system and the instrument landing system (ILS) were not available to aid in identifying that runway.<sup>4</sup>

**Figure.** Diagram Showing ATL Runways 27L, 27R, Taxiway M

According to the captain, who was the flying pilot, he maneuvered for the sidestep from runway 27L to 27R and lined up on “the next brightest set of lights” he saw. He said that he saw “bright edge lights and centerline lights” and thought he had the runway in sight. The first officer was preoccupied during the final approach with attempting to tune and identify the ILS frequency for runway 27R. Just prior to the airplane touching down, the captain realized they were landing on a taxiway. The airplane landed on taxiway M, 200 feet north of, and parallel to, runway 27R. The local controller did not notice the crew’s error until after the airplane had landed. The taxiway was unoccupied, and the flight crew was able to stop the aircraft safely and taxi to the gate.
