SAFER SEAS DIGEST

2019

Lessons Learned *from* Marine
Accident Investigations

NTSB | National
Transportation
Safety Board

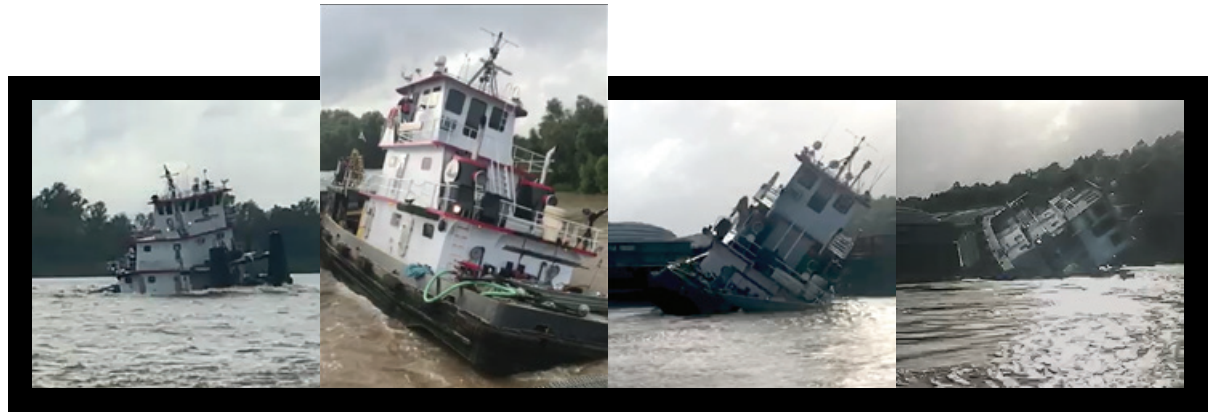
Figure 8. Sequence of events as the *Miss Roslyn* headed toward moored barges with a heavy list to starboard and eventually capsized. Left to right: (1) About 1650, the *Miss Roslyn* began crossing the Mississippi River with a noticeable list to starboard. As the vessel crossed the river, water increased on deck, and the vessel sank lower into the water. (2) The deckhands evacuate the *Miss Roslyn*. (3) About 1658, the vessel's list increases rapidly to starboard. (4) About 1659, the vessel lists further to about 90 degrees. SOURCE: CLAY HEBERT, ITV KRISTY DUTSCH

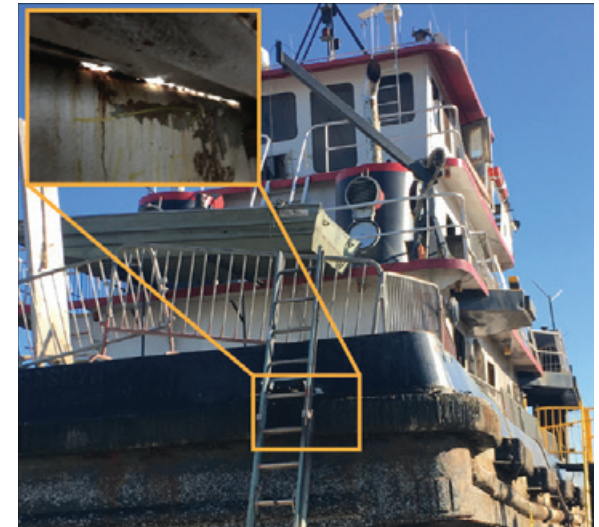
Prior to the sinking, the *Miss Roslyn* was in drydock in June 2017 for maintenance and repairs to the hull. However, on November 16, a marine surveyor found two wastage holes and a fractured weld seam at the main deck to the starboard steering void, which therefore was not watertight. The captain stated that he was assisting in making up a tow, which required him to push against the tow at a 90-degree angle to the bank for 2.5 to 3 hours. This action, in combination with the current, likely would have lowered and intermittently submerged the wastage and fracture holes on the starboard stern quarter (which were normally just above the waterline) and allowed continuous water ingress to the starboard steering void for about 3 hours. As the *Miss Roslyn* got under way to head back for crew change, the aft steering void would have been partially flooded, which likely caused the observed starboard list. Once the hull flooded, the vessel sank lower, increasing the rate of flooding through the holes to the starboard steering void, thus increasing the starboard heel and submerging the starboard bulwark and then the stern deck. Eventually, the port flanking void flooded, resulting

The severe wastage found throughout the vessel in the postaccident survey indicates that the *Miss Roslyn* was poorly maintained, so holes in and fractures to the hull and deck went undetected and ultimately led to flooding. An effective maintenance program would have prevented the holes from forming and made identification of hull fractures easier to see and flag for repair, or helped to determine when the vessel had outlived its useful service life.

The probable cause of the capsizing of the *Miss Roslyn* was the company's lack of effective hull inspection and maintenance program, which resulted in flooding into a steering void through multiple wastage holes in the hull.

Figure 10. The orange outline approximate location of a large hole along the seam between the *Miss Roslyn*'s starboard steering void and aft main deck; the hole is shown in the inset image.

To protect vessels and the environment, it is good marine practice for owners to conduct regular oversight and maintenance of hulls, including between drydock periods. Regardless of inspection requirements, owners are obligated to ensure vessels are properly maintained, equipped, and operated in a safe condition. Issues with watertight integrity and wastage need to be addressed by permanent means.

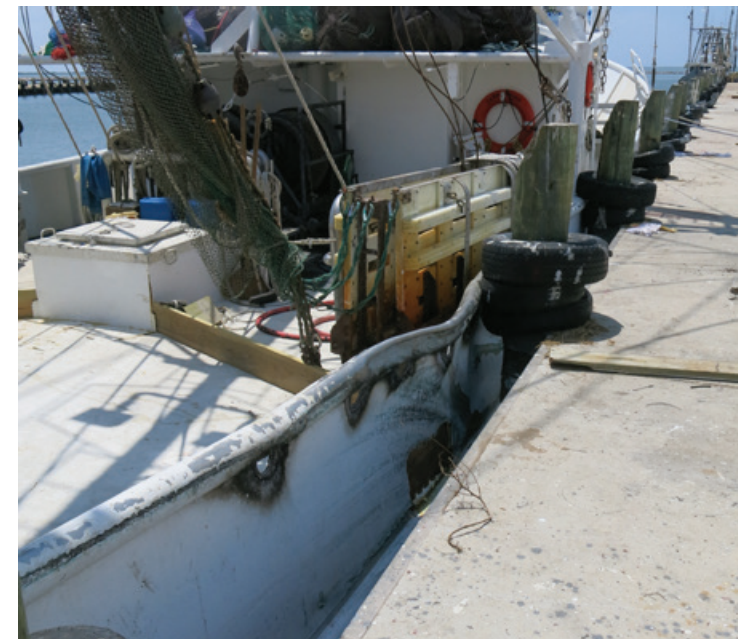
Figure 24. The starboard (damaged) side of *Lady Toni*.

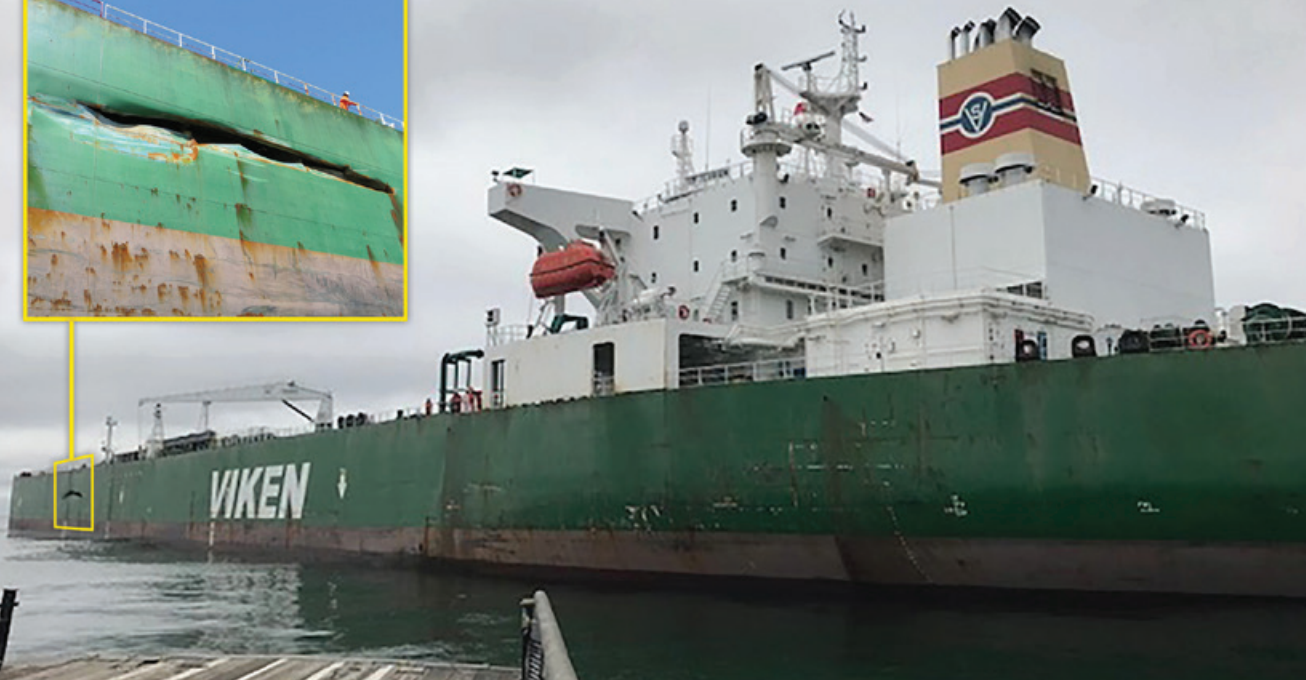
Figure 29. Main damage area of hull of *Tofteviken*.

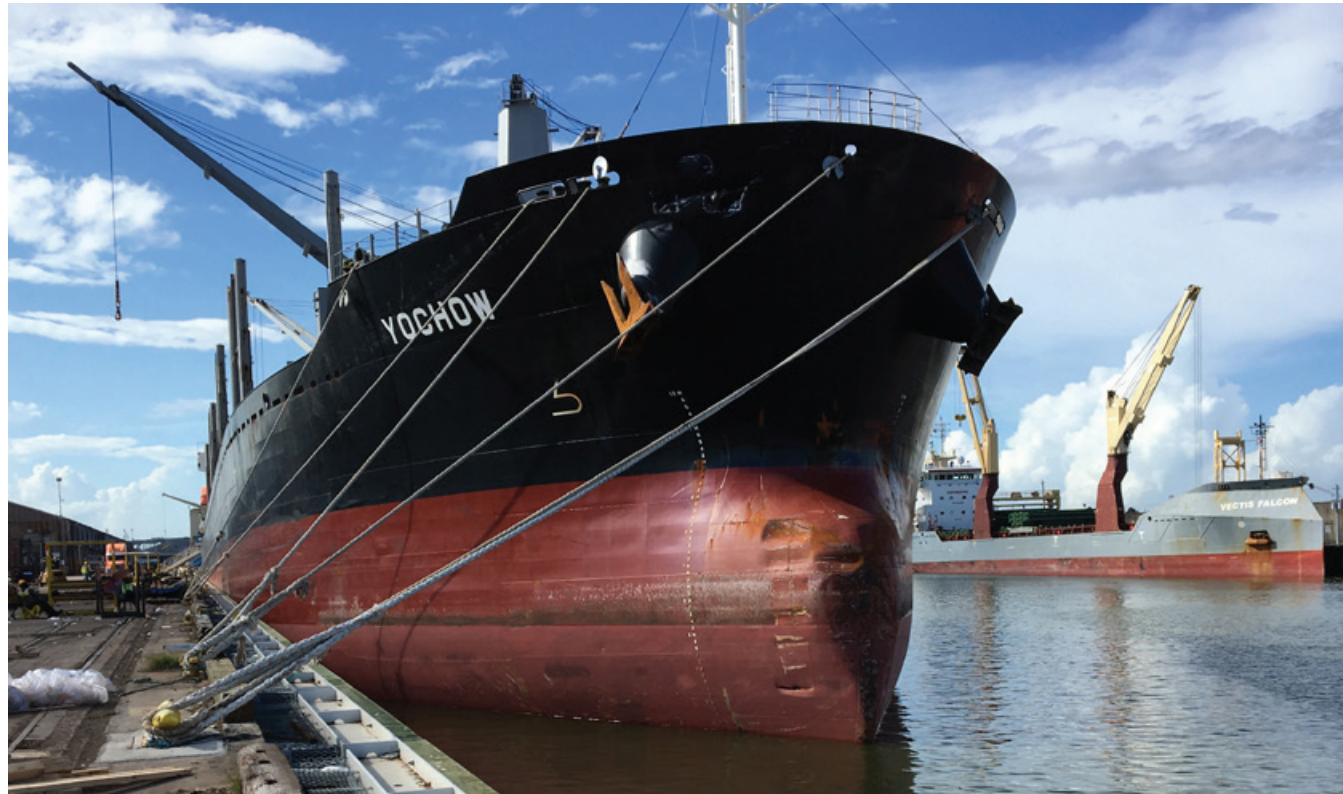
Figure 40. The *Yochow* at port, following the accident.

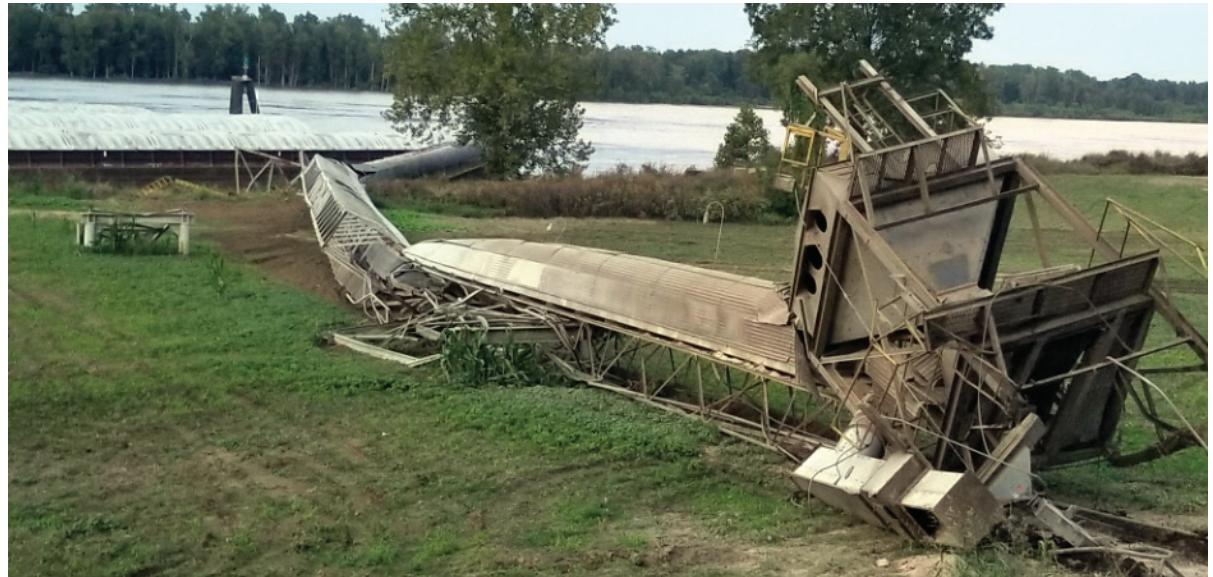
Figure 45. Damaged conveyor as seen from the bank looking toward the river.

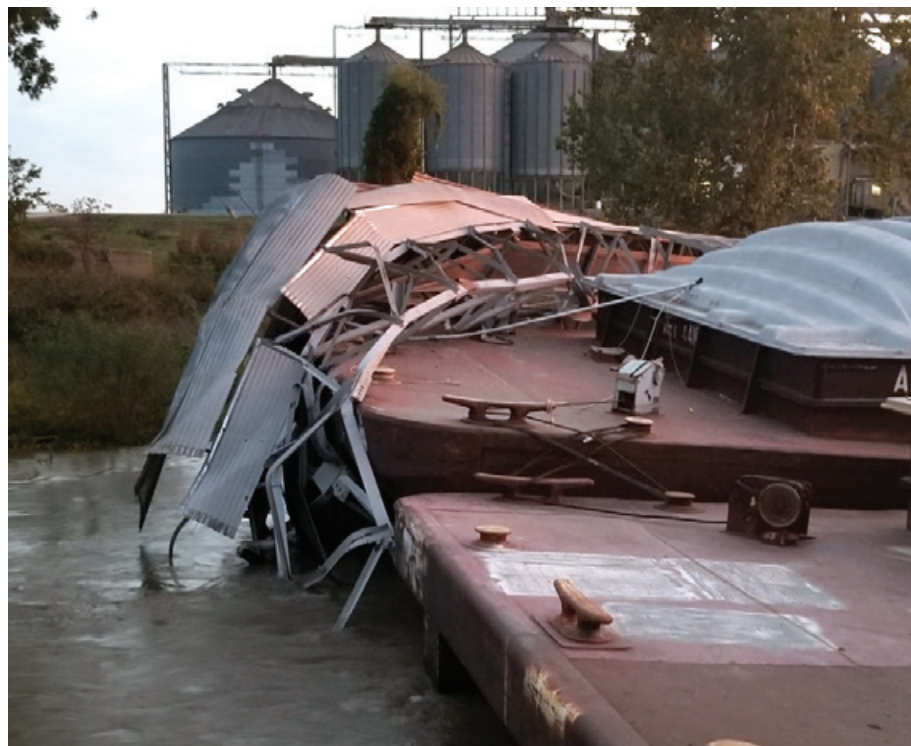
Figure 46. Damaged conveyor and catwalk laying across the forward deck of barge ART 44160. The Farmers Grain Terminal can be seen in the background.

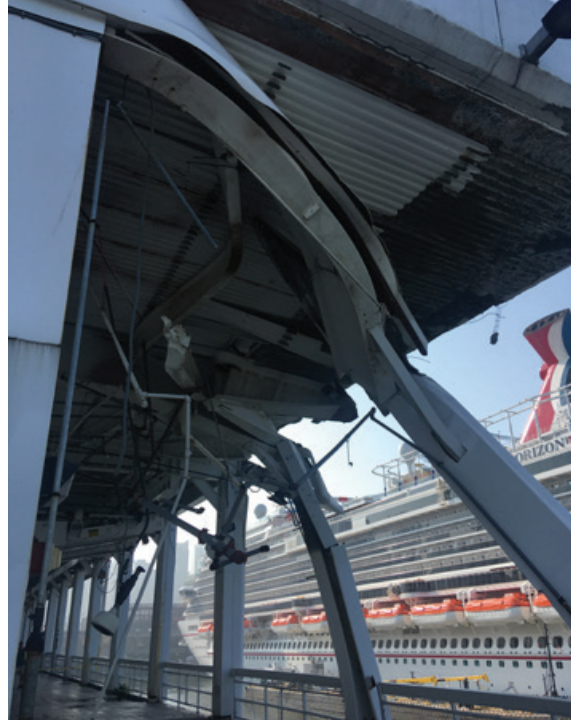
Figure 56. Structural damage to Pier 90's parking garage.

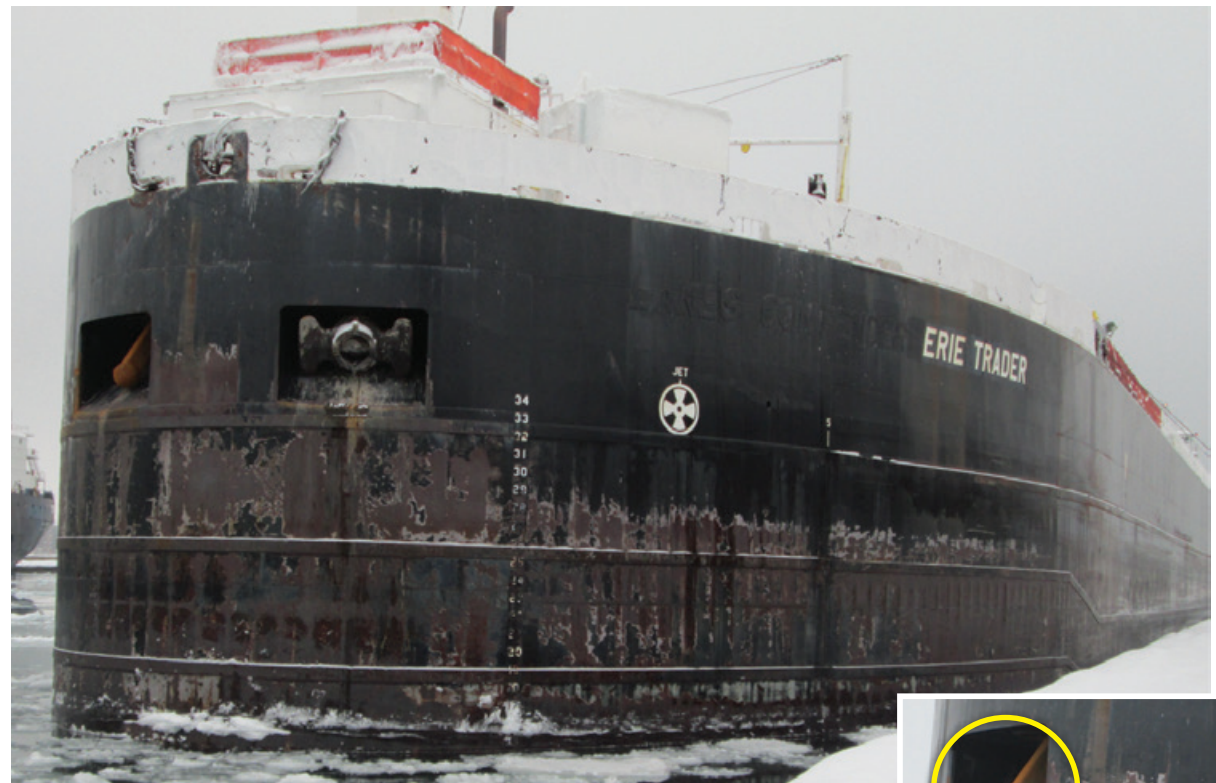
Figure 60. The bow of barge *Erie Trader* after the accident. At right: the remnant shank of the starboard anchor in the anchor pocket is highlighted. SOURCE: COAST GUARD

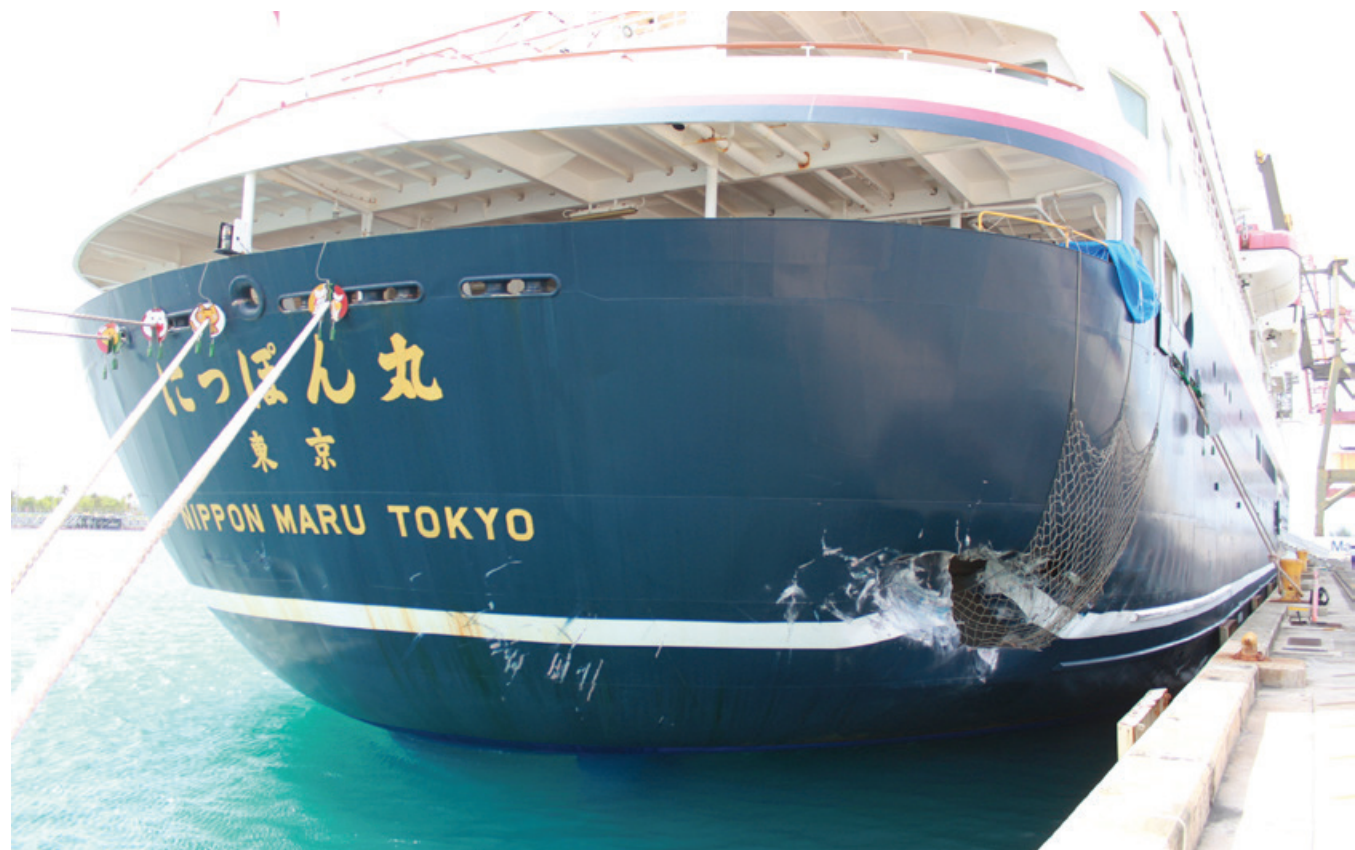
Figure 62. Starboard side of the stern of the *Nippon Maru* shows the damage to the ship.

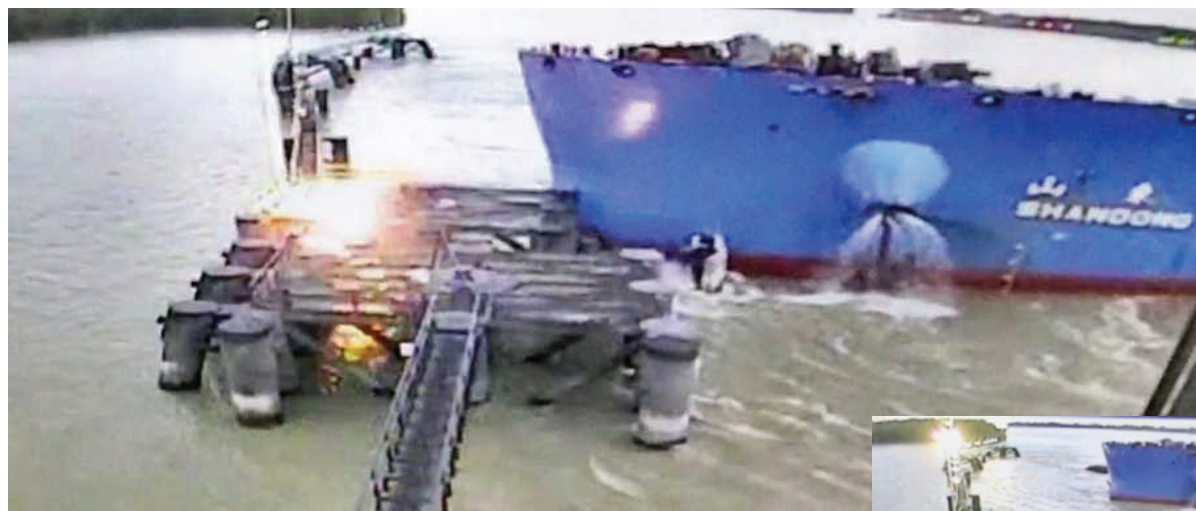
Figure 65. Initial impact of the *Shandong Fu En* bow swinging into the Ergon-St. James Terminal wharf at 0637:08. At right: Screenshot of the *Shandong Fu En* 20 seconds earlier. A crack and three other holes were found in the bulk carrier's shell plate below the waterline. SOURCE: ERGON-ST. JAMES TERMINAL

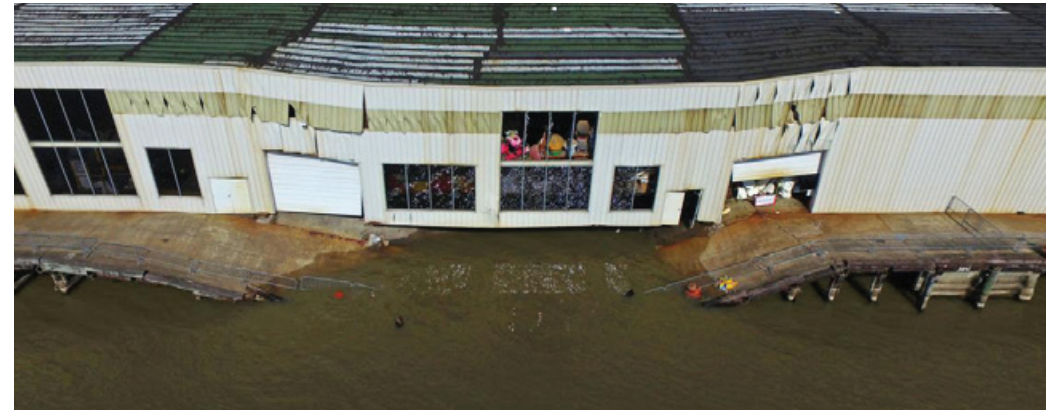
Figure 71. Damage to the Mardi Gras World warehouse and wharf. SOURCE: COAST GUARD

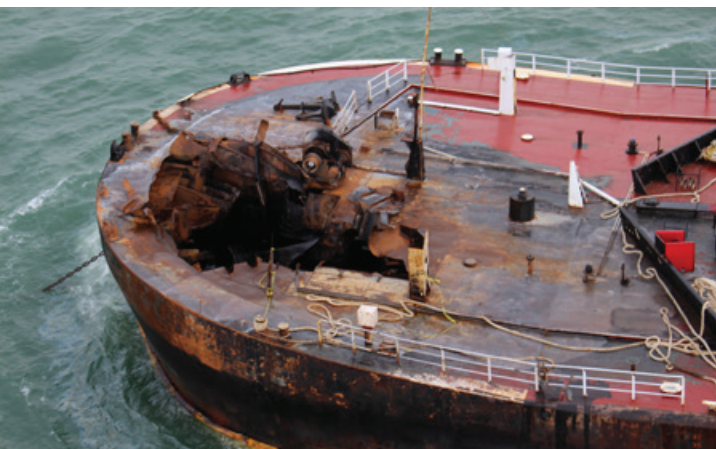
Figure 74. Explosion and fire damage to port bow of *B. No. 255*. SOURCE: COAST GUARD

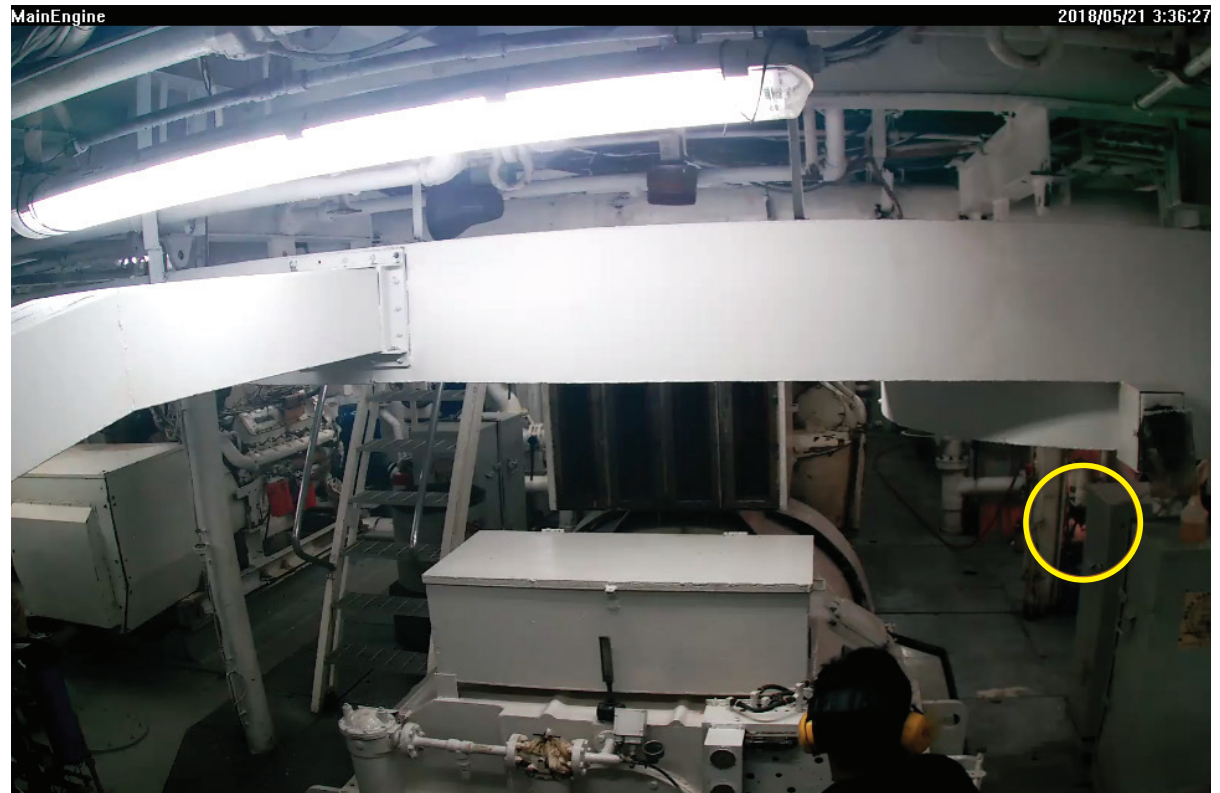
Figure 79. Screenshot from the closed-circuit television camera in the lower engine room, looking forward. The initial fire began in the area overlaid by a yellow circle (starboard side). SOURCE: COAST GUARD

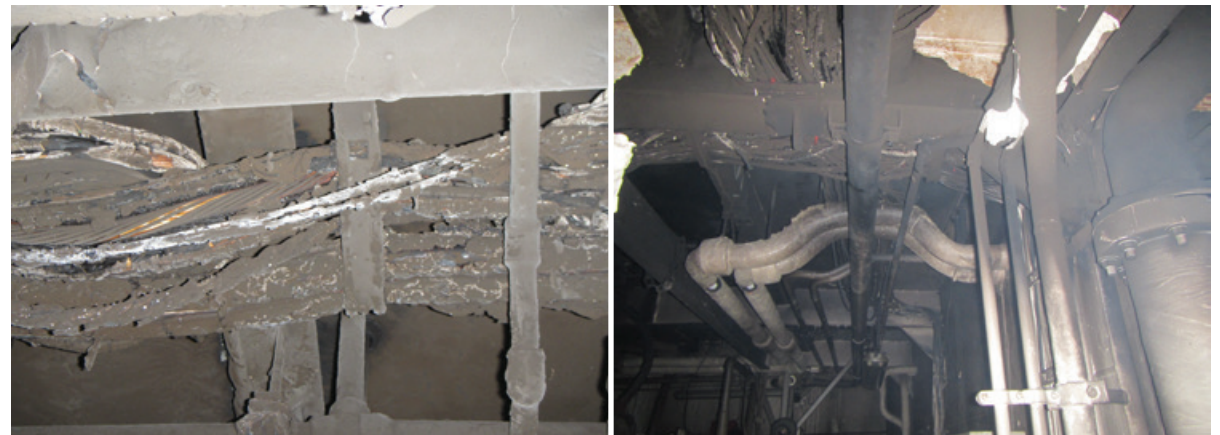
Figure 80. Left: Electrical cabling above generator no. 2. Right: Smoke and heat damage in the overhead of the starboard forward corner of the lower engine room. SOURCE: COAST GUARD

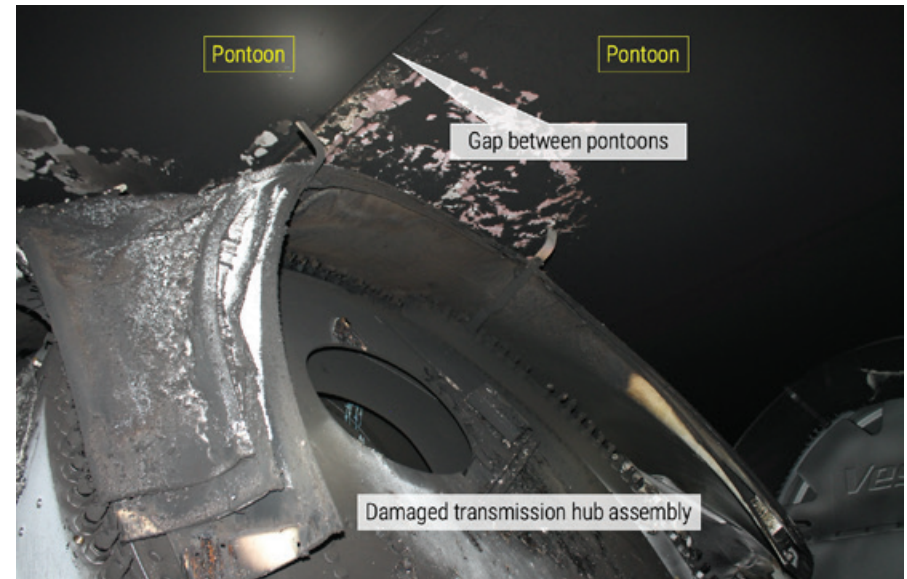
Figure 84. Fire damage to transmission hub in cargo hold no. 3 aboard *Chipolbrok Moon* directly below gap between pontoons. SOURCE: HOUSTON FIRE MARSHAL

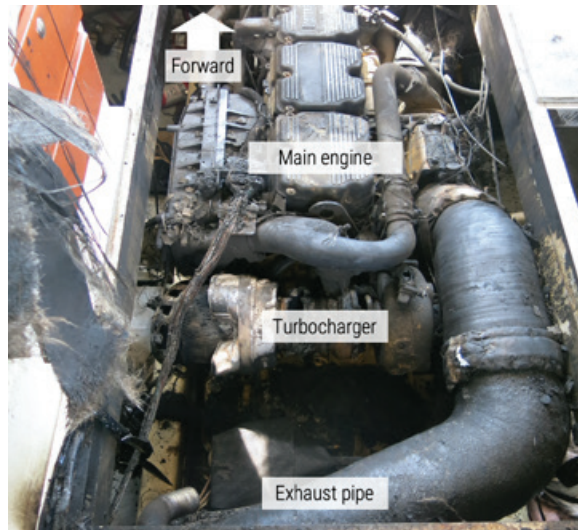
Figure 91. Damage to the engine as seen from above. Right: Damaged exhaust tubing after removal from engine room.

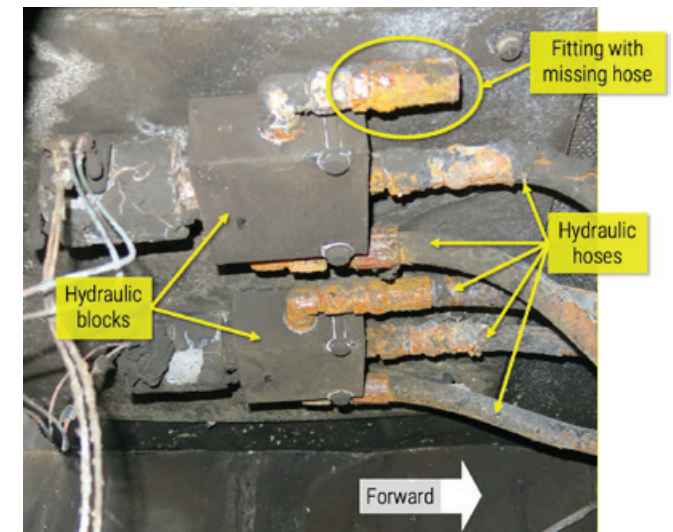
Figure 92. Hydraulic block with parted hose fitting, circled in yellow.

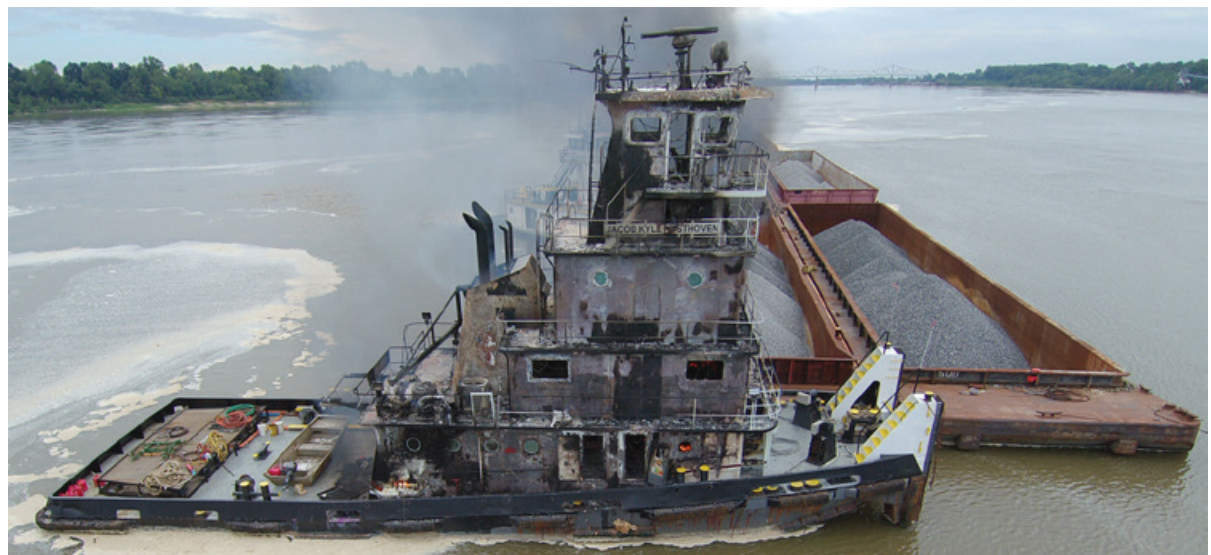
The probable cause of the engine room fire on board the towing vessel *Jacob Kyle Rusthoven* was an engine lube oil leak that ignited off a hot surface near the starboard main engine turbocharger. Contributing to the severity of the fire was the lack of crew measures to activate the engine fuel supply shutoffs and secure open doors ventilating the engine room.

Figure 98. The abandoned *Jacob Kyle Rusthoven* on fire.

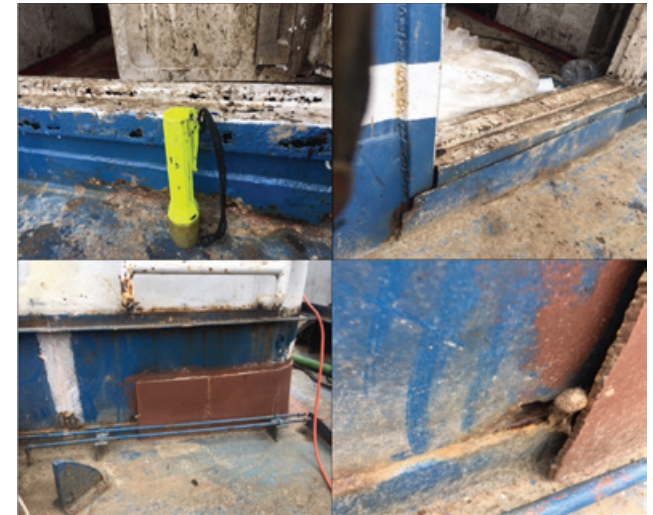
Figure 131. Wastage and doubler plates as found on *Ms Nancy C* deckhouse. Top left: doubler plate over wastage below starboard engine room entrance. Top right: doubler plate over wastage below port engine room entrance. Bottom left: doubler plates over wastage on starboard aft deckhouse. Bottom right: close-up of starboard aft doubler plate showing gap between plate and wastage area.

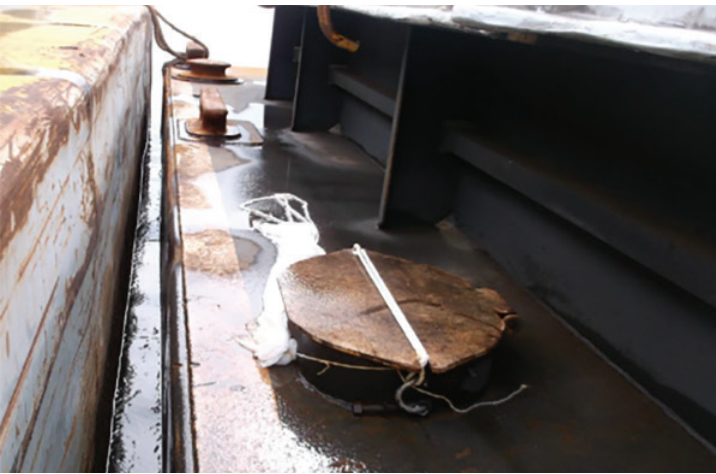
Figure 135. Postaccident views of a manhole cover on the *PTC 625* is in poor condition, with missing dogs, and strapped down with line.

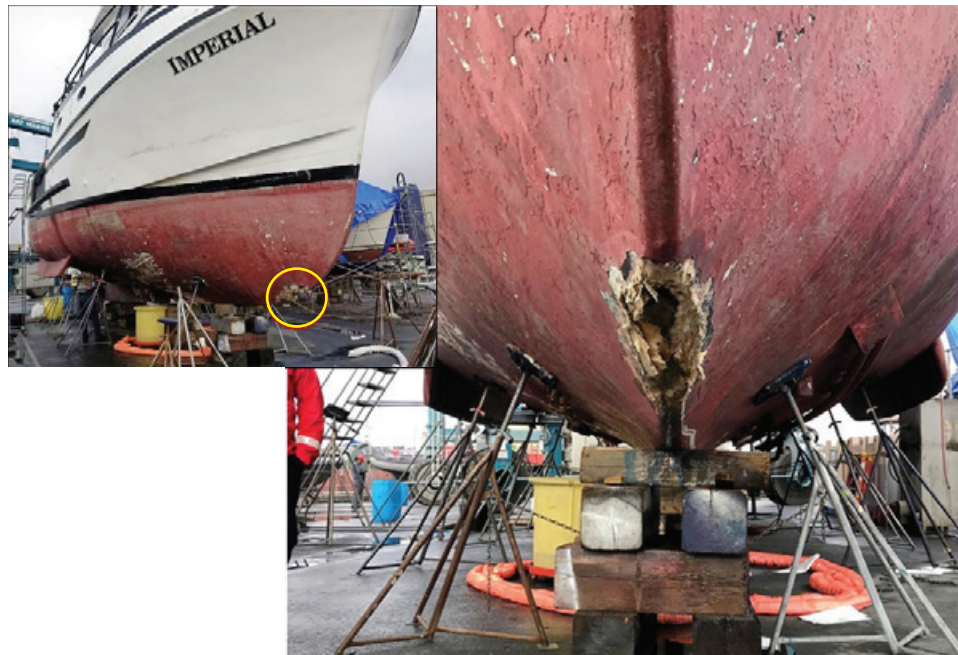
Figure 152. Left, *Imperial* bow damage. The damage is indicated with a yellow circle in the inset image.
 SOURCE: COAST GUARD

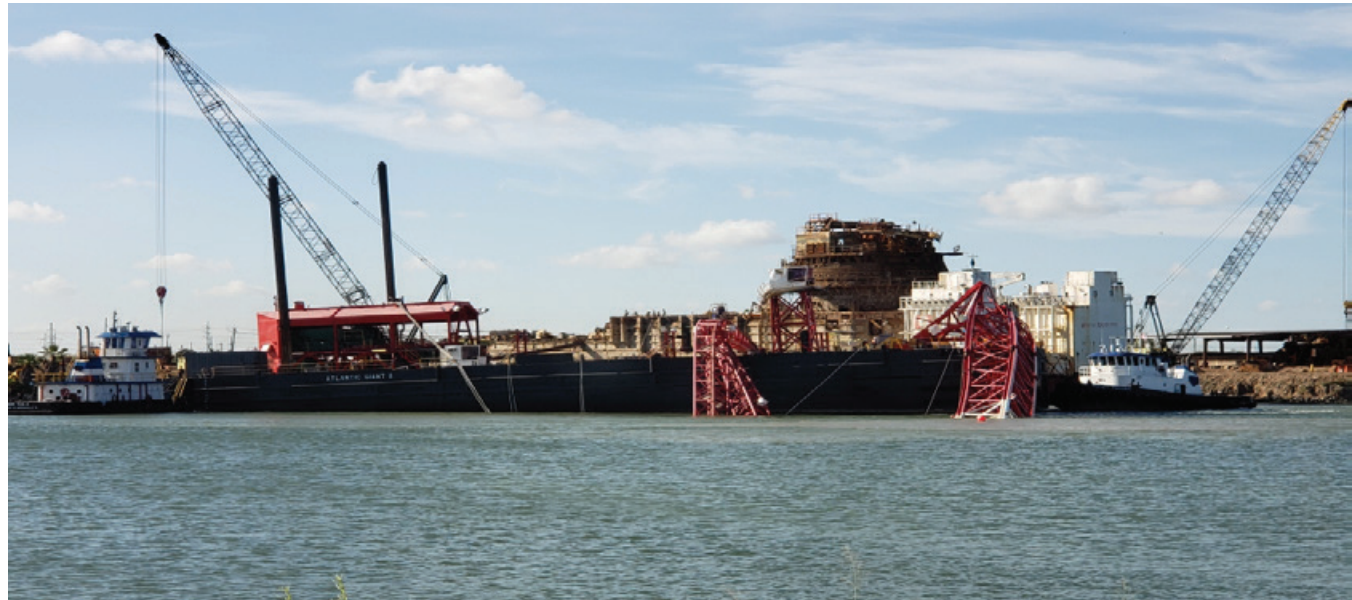
Figure 153. Collapsed crane boom on *Atlantic Giant II*. In background are *TOPS DB1* and *BOABARGE 29*.

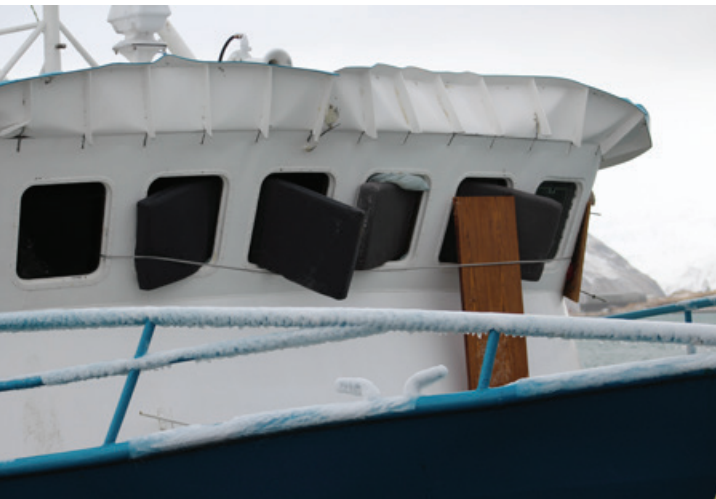
Figure 157. Wheelhouse damage and missing windows on the *Progress*.

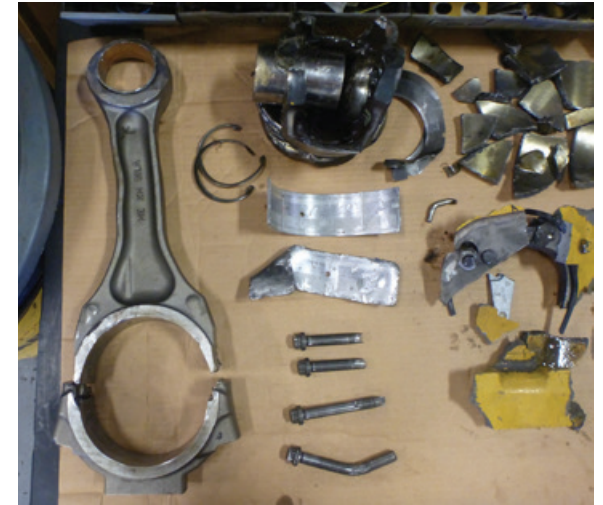
Figure 163. Connecting rod, cap, bolts, and bearing halves of cylinder no. 8. SOURCE: COAST GUARD
