# SAFER SEAS Digest 2020

Lessons Learned from  
Marine Accident Investigations

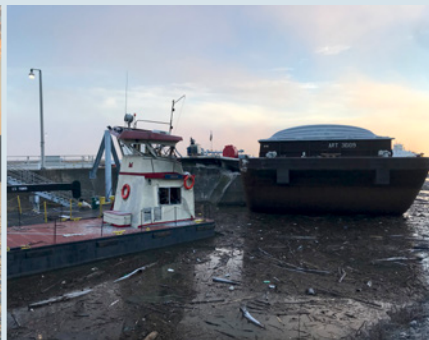
Back cover: Damage to the workboat *Gibson* (see page 54).

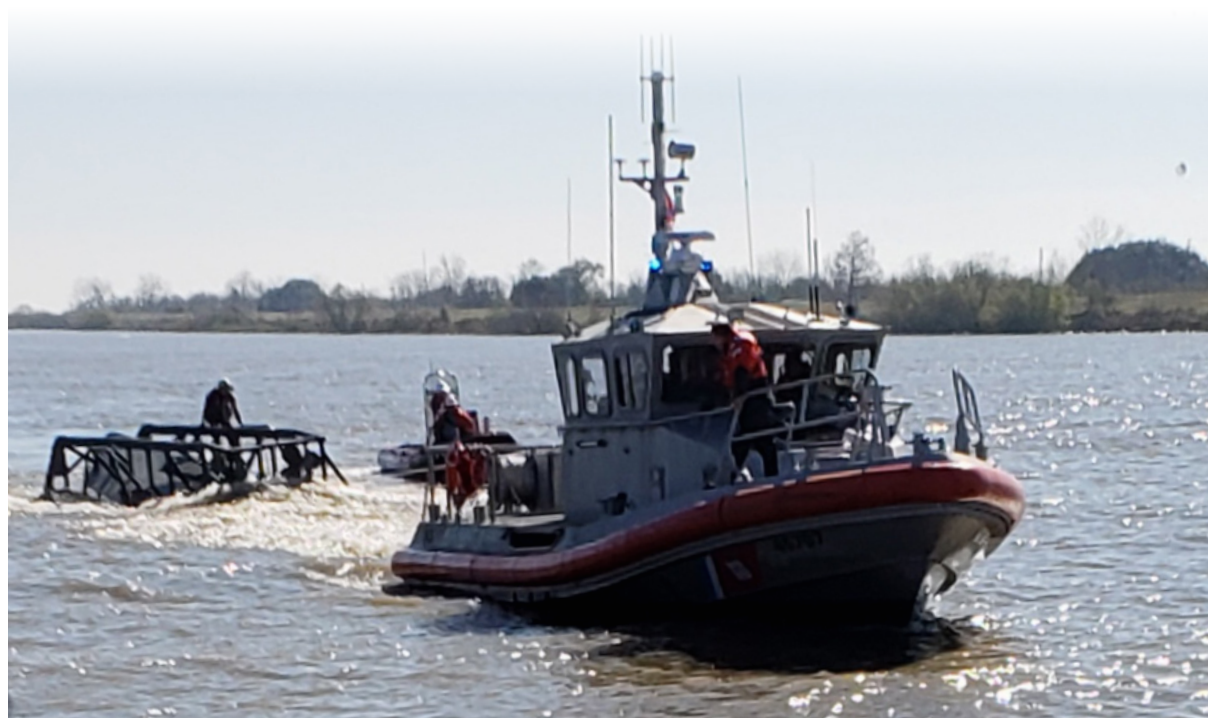
Figure 3. CG 45707 tows the overturned *MSRC 8-1*. SOURCE: BSEE.

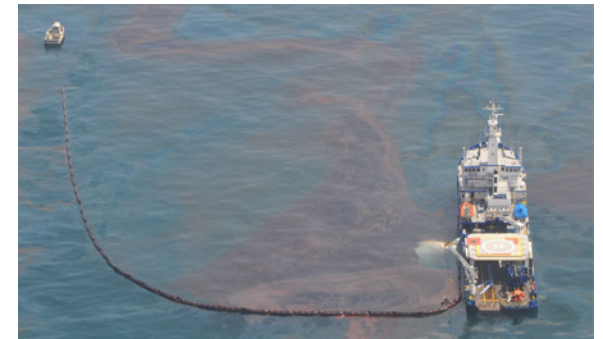
Figure 4. J-configuration deployment of oil spill boom by MSRC OSRV (right) and 32-foot workboat (left) during *Deepwater Horizon* oil spill response in May 2010.

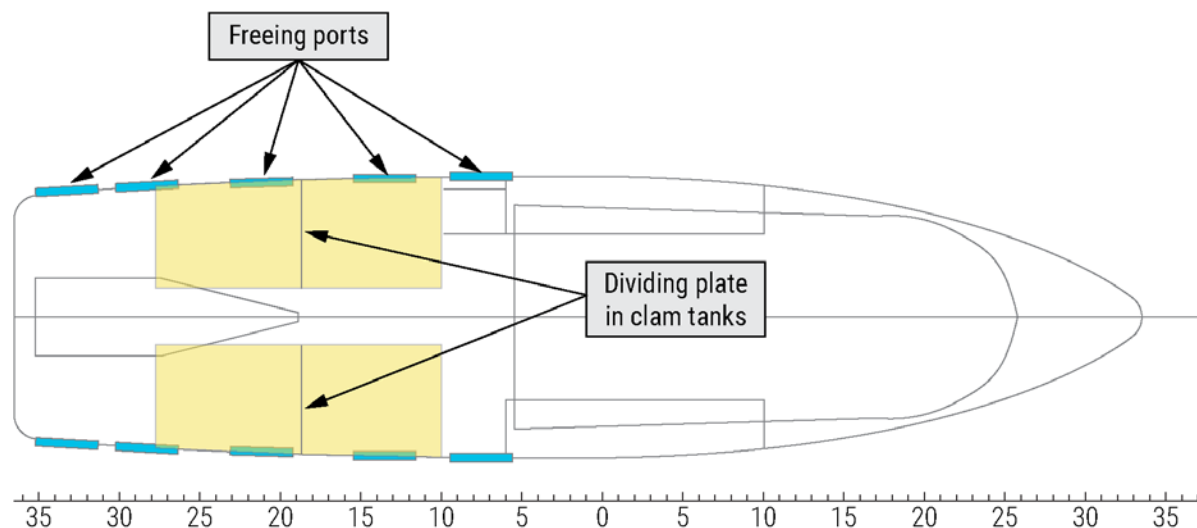
**Figure 9.** Plan view of *Misty Blue*'s tank layout and freeing port locations. The clam tanks are highlighted in yellow.

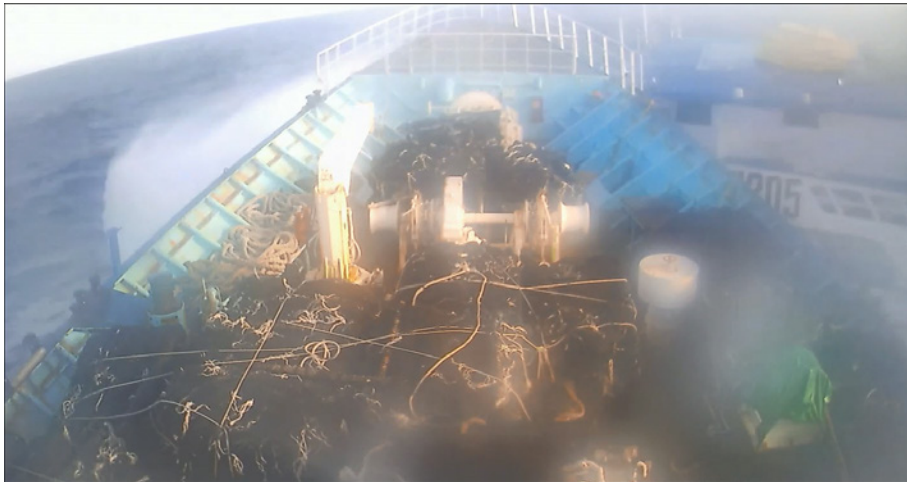
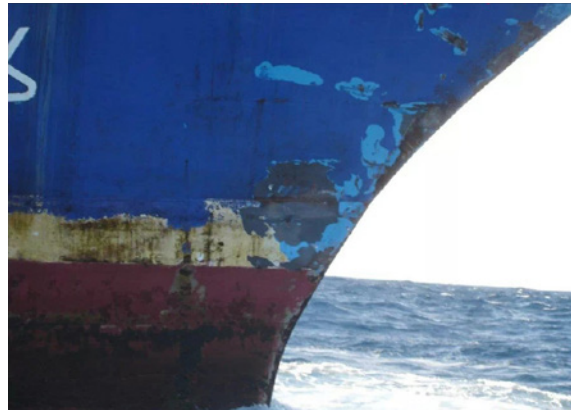
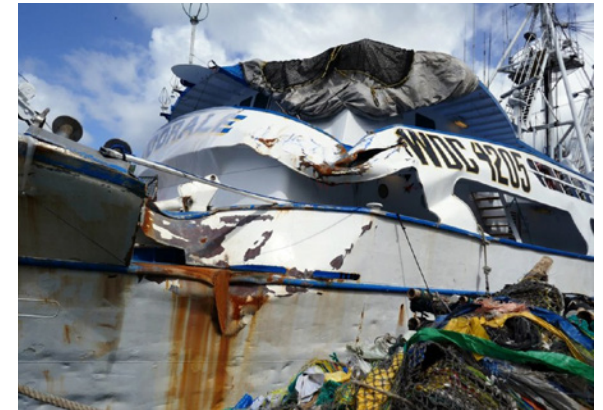
**Figure 11.** Damage sustained to both vessels. Bow of *American Eagle* (left) and *Koorale* (right). SOURCE: AMERICAN EAGLE FISHING, LLC.

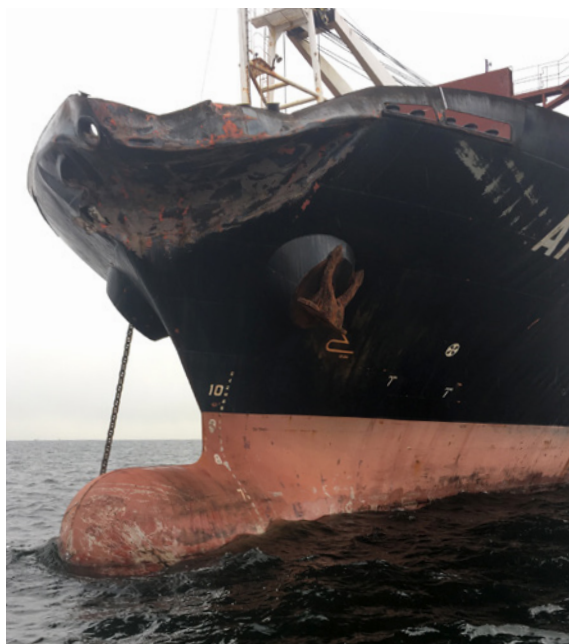
Figure 15. Damage to *APL Guam*. SOURCE: COAST GUARD.

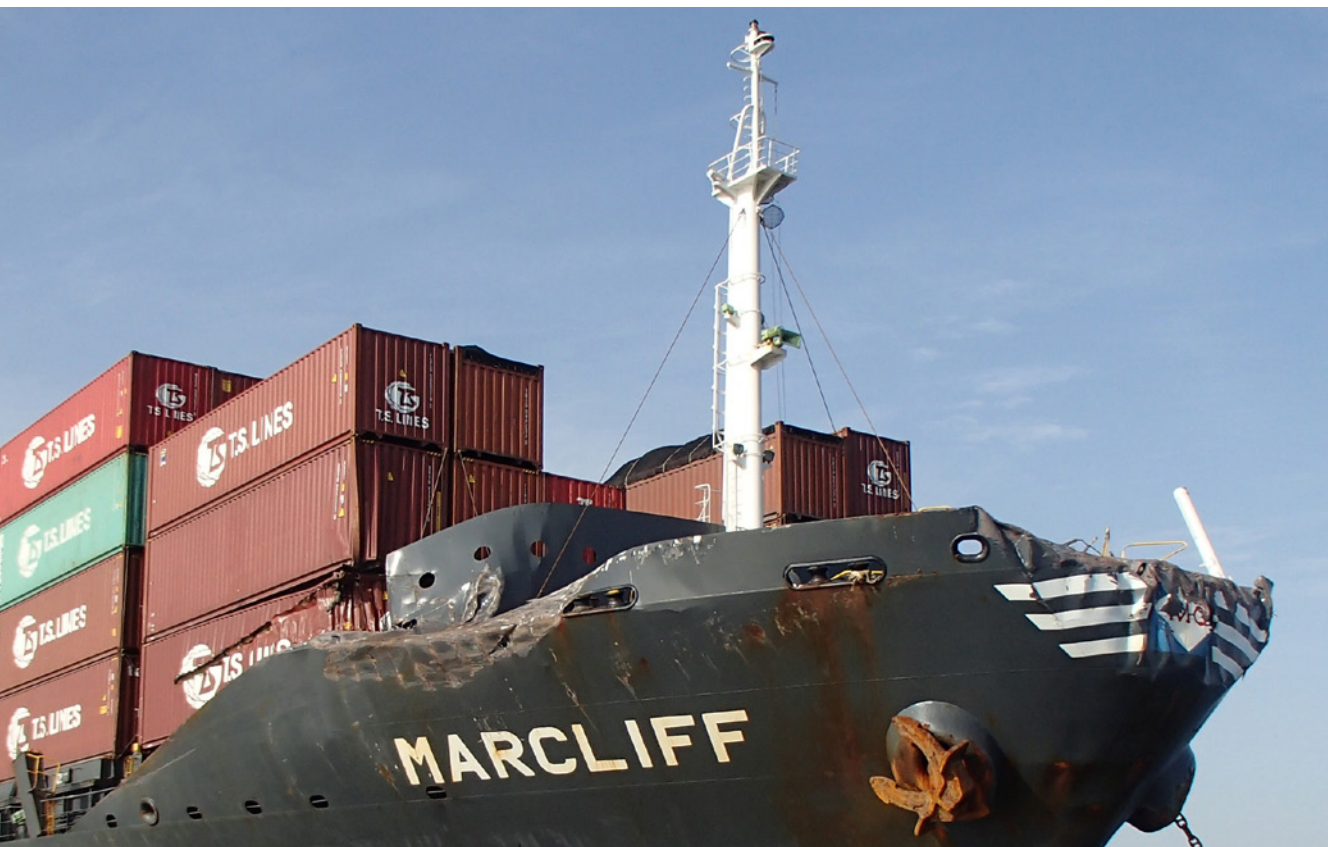
At 2327 local time on March 21, 2019, the containership *Marcliff* was outbound from the Port of Yokohama, Japan, when it collided with the containership *APL Guam*, which was inbound to an anchorage at the port. After the initial collision, the *Marcliff* then collided with the containership *Hansa Steinburg*, which was anchored nearby. No pollution or injuries were reported. Damages to the three vessels were estimated at \$1,178,200.

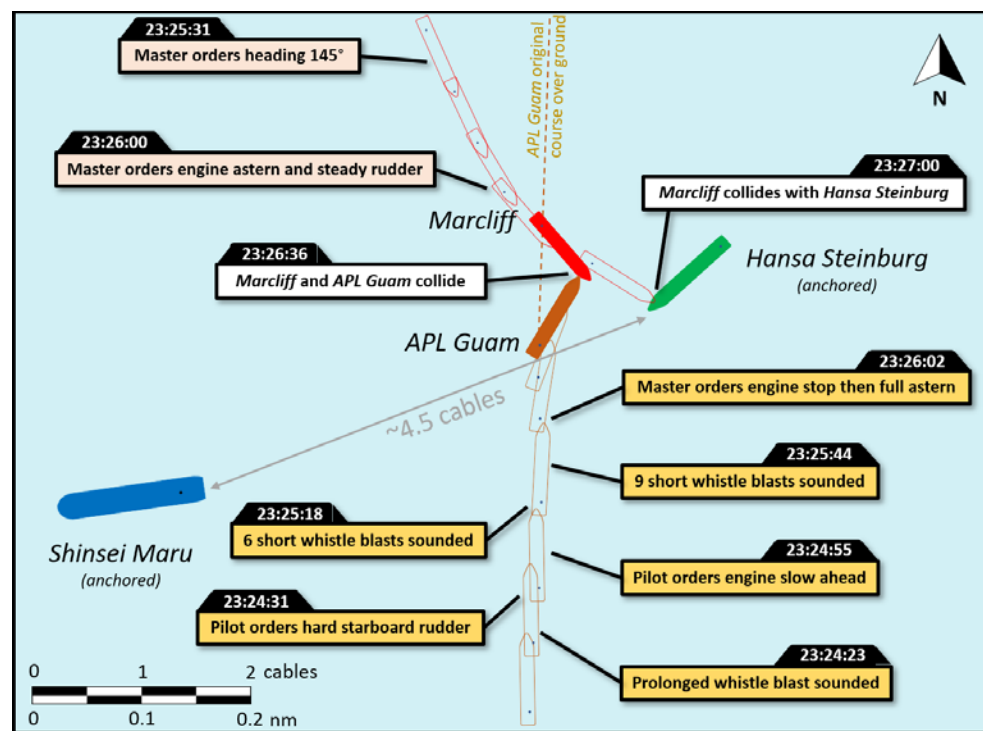
The probable cause of the collision between the containerships *Marcliff* and *APL Guam* was the *Marcliff* master's attempt to pass between the *APL Guam* and the anchored *Hansa Steinburg* with insufficient safe maneuvering room. Contributing to the accident was a lack of communication between the *Marcliff* bridge team and the *APL Guam* pilot and bridge team to establish their maneuvering intentions.

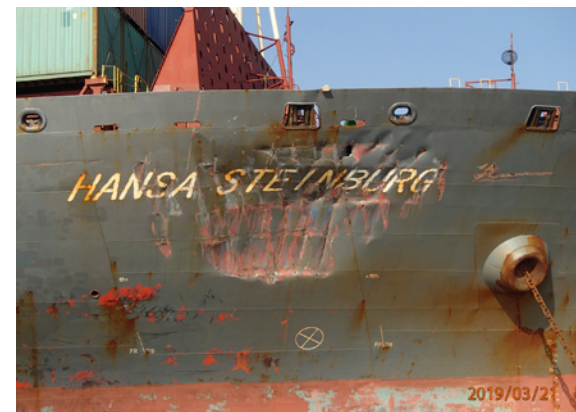
**Figure 18.** Damage to *Hansa Steinburg* starboard-side bow. SOURCE: COAST GUARD.

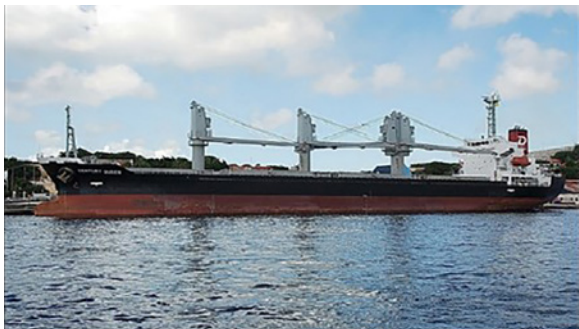
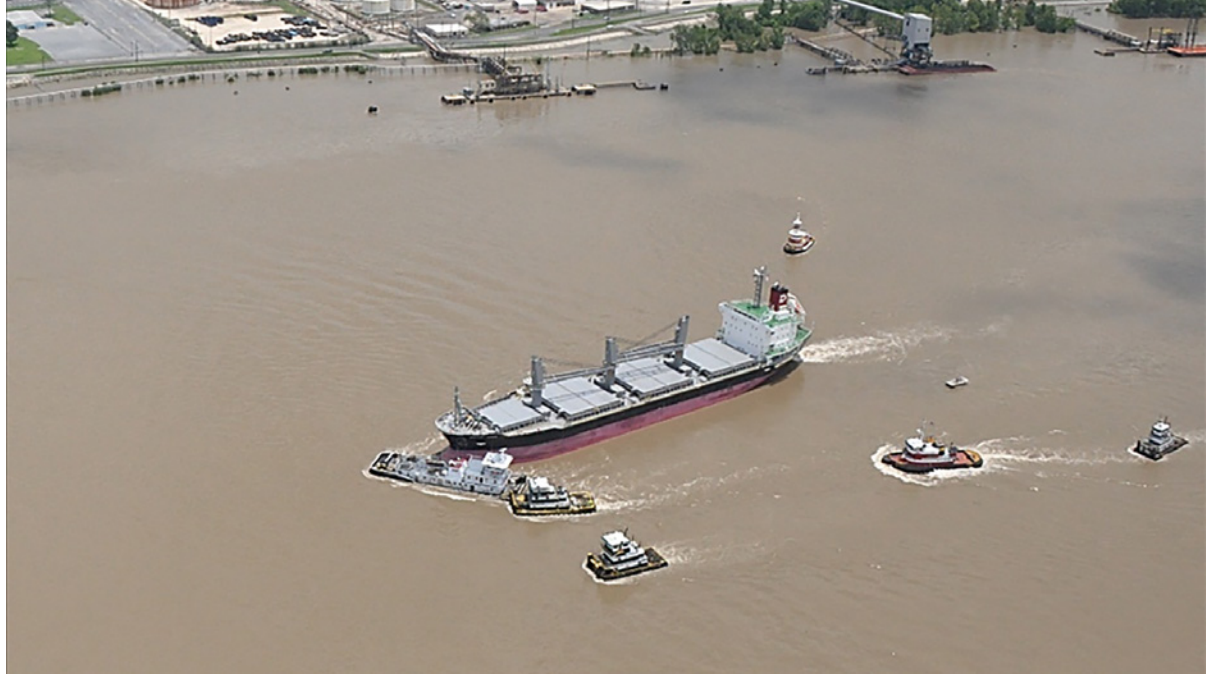
Figure 21. Both vessels shortly after the collision. SOURCE: COAST GUARD.

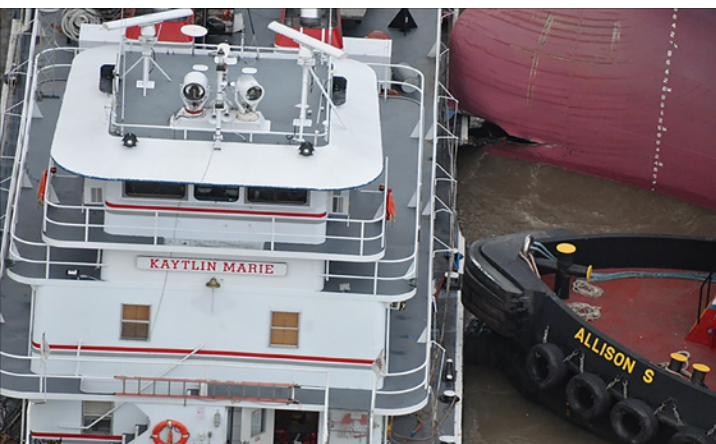
**Figure 22.** *Kaytlin Marie* embedded in the *Century Queen*'s bulbous bow. SOURCE: COAST GUARD.

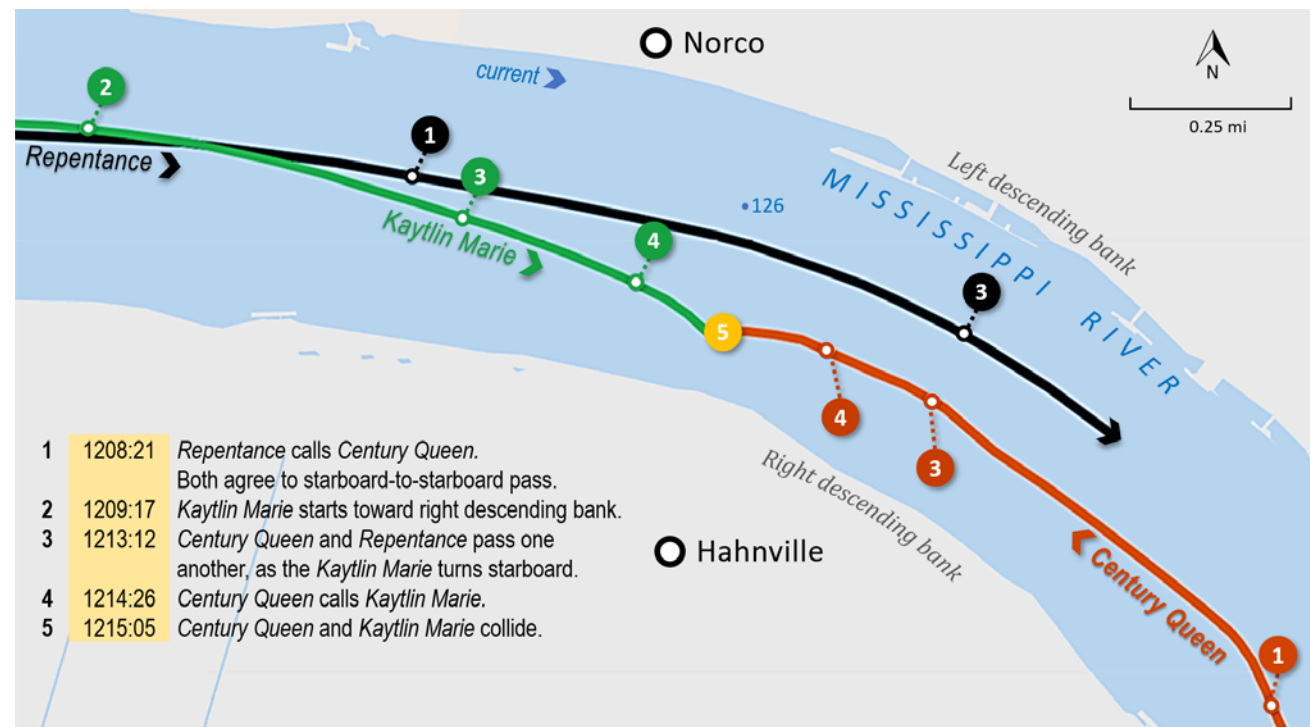
**Figure 23.** Tracklines of the vessels during the last 7 minutes prior to the collision. The *Century Queen* is represented in red, the *Kaytlin Marie* in green, and the *Repentance* in black. BACKGROUND SOURCE: GOOGLE MAPS.

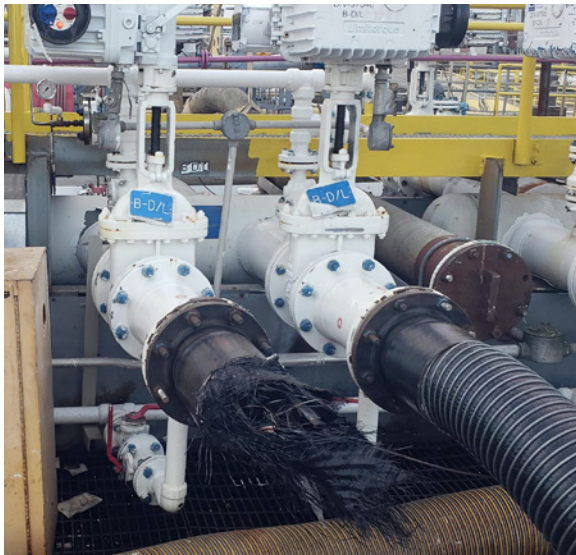
**Figure 24.** Damaged shoreside cargo hose and deformed piping at the manifold at the Kinder Morgan facility.

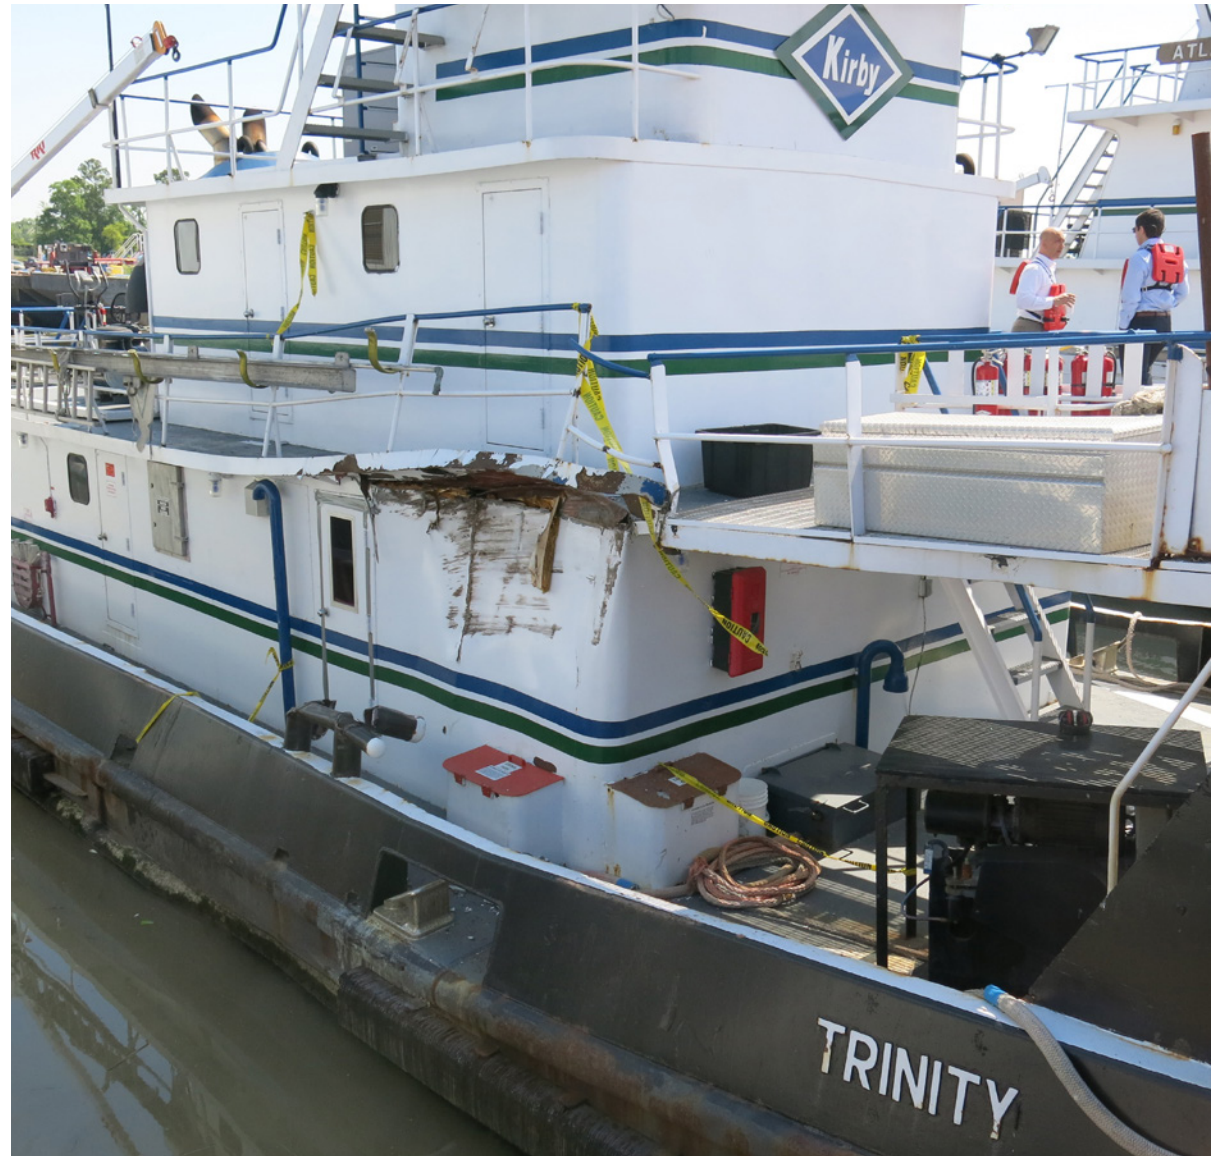
About 0400, the *Dixie Vandal* and tow were approaching Crown Bend, upcoming just north of the Kinder Morgan facility, intending to pass the facility on the tow's port side. Docked at the facility was the *Trinity* and barges *Kirby 29051* and *EBL 2997*.

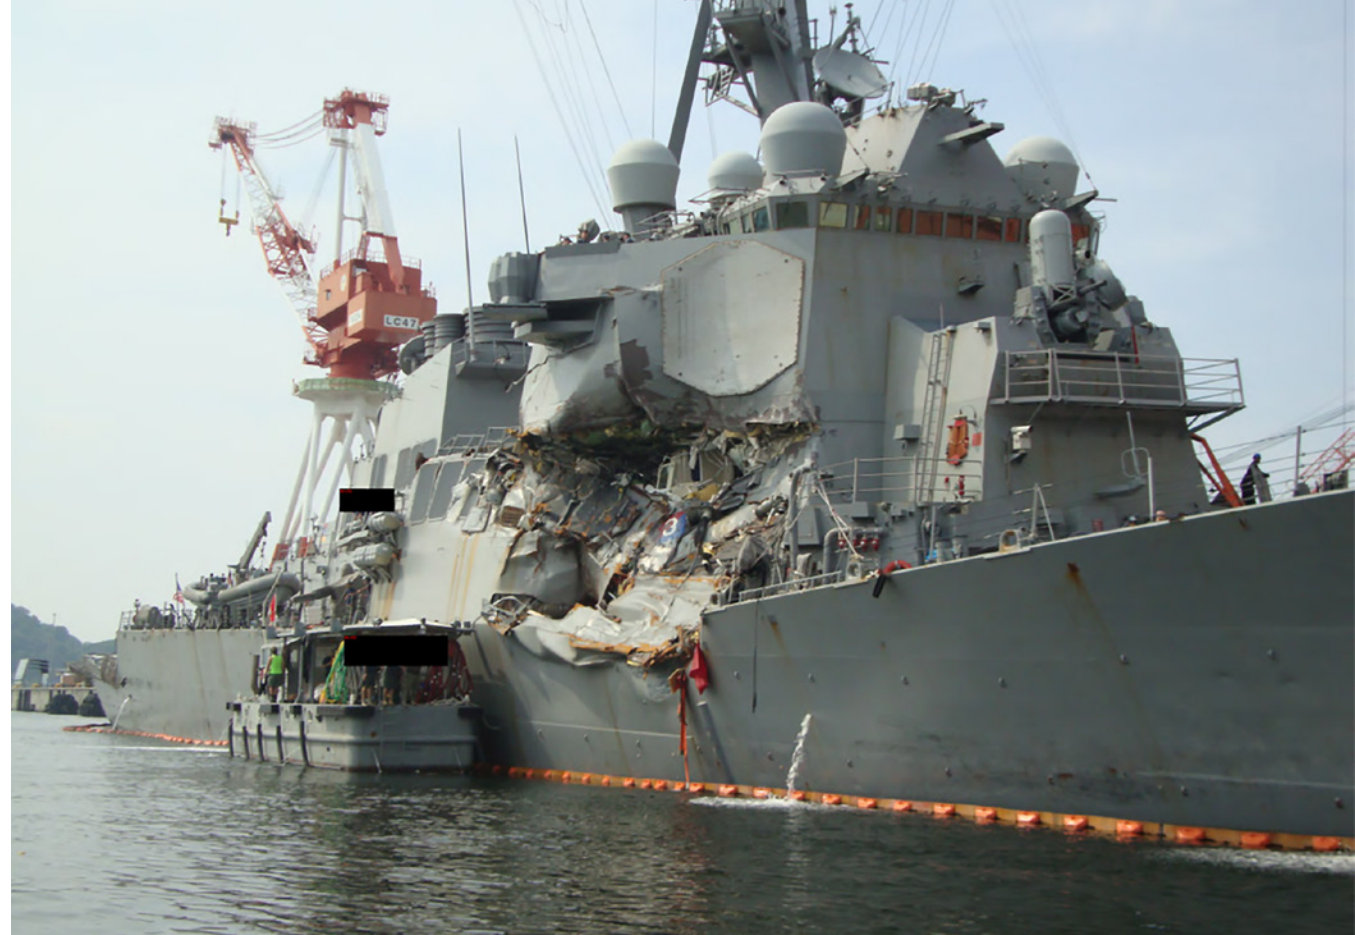
**Figure 29.** Post-collision damage to the *Fitzgerald*'s starboard side. SOURCE: US NAVY.

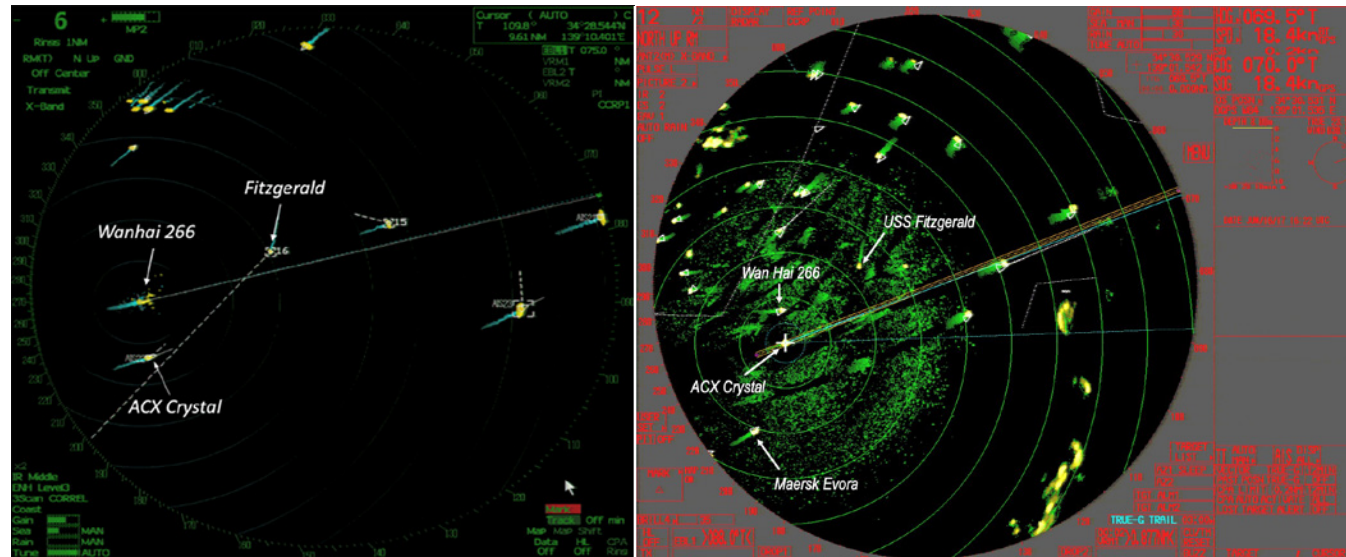
**Figure 32.** A comparison of radar screens from different vessels before the collision. **Left:** Screen capture from the *Wan Hai 266* electronic navigation software, about 6 minutes before the collision. **Right:** Screen capture from the *ACX Crystal* electronic navigation software (radar and ARPA), at the same time. (Vessel names have been added to screen images.)

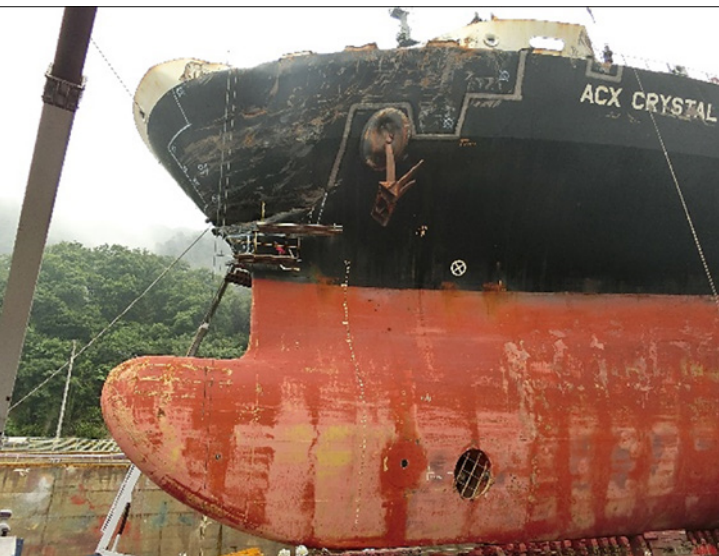
**Figure 33.** Postaccident damage to the *ACX Crystal*'s bow.  
SOURCE: JAPAN TRANSPORT SAFETY BOARD.

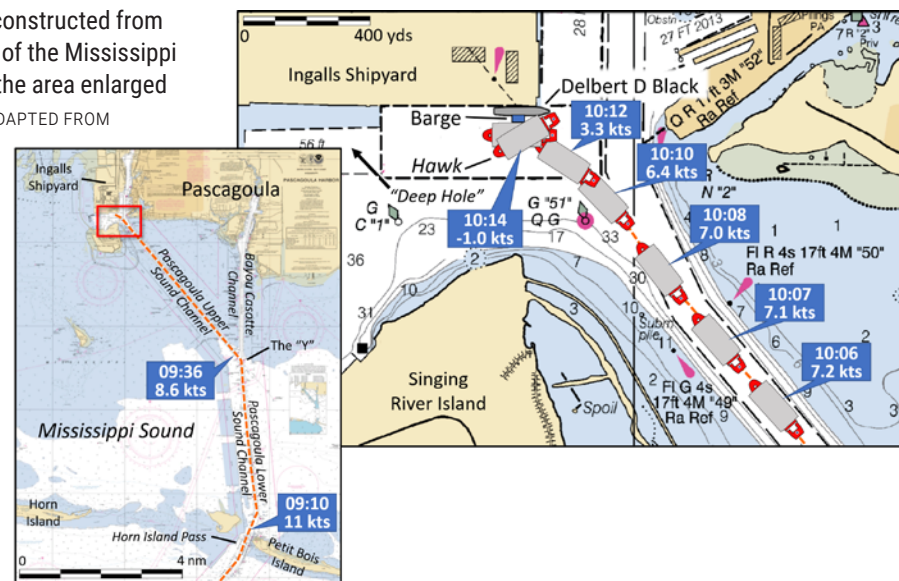
**Figure 36. Below:** Damage to the *Delbert D Black*'s starboard hull (left) and bow (right).

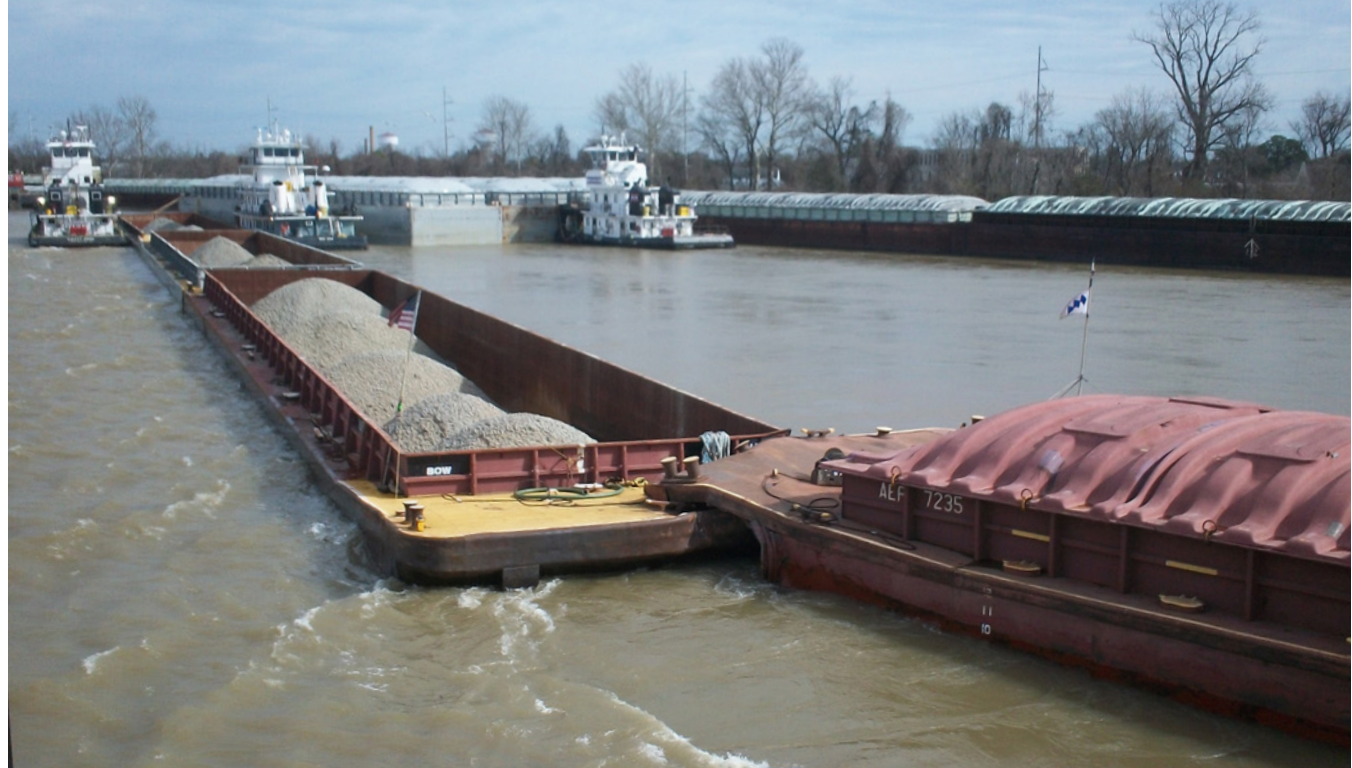
**Figure 38.** The AEP 7235 lying across the 005492 after the collision.

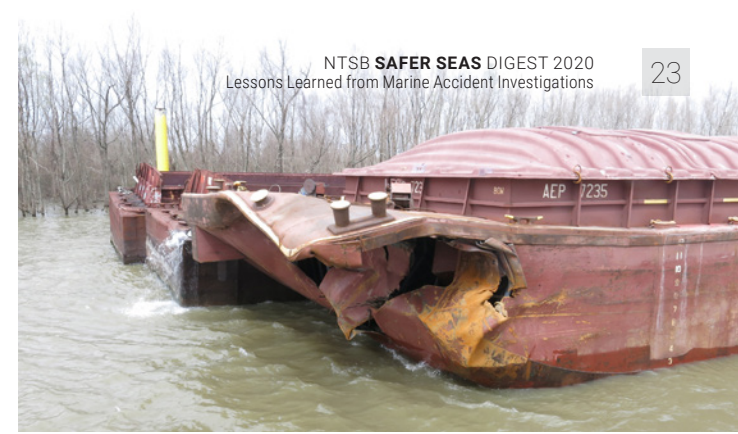
Figure 40. Damage to port bow of the AEP 7235.

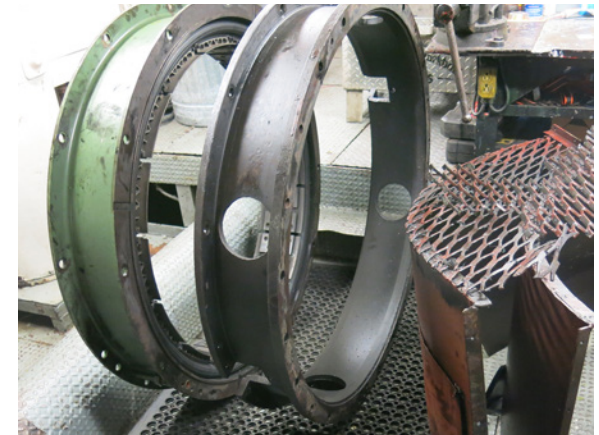
Figure 41. Above: Port clutch assembly steel rings removed from the *Miss Dixie* during postaccident inspection. Below: Condition of the port engine clutch friction pads aboard the *Miss Dixie* after the accident.

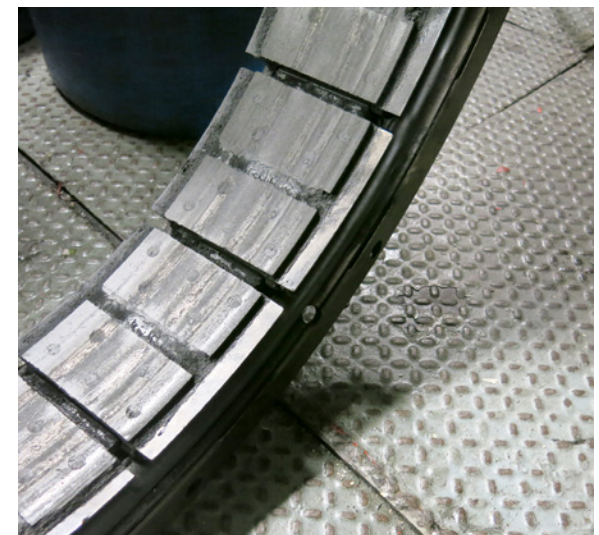
### Inspection of Propulsion System Clutch Assemblies

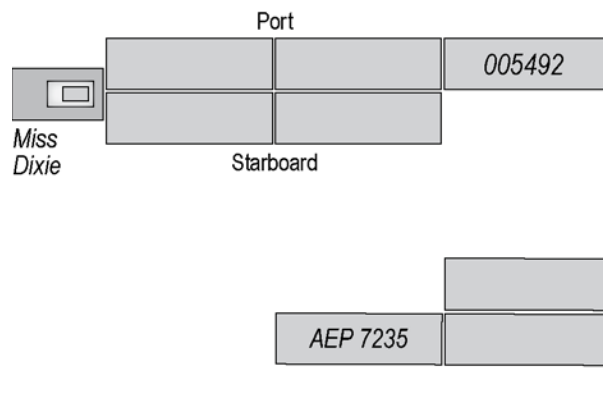
Figure 39. Left and below: Simplified towing arrangements of the *Miss Dixie* and the *D. & R. Boney* on the evening of the accident (not to scale).

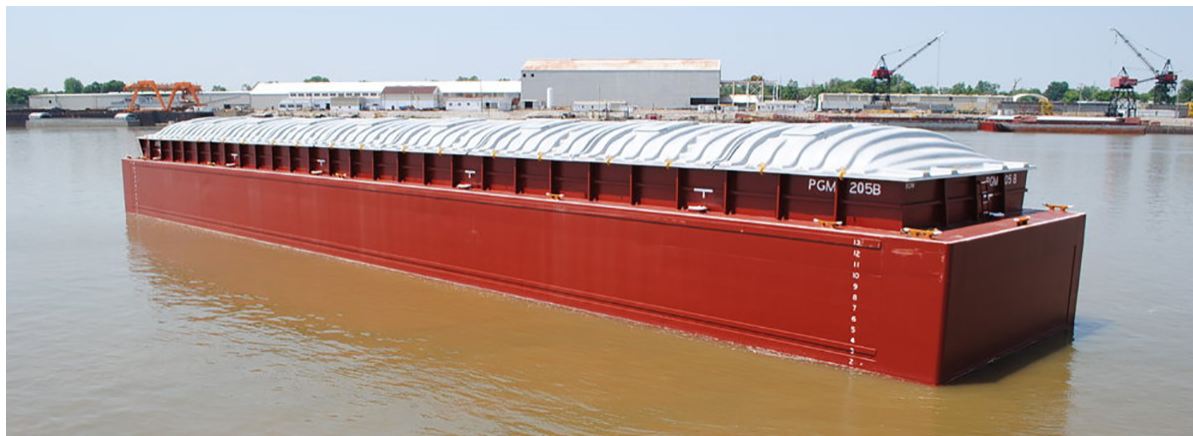
**Figure 44.** A barge similar to the *LTD 14161*. SOURCE: COOPER CONSOLIDATED, LLC.

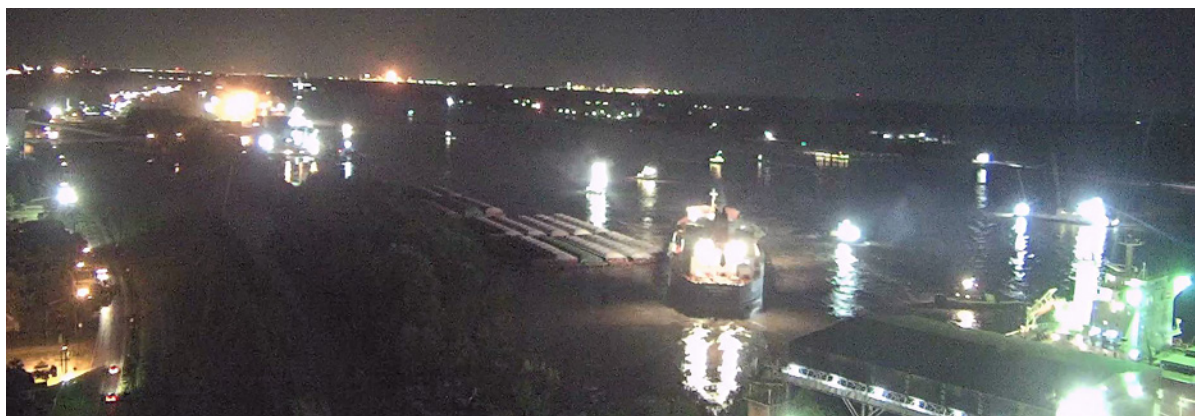
On May 16, 2019, at 2042 local time, the fully laden product tanker *American Liberty* got under way with a pilot on the Lower Mississippi River, at mile 140.2 near Reserve, Louisiana, when the bridge team lost control of the vessel in the fast current, and made contact with moored vessels, barges, and wharfs along the left descending bank from miles 139.5 to 138.7 as it moved down river. Four injuries and no pollution were reported. There was a reported \$40.5 million in damages to the vessels, barges, and terminals.

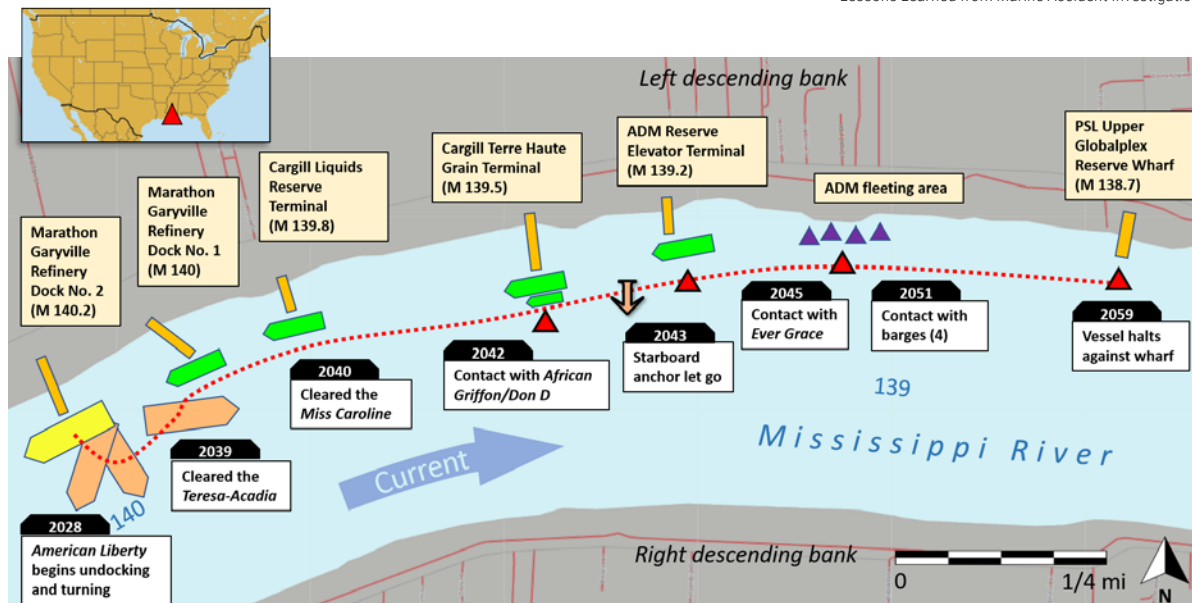
**Figure 48.** From where the *American Liberty* was moored, there were five wharfs on the left descending bank down river. All vessels were moored starboard-side-to, bow pointed upriver. Shown is the vessel's AIS track (red dots) getting underway, turning counterclockwise, moving bow first down river, and contacting vessels and wharfs along the left descending bank, as indicated by the red triangles. Not to scale. BACKGROUND SOURCE: GOOGLE MAPS.

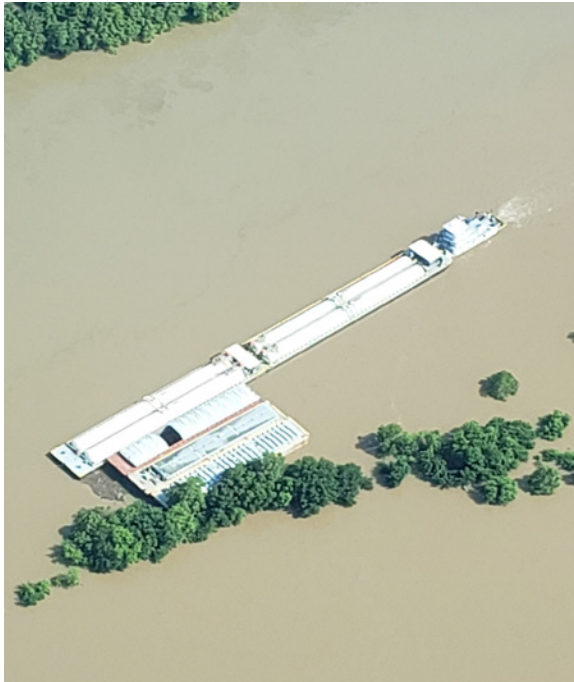
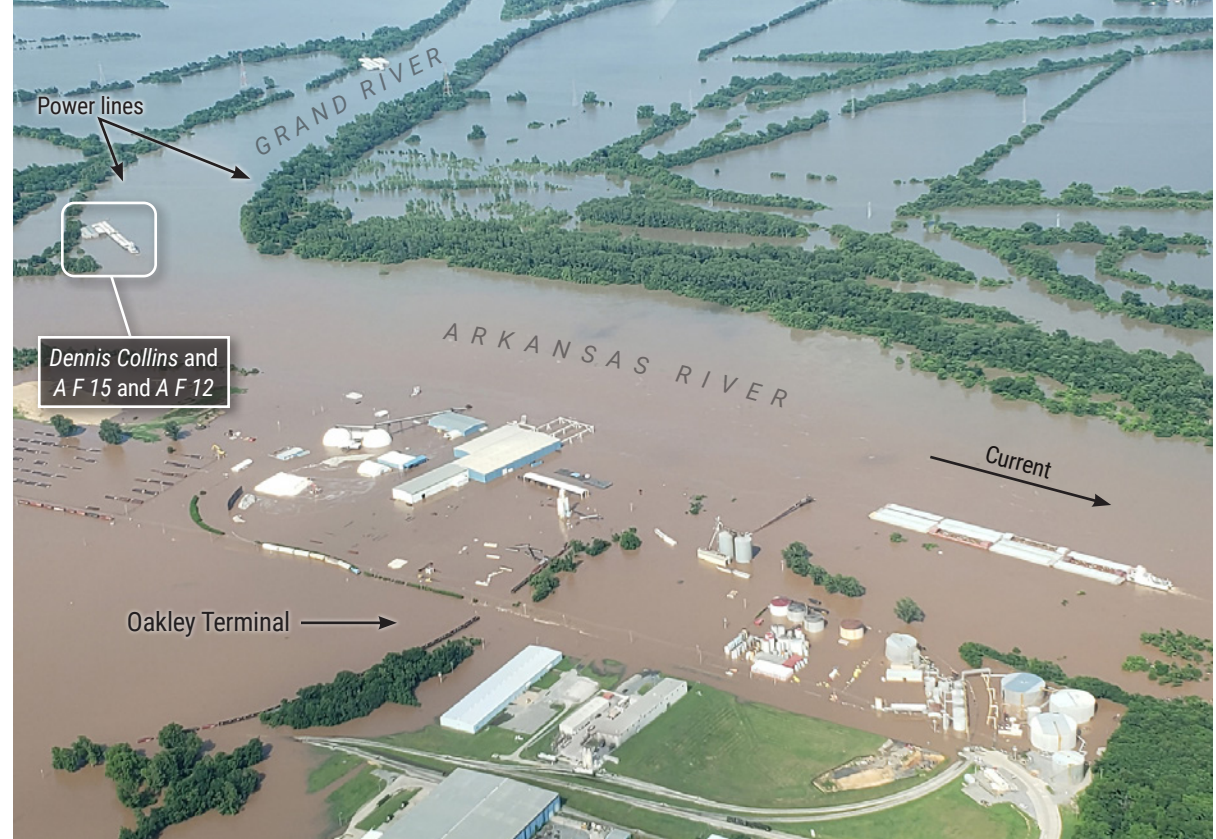
**Figure 51.** Muskogee, Oklahoma, where the Grand River meets the Arkansas River. Photograph taken three days after the breakaway, at 1600 on May 25, when the Arkansas River stage and flow in Muskogee were 46.28 feet and 595,000 cfs. SOURCE: COAST GUARD.

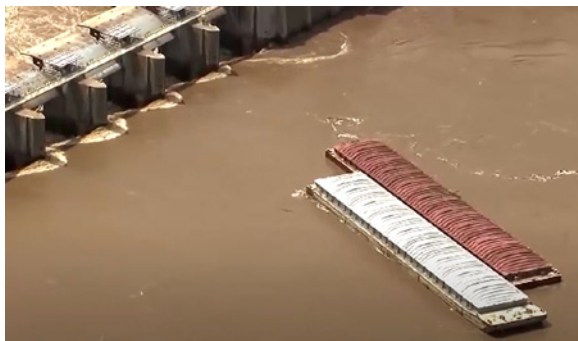
**Figure 52.** Barges *MTC 7256* and *LTD 1140* shortly before striking Webbers Falls Dam. SOURCE: KJRH-TV.

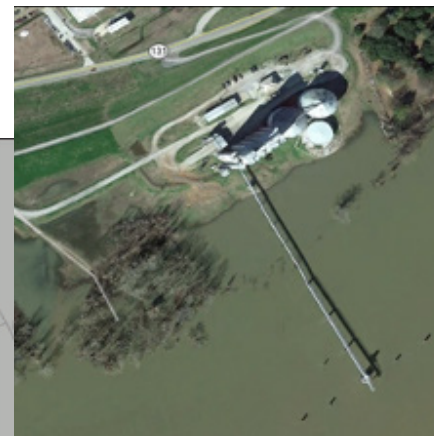
**Figure 56.** The Bunge facility, including silos, conveyor, and mooring pilings. SOURCE: GOOGLE EARTH.

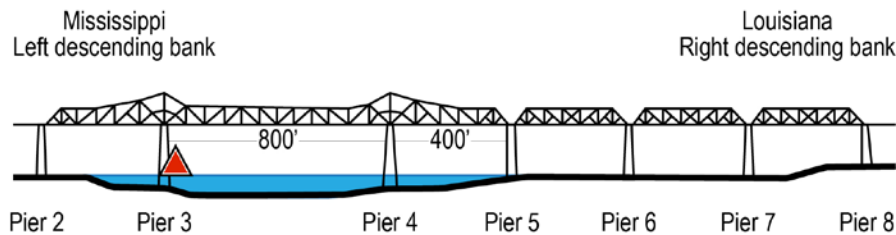
**Figure 60.** A drawing of the Old Highway 80 Bridge looking down river. The red triangle indicates the location of the bridge strike.

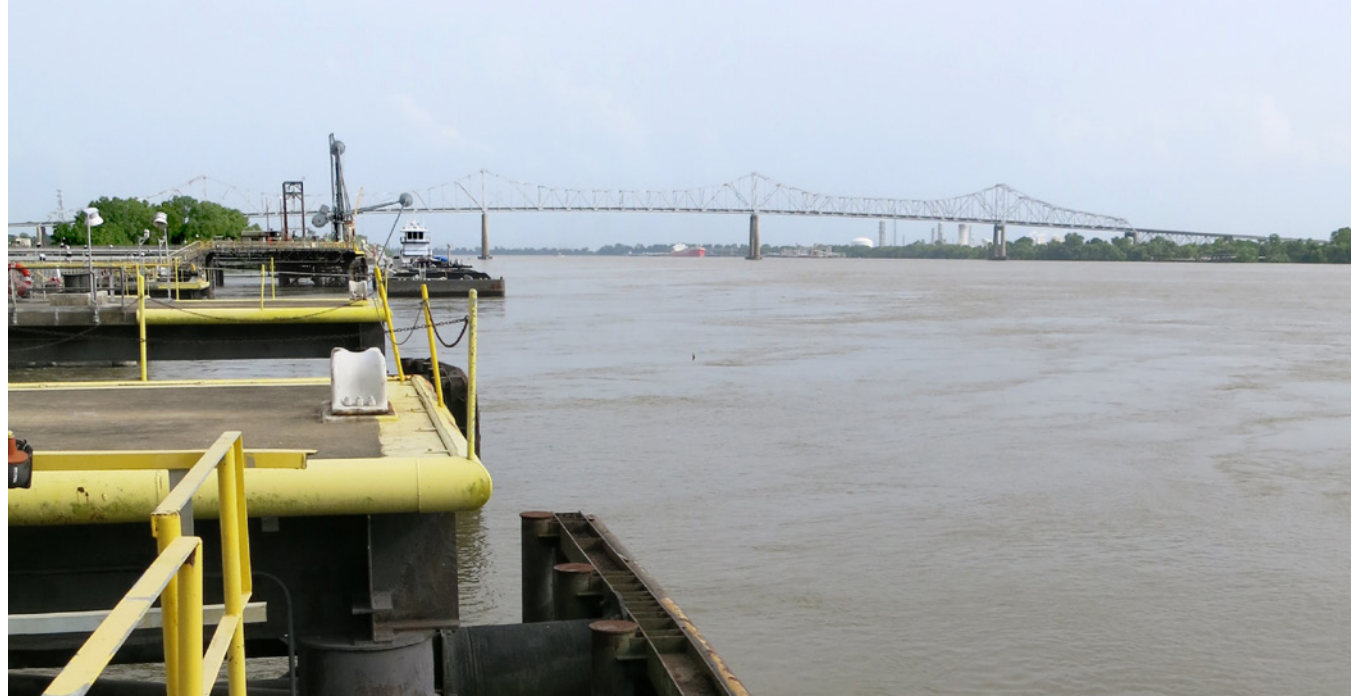
Figure 63. Sunshine Bridge looking down river from the berth where the *Dank Silver* undocked.

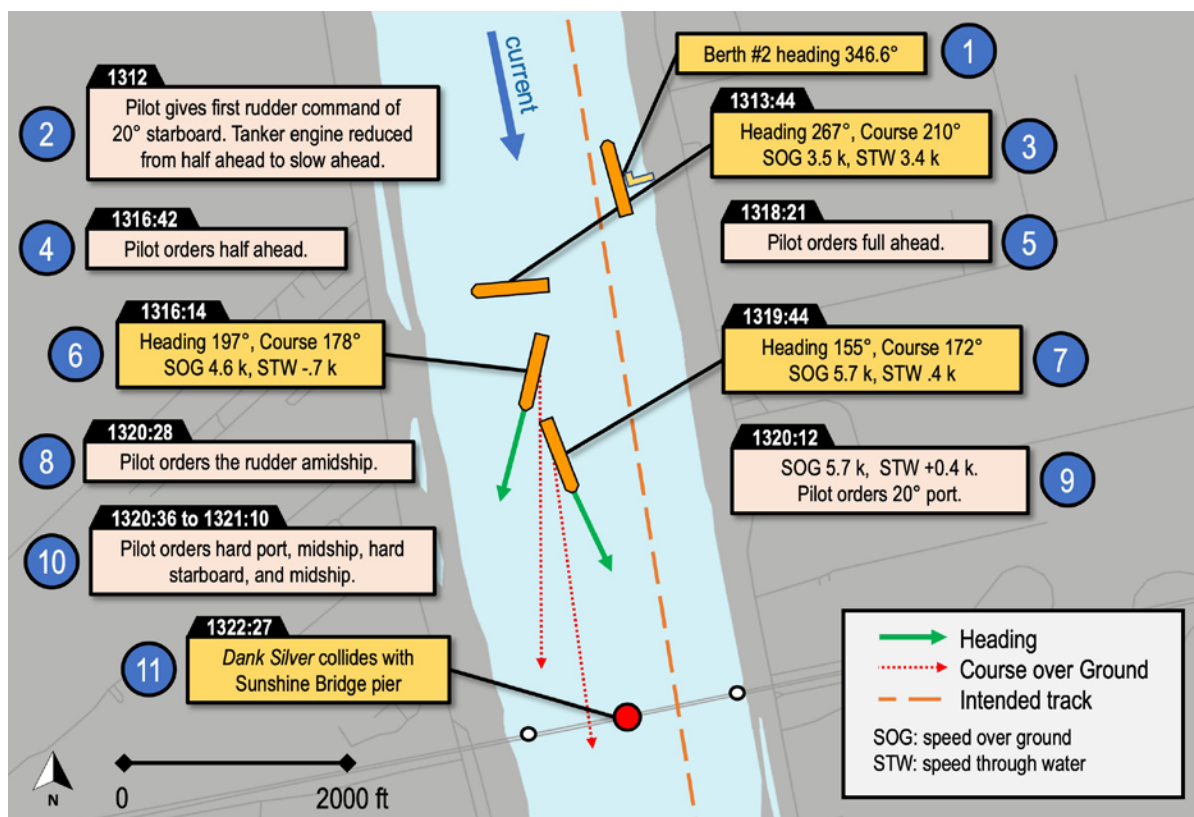
Figure 64. Course of the *Dank Silver* from ECDIS data. BACKGROUND SOURCE: GOOGLE MAPS.

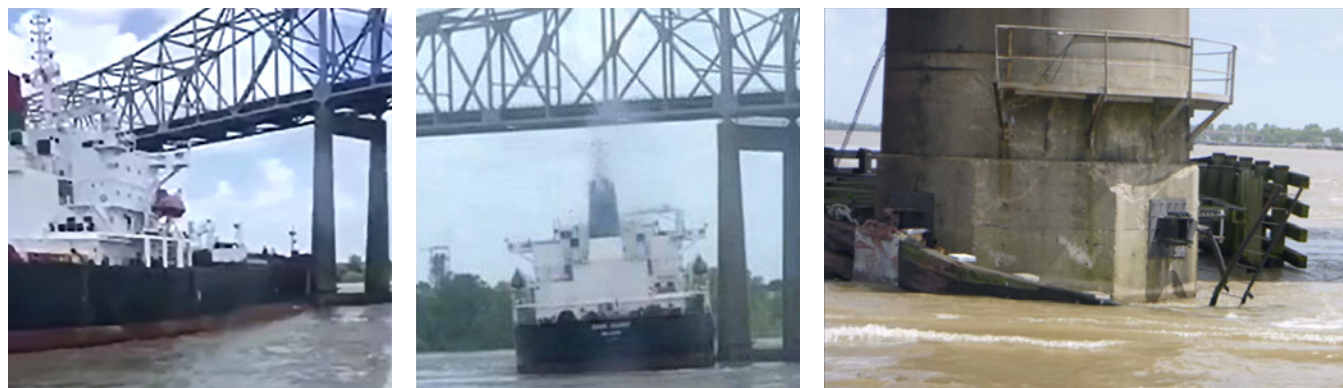
Figure 65. Left and middle: Two photos showing the *Dank Silver* striking the Sunshine Bridge. SOURCE: CRESCENT TOWING. Right: Damage to the fendering system for the western pier of the Sunshine Bridge, from the north. SOURCE: LOUISIANA DEPARTMENT OF TRANSPORTATION AND DEVELOPMENT.
