# SAFER SEAS Digest 2020

Lessons Learned from  
Marine Accident Investigations

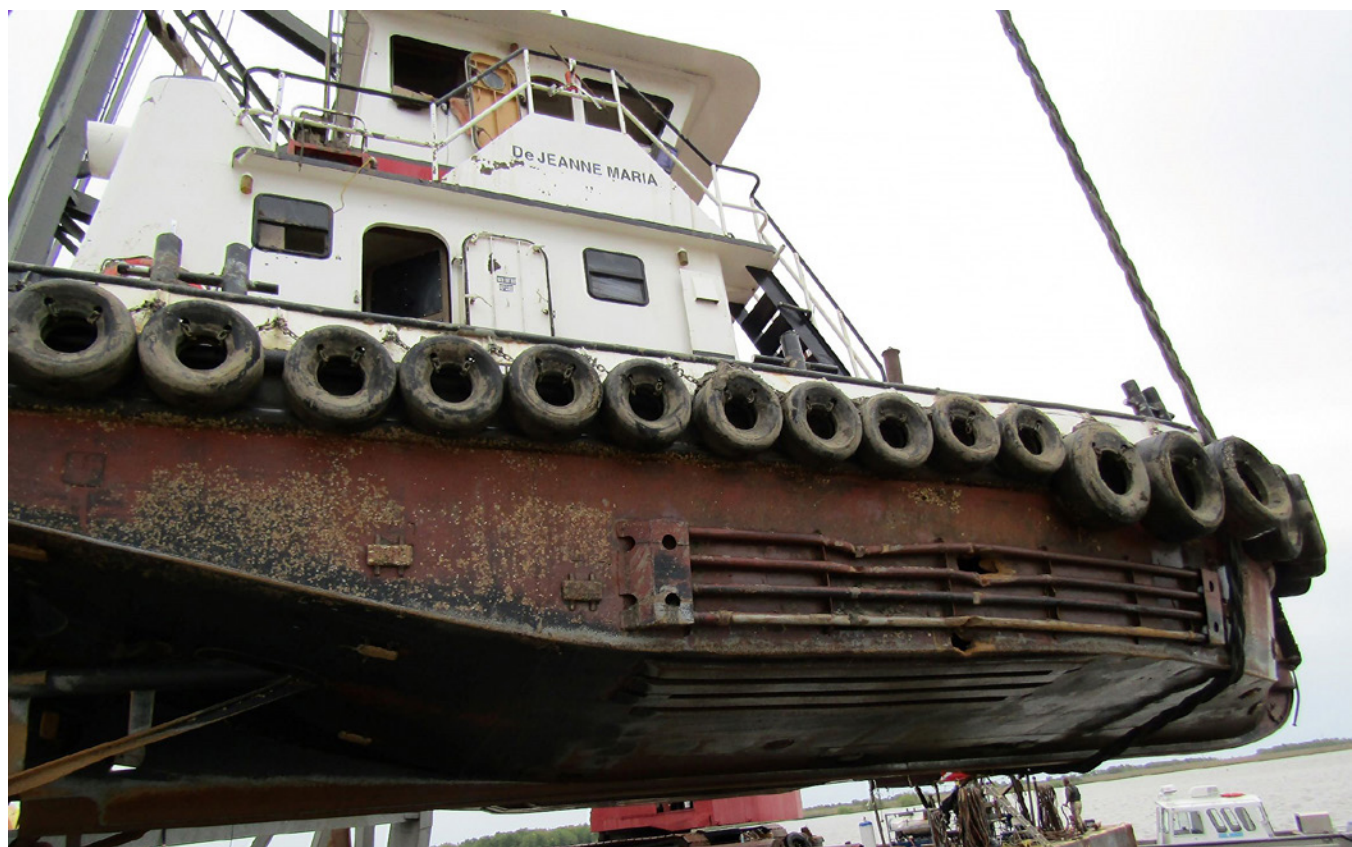
**Figure 67.** *DeJeanne Maria* during recovery. Punctures to the vessel's hull are visible. SOURCE: CENTRAL MARITIME, L.L.C.

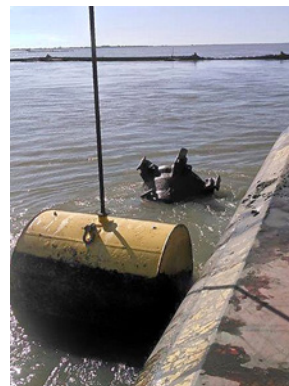
**Figure 69. Left and below:** End of the submerged pipeline and its buoy. SOURCE: WEEKS MARINE.

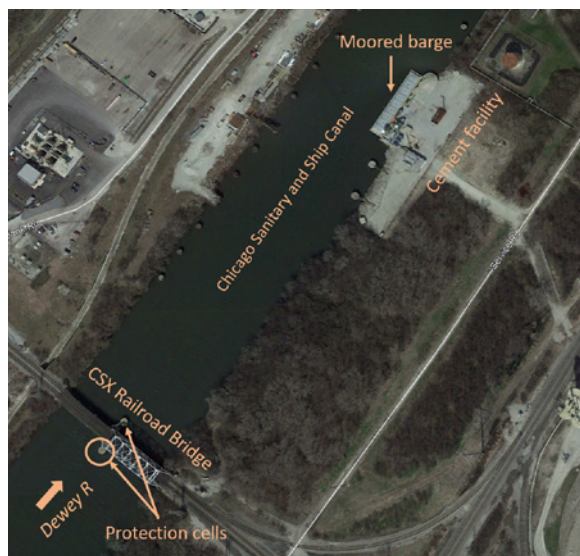
**Figure 70.** Location of the Chicago Sanitary and Ship Canal where the *Dewey R* and tow attempted to pass through the CSX Railroad Bridge, and location of a barge moored at the cement facility, similar to the barge that was moored at the time of the accident. The protection cell that was struck is circled. BACKGROUND SOURCE: GOOGLE MAPS.

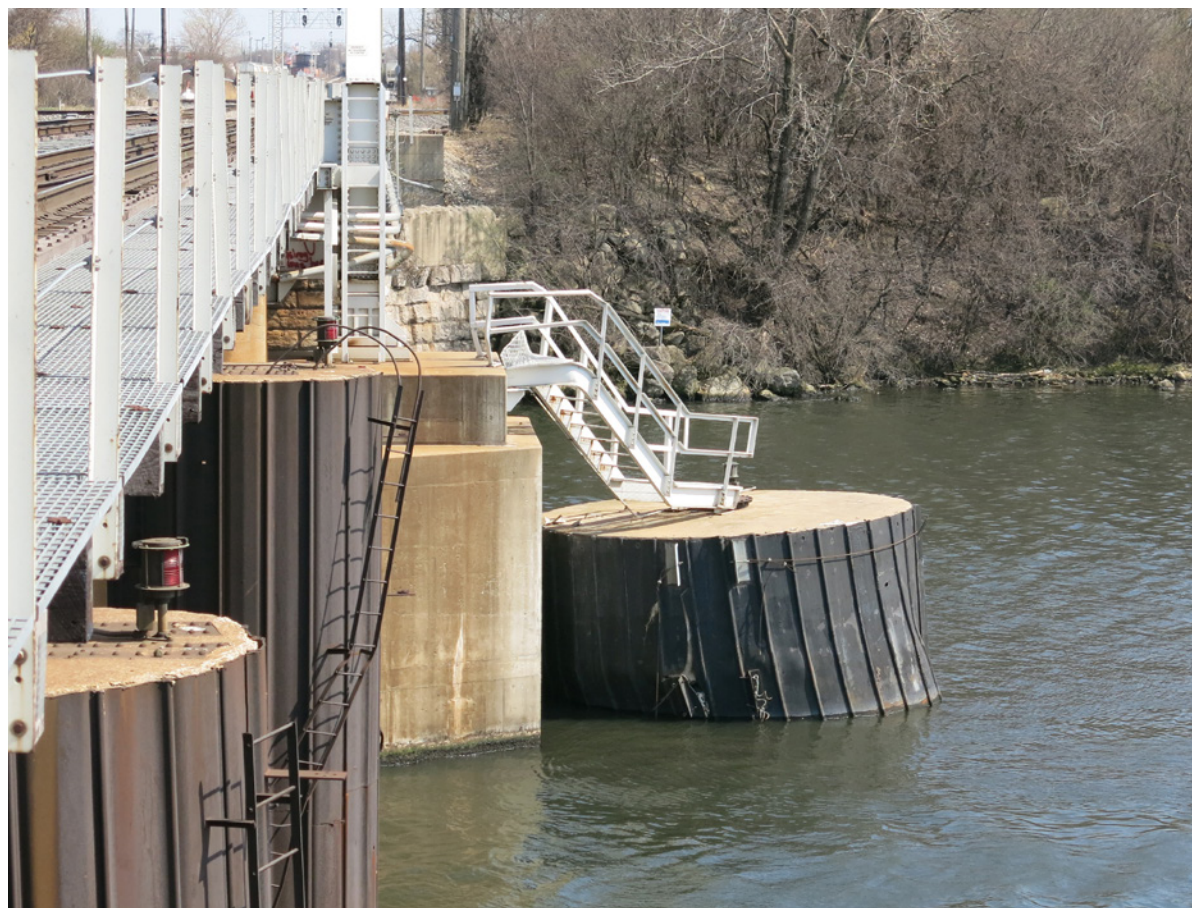
**Figure 71. Below:** Postaccident condition of the south side of the CSX Railroad Bridge.

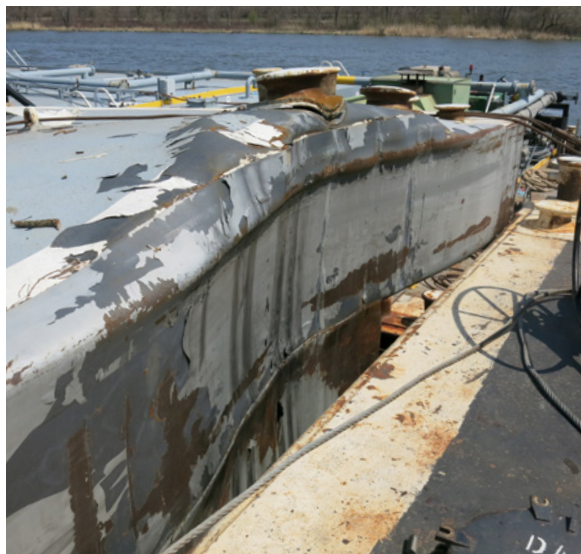
**Figure 72.** Damage to tank barge ATC 3404.

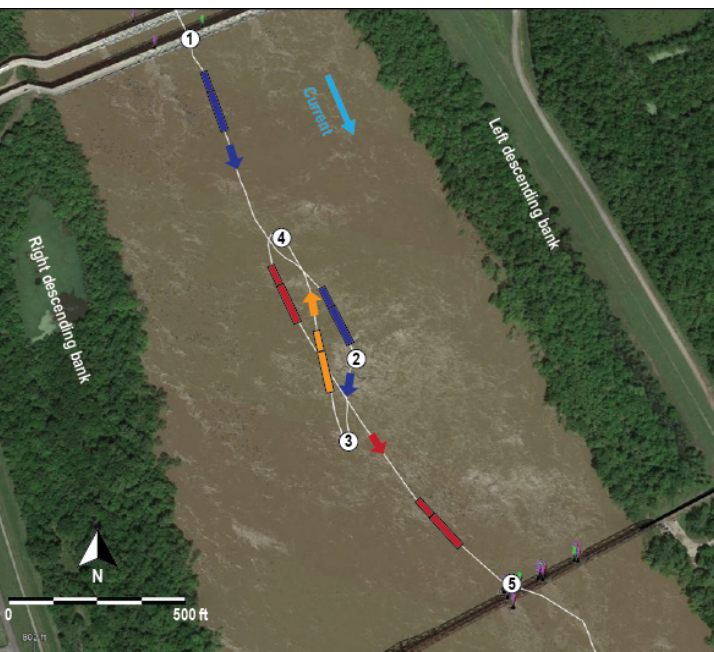
**Figure 75. Left:** The *Edna T. Gattle*'s approach to the Union Pacific Railway Bridge. The track is shown as a white line. **1.** At 2328, the *Edna T. Gattle* and tow passed under the US 190 Bridge, with a speed over ground of 7.5 mph. **2.** At 2336, the vessel was set to starboard while backing down, with a speed over ground of 1.8 mph. **3.** At 2339, the vessel began backing up river. **4.** At 2345, with the bridge fully open, the captain started his second approach. **5.** At 2348, the tow contacted the Union Pacific Railway Bridge, with a speed over ground of 13.7 mph.

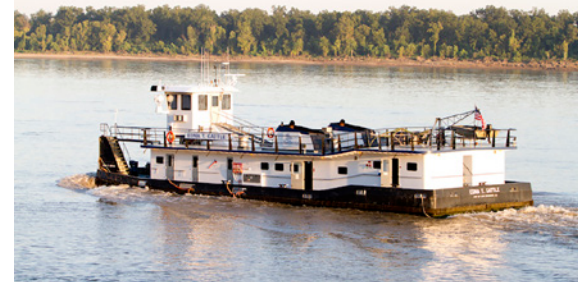
**Figure 78.** The towboat *Edna T. Gattle*.  
SOURCE: TERRAL RIVER SERVICES, INC.

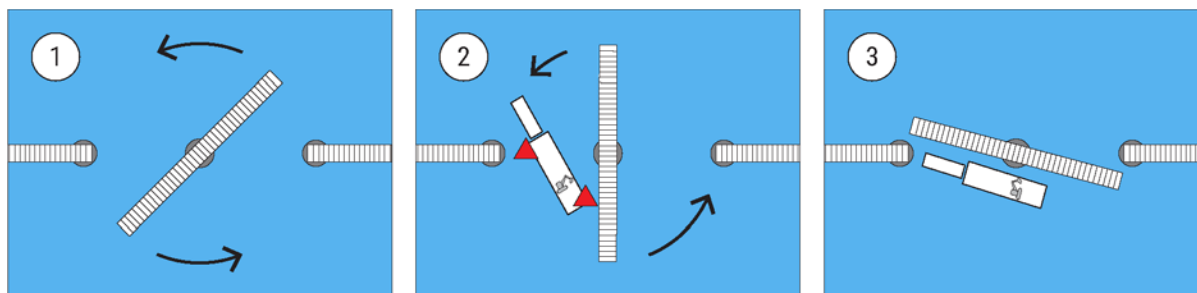
**Figure 76.** The Union Pacific Railway Bridge as viewed from the approach of the *Edna T. Gattle*.  
BACKGROUND SOURCE: US ARMY CORPS OF ENGINEERS.

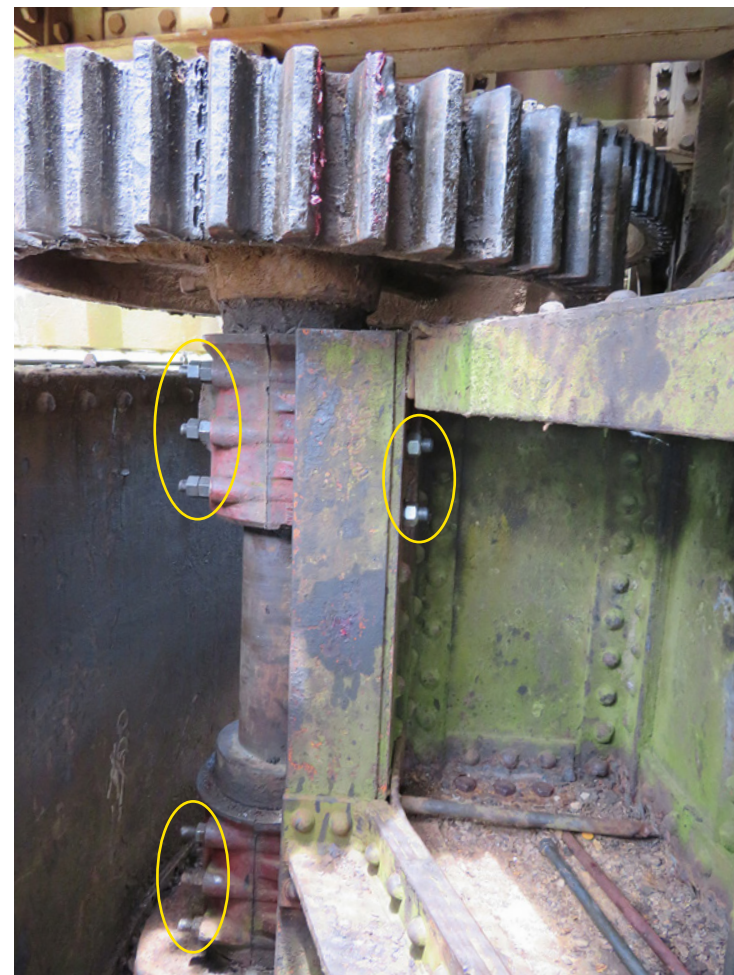
**Figure 79. Below:** A repaired gear within the pedestal. The new bolts are shown circled in yellow.

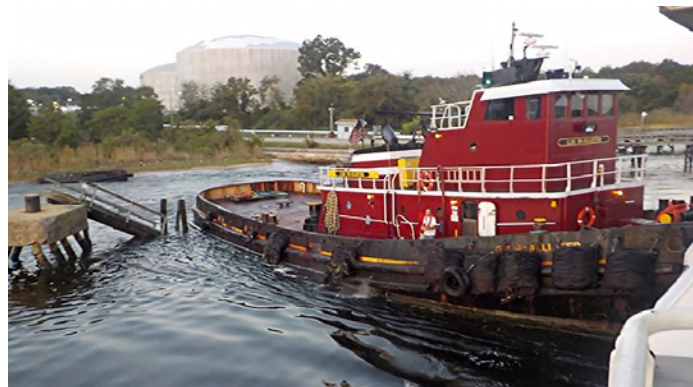
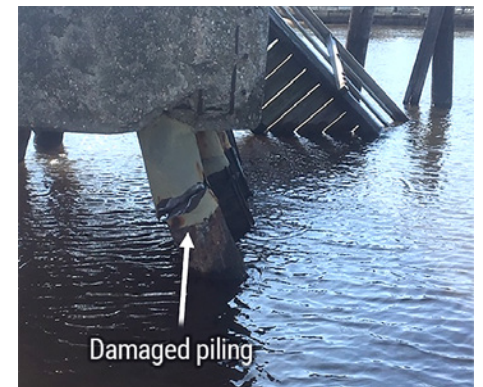
Figure 81. Left: *G.M. McAllister* at the NGL Energy Partners berth immediately after the accident.

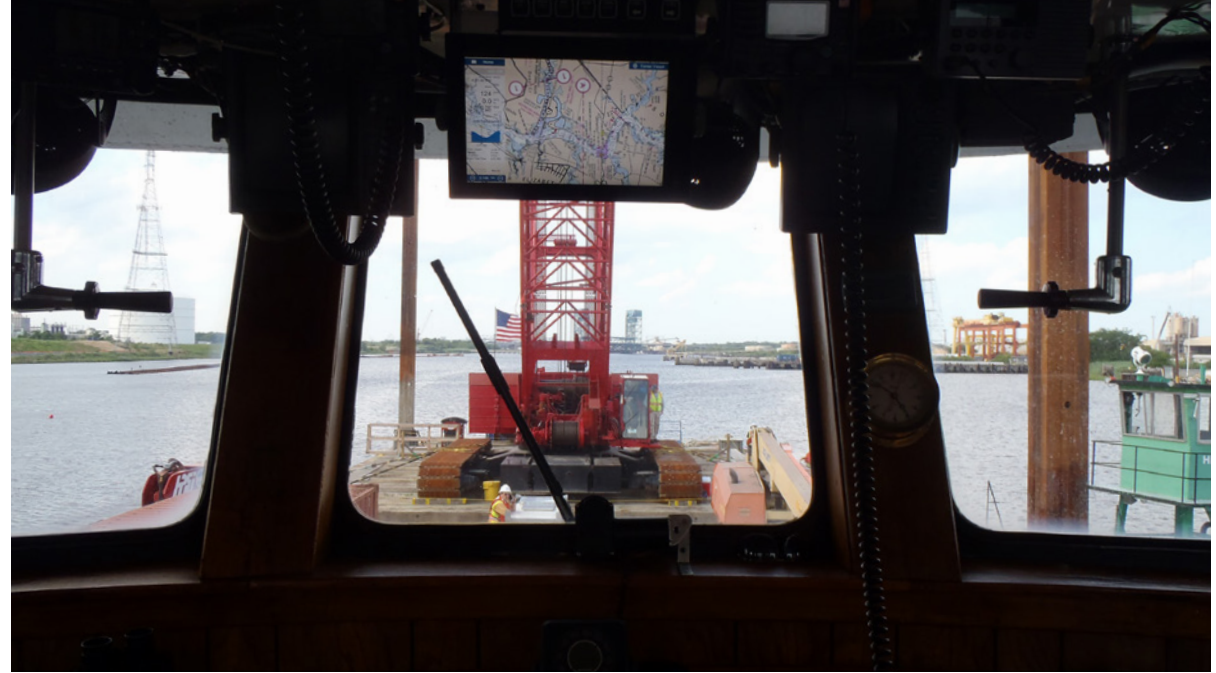
**Figure 85.** View from *Goose Creek*'s wheelhouse after the accident facing north towards Gilmerton Bridge and no. 120 transmission tower on the left (west) with the Manitowoc crane (centered) and *Heidi C* (right) moored to crane barge *U1510*. SOURCE: COAST GUARD.

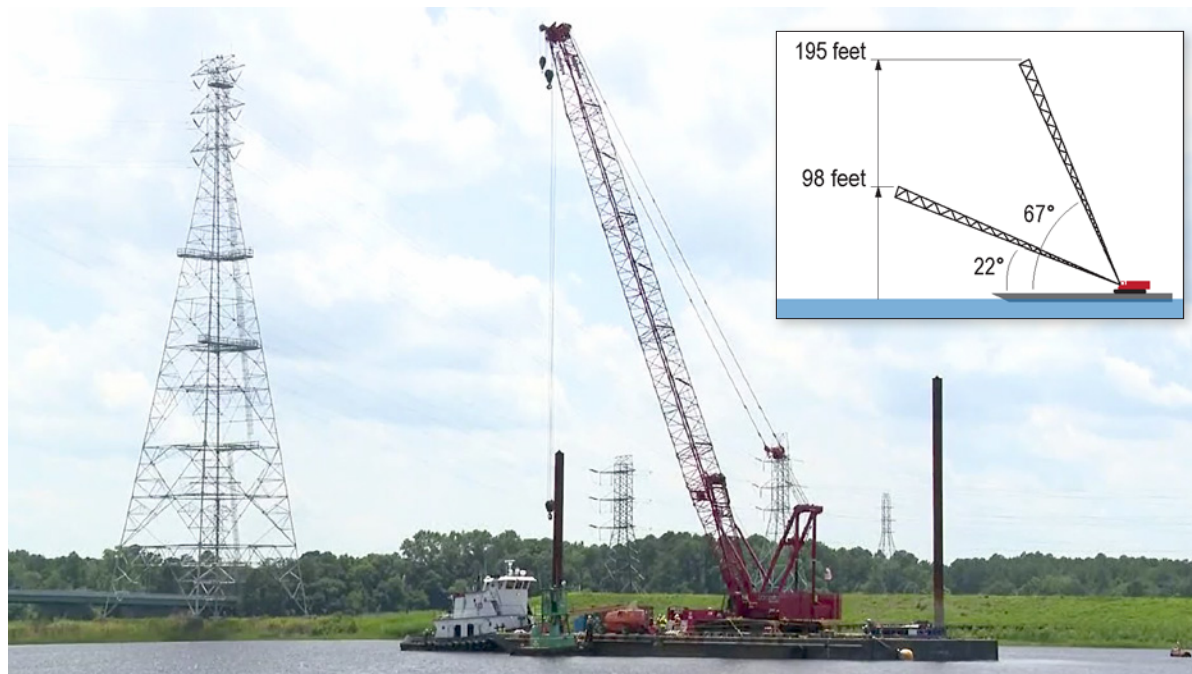
**Figure 86.** Towing vessel *Goose Creek* and crane barge *U1510* spudded down in Chesapeake, Virginia, after the accident. Inset (not to scale) depicts the crane boom elevation when stowed at 22° and as determined after the accident with an angle of 67°. SOURCE: COAST GUARD; ILLUSTRATION BY NTSB.

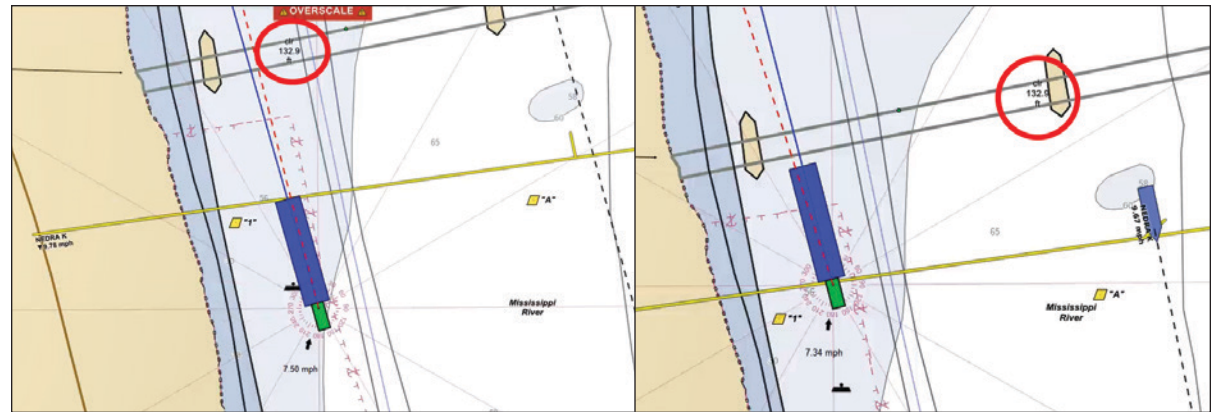
Figure 88. Screenshots of the *Kristin Alexis*' Rose Point at 0139 (left) and at 0140 (right). The vertical clearance for the Sunshine Bridge is circled in red.

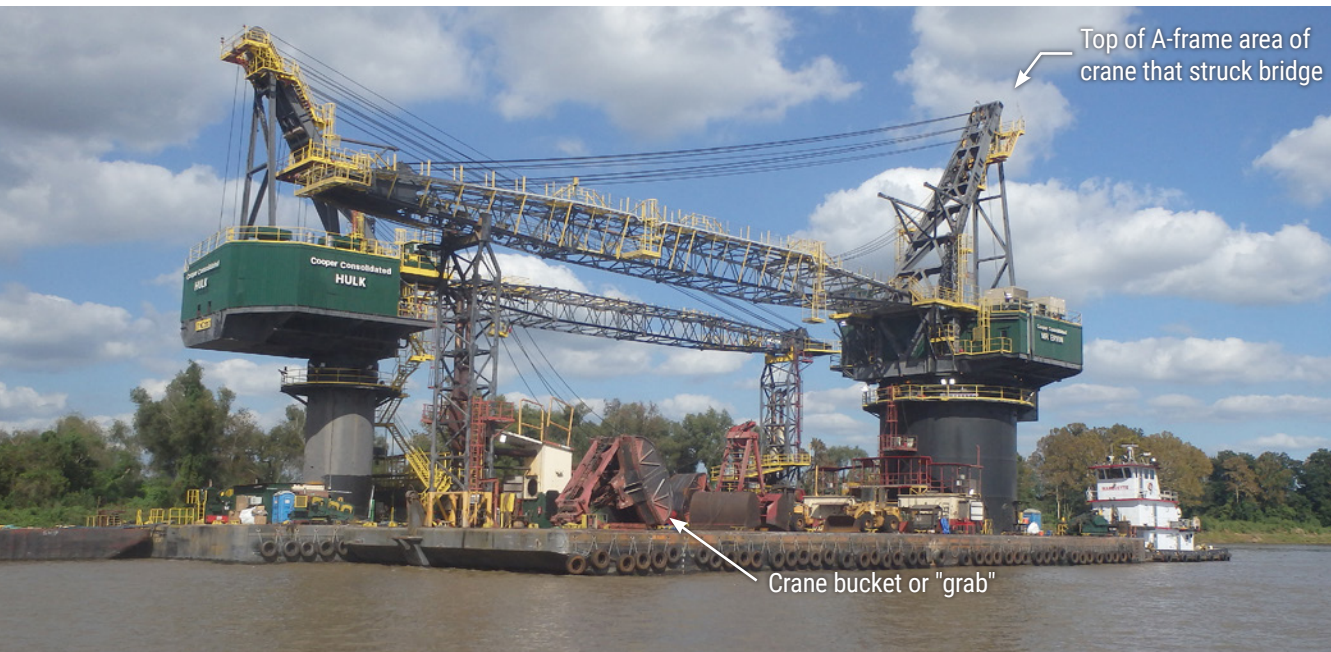
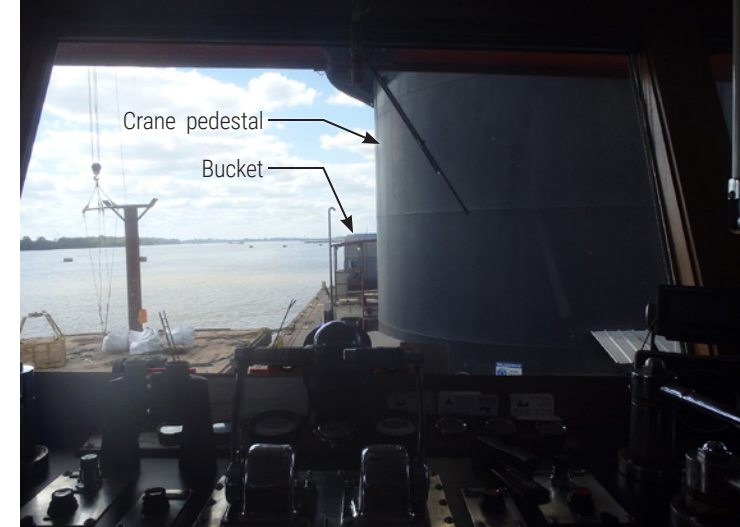
**Figure 92.** Forward view from the *Kristin Alexis*' wheelhouse. The crane's pedestal blocks most of the starboard view, while the crane bucket blocks a portion of the forward view ahead.

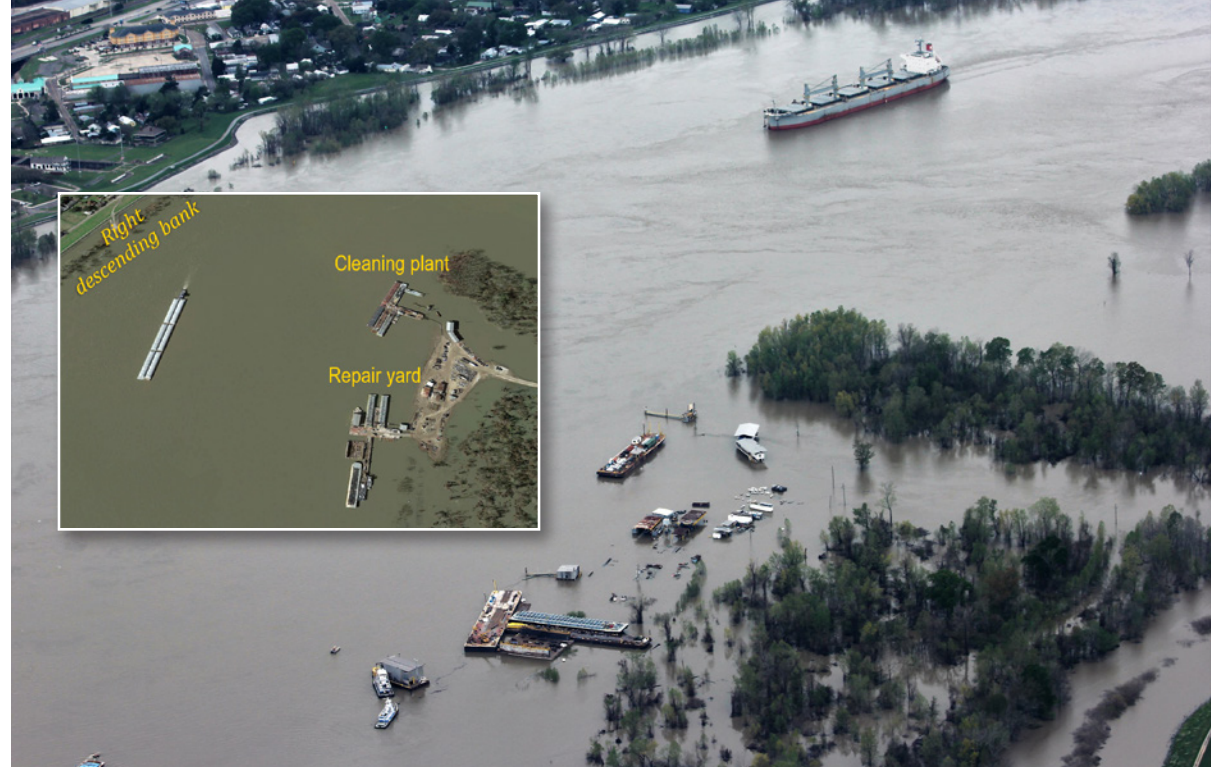
**Figure 97.** Plaquemine Point Shipyard immediately after the accident during major flood stage; inset shows the same area in January 2019. SOURCE: COAST GUARD. INSET: GOOGLE EARTH; ANNOTATED BY NTSB.

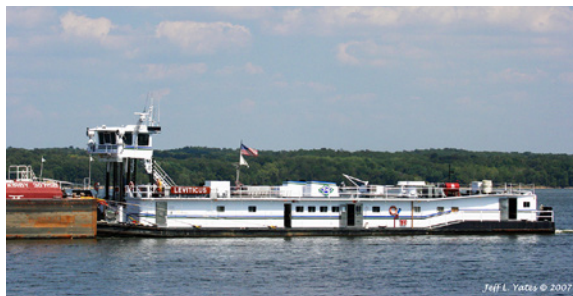
**Figure 98.** *Leviticus* under way before the accident.

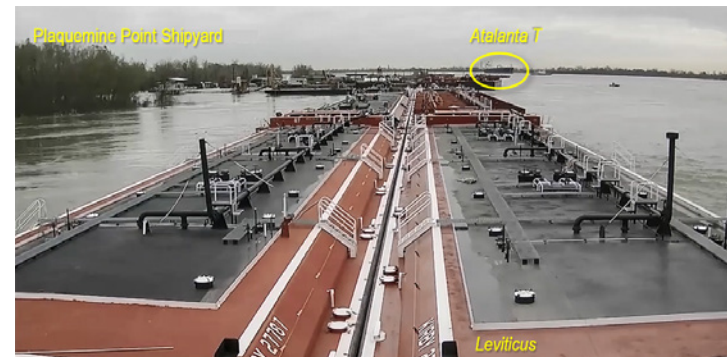
**Figure 99.** Screen capture from the *Leviticus*' video recorder at 1020 looking forward shows initial impact with the moored barges at the shipyard's cleaning plant.

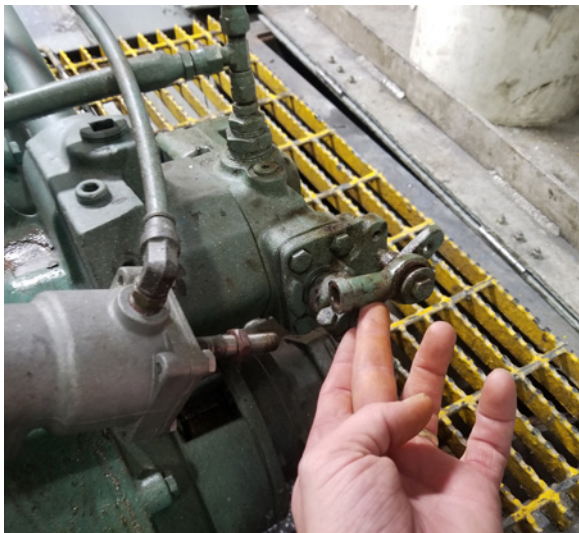
**Figure 101.** Starboard engine pneumatic gear clutch actuator linkage disconnected aboard the *Lindberg Crosby* as found after the accident.

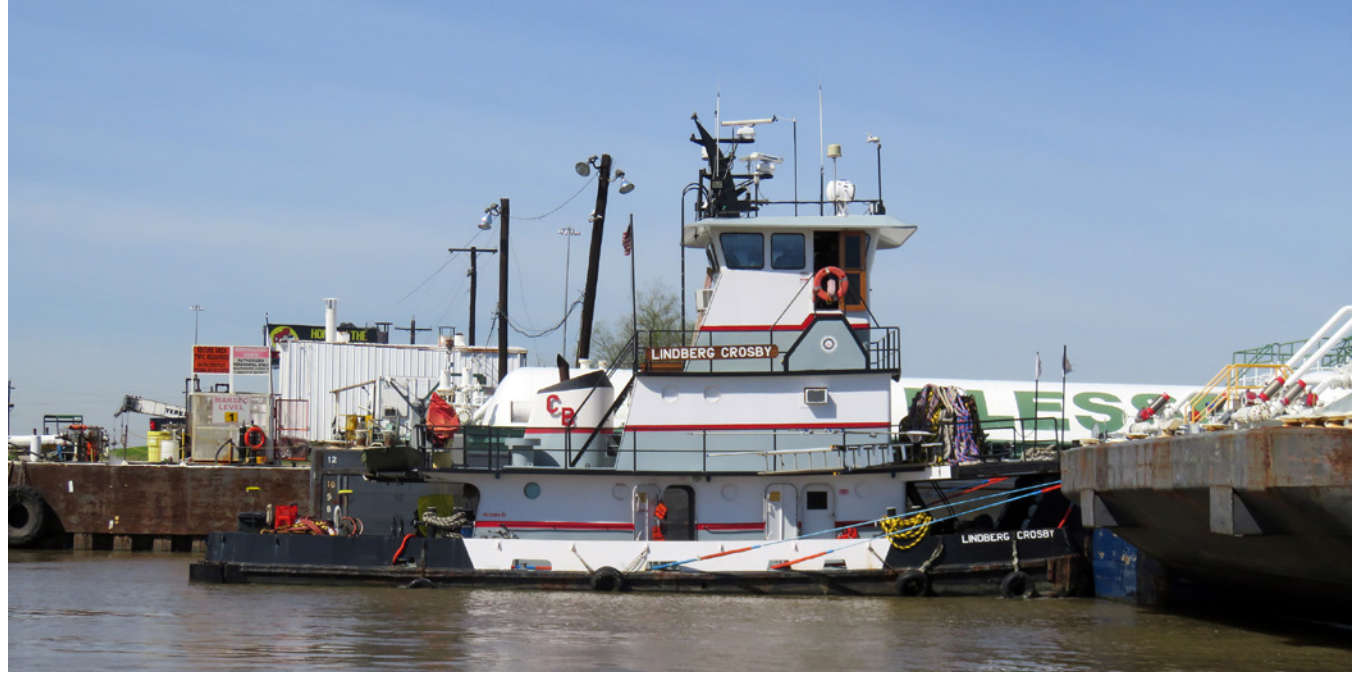
**Figure 102.** Towing vessel *Lindberg Crosby* docked in Houston, Texas, after the accident.

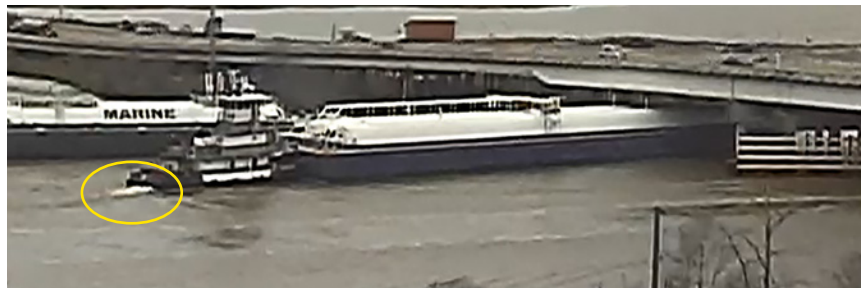
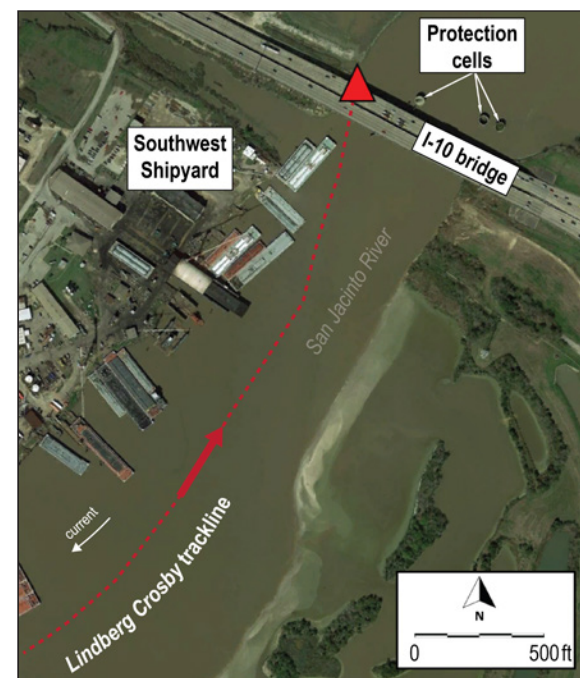
**Figure 104.** Trackline and location of the *Lindberg Crosby* when the tow struck the I-10 bridge (marked with red triangle). BACKGROUND SOURCE: GOOGLE EARTH.

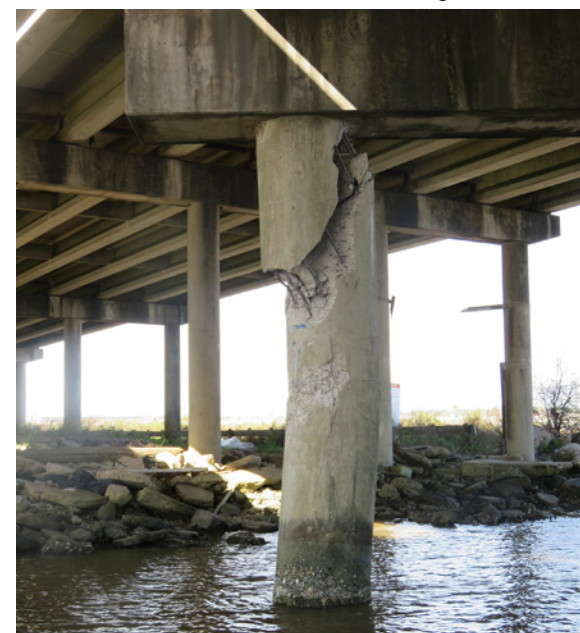
**Figure 105. Below:** Damaged section of struck pier column under westbound lanes of I-10 bridge.

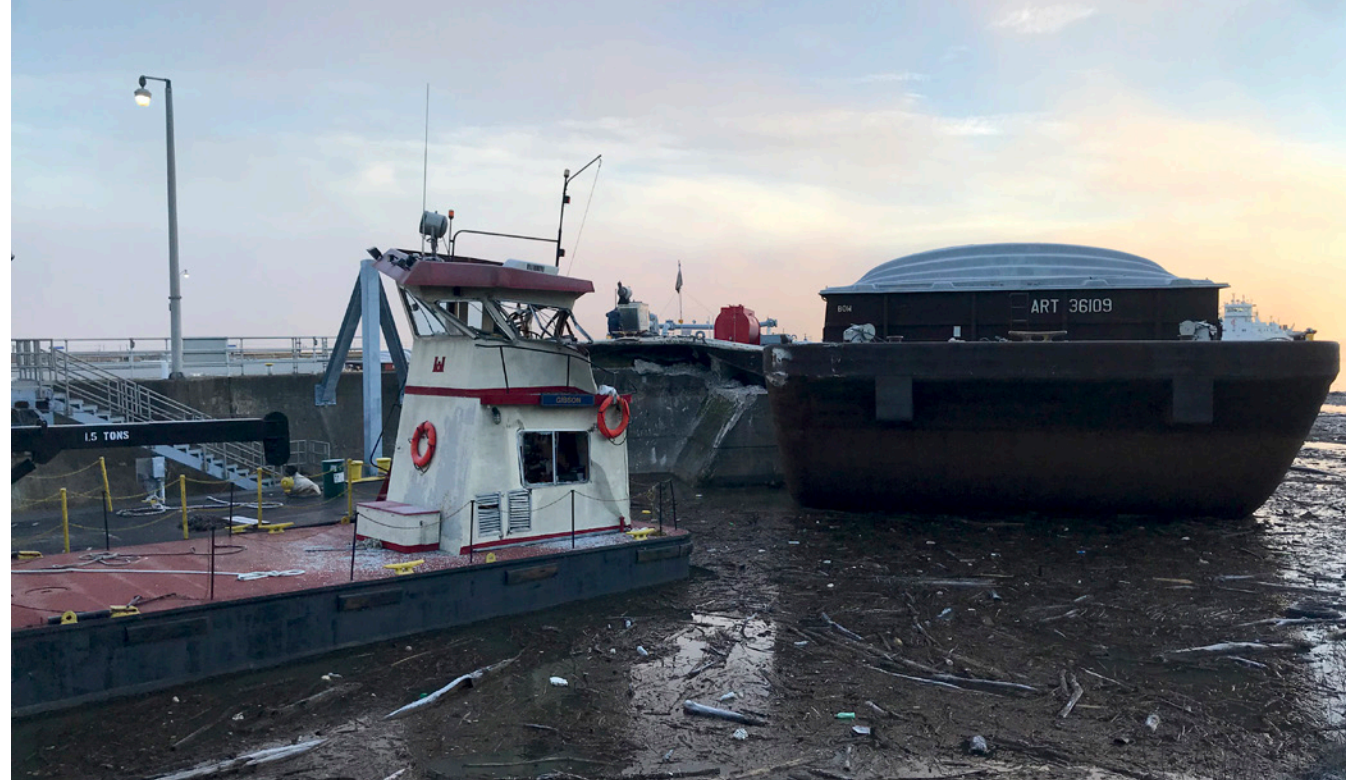
Figure 107. The *Gibson* and barge ART 36109 three days after the accident. SOURCE: COAST GUARD.

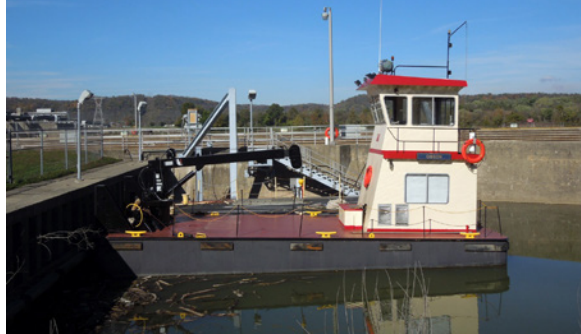
**Figure 108.** Corps of Engineers workboat *Gibson*.

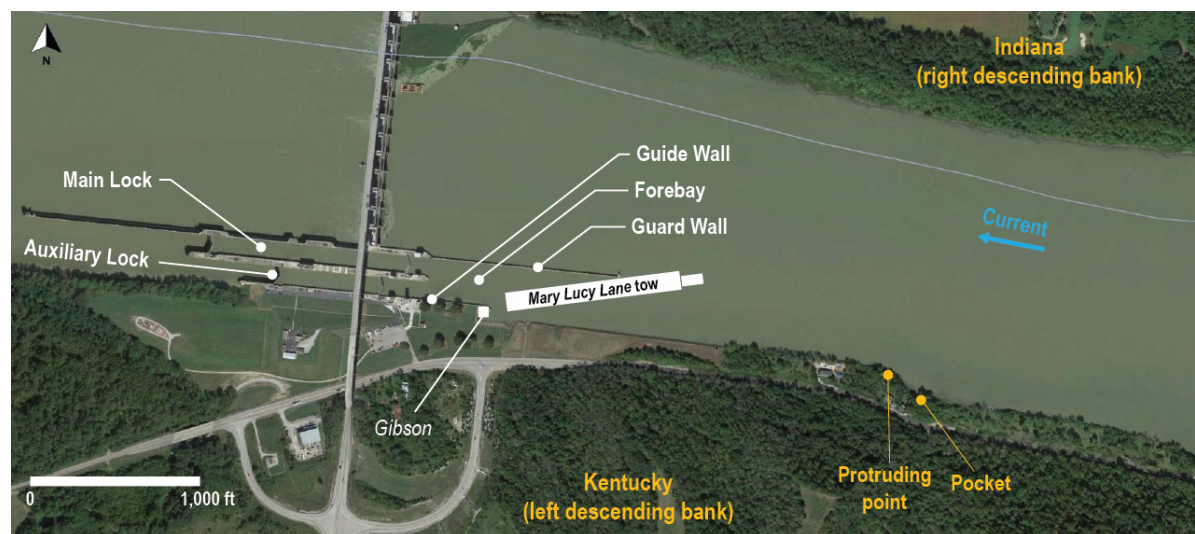
**Figure 109. Below:** Approximate positions of the *Mary Lucy Lane* tow and the workboat *Gibson* about 1555, when the tow contacted the guard wall. BACKGROUND SOURCE: GOOGLE EARTH.

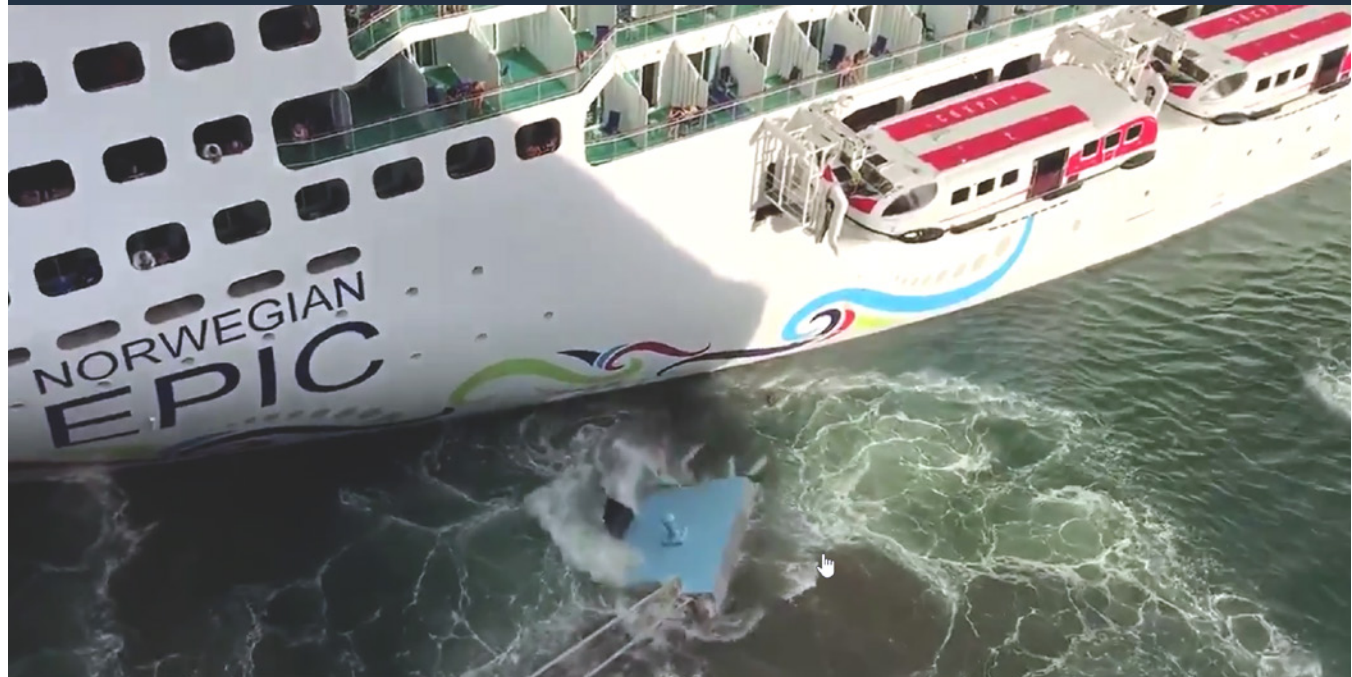
**Figure 111.** Above: The *Norwegian Epic* as it struck the first mooring dolphin and catwalk, which collapsed. Below: The second dolphin and catwalk as it collapsed after being struck. SOURCE: TWEETSWITHTITO@DUNARD2.

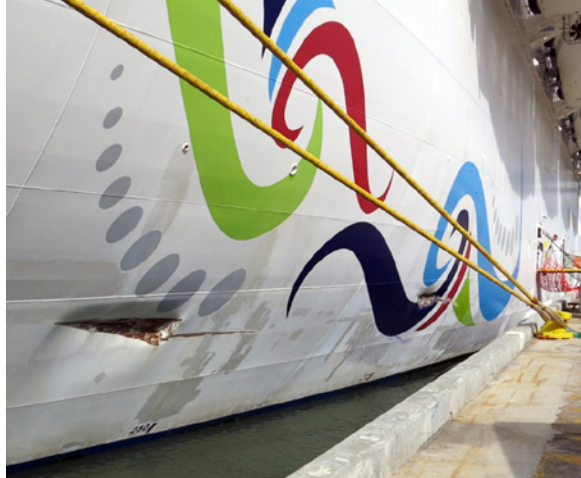
**Figure 112.** Damage to the *Norwegian Epic's* hull.

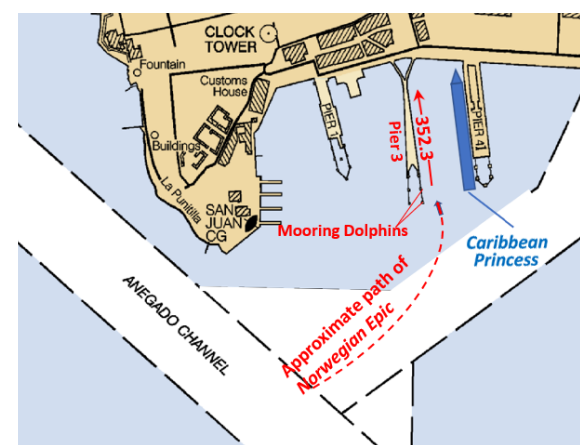
**Figure 113. Below:** Berthing area and approximate path of the *Norwegian Epic*. The *Caribbean Princess* is not to scale. BACKGROUND SOURCE: NOAA CHART 25670.

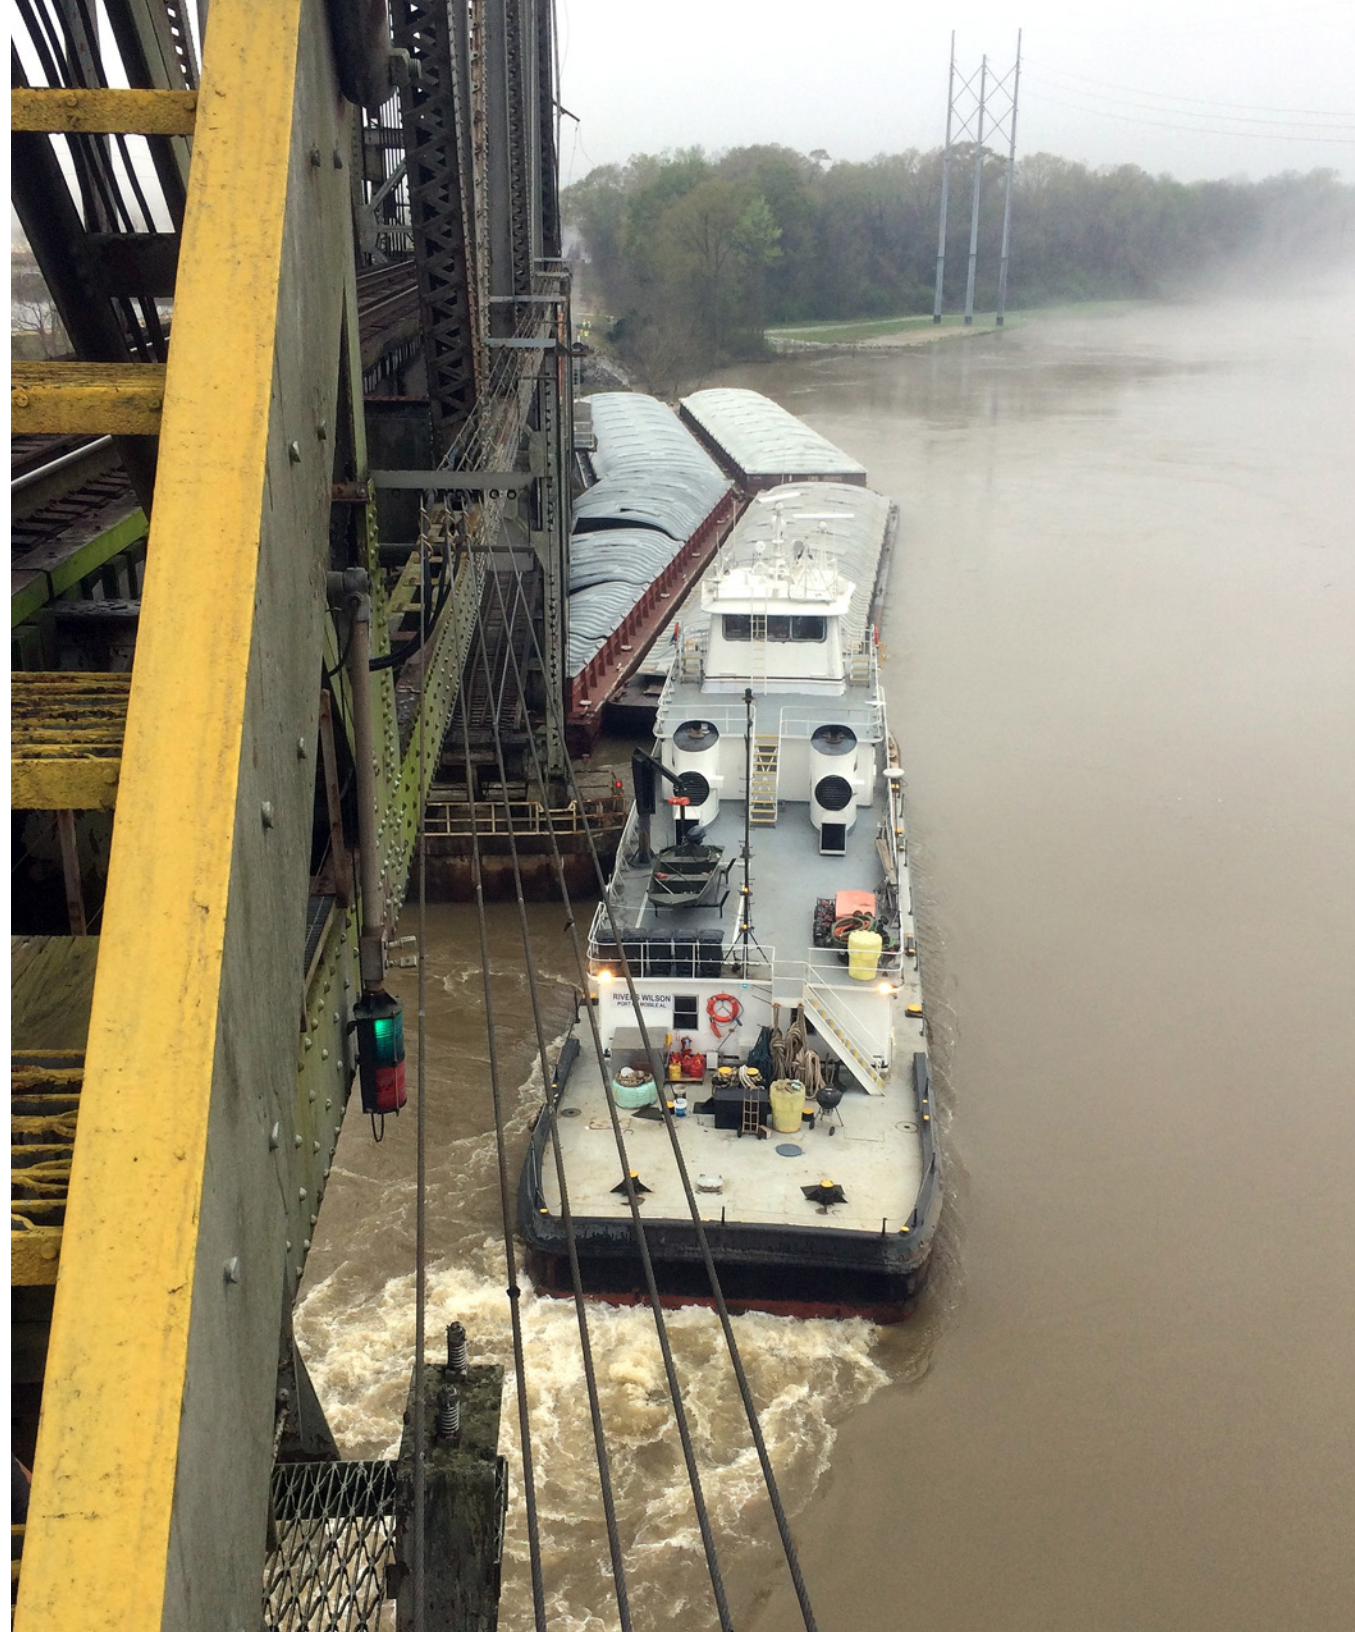
On March 10, 2019, at 0100 local time, the towing vessel *Rivers Wilson*, with eight crewmembers and pushing six loaded barges, contacted the Norfolk Southern railway bridge near Jackson, Alabama. As a result, a bridge support was shifted out of position, and the tracks above deflected. Rail traffic was suspended for 27 hours until temporary repairs were made. One crewmember sustained a minor knee injury in the immediate response. No pollution was reported.

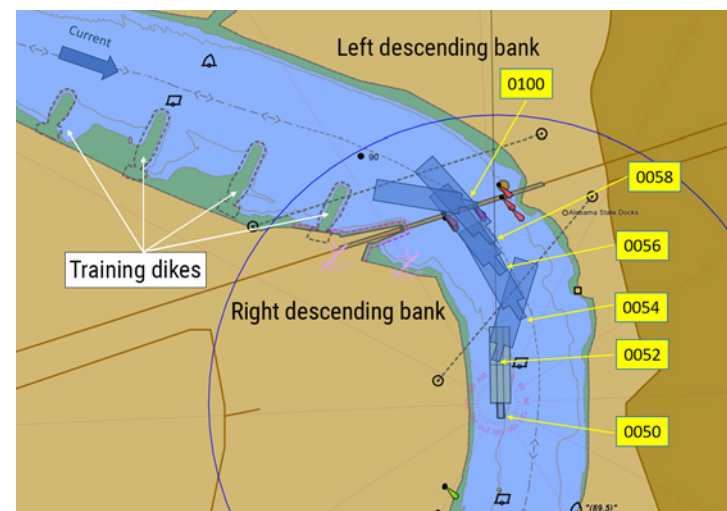
**Figure 116.** Select positions of the *Rivers Wilson* and barges on the Tombigbee River near mile 90 before the accident. Note the training dikes up river of the bridge on the right descending bank. BACKGROUND SOURCE: CORPS OF ENGINEERS; VESSEL DATA: GRAESTONE.

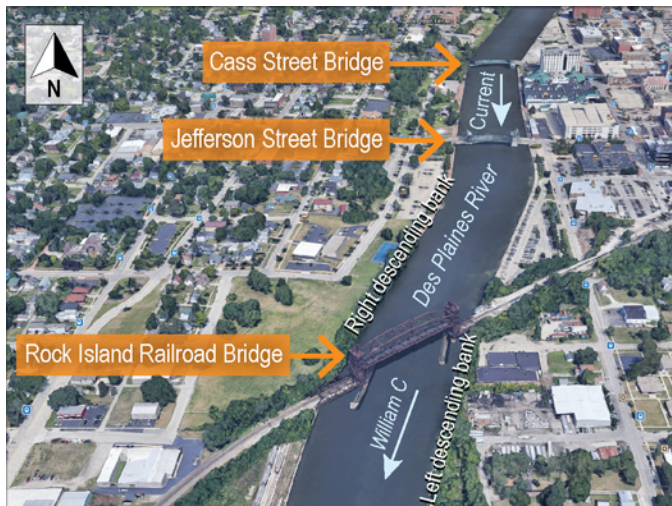
**Figure 120.** Bridges through which the *William C*'s tow transited. BACKGROUND SOURCE: GOOGLE EARTH.

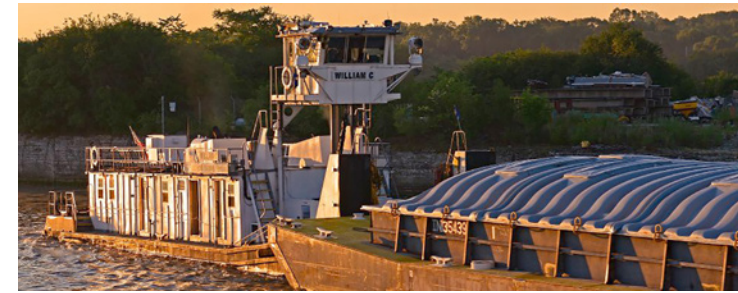
**Figure 122.** Preaccident image of the *William C*.

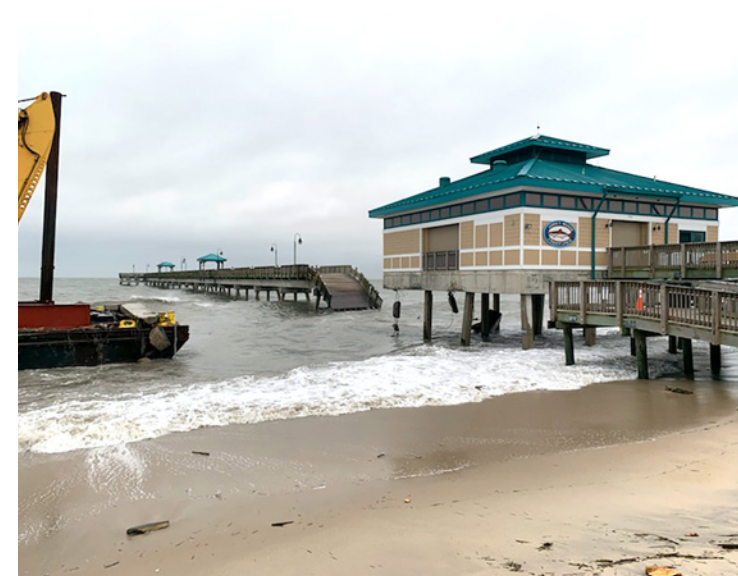
**Figure 124.** The damaged fishing pier with debris on the deck of the *YD 71*.

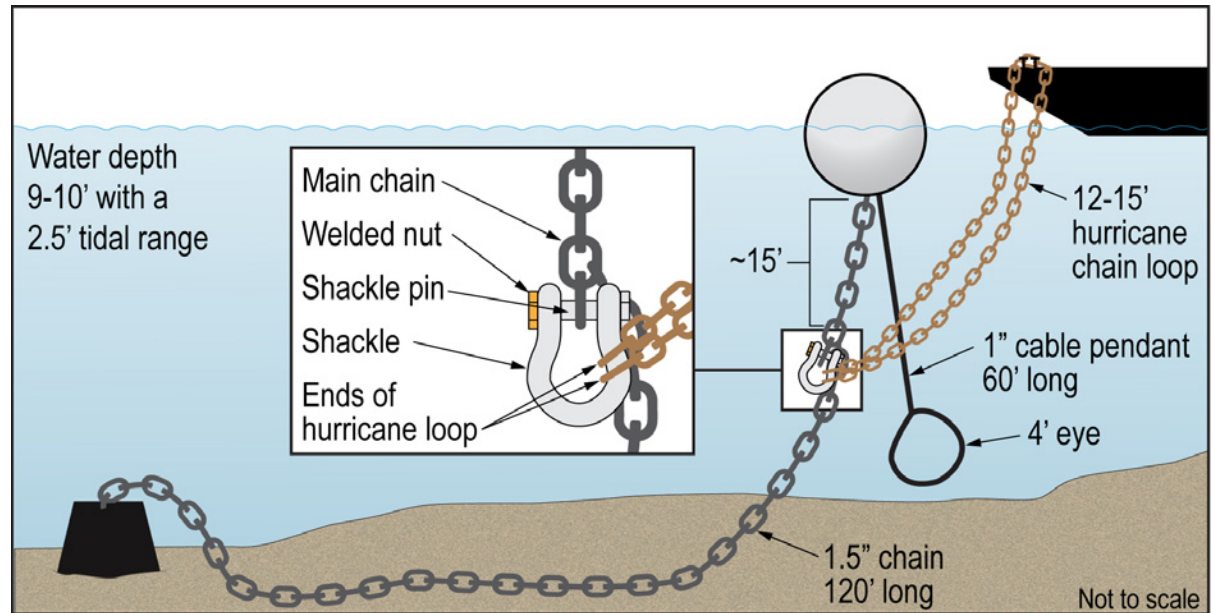
Figure 126. A representation of the arrangement of the YD 71's mooring at the time of the accident.

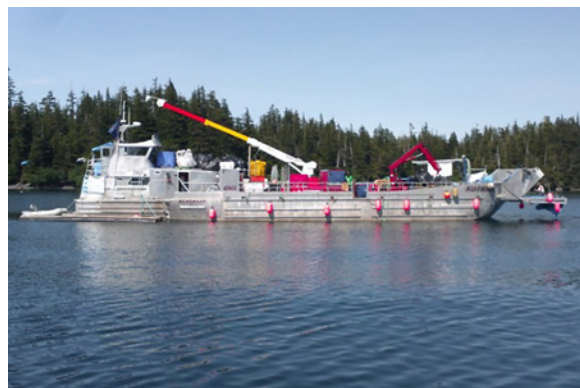
**Figure 129.** *Alaganik* before the accident.  
SOURCE: VESSEL OWNER.
