# SAFER SEAS Digest 2020

Lessons Learned from  
Marine Accident Investigations

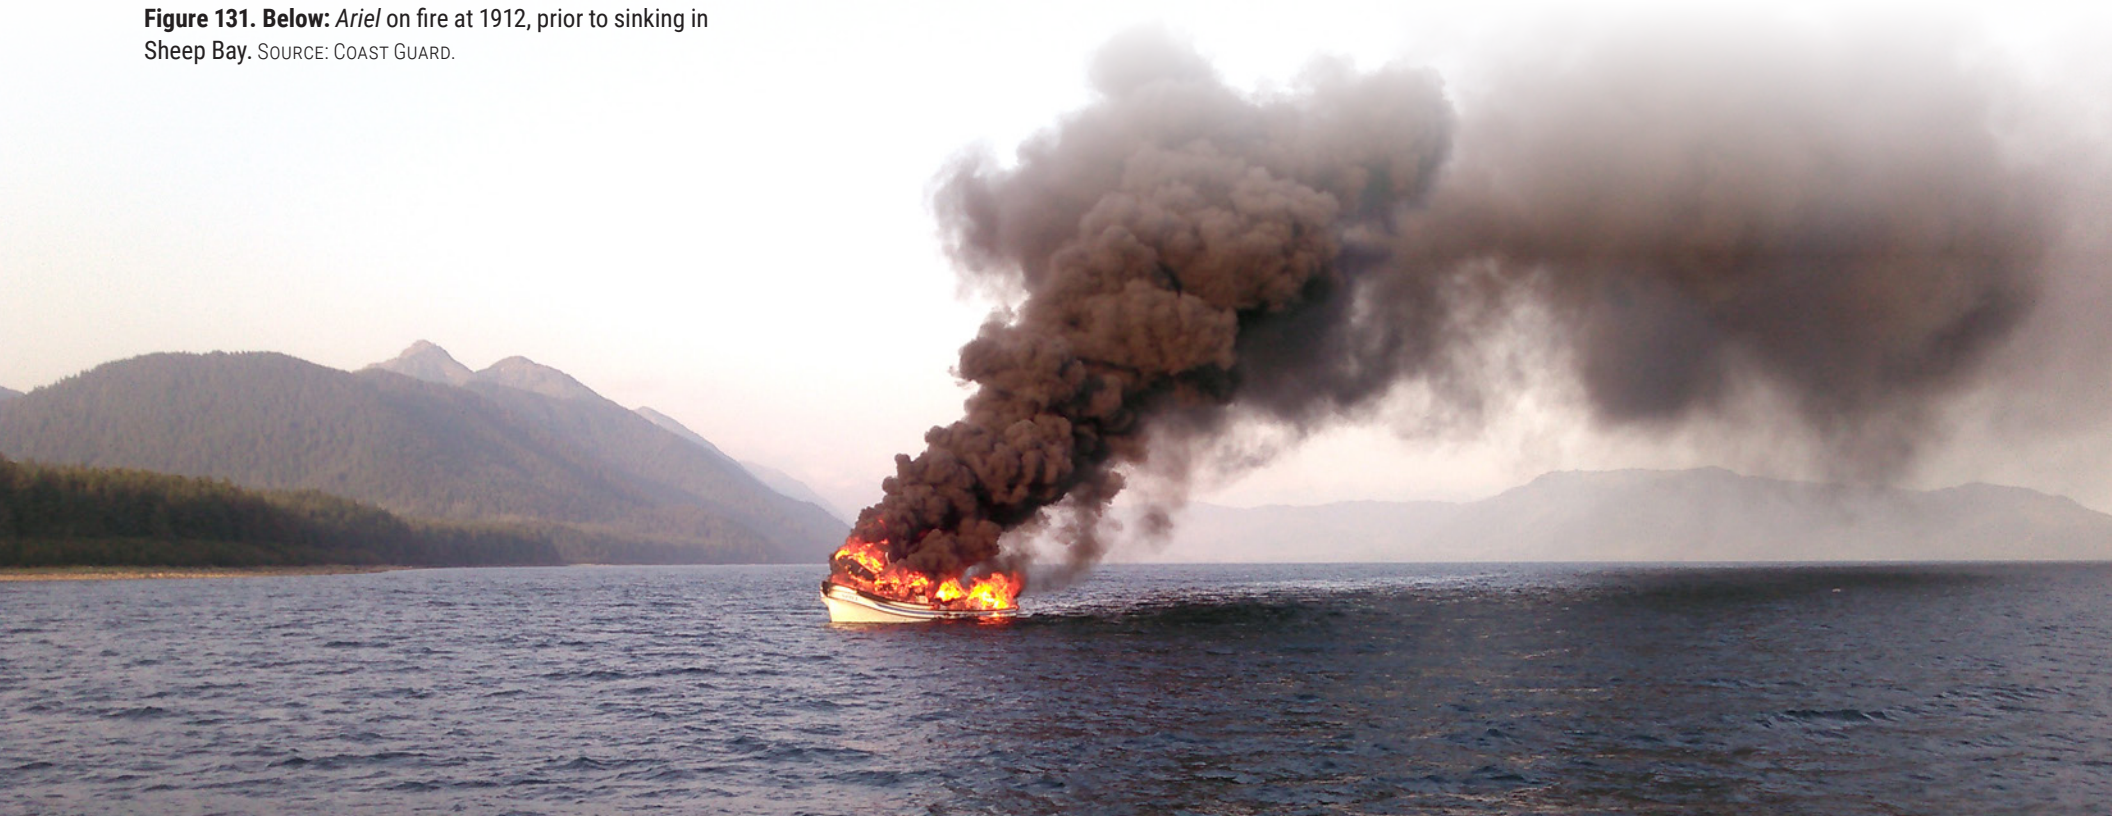
chemical fire extinguishers through an engine room hatch on the port side of the cabin, which was closer to the apparent source of the fire at the generator below. However, smoke drove them out of the cabin. As they left, they closed the hatch. The captain returned to the wheelhouse and made a Mayday call. The crew also discharged extinguishers into the stacks aft on the deckhouse and into the ventilation inlets on either side of the exterior cabin.

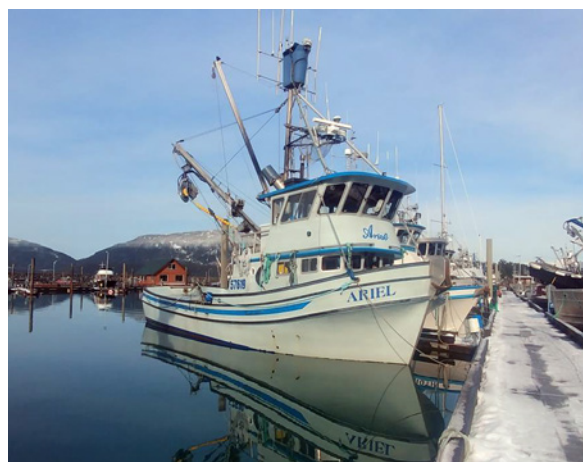
Figure 132. *Ariel* moored before the accident.

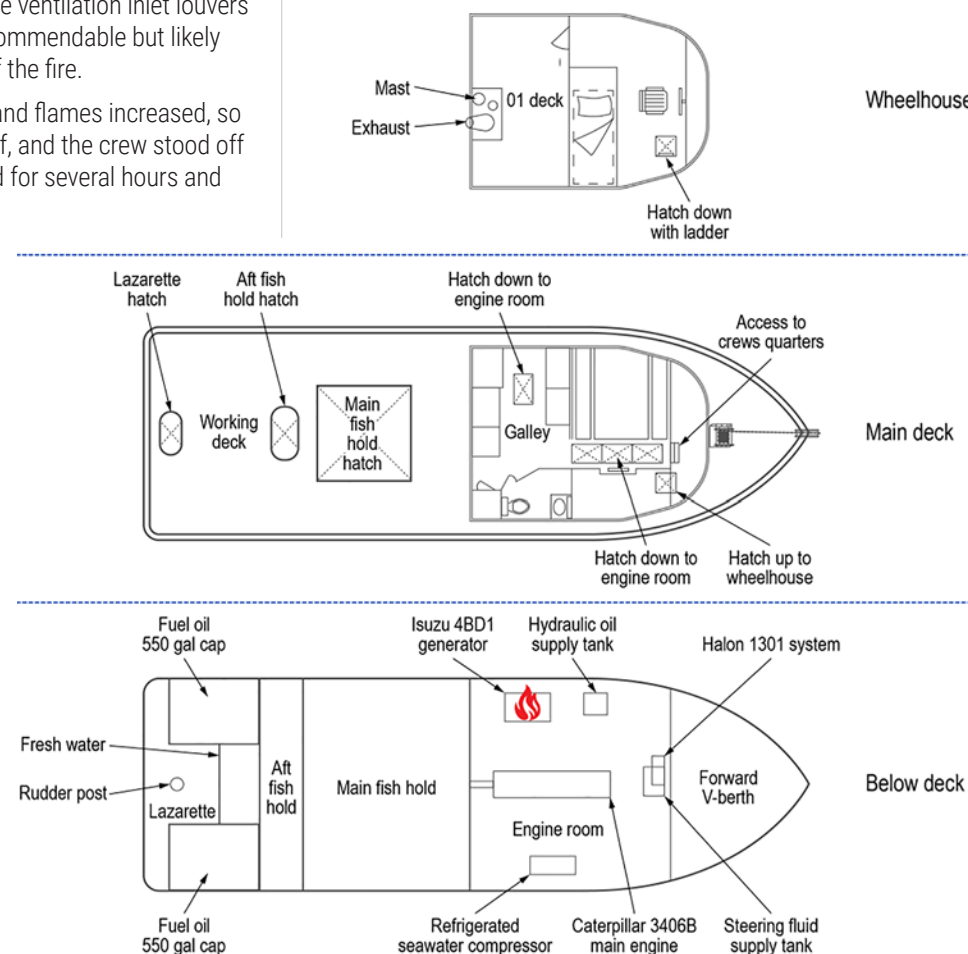
### Closing Ventilation During Fixed Fire-Extinguishing System Activation

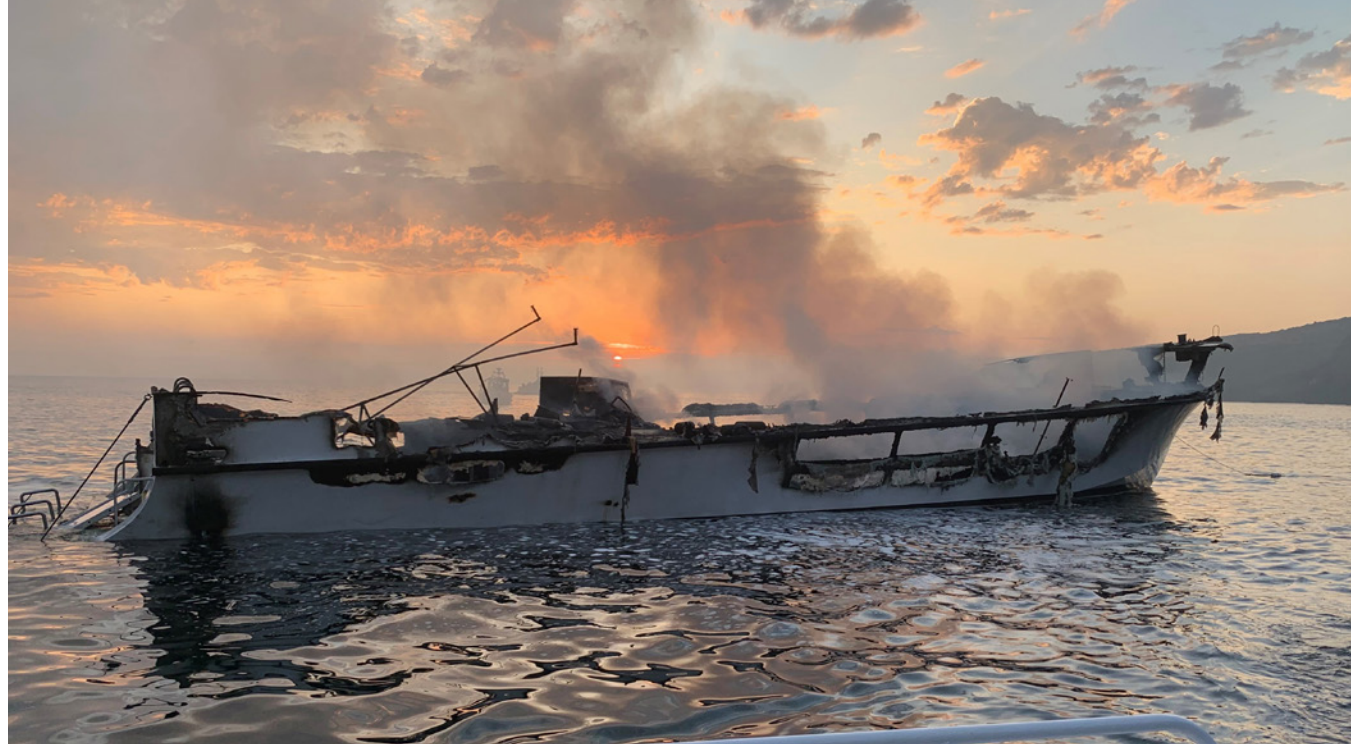
**Figure 135.** Small passenger vessel *Conception* at sunrise prior to sinking. SOURCE: VENTURA COUNTY FIRE DEPARTMENT.

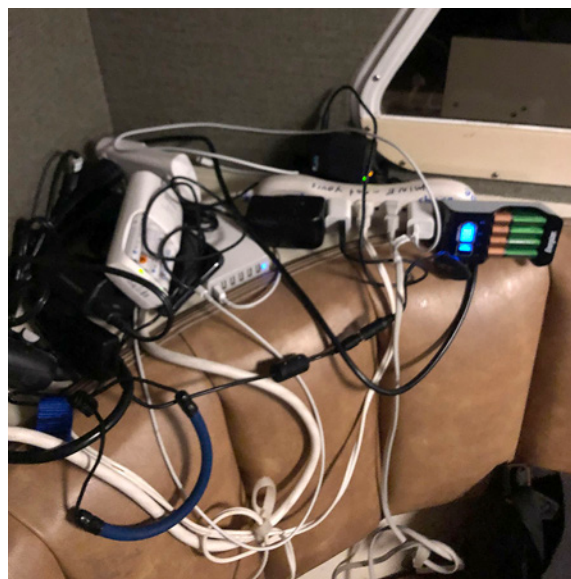
**Figure 137.** Photo taken August 31, 2019, of devices plugged in to charge at the port side aft corner of the salon on the *Conception*. SOURCE: J. DIGNAM.

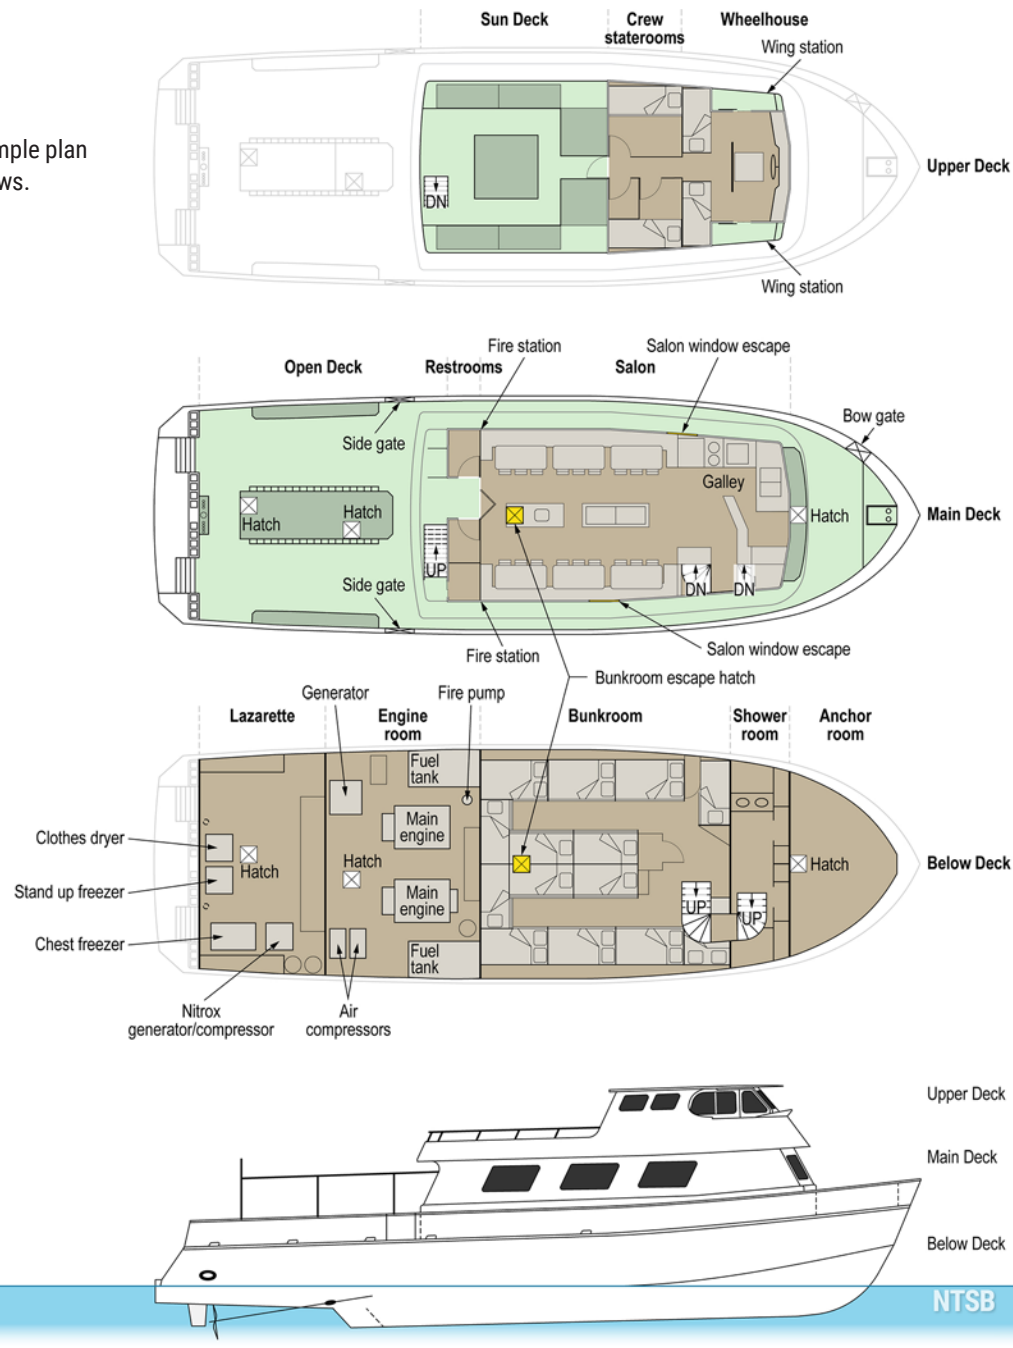
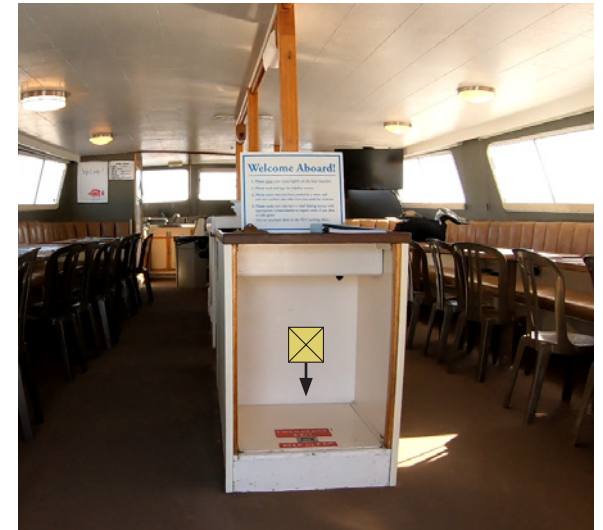
**Figure 139.** The bunkroom escape hatch, viewed from aft in the salon on the main deck.

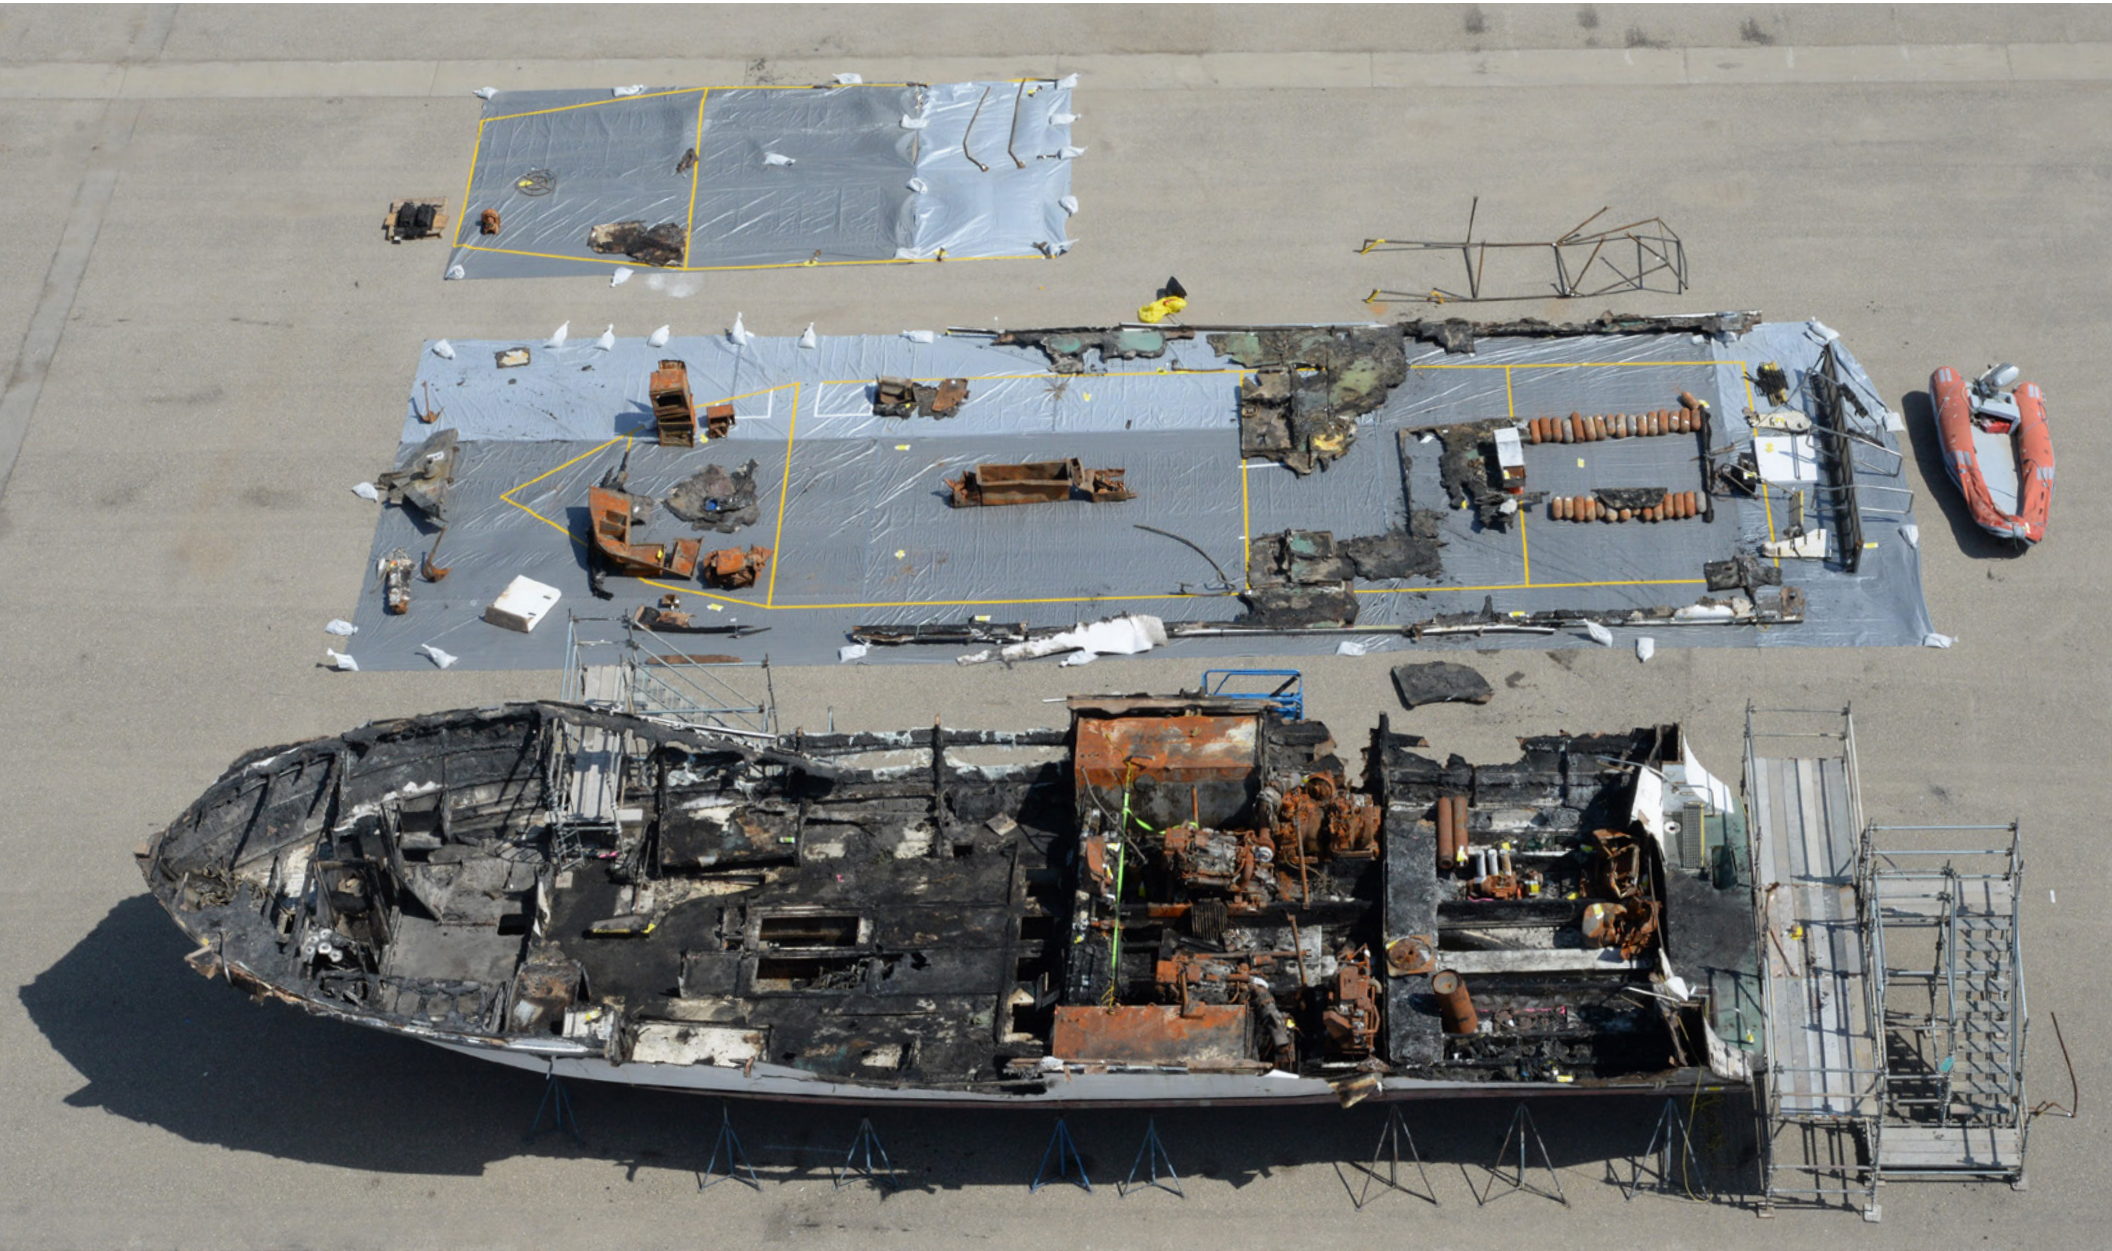
The wreckage and debris of the *Conception* was later salvaged and examined by investigators. Very little material remained from the upper deck and main deck. Examination of the recovered wreckage and debris did not yield any physical evidence relevant to the cause and origin of the fire. Although a definitive ignition source could not be determined, the most likely ignition sources include the electrical distribution of the vessel, unattended batteries being charged, improperly discarded smoking materials, or another undetermined ignition source. (PHOTO SOURCE: FEDERAL BUREAU OF INVESTIGATION.)

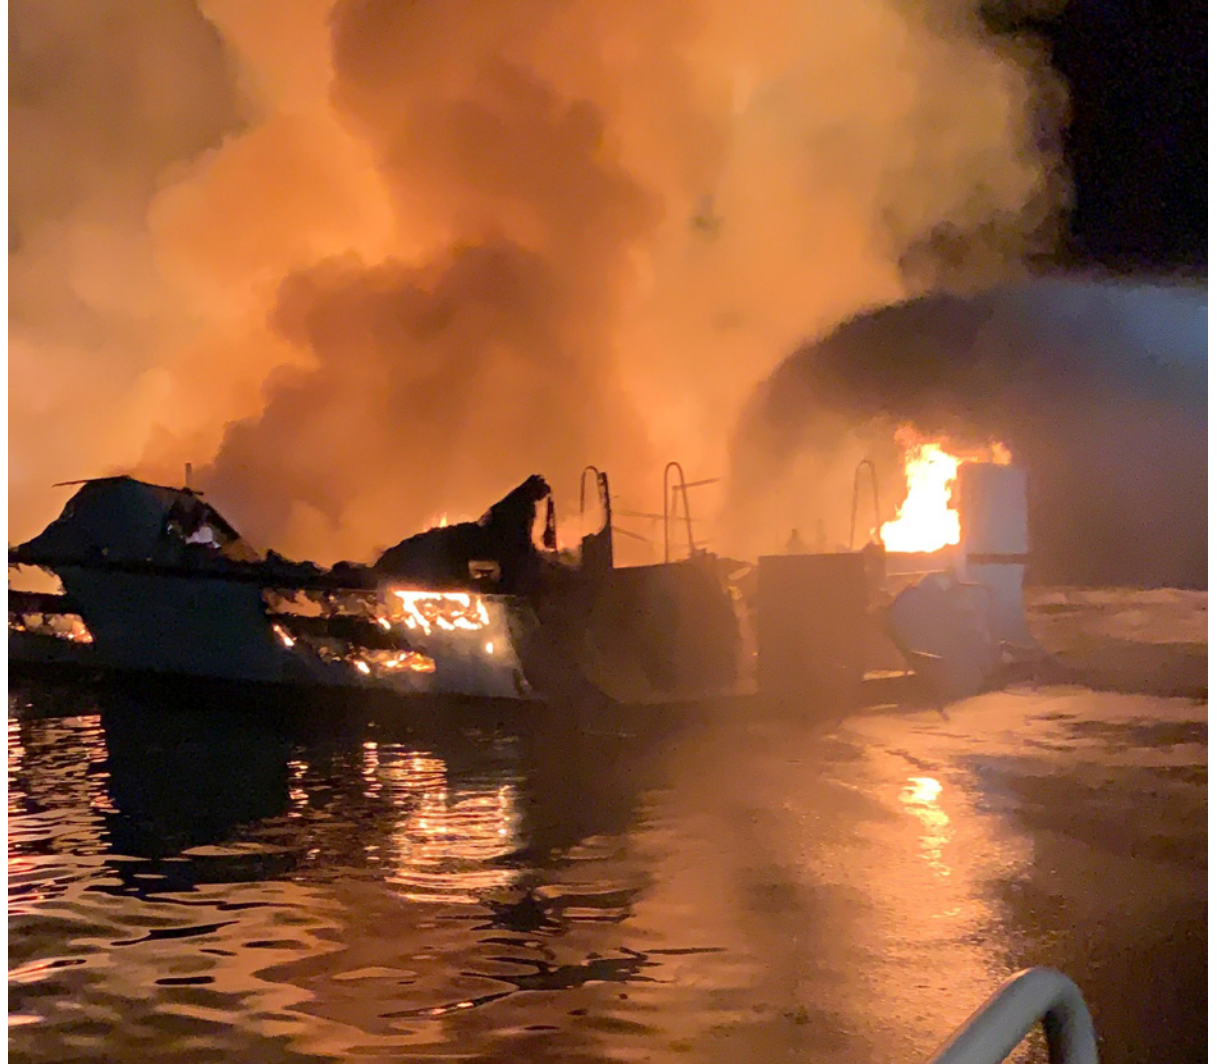
**Figure 141.** *Conception* fire suppression activities. SOURCE: CHANNEL ISLANDS HARBOR PATROL.

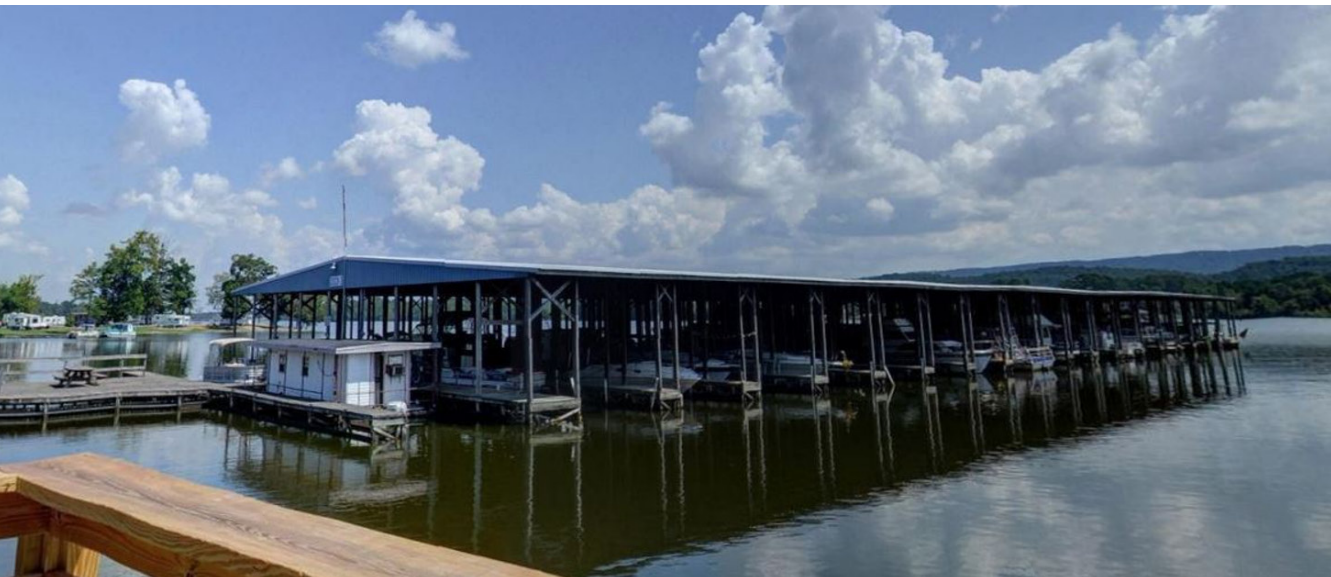
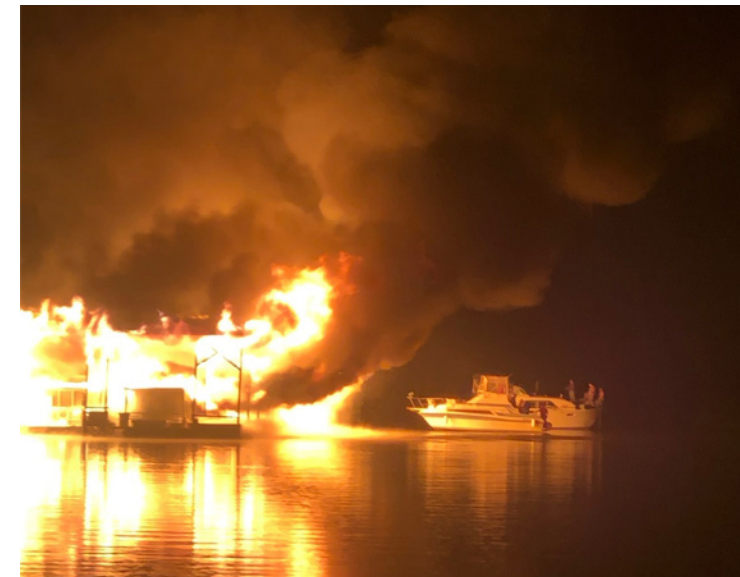
On January 27, 2020, about 0035 local time, fire broke out aboard the *Dixie Delight*, a 43-foot live-aboard houseboat, tied to Dock B at Jackson County Park Marina in Scottsboro, Alabama. The owner of the vessel attempted to extinguish the fire and push the burning vessel away from the dock, but the blaze engulfed the *Dixie Delight* and then spread to neighboring vessels and the wood-framed covered dock. The fire trapped seventeen people on the dock. In the process of attempting to escape, eight people died. An estimated 4,000 gallons of fuel and lube oil were released, with the majority consumed during the fire. The value of Dock B and the 35 vessels destroyed was estimated at more than \$500,000.

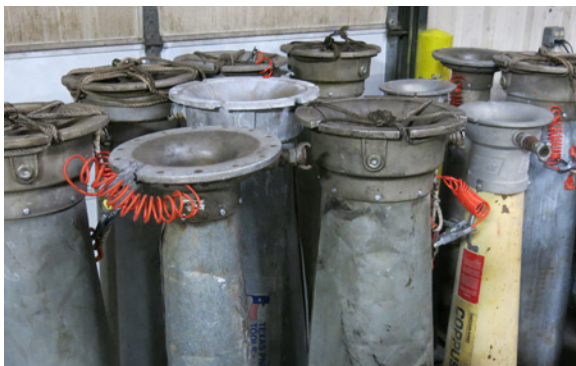
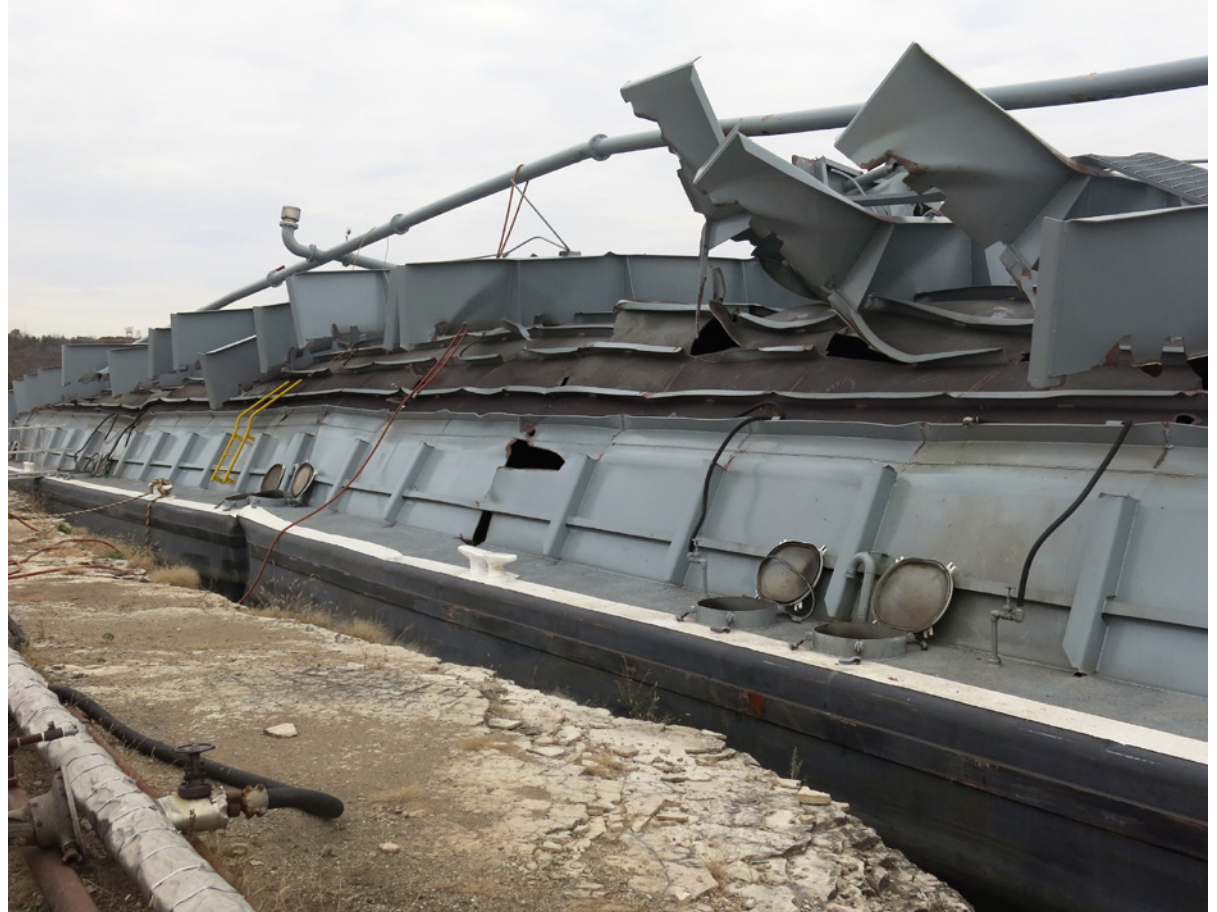
**Figure 150.** Damage of the *IB1940* after the explosion shows a distorted portside tank bulkhead and raised tank-top.

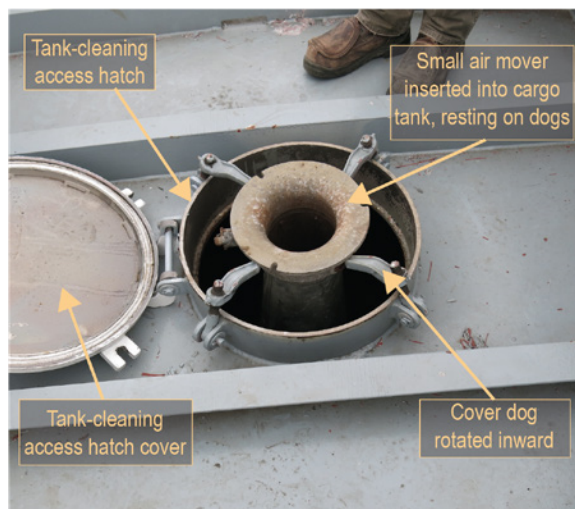
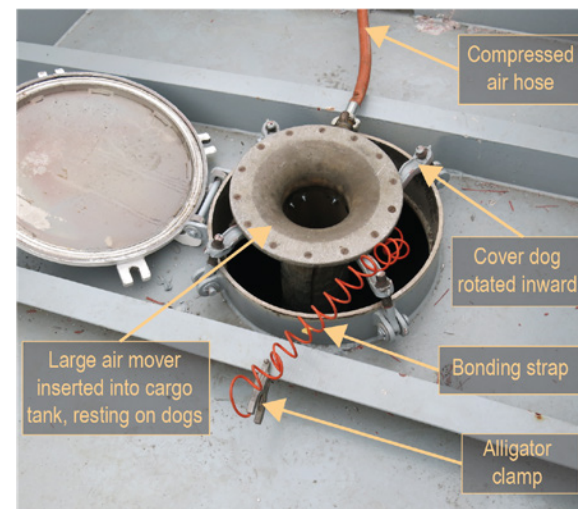
**Figure 151.** Demonstration of air-mover-installation methods reconstructed after the accident. **Left:** Smaller (6-inch diameter) air mover without compressed air hose and bonding wire. **Right:** Larger (11-inch-diameter) air mover connected with compressed air hose and bonding wire with clamp.

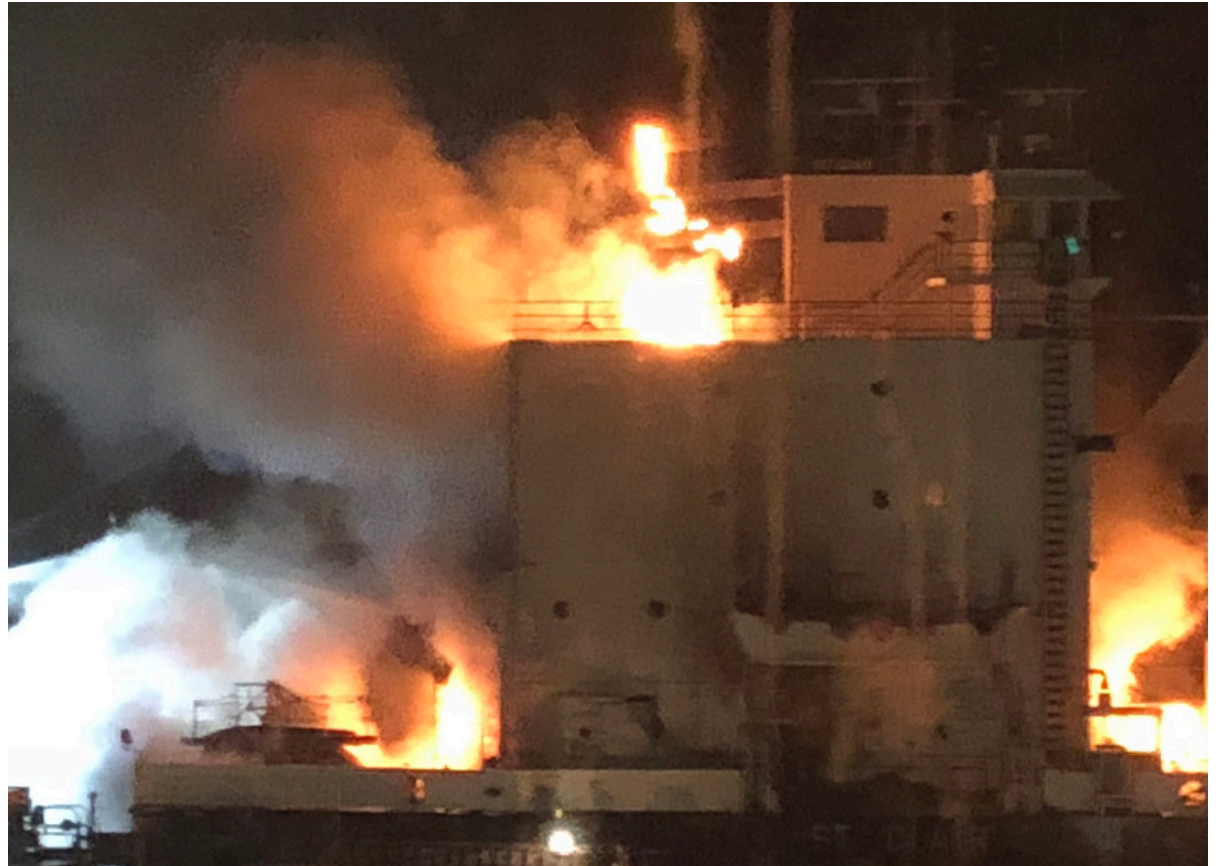
About 2010 local time on February 16, 2019, a fire was reported on the bulk carrier *St. Clair* while the vessel was laid-up for the winter at the CSX TORCO Iron Ore Terminal at the mouth of the Maumee River in Toledo, Ohio. No one was on board. The fire was extinguished approximately 36 hours later by shore-side firefighters. No pollution or injuries were reported. The estimated property damage exceeded \$150 million.

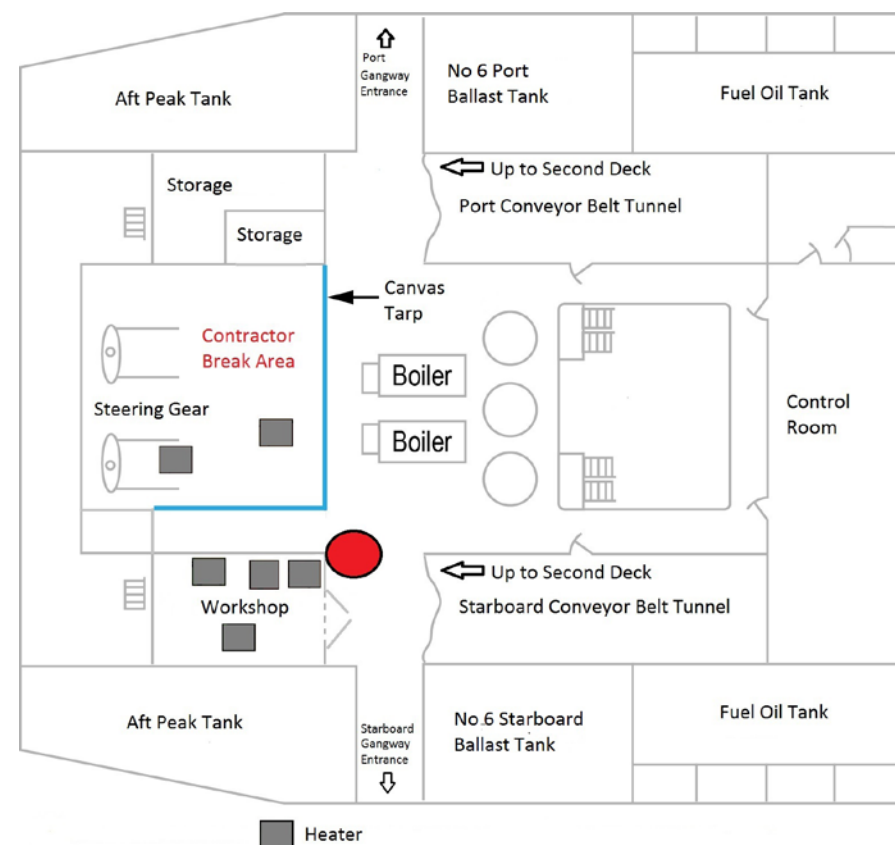
**Figure 156.** Drawing (not to scale) of third deck, showing location of heaters and tarp in the engine room. A red circle identifies the structural fire damage on the third deck.

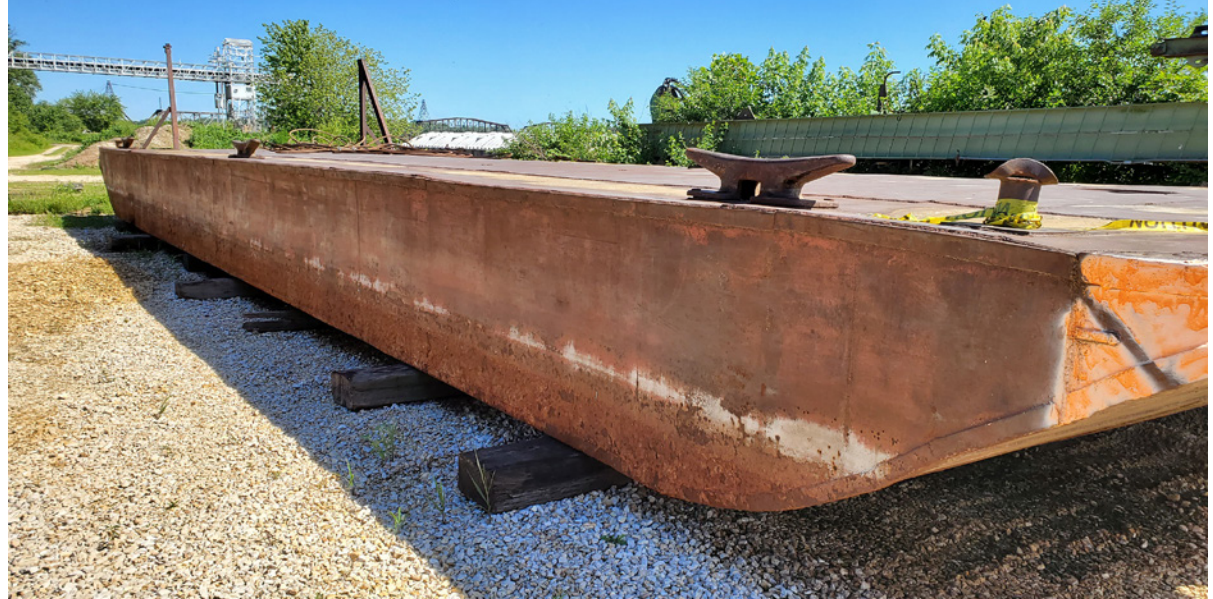
**Figure 158.** The unnamed deck barge after the accident. SOURCE: HEX STONE.

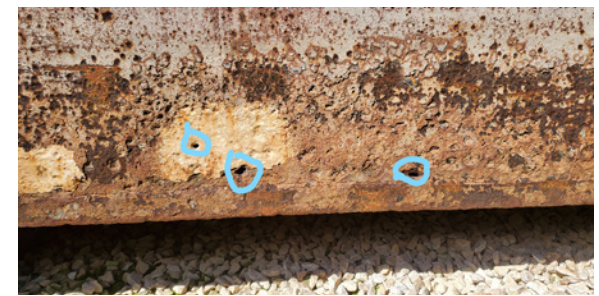
**Figure 159.** An annotated photo from the vessel company identifies holes on the side shell of the barge near the bottom plating. SOURCE: HEX STONE.

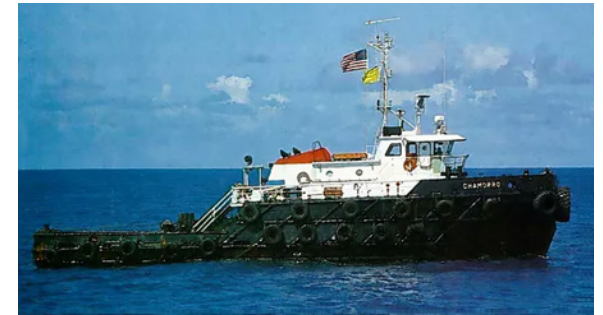
**Figure 162.** *Chamorro* (above) and *Mangilao* (below) under way prior to the accident voyage.

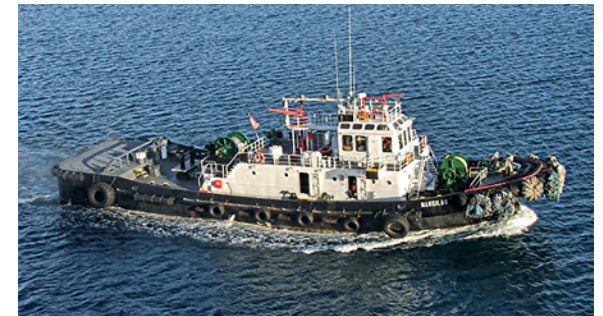
About 0900, the captain reduced the *Chamorro*’s engine speed and called all hands to the wheelhouse for a safety briefing. He directed the crew to extend the tow wire to about 1,400 feet to provide a smoother ride in the impending weather. Throughout the remainder of the day, they encountered significant winds and reported that the *Mangilao* was rolling and pitching.

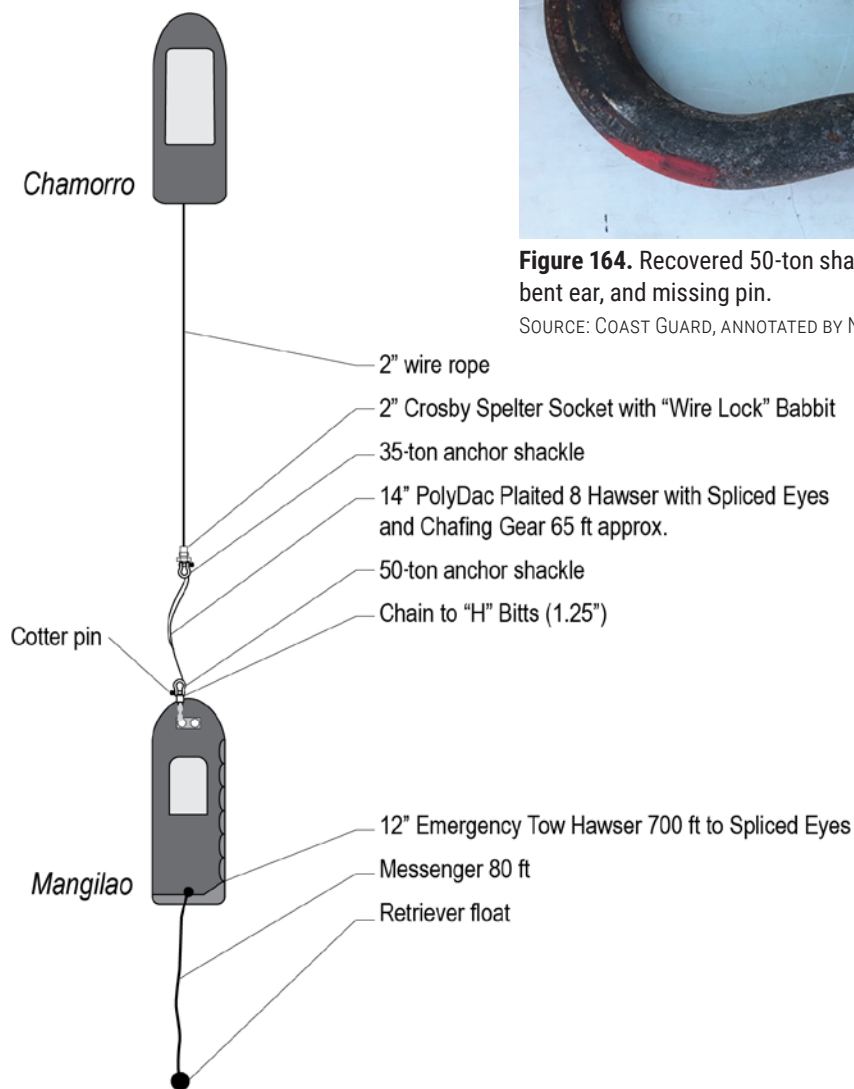
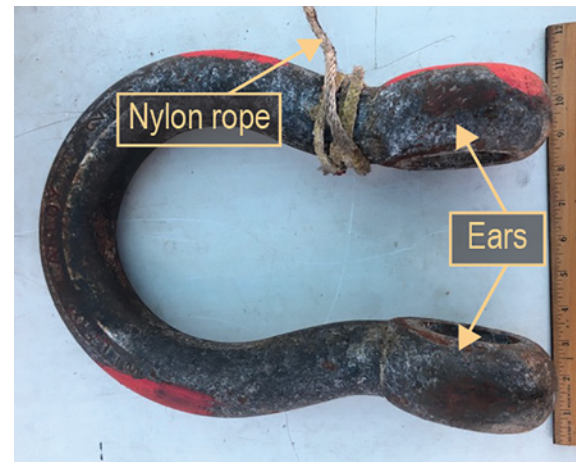
**Figure 164.** Recovered 50-ton shackle with nylon rope, bent ear, and missing pin.

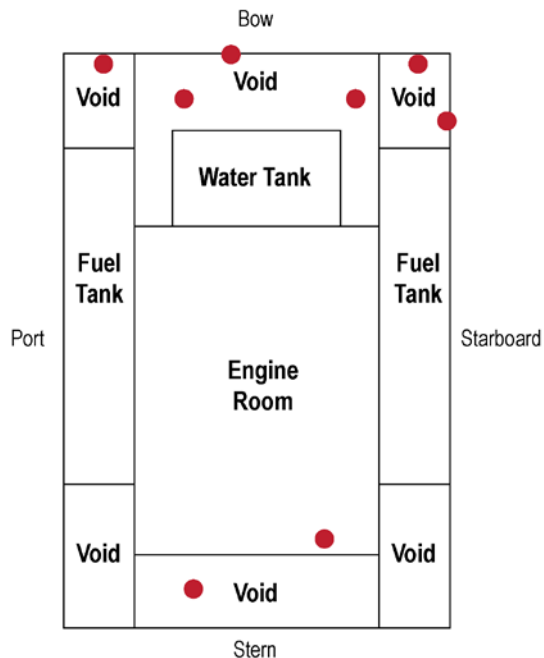
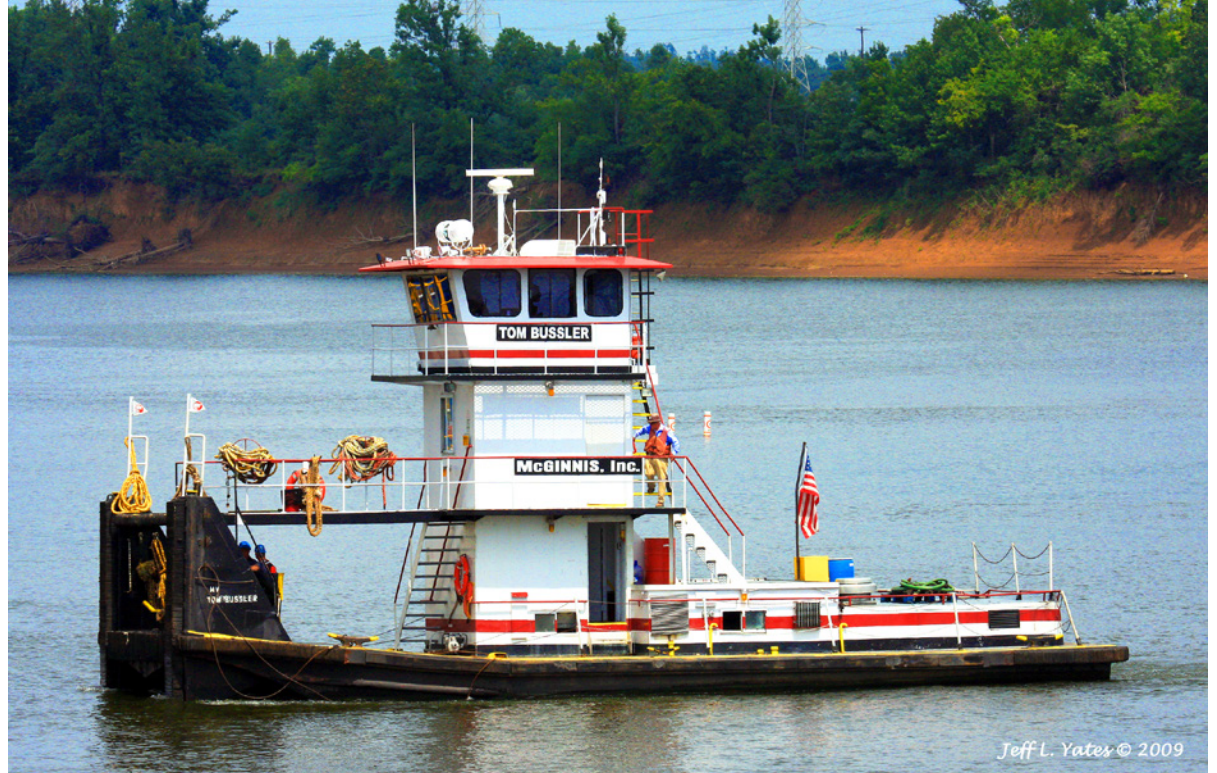
**Figure 168.** *Tom Bussler* under way before the accident. SOURCE: JEFF L. YATES

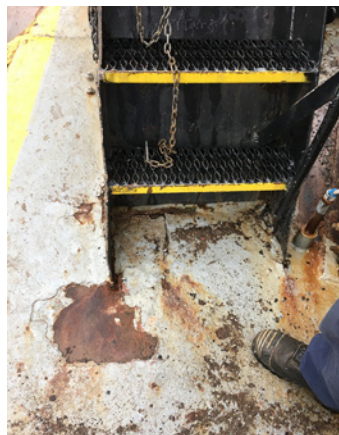
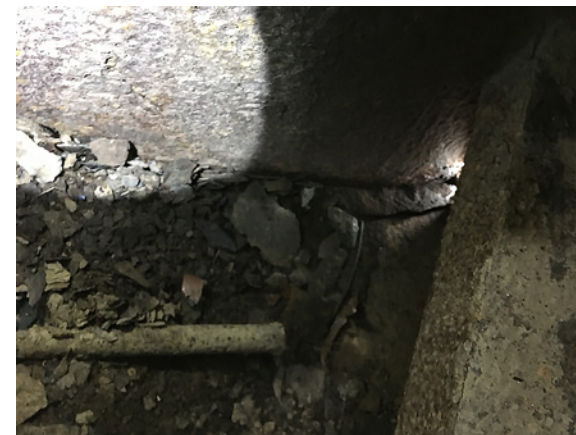
The probable cause of the flooding and sinking of the tugboat *Tom Bussler* was the company's lack of an effective hull maintenance and repair program, which resulted in flooding into the bow voids and engine room through fractures in the hull.

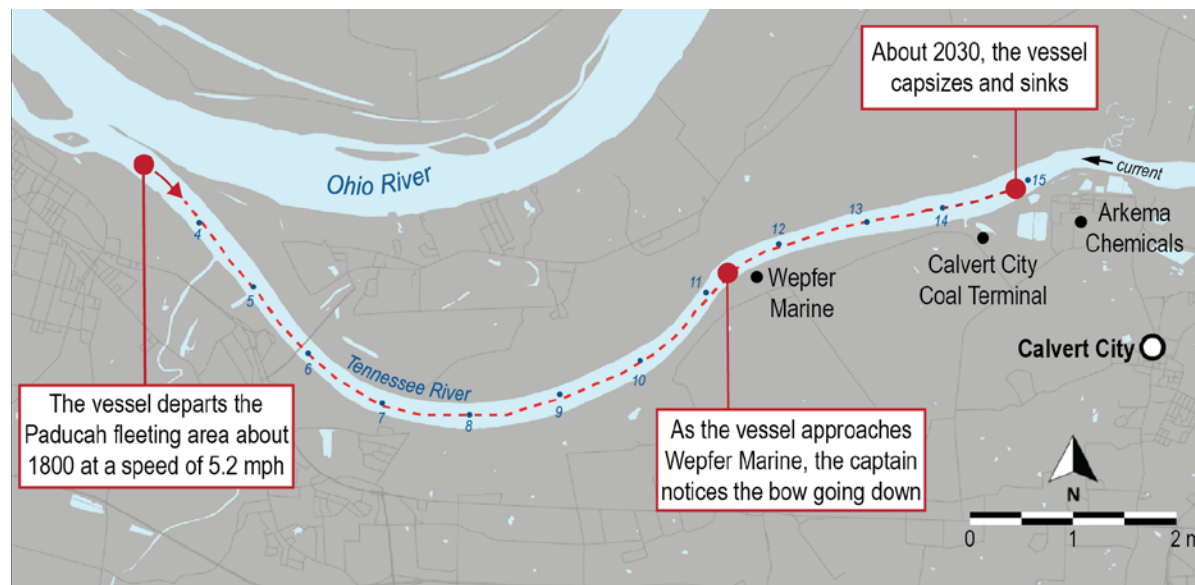
**To protect vessels and the environment, it is good marine practice for owners to conduct regular oversight and maintenance of hulls, including between drydock periods. Regardless of inspection requirements, owners are obligated to ensure vessels are properly maintained, equipped, and operated in a safe condition. Issues with watertight integrity and wastage should be addressed immediately.**

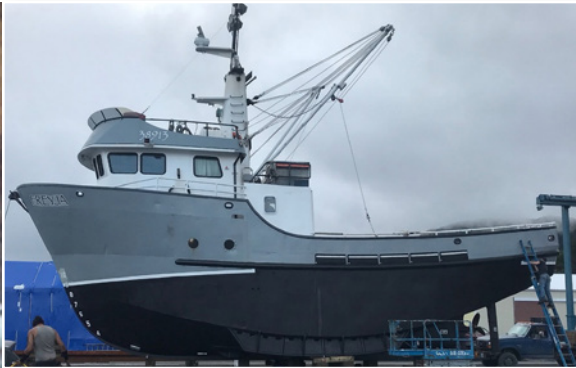
About 0155 local time on March 9, 2019, the commercial fishing vessel *Freyja* was longline fishing in the Bering Sea near Point Tebenkof, Unalaska Island, Alaska, when the vessel grounded and remained stranded on the rocks. The four crewmembers abandoned the vessel and swam to a nearby Good Samaritan vessel. The vessel was considered a total loss, with damage estimates at \$550,000. There were no reports of injuries or pollution.

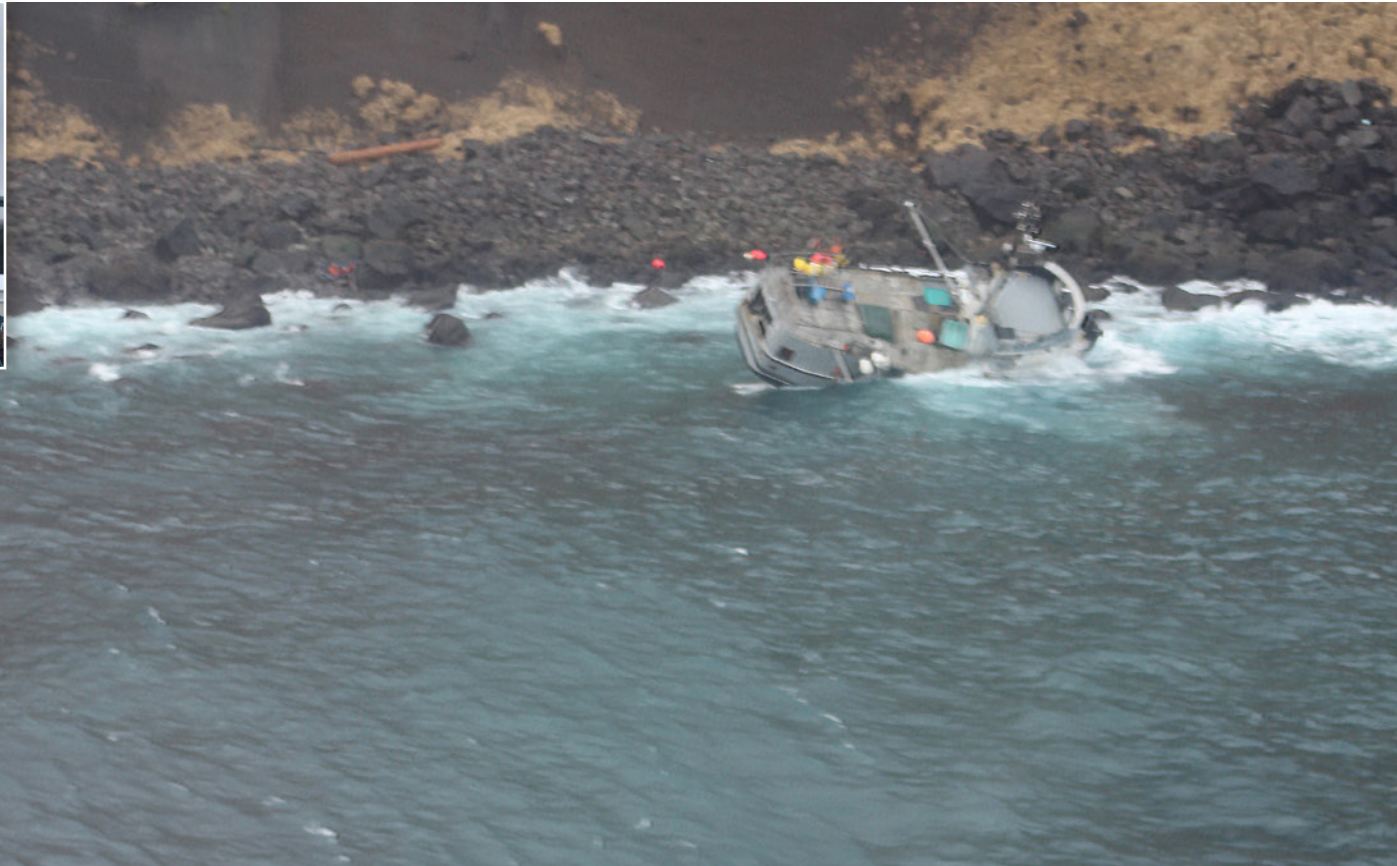
**Figure 172. Below:** The *Freyja* postaccident, on March 18, 2019, along the shore of Point Tebenkof. SOURCE: COAST GUARD.

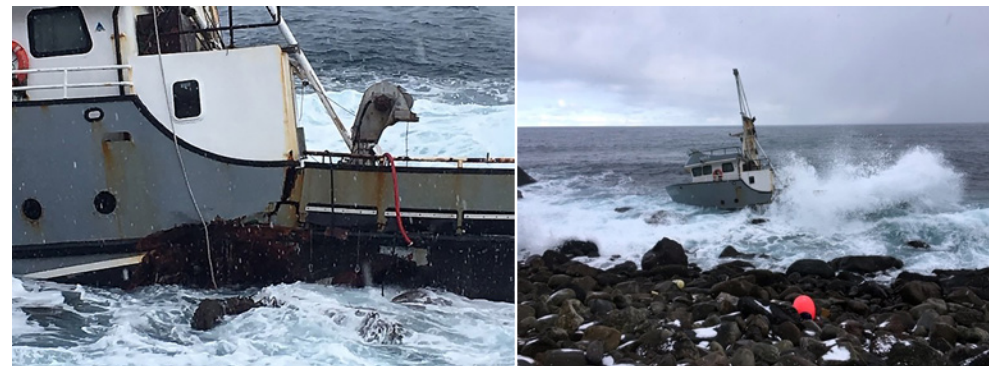
SOURCE: RESOLVE MAGONE MARINE.
