# SAFER SEAS Digest 2020

Lessons Learned from  
Marine Accident Investigations

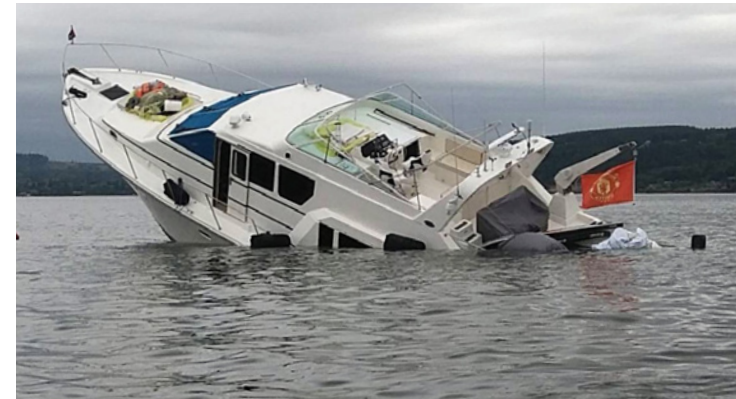
**Figure 176.** *Silver Lining* following the accident.

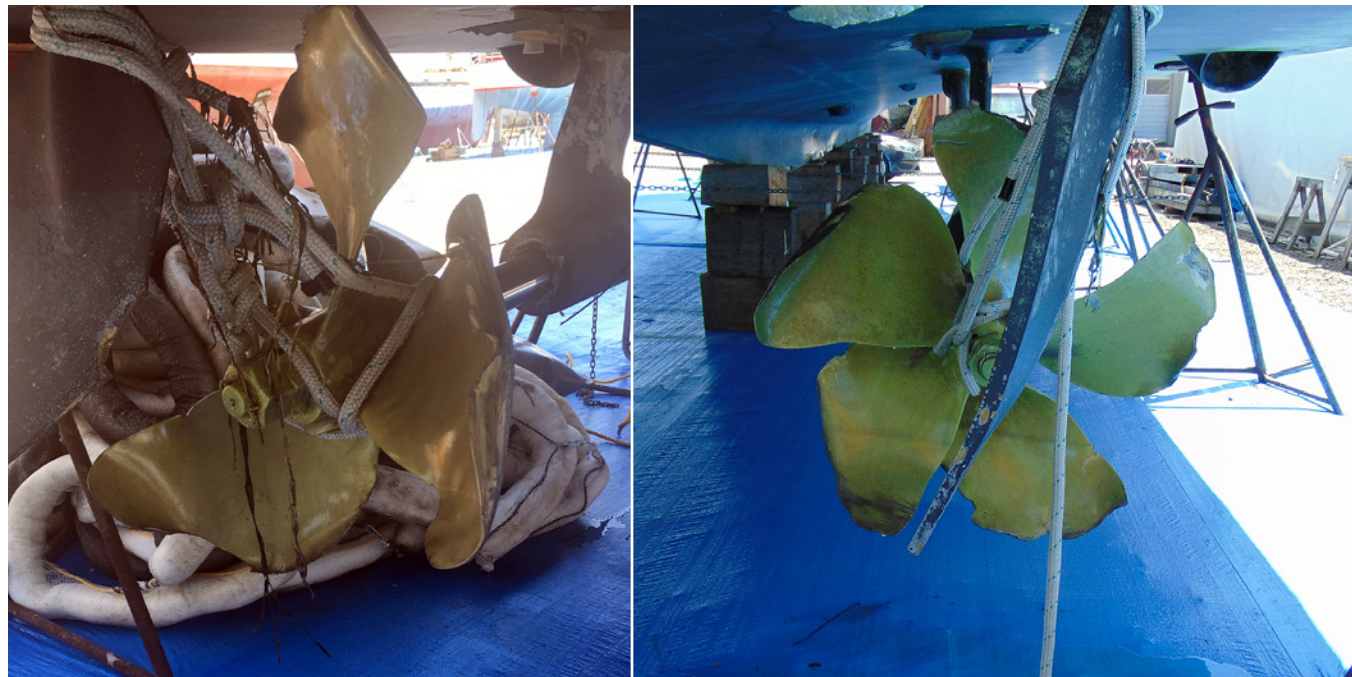
**Figure 177. Below:** Damage sustained to the port propeller and rudder (left) and starboard propeller and rudder (right) of the *Silver Lining* following the accident.

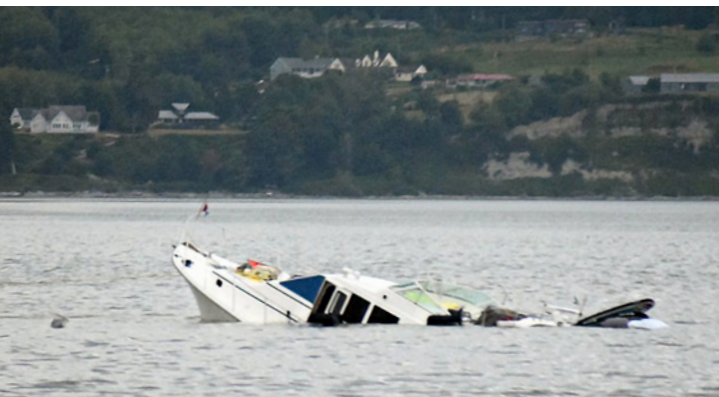
**Figure 178.** *Silver Lining* following the accident.

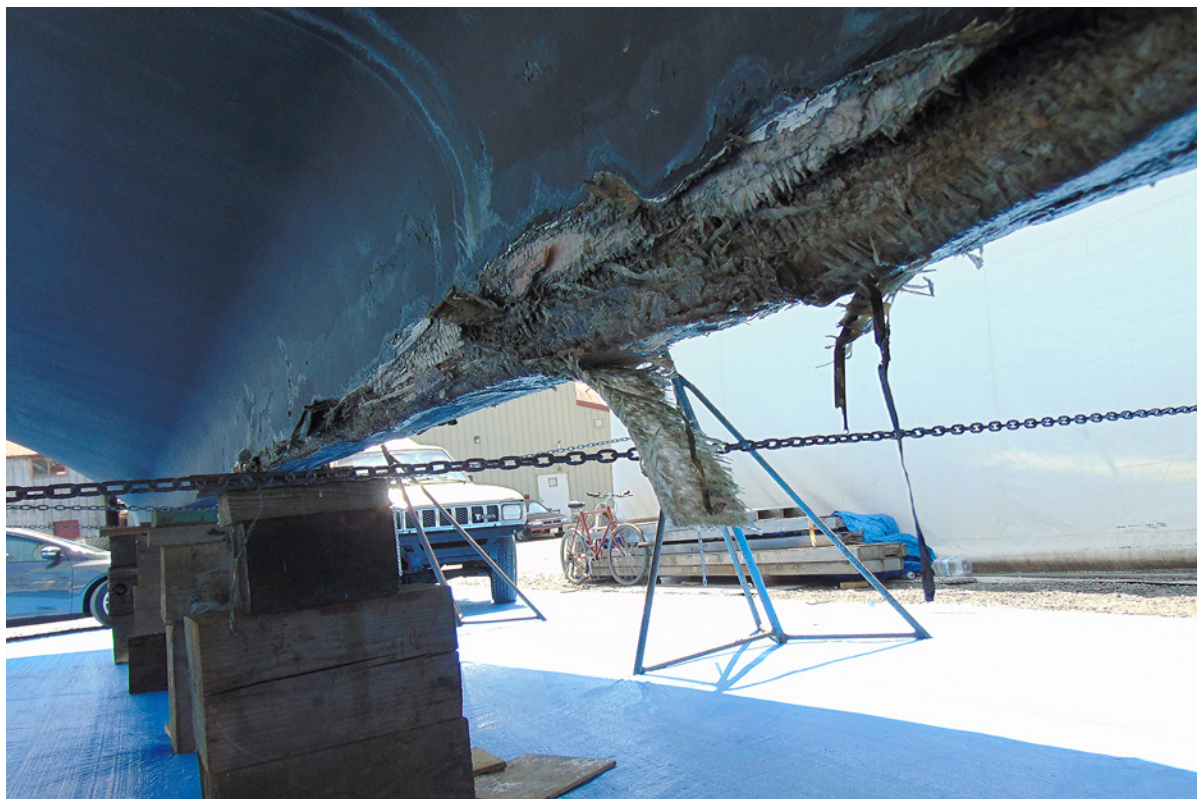
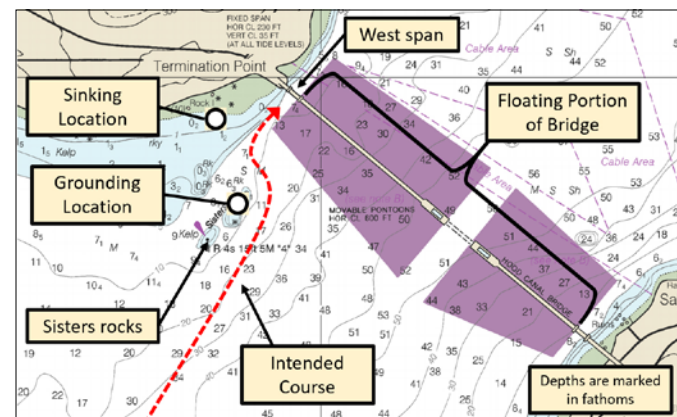
**Figure 180.** Map of the Hood Canal Bridge, including an estimated trackline of the *Silver Lining's* intended course.

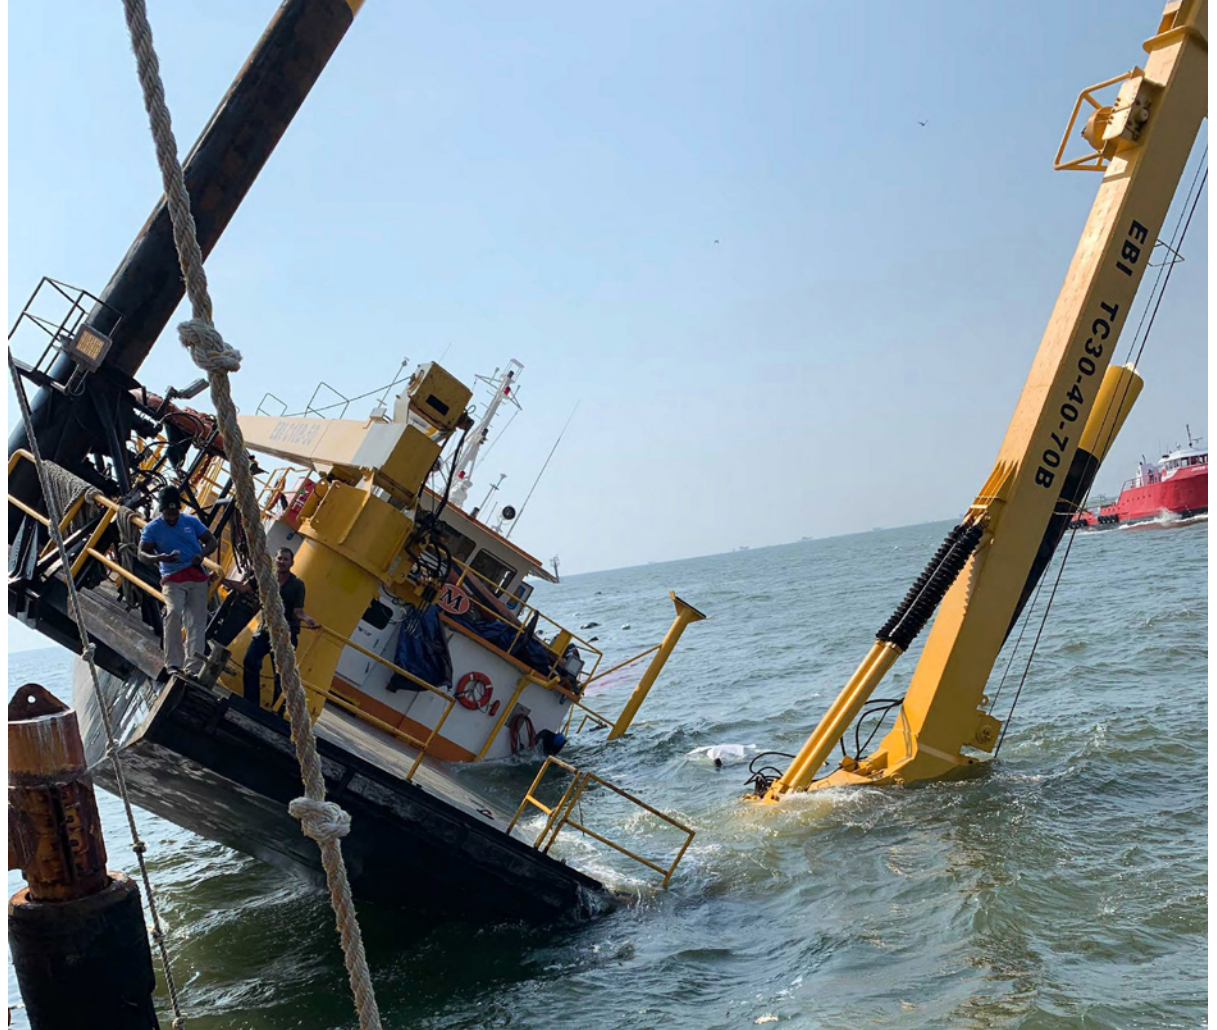
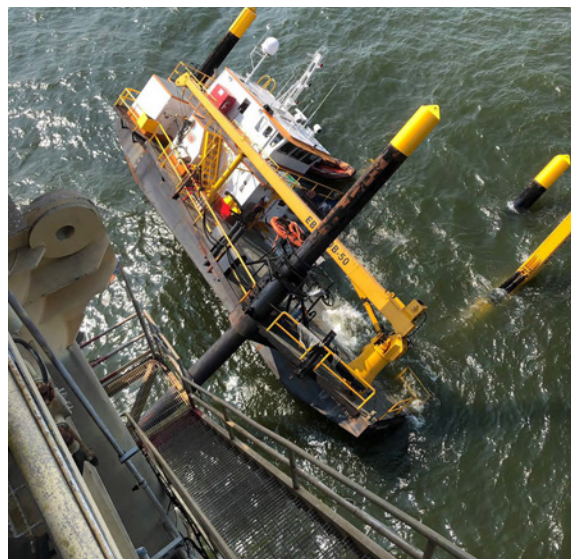
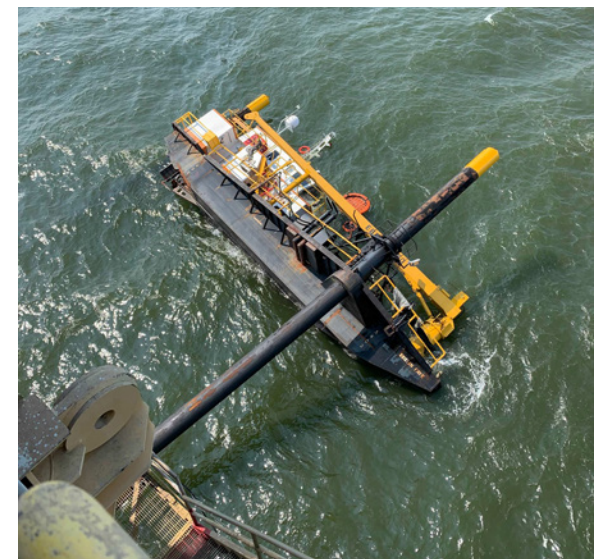
**Prior to jacking up to expected operating height and commencing operations, liftboat operators should conduct preload tests, with the hull close to the water, that simulate all planned operational loads.**

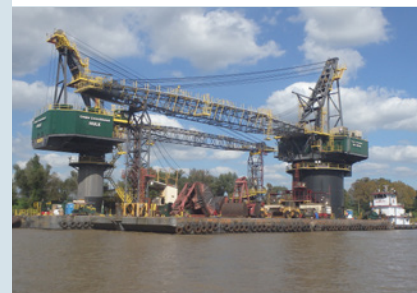
## Standard Operating Procedures

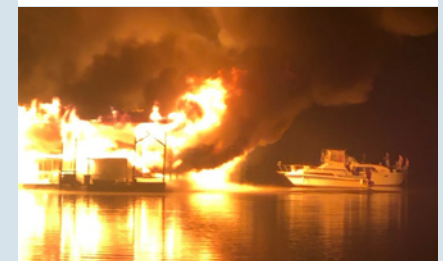
**Failure to follow standard operating procedures** was a factor in the *Fairchem Filly*, *Fitzgerald*, and *Conception* accidents.

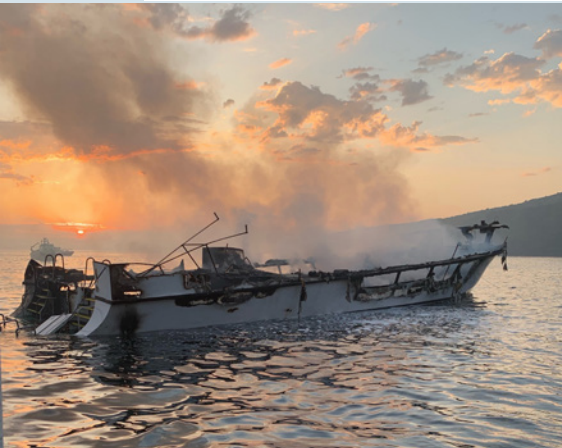
## Voyage Planning and Dynamic Risk Assessment

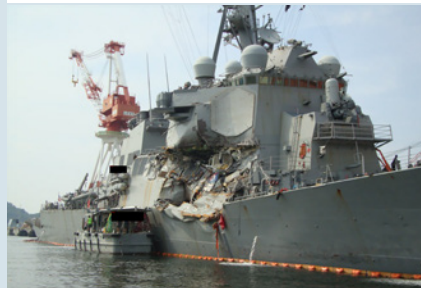
## Effective Communication

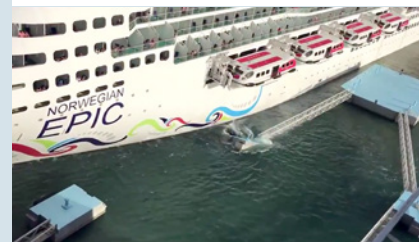
## Operating in High-Water/High-Current Conditions

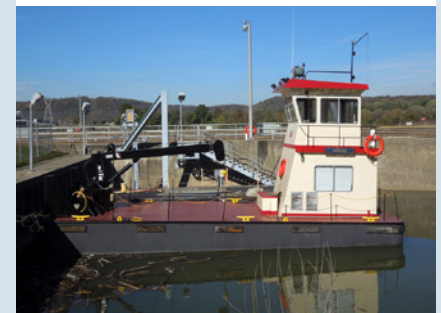
## Lithium-ion Battery Hazards

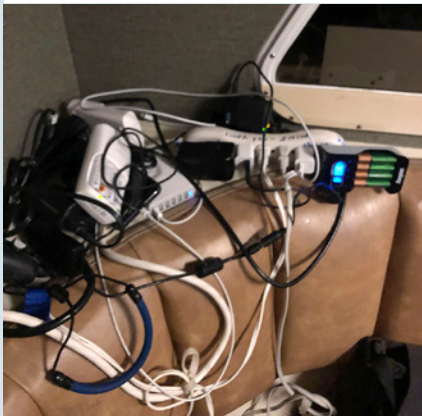
**The unmonitored charging and storage of lithium-ion batteries may have been a factor in the *Conception* accident.**

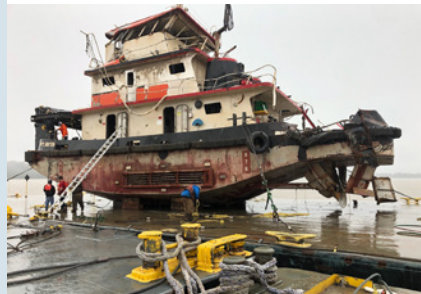
**Ineffective crew training was a factor in the *Conception*, *St. Rita*, *Leviticus*, and *Fitzgerald* accidents.**

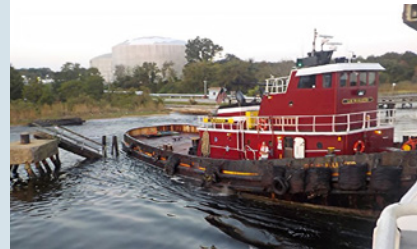
## Storage of Flammable or Combustible Materials

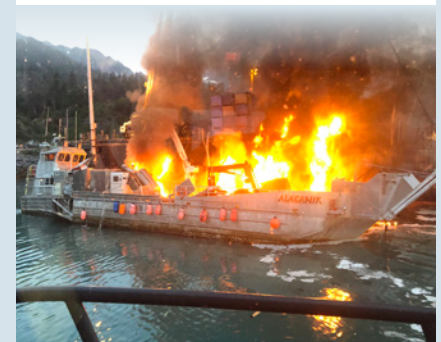
## Closing Ventilation Inlets During a Fire

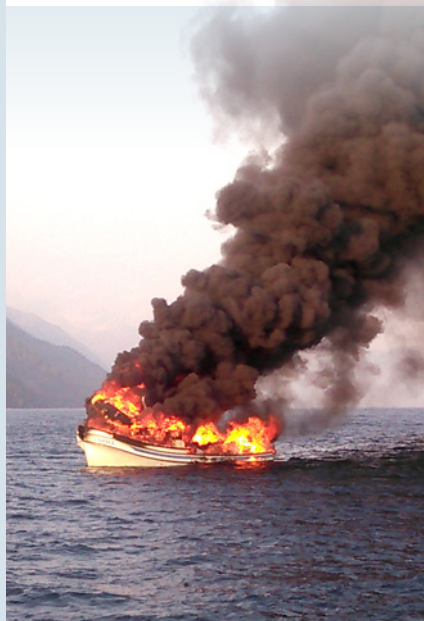
## Effective Hull Inspection and Maintenance

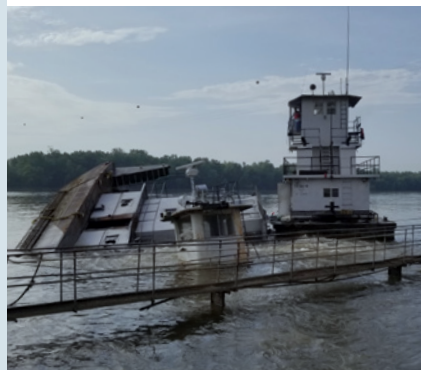
## Inspection of Control Linkages

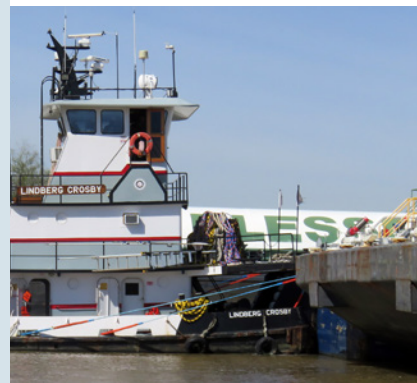
**The failure of a critical linkage** was a factor in the *Lindberg Crosby* accident.

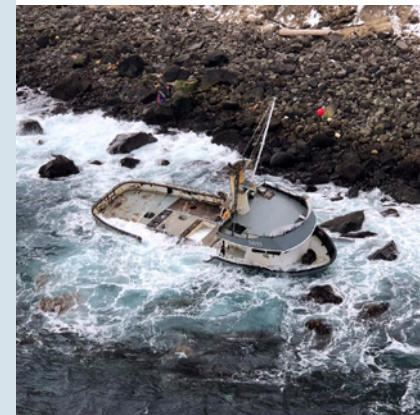
"With every investigation we learn new safety lessons to prevent or mitigate future losses, but only when marine stakeholders at all levels of the industry apply these lessons."

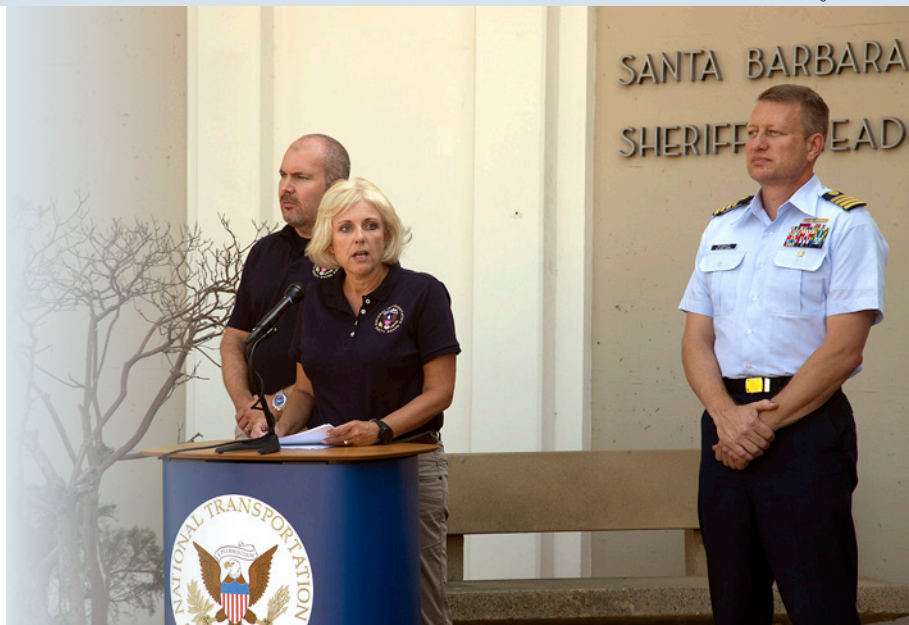
**Figure 187.** NTSB Chair Jennifer Homendy, with staff and Coast Guard Captain Jason Neubauer, gives a press briefing during the *Conception* investigation.

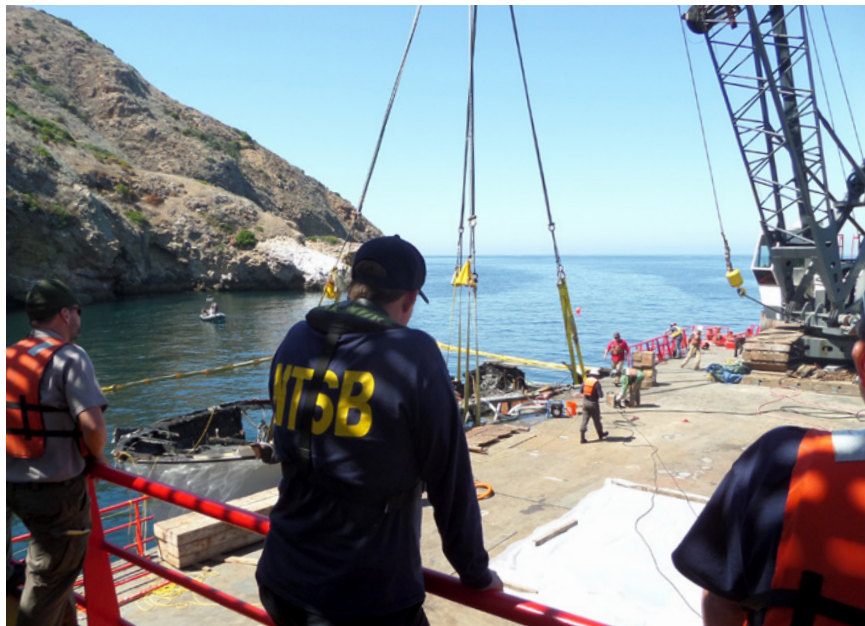
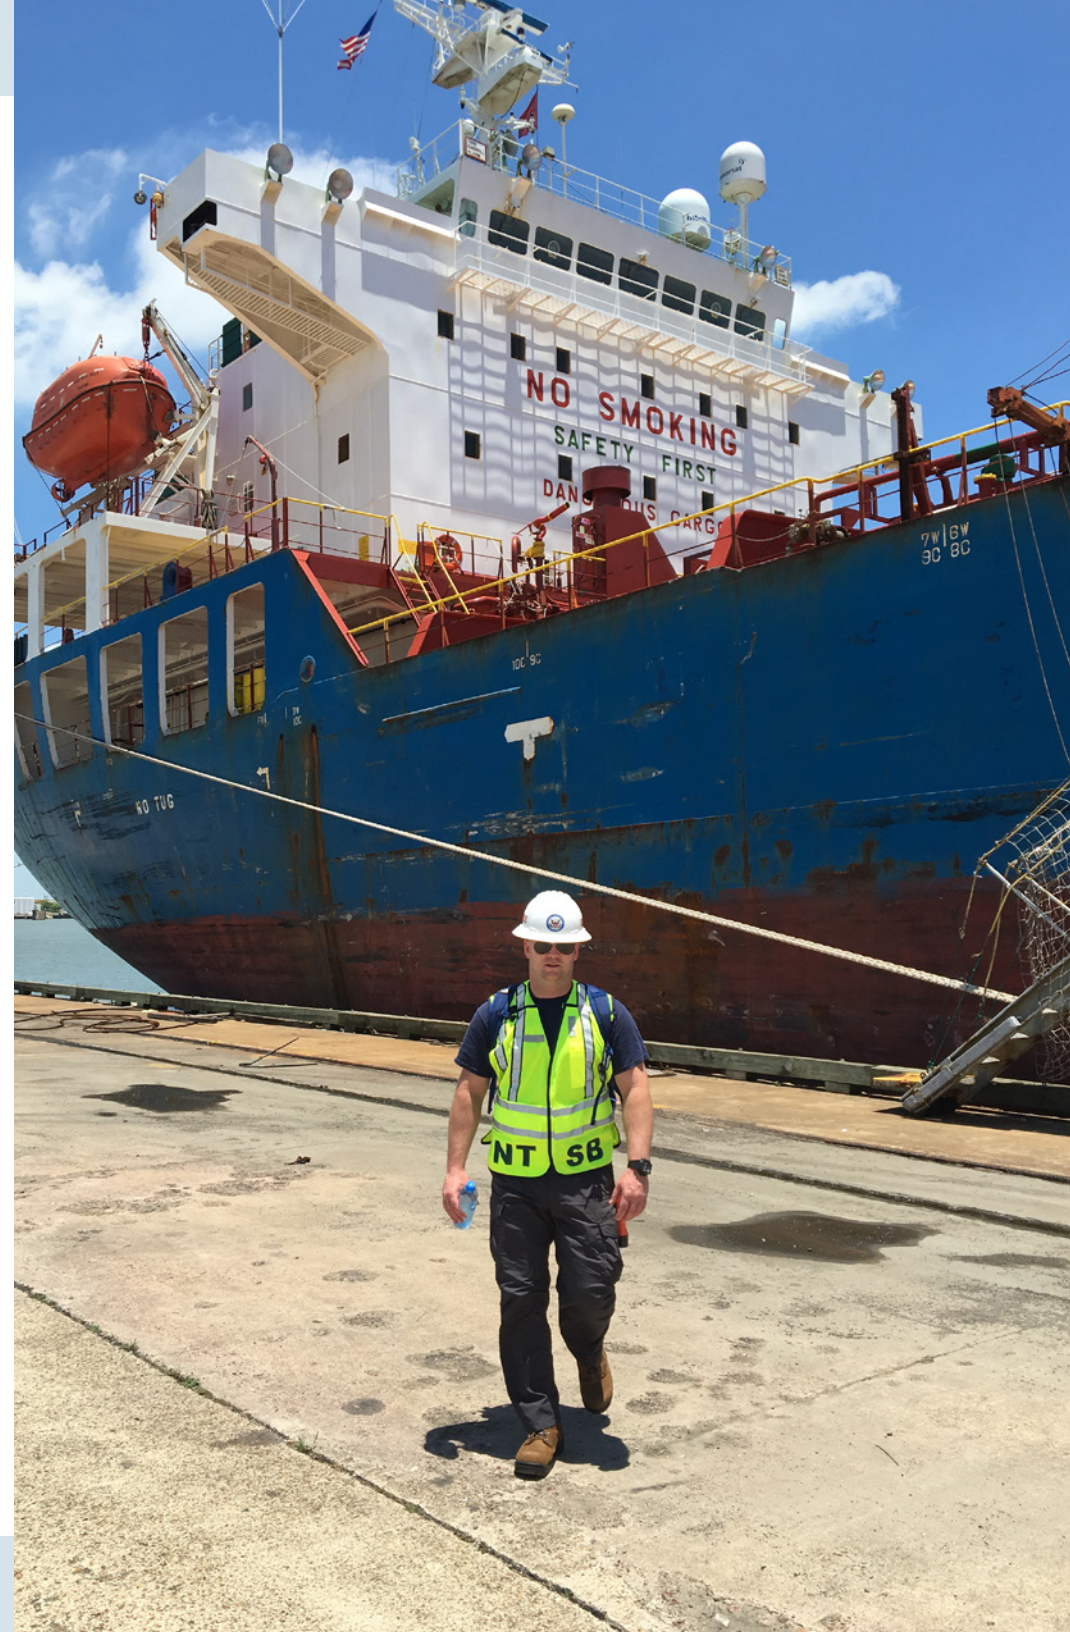
**Figure 190. Below:** An NTSB investigator watches as the wreckage of the *Conception* is pulled from the water.

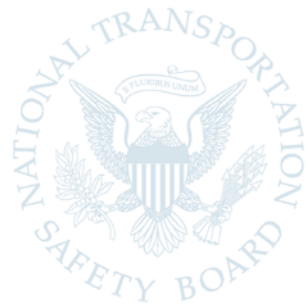
The NTSB is the independent federal agency tasked by Congress with investigating highway, marine, rail, pipeline, and civil aviation accidents, determining their probable causes, and making safety recommendations aimed at preventing future accidents.
