December 1, 2022

Aviation Investigation Report AIR-22-10

Require Immediate Inspection of Bell 407 Tail Boom Attachment Hardware and Fittings

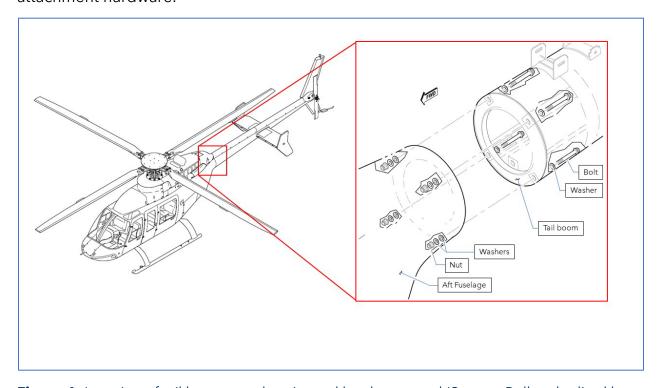
attach point. Figure 1 shows the location of separation and the attachment fittings and hardware used to secure the tail boom to the fuselage.

Figure 1. Location of tail boom attach point and hardware used (Source: Bell and edited by NTSB). Attachment hardware consists of a bolt, washers, and a nut.

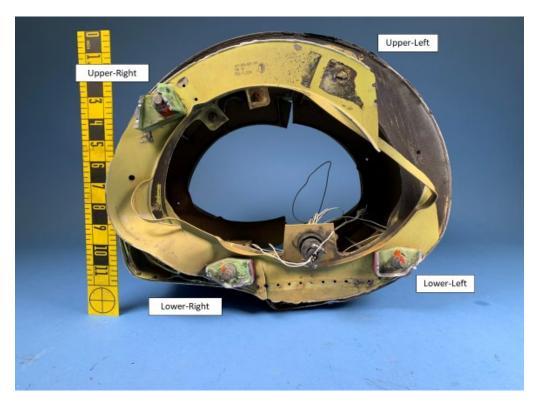
The upper-left tail boom attachment hardware, consisting of a bolt, washers, and a nut, was not present at the accident site and was not found. The attachment fitting remained connected to the fuselage. Damage to the upper-left attachment bolt holes indicates the bolt had been installed at some point before the accident flight; it is unknown at this time when or why the bolt separated. Additionally, the lower-left, lower-right, and upper-right tail boom attachment fittings (connecting the tail boom to the aft fuselage) were fractured and found, along with their attachment hardware, with the tail boom wreckage. The lower-left fitting had multiple fatigue fractures, while the upper-right and lower-right attachment fittings had overload fractures. The initiation of fatigue cracks on the lower-left fitting indicates that the tail boom did not immediately separate from the helicopter upon the separation of the upper-left attachment hardware.

Figure 2 shows the accident helicopter tail boom with the fractured remnants of the upper-right, lower-left, and lower-right attachment fittings and their respective attachment hardware. Figure 3 shows the upper-left tail boom attachment fitting found with the main fuselage wreckage.

Figure 2. Tail boom with fractured remains of attachment fittings and hardware. Upper-left attachment hardware (bolt, washers, and nut) was not present. The lower left, lower right, and upper right attachment hardware (bolt, washers, and nut) remained installed.

Require operators of Bell 407 helicopters to conduct an immediate torque check of the tail boom attachment hardware, as well as a visual inspection of the tail boom attachment fittings for evidence of cracks and fractures, and report findings to the FAA. (A-22-28) (Urgent)

Require operators of Bell 407 helicopters to conduct subsequent torque checks of the tail boom attachment hardware and visual inspection of the tail boom attachment fittings as referenced in Safety Recommendation A-22-28 at an interval significantly less than the currently required interval to provide multiple opportunities for detecting any improperly installed or fractured attachment hardware or fittings. Require operators to report findings to the FAA. (A-22-29) (Urgent)

Require operators of Bell 407 helicopters to conduct an immediate torque check of the tail boom attachment hardware, as well as a visual inspection of the tail boom attachment fittings for evidence of cracks and fractures, and report findings to Transport Canada. (A-22-30) (Urgent)

Require operators of Bell 407 helicopters to conduct subsequent torque checks of the tail boom attachment hardware and visual inspection of the tail boom attachment fittings as referenced in Safety Recommendation A-22-30 at an interval significantly less than the currently required interval to provide multiple opportunities for detecting any improperly installed or fractured attachment hardware or fittings. Require operators to report findings to their respective regulatory authority. (A-22-31) (Urgent)

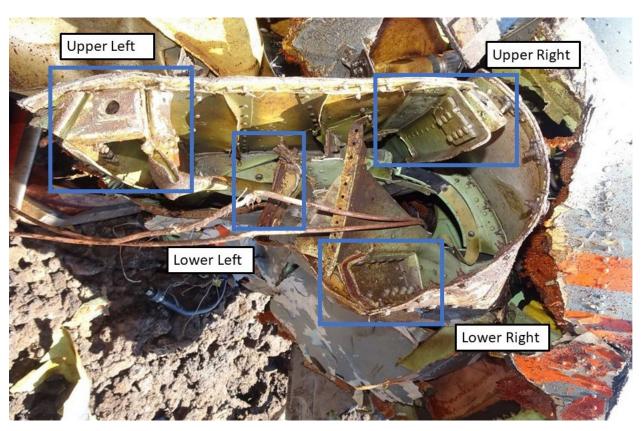
Figure 3. Aft fuselage with upper-left tail boom attachment fitting.

According to Bell (the helicopter manufacturer), the upper-left tail boom attachment fitting has the highest tension loading of the four attachment fittings and is considered the most important of the four attachment fittings between the tail boom and the aft fuselage. The upper-left tail boom attachment bolt separated first, resulting in the redistribution of the load normally carried by the upper-left attachment fitting to the remaining three attachment fittings and the subsequent initiation of fatigue fractures on the lower-left attachment fitting. Based on preliminary analysis of the fatigue crack growth on the lower-left attachment fitting, it is possible that the fatigue crack grew over multiple takeoffs and landings. However, this analysis is ongoing, and the results of the analysis, once completed, will be shared with the FAA and the Transportation Safety Board of Canada.
