PILOTS: Ensure Your Fuel Selector Works

Worn components can lead to fuel starvation and sudden loss of engine power

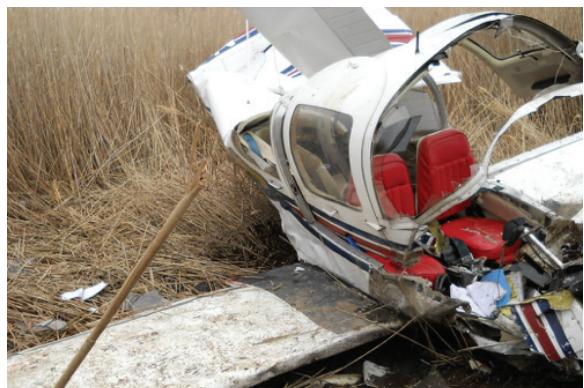
Figure 1. Photograph of accident airplane.

- During the initial climb after a touch-and-go landing in a Piper PA-38-112, the flight instructor reported an emergency and indicated that he would return to the airport. The airplane then spun to the left and impacted a marsh. The airplane was destroyed (figure 1); the flight instructor sustained serious injuries, and the student pilot died. Although the fuel selector handle was positioned to the right main fuel tank, an insert in the fuel selector had fractured into multiple pieces that showed overstress and wear (figure 2, next page). The fuel selector handle likely had been difficult to move for some time, and excessive force would have been required to move the handle from one position to another, thus causing the wear. **The failure of the fuel selector valve in a position that**

restricted fuel flow to the engine led to the total loss of engine power due to fuel starvation. The operator failed to detect and resolve the wear of the fuel selector valve. (ERA17FA112)

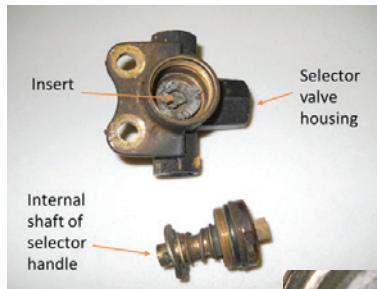
Figure 2. Fuel selector valve housing and section of selector handle (above) and fuel selector insert with fractured pieces (right).

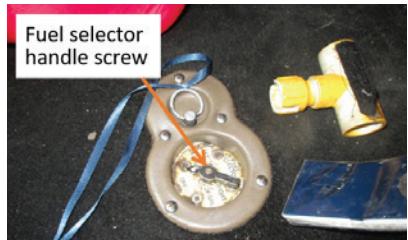
The pilot of a Mooney M20 airplane reported that, during the initial climb from the airport, he noted the engine power slowing, turned on the boost pump, checked the magnetos and fuel mixture, and then attempted to switch the fuel selector to the other fuel tank, which had usable fuel. The engine experienced a total loss of power, and the airplane impacted the ground. A passenger sustained minor injuries, and the pilot and another passenger were uninjured. **The fuel selector handle screw was loose and prevented the fuel selector from moving to the fuel tank position for the tank with usable fuel, resulting in fuel starvation and the subsequent total loss of engine power** (see figure 3). (GAA17CA260)

Figure 3. Photograph of fuel selector.
(Source: FAA)
