Mechanics: Ensure B-nuts Are Properly Secured!

B-nuts are a small piece of hardware that can cause a big problem if they are not properly secured.

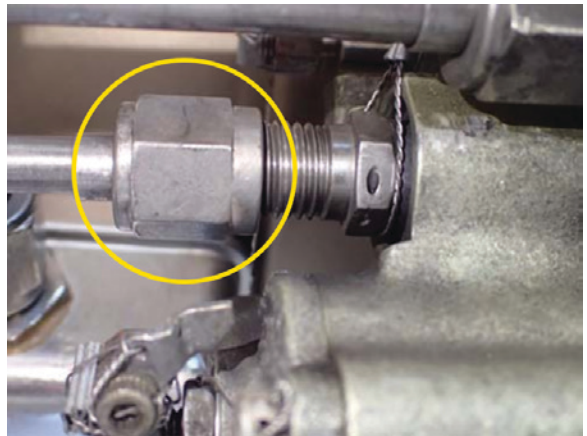
- The figure at the right shows a loose B-nut that was examined as part of National Transportation Safety Board (NTSB) investigation [ERA21LA023](#) (which is discussed in this safety alert). The threads from the line are visible in the figure.

Figure. Loose B-nut at the fuel control unit of the accident engine (SOURCE: ROLLS-ROYCE ENGINES).

- A Hughes (MD Helicopters) 369D helicopter lost partial engine power during external load (longline) operations. The pilot attempted an autorotation, but the helicopter impacted muddy terrain and rolled onto its right side, resulting in substantial damage. On the day before the accident, the fuel control unit on the overhauled turboshaft

engine was replaced with a unit that had previously been installed on the helicopter. A leak check and a ground run were then performed, which were successful. On the day of the accident, the pilot aborted the first engine start due to a high turbine outlet temperature. A mechanic adjusted the acceleration settings, and the second start was within turbine outlet temperature limitations. Postaccident examination of the helicopter revealed that the air line that connected the governor to the fuel control unit was not attached and that the fuel control B-nut had “backed out” to the elbow of the air line. These findings indicated that the mechanic had not properly secured the fuel control unit B-nut and that the loose B-nut led to the partial loss of engine power. **Even though the pilot avoided serious injuries during the autorotation, the mechanic’s failure to secure the fuel control B-nut could have had catastrophic consequences.** (CEN22LA146) After the accident, MD Helicopters issued an [operational safety notice](#) about maintaining external lines on the accident model engine (a Rolls-Royce M250 engine).

- **Ensure that the proper type of B-nut is used for the maintenance task and that the B-nut does not have any pre-existing damage, especially to the threads or the sealing surfaces. If a B-nut (or any hardware) appears questionable, remove it from service—when in doubt, throw it out!**

- **Develop a process to ensure that B-nuts that have been tightened during maintenance are also torqued as part of the task. Ensure that proper torquing practices are followed. Use appropriate checklists.**

- **Perform the required leak checks after the task is completed.**
- **Properly apply torque stripe paint to the B-nuts, after they have been tightened and torqued, to provide a visual aid for identifying a B-nut that has become loose or is otherwise not properly secured. Remove any previous torque stripe paint before applying the new torque stripe paint.**
