Flying in Icing Conditions?

Assess the Effect on Airplane Performance and Consult Your Pilot's Operating Handbook!

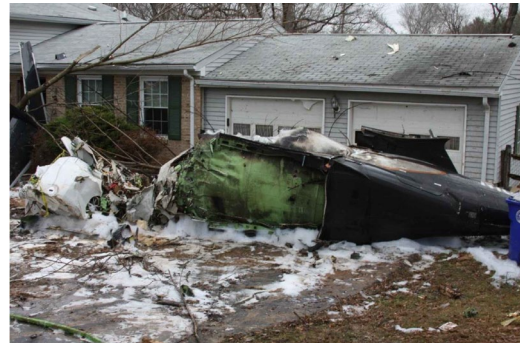
- The pilot of an Embraer EMB-500 began a descent from 23,000 ft. The pilot confirmed to air traffic control that he had the destination airport’s current weather observation, which indicated conditions favorable for structural icing during the airplane’s descent and approach. About 3/4 mile from the approach end of the runway, the airplane stalled and impacted three houses and the ground, and a postcrash fire ensued (see figure 1). The pilot, both passengers, and all three people in one of the houses sustained fatal injuries. Before beginning the descent, the pilot incorrectly used the Normal checklist (non-icing), which did not call for the activation of the wing and horizontal stabilizer deice system. Further, he set the landing reference speed at 92 knots rather than the 126 knots he should have used to account for the icing conditions.

Figure 1. Fuselage showing impact and fire damage to house.

Had the pilot used the correct checklist in the POH for approach in icing conditions, the airframe likely would not have accumulated ice, and the pilot would have used appropriate landing performance speeds for the conditions. Thus, not using the correct checklist led to an aerodynamic stall at an altitude at which recovery was not possible. ([AAR-16-01](#))

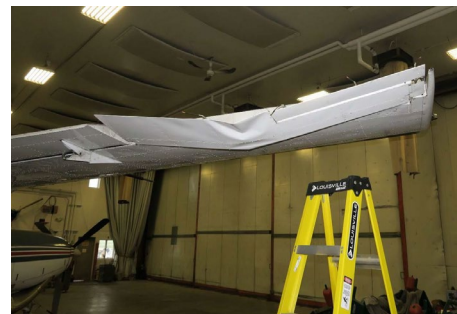
- After encountering supercooled large droplets that led to ice accumulation, the pilot of a Cessna 208B airplane began a gradual descent from 10,500 ft mean sea level (msl) to 10,000 ft msl during which the airplane entered an abrupt uncommand right bank followed by a steep, nose-down, spiral descent. The pilot regained control of the airplane, returned to the departure airport, and made an emergency landing. The airplane’s POH and applicable supplements stated that the minimum speed for flight in icing conditions was 130 knots and that the autopilot must be disconnected once every 10 minutes in icing conditions to check for any out-of-trim conditions caused by ice buildup. Data obtained from the autopilot revealed that it was not disconnected every 10 minutes through the course of the flight as required, and the indicated air speed was below 100 knots in the seconds preceding the upset. A postaccident examination revealed substantial damage to the

Figure 2. Damage to right aileron.

wings and right aileron (see figure 2). **Had the pilot complied with instructions in the POH to periodically disconnect the autopilot to check for out-of-trim conditions and to maintain the minimum airspeed for flight in icing conditions, he likely would not have experienced a loss of control of the airplane and subsequent substantial damage to the aircraft.** ([ANC21LA073](#))
