Decatur, Tennessee: Collision Between Service Truck and School Bus

Service utility truck departs roadway, returns and crosses into opposite travel lane in front of school bus

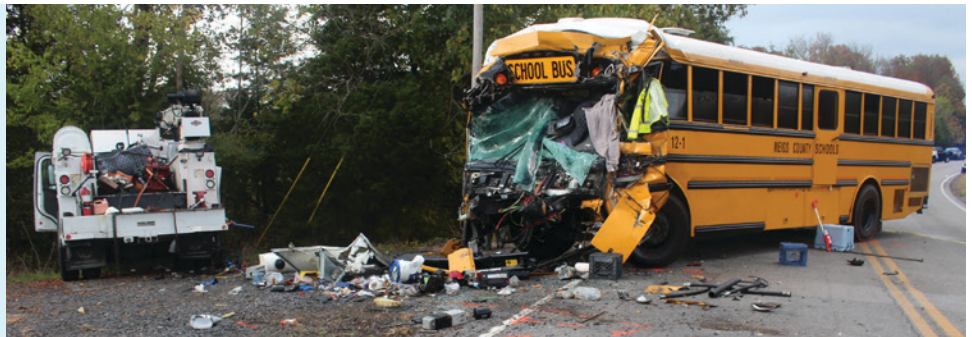
A service utility truck was traveling at an estimated speed of about 52 mph on a two-lane state route when its right-side wheels departed the roadway. When the driver steered the truck back onto the roadway, the truck yawed counterclockwise, crossed into the opposing travel lane, and was almost perpendicular to the roadway. At the same time, a school bus was traveling in the opposing travel lane at 46 mph. Although the bus driver braked, she did not have time to avoid the collision, and the school bus struck the right side of the truck.
