NATIONAL TRANSPORTATION
SAFETY BOARD

NTSB/SPC-16-01

SAFER SEAS DIGEST

LESSONS LEARNED FROM MARINE ACCIDENT INVESTIGATIONS

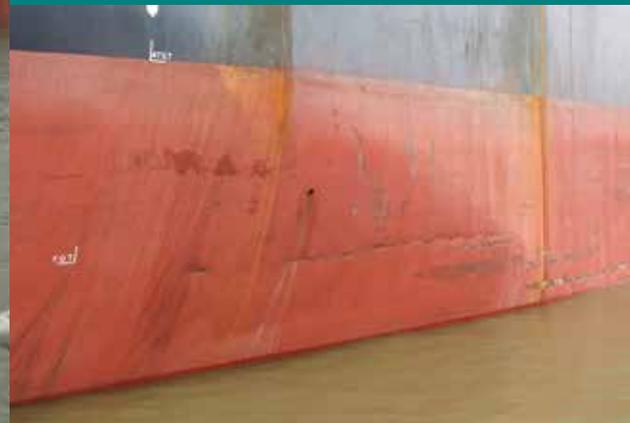
Damaged area of Anna Smile's hull. OPPOSITE PAGE, east tower of Louis Dreyfus grain elevator, which was damaged in the allision.

The bulk carrier *Anna Smile* allided with the Louis Dreyfus grain elevator in Houston, Texas, at 0504 on July 14, 2014, while maneuvering during docking operations. Damage to the grain elevator and its foundation was estimated at \$2.5 million. The *Anna Smile* suffered minor insets on the hull plating for a length of about 30 feet, but a damage estimate was not provided.

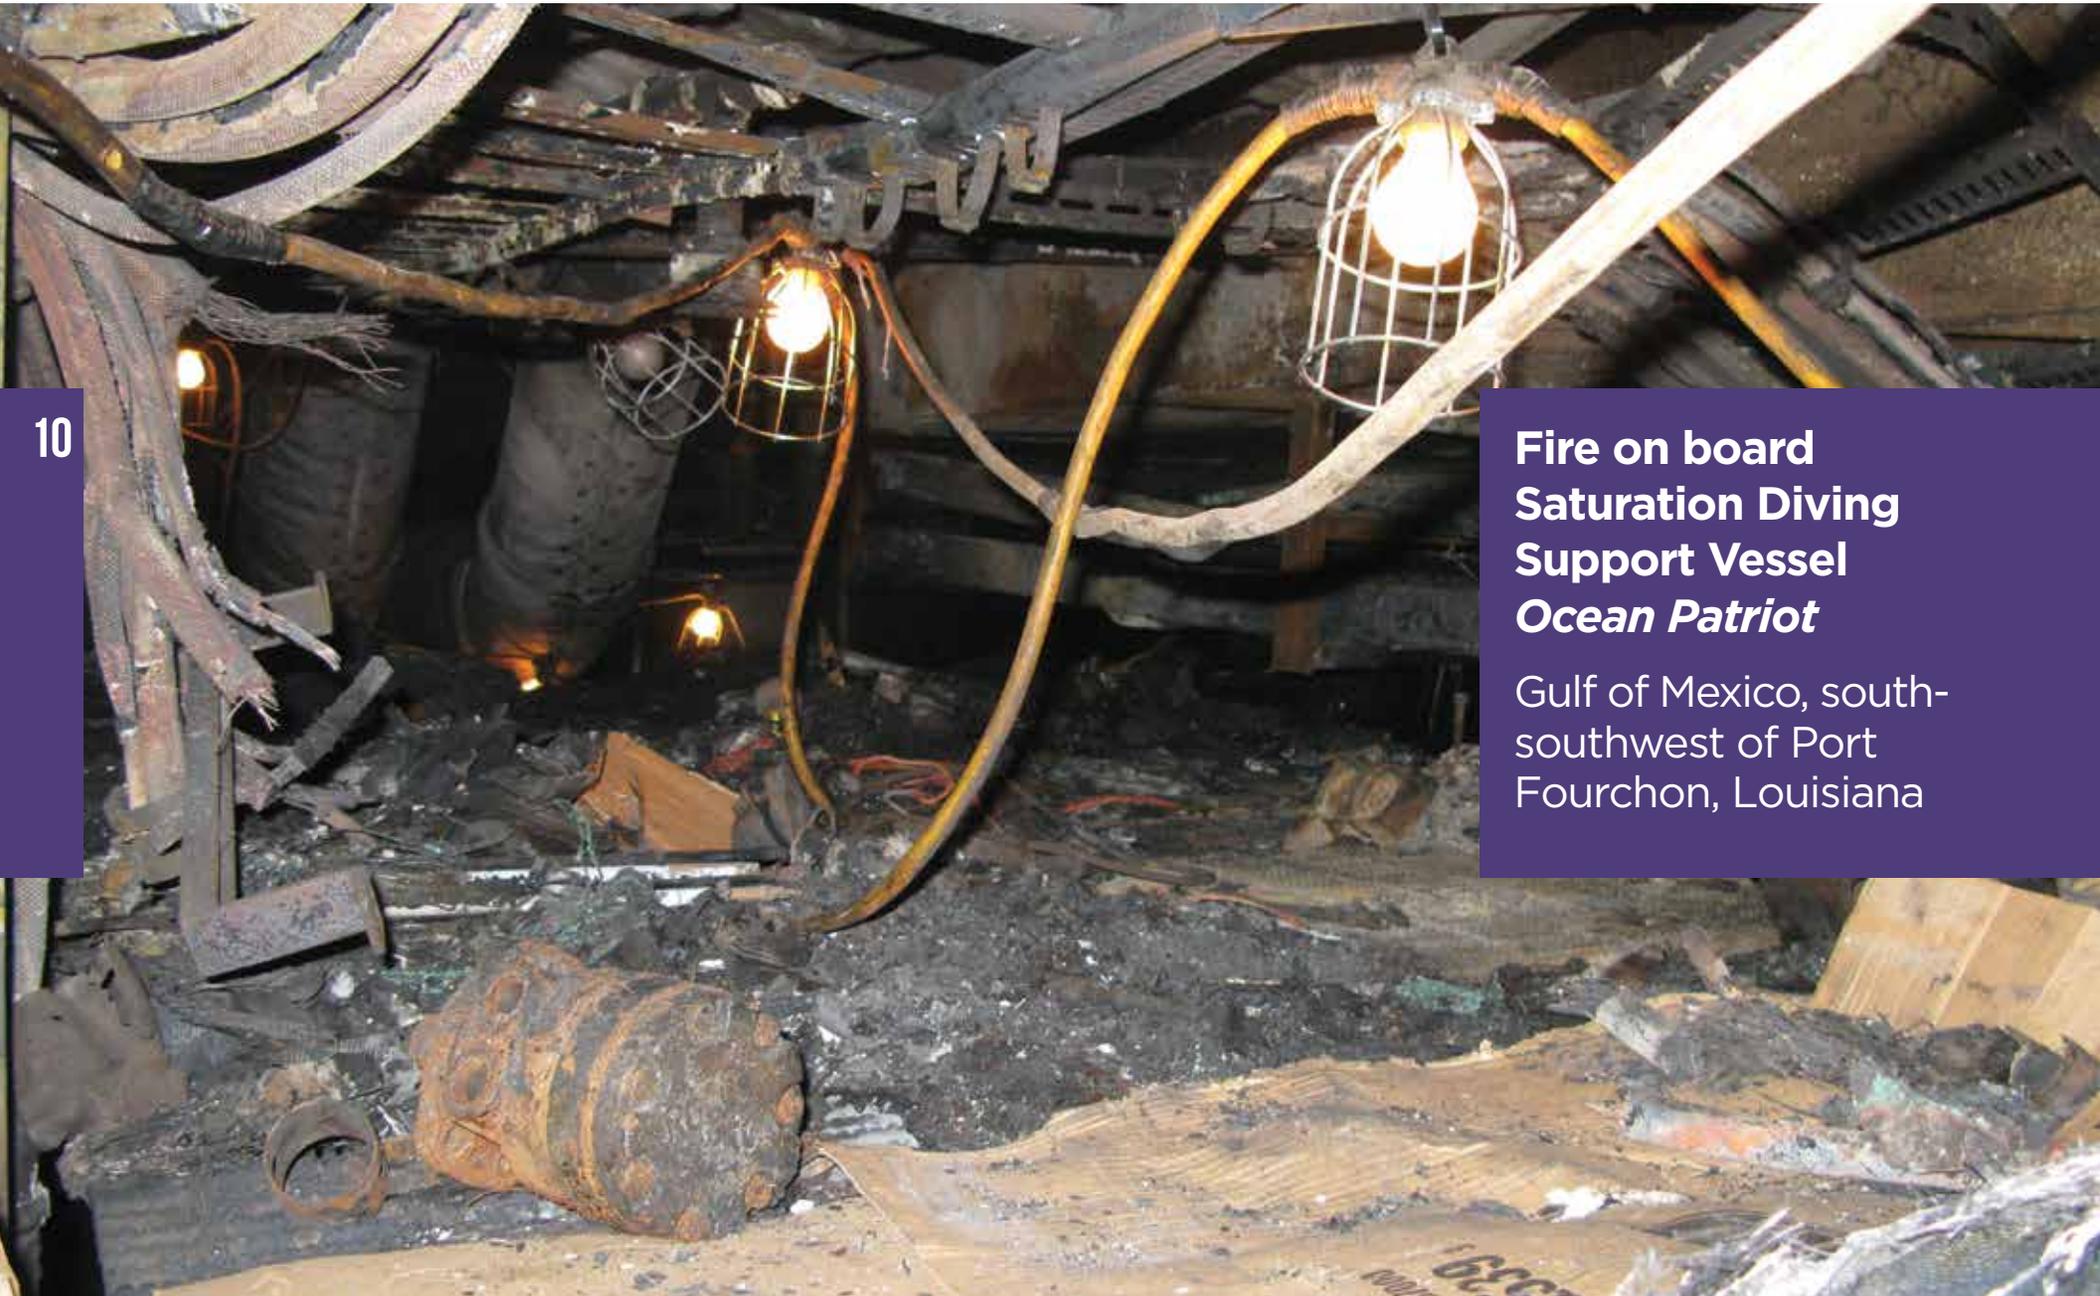
Damaged electrical cables and cable tray on Ocean Patriot. OPPOSITE PAGE, the vessel after the fire.

An integrated forensic engineering investigation firm confirmed that the source of ignition was damaged electrical cables located in a cable tray that contained combustible material in storage racks just below. The fire damaged motor control centers and their associated cabling, helium storage bottles, a ventilation trunk, and various piping systems. Considerable smoke and soot damage was found in the machinery space, and the diving deck equipment stored there was also damaged. A main generator and frequency drive sustained water damage, and heat from the fire caused severe buckling to the main deck in the changing area.

The National Transportation Safety Board determined that the probable cause of the fire on board the *Ocean Patriot* was damage to electrical cables due to the tightly installed metal securing bands in a cable tray chafing the protective layers of the cables and creating an ignition point. Contributing to the extensive damage was the combustible material stored immediately below the cable tray area fueling the fire.

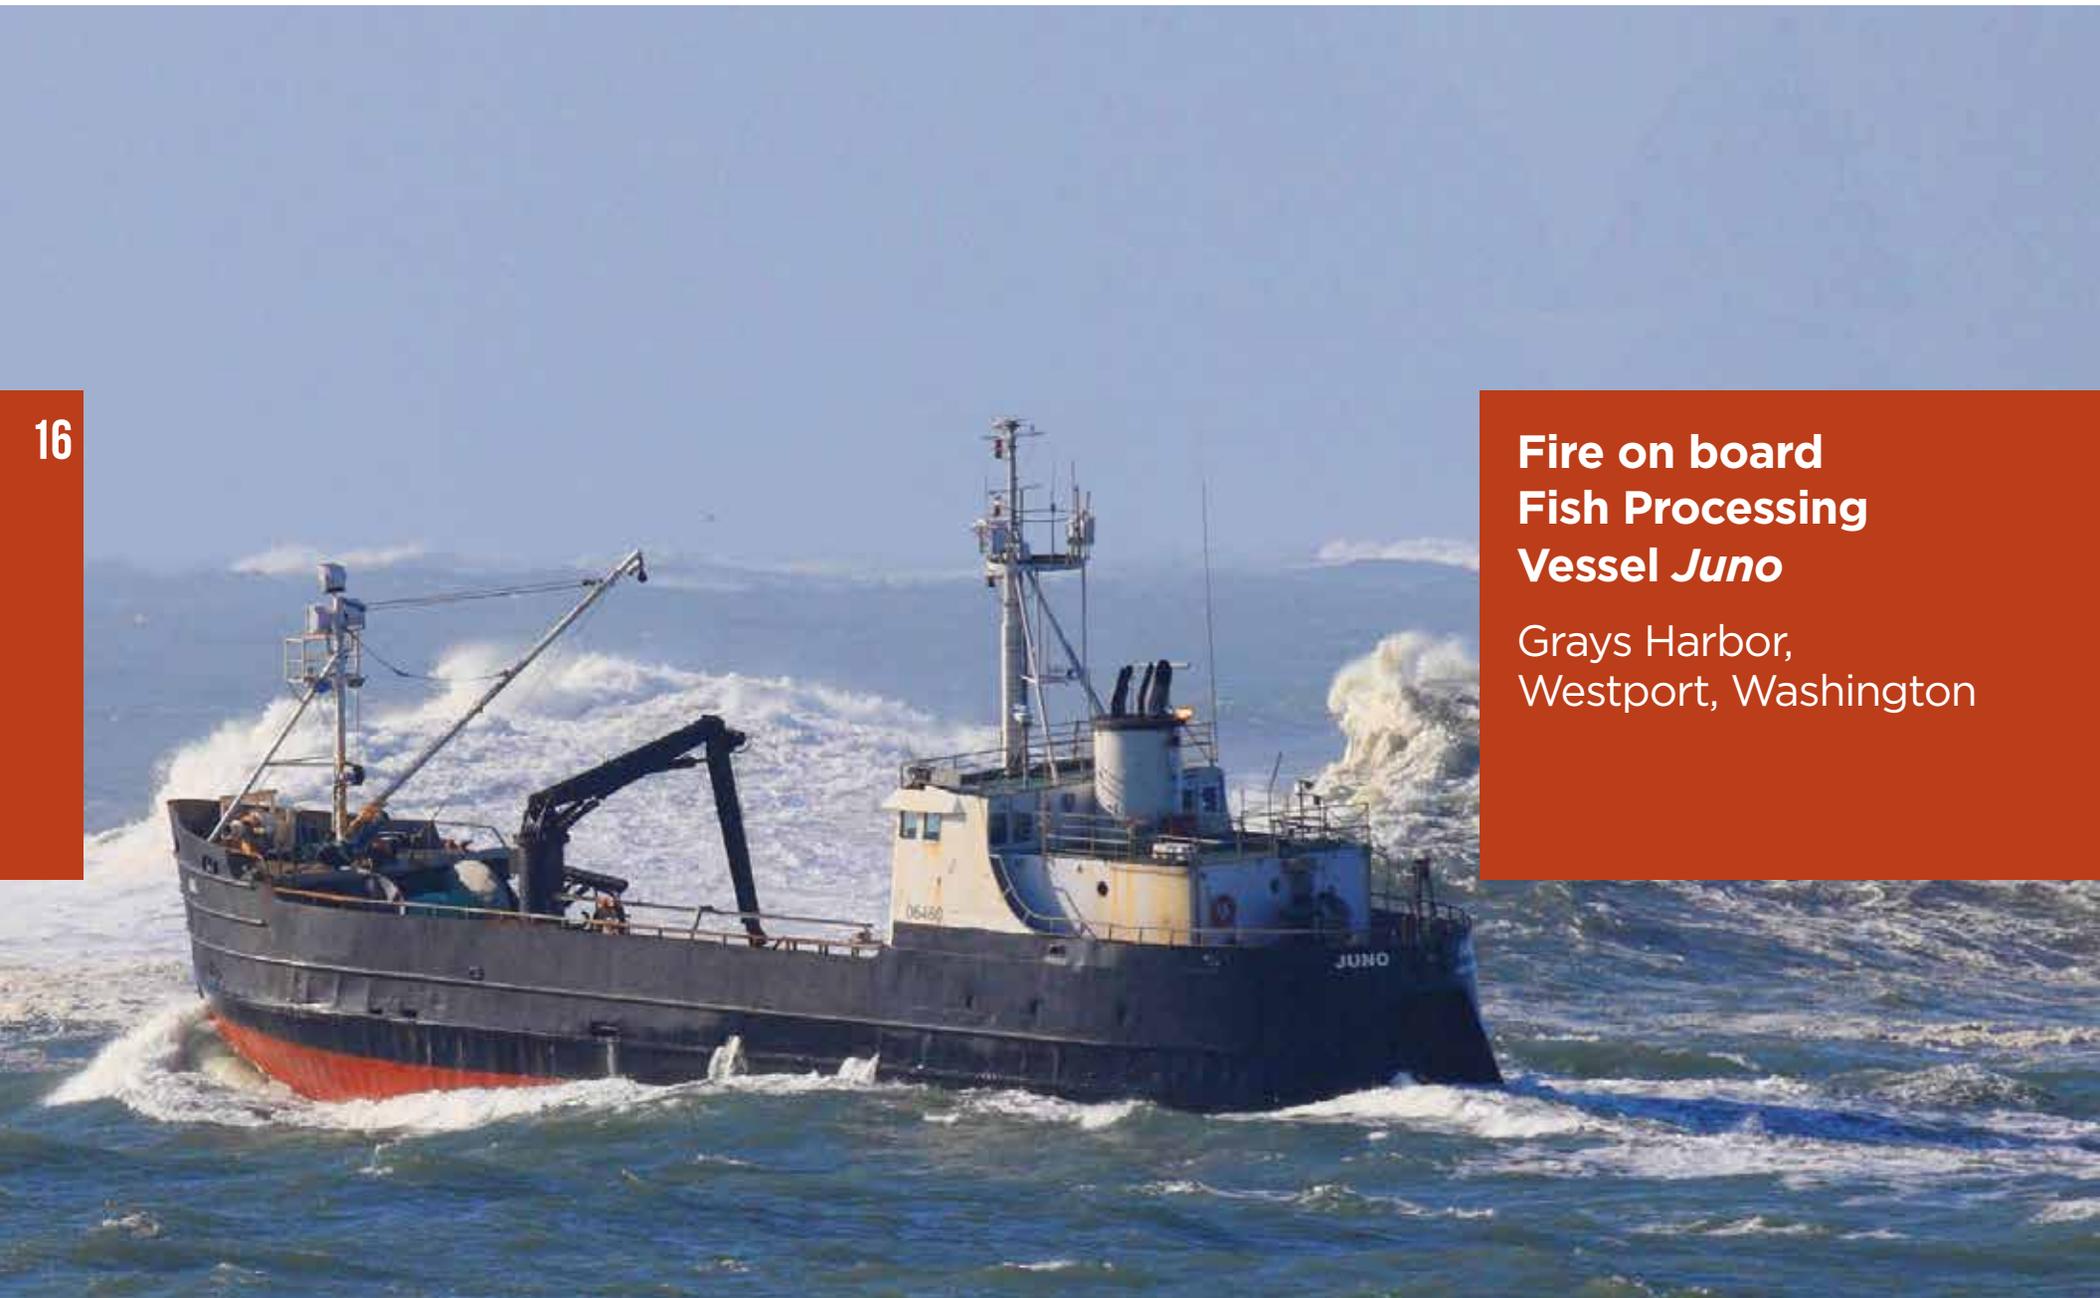
Juno under way before the accident (photo by Florian Kainz). OPPOSITE PAGE, fire damage to the stack and aft end of the vessel's house structure.

The fire department report stated, "A lack of built-in 'structural fire stops' in the vessel ...created a chimney effect which allowed superheated gases to spread to the cabin areas." In addition, the report found that modifications made to the vessel using combustible interior finishes such as plywood and wood paneling contributed to the fire's propagation.

The National Transportation Safety Board determined that the probable cause of the fire on the fish processing vessel *Juno* was a space heater that experienced an electrical fault (short circuit). Contributing to the extent of the fire's damage was the improper stowage of flammable materials near the heater. Also contributing was the vessel's lack of structural fire protection and use of combustible materials in interior finishes.

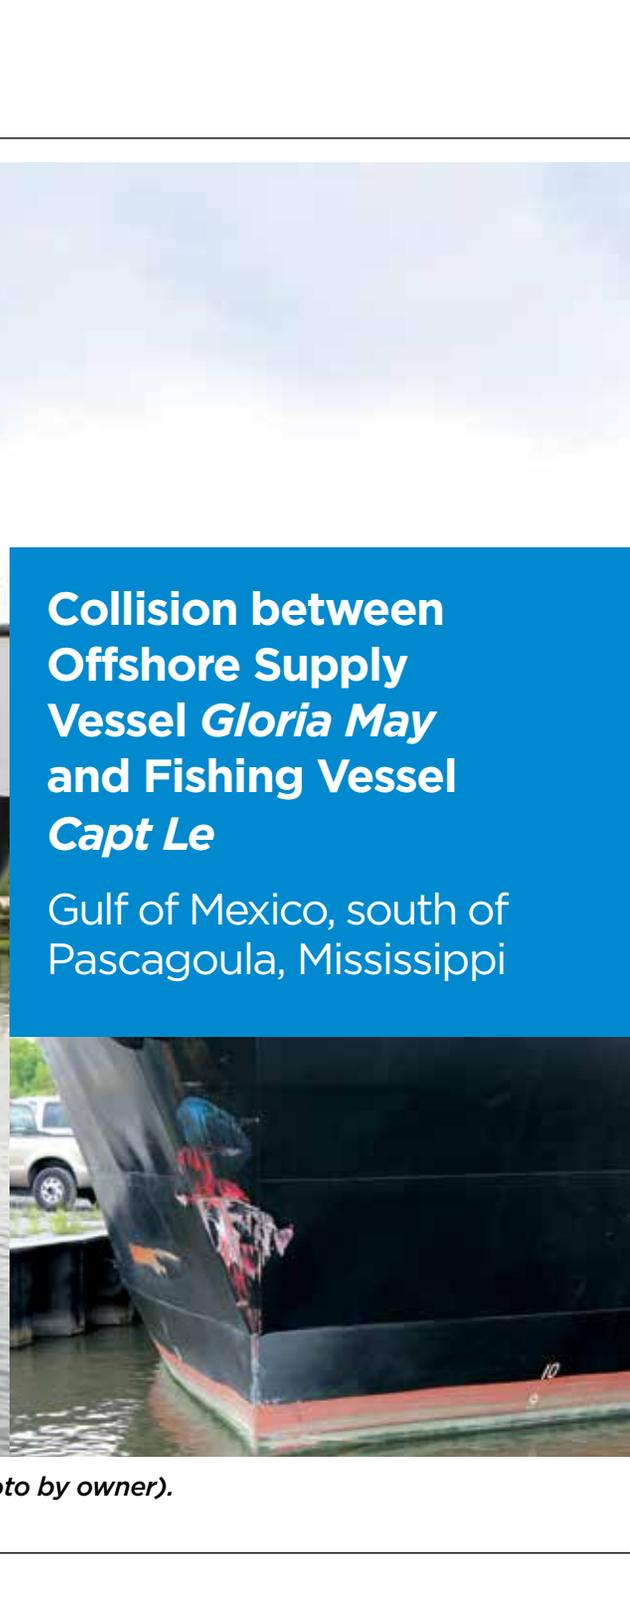
Scraping and denting damage to the bow of *Gloria May*. OPPOSITE PAGE, *Capt Le* before the accident (photo by owner).

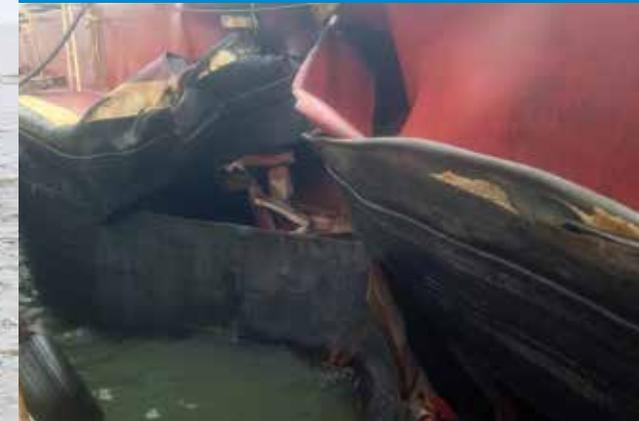
Bow damage of Summer Wind. ABOVE RIGHT, punctured hull on the starboard side of the lead barge in Miss Susan tow (photo by Coast Guard).
